**INSPECTOR GENERAL  
DEPARTMENT OF DEFENSE  
400 ARMY NAVY DRIVE  
ARLINGTON, VIRGINIA 22202-2884**

May 21, 1991

SUBJECT: Report on the Audit of Performance and Reliability of  
Cobra Helicopter Rotor Blades (Report No. 91-082)

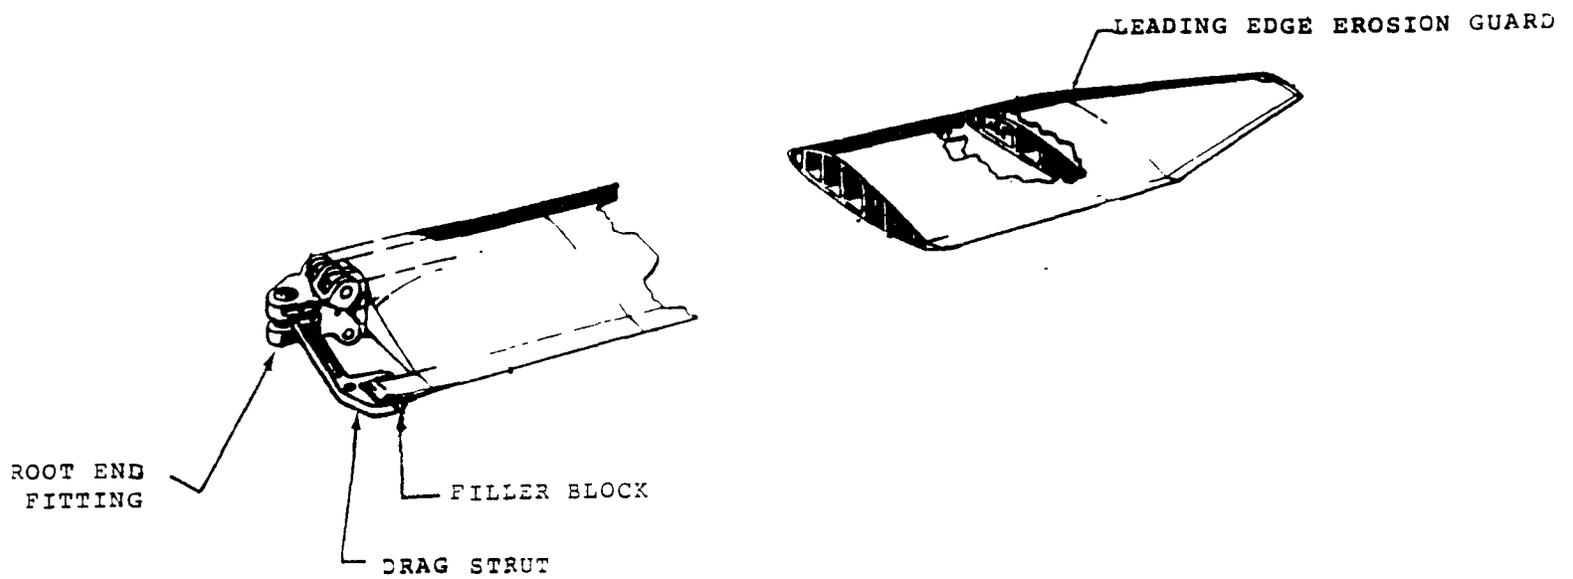
COBRA HELICOPTER K747 MAIN ROTOR BLADE

The K747 blade that is used as the main rotor blade on the AH-1 Cobra Helicopter has had performance and reliability problems. The blade's most serious performance and reliability problems included cracking in the root end fitting and erosion of the blade's leading edge (see Enclosure 1). However, the Government and the blade's manufacturer identified and corrected the problems. The actions appeared to be complete and satisfactory.

The cracks and voids in the blade discovered by Sharpe personnel did not appear to be a problem. Sharpe Army Depot's Nondestructive Evaluation Team discovered cracks and voids in the blade drag strut attaching point (see Enclosure 1) by X-ray imaging in February 1989. Sharpe submitted six Quality Deficiency Reports addressing the deficiencies to the Army Aviation Systems Command. The Army Aviation Systems Command's engineering department replied to Sharpe's deficiency reports in February 1990 stating that the cracks and voids that Sharpe identified were located within the filler block of the blade and that cracks and voids in this area were acceptable. The Army Aviation Systems Command's conclusion was based on an engineering evaluation that the contractor performed and the Government's plant representative monitored. Additionally, in June 1990, the Army Materiel Command informally requested that engineering
