DEFENSE INFORMATION SYSTEMS AGENCY  
MEGACENTER CONSOLIDATION

Report No. 98-159

June 22, 1998

Office of the Inspector General  
Department of Defense

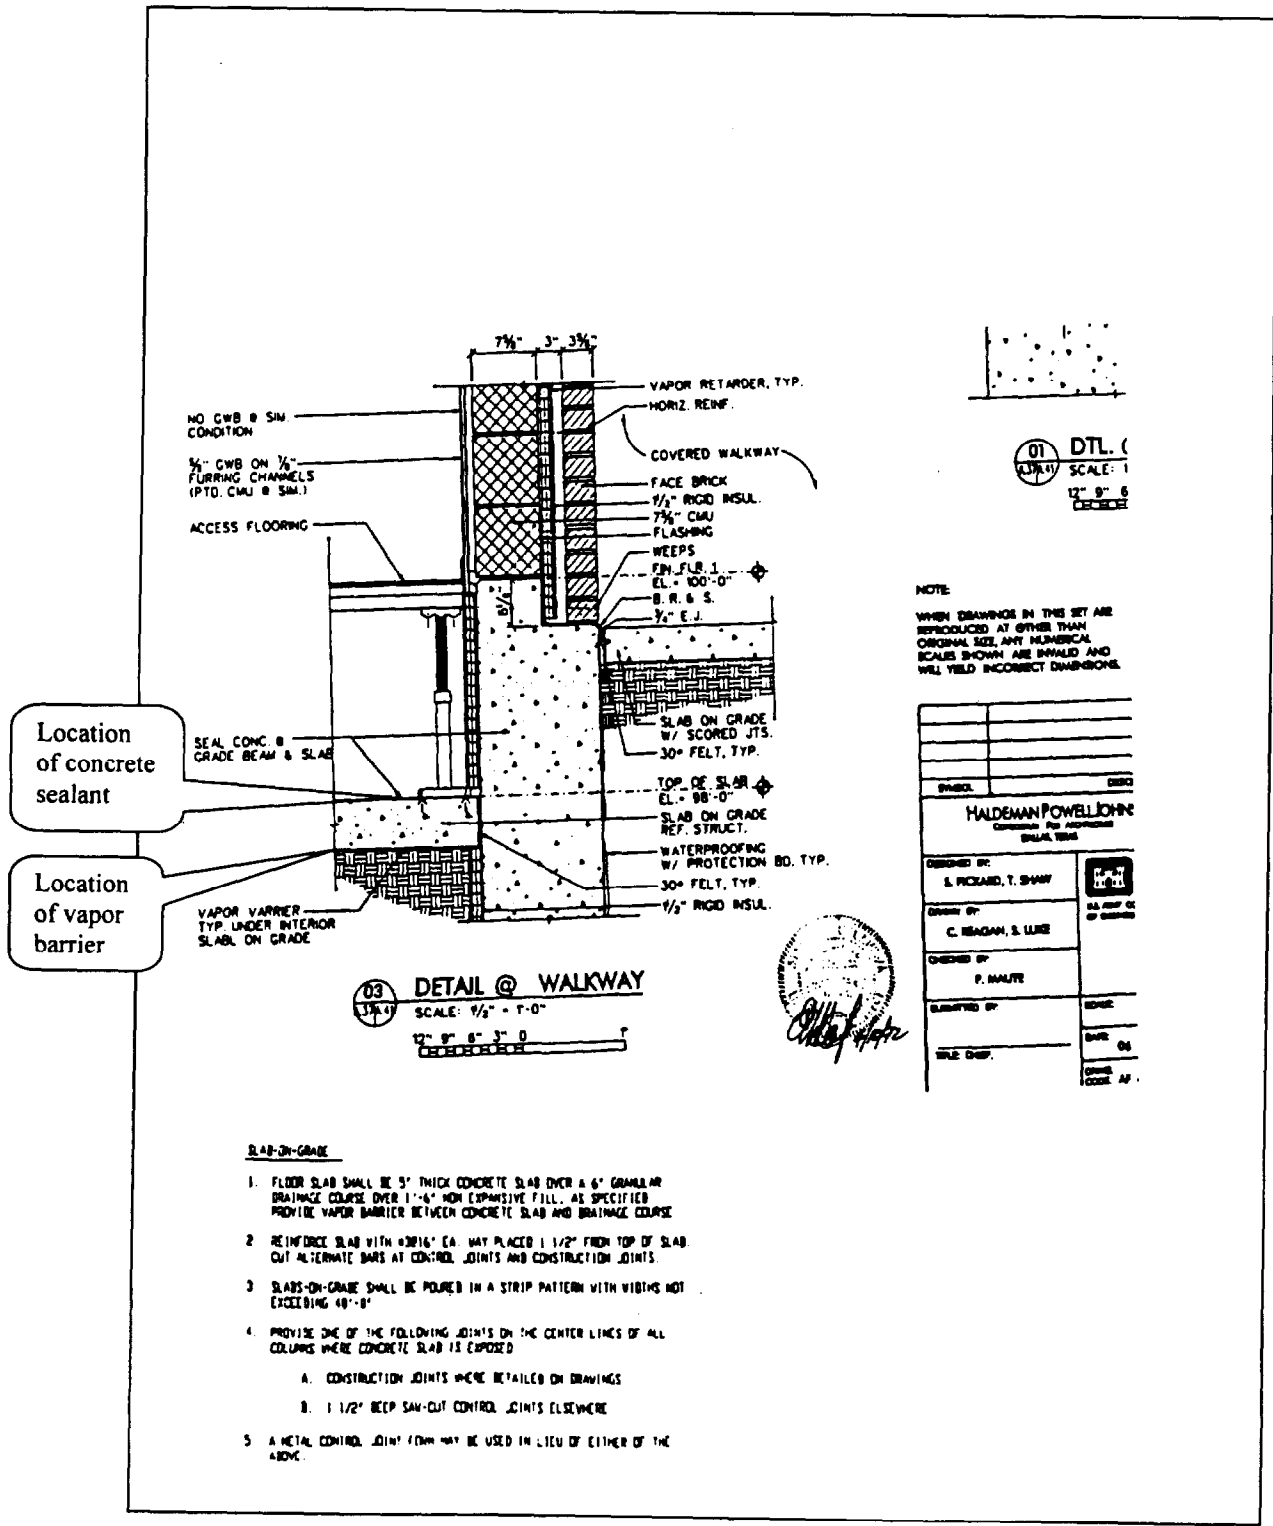
# Appendix I. Concrete Sealant Specifications for DMC Oklahoma City (April 1992)

is finished. The sealer provides a moisture barrier consistent with specifications for megacenter subfloors when this building was constructed in 1994. See Appendix I for a cross-section drawing depicting the application and location of the concrete sealant and vapor barrier.
