Report No. D-2011-088

United States Department of Defense

Ballistic Testing for Interceptor Body Armor Inserts Needs Improvement

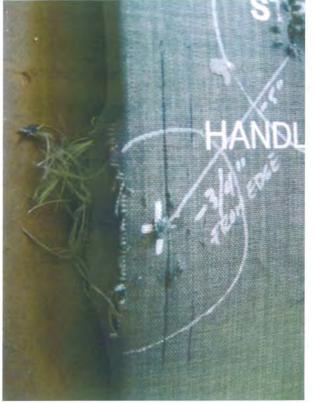
Figure 2. Photograph of the Contested Ballistic Insert

PM SEQ did not properly document and support its decision to overturn a potential catastrophic failure as defined by the COPD. PM SEQ accepted ballistic inserts on contract W91CRB-04-D-0040 although a LAT had a BFD of 48 mm. PM SEQ officials did not adequately document their decision to accept the lot even though the COPD considers a BFD of 48 mm to be a catastrophic failure. The chief scientist claimed that the lot did not fail because the shot was too close to the edge. The COPD requires that the first shot be between .75 and 1.25 inches from an edge. PM SEQ did not document the incident.

On March 29, 2007, an additional ballistic insert was tested and achieved a passing score. Based on this test, PM SEQ accepted and distributed the lot. Figure 2 contains a photograph of the ballistic insert, taken by the contractor and provided to us by PM SEQ. However, there were no identifiable serial numbers or tile numbers to indicate that the ballistic insert in question was the same as the one in the photograph. We asked to see the ballistic insert, but PM SEQ staff could not locate it.

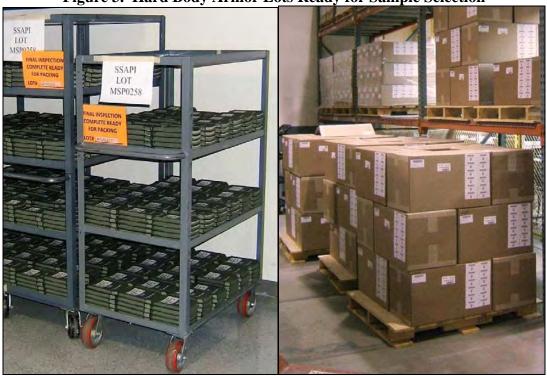
Figure 3. Hard Body Armor Lots Ready for Sample Selection

The LAT sample selection process begins when contractor personnel notifying DCMA QARs that a lot is ready for a LAT. Depending on the lot size, the QAR selects three, five, or eight samples. Figure 3 shows examples of lots ready for sample selection.

DCMA Phoenix QARs did not use an appropriate sample selection process for selecting of ballistic inserts, and their method did not ensure that all items in the lot had the same probability of being selected for testing. This negated the sample test results and diminished the possibility the test labs would identify defects during LATs. In April 2010, we interviewed two QARs responsible for overseeing the BAE Systems and ArmorWorks contracts to identify the sampling methodology used to select ballistic inserts for LATs.
