Report No. DODIG-2012-132 September 14, 2012

Project Planning Resulted in Outstanding Building Deficiencies and Decreased Functionality of the Main Fire Station at Naval Station Great Lakes

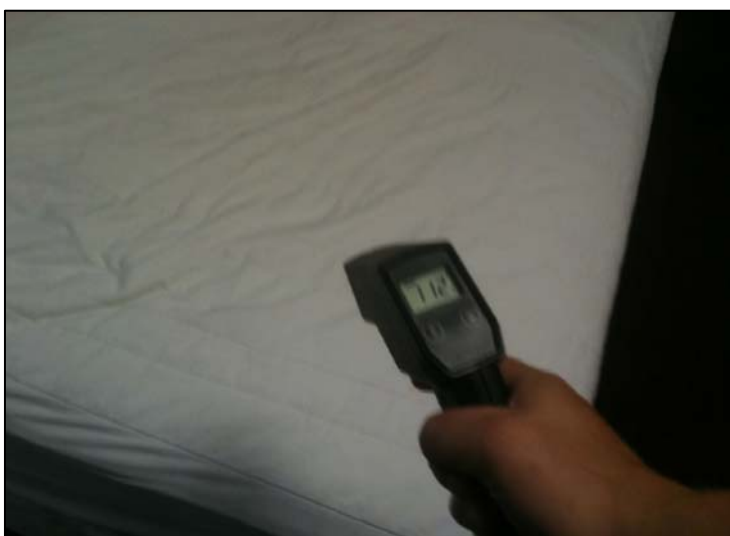
Firefighters stated that during the winter, temperatures inside the dorm rooms reached 55 degrees Fahrenheit and, during the summer, temperatures reached 112 degrees Fahrenheit...

Figure 4. Temperature Inside a Dorm Room Exceeded 100 Degrees Fahrenheit

112 degrees Fahrenheit, as shown in Figure 4. Before the renovation, a radiator regulated the temperature in the fire station. After the renovation, the dorm rooms had a centralized thermostat control, but problems with the heating and air conditioning made the rooms extremely uncomfortable and almost uninhabitable. When firefighters respond to emergency calls, their ability to perform their work is directly tied to how rested they are. Living conditions in the fire station did not provide a comfortable and relaxing environment, which may affect the performance of the firefighters when responding to emergencies. According to the Naval Station Great Lakes Fire Chief, NAVFAC Midwest and the contractor repaired the condenser, condenser fan, and computer board for the HVAC system. Additionally, NAVFAC Midwest officials and the contractor verified temperature readings in September 2011. However, according to the Naval Station Great Lakes Deputy Fire Chief, as of April 2, 2012, neither the contractor nor NAVFAC Midwest corrected the HVAC issues. The Deputy Fire Chief stated that firefighters continue to experience problems with the temperatures throughout the fire station. On April 11, 2012, NAVFAC Midwest officials stated that they would work with the Great Lakes Fire Department to address the temperature issues in the dorm rooms.

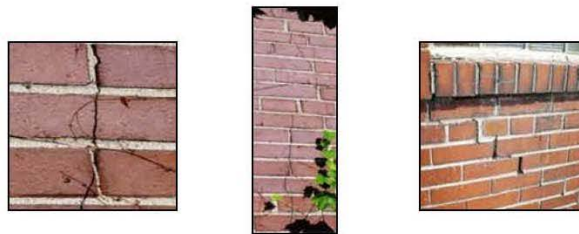
Preliminary Results: West Exterior Wall Cracks

As of August 26, 2011, the audit team observed vertical cracks on the west exterior brick wall.

- The Phase II Technical Proposal, Factor 2, Exterior Architectural Elements, states that for Exterior Masonry Walls, "the exterior brick and masonry façade, parapet wall and coping requires some maintenance consisting of tuck pointing and the repair of vertical cracks and water infiltration."
