Assessment of the USAF Aircraft Accident
Investigation Board (AIB) Report on the F-22A Mishap
of November 16, 2010

SUBJECT: Assessment of the USAF Aircraft Accident Investigation Board (AIB) Report on the F-22A Mishap of November 16, 2010 (Report No. DODIG-2013-041)

F-22A, T/N 06-4125

DATE OF ACCIDENT: 16 NOVEMBER 2010

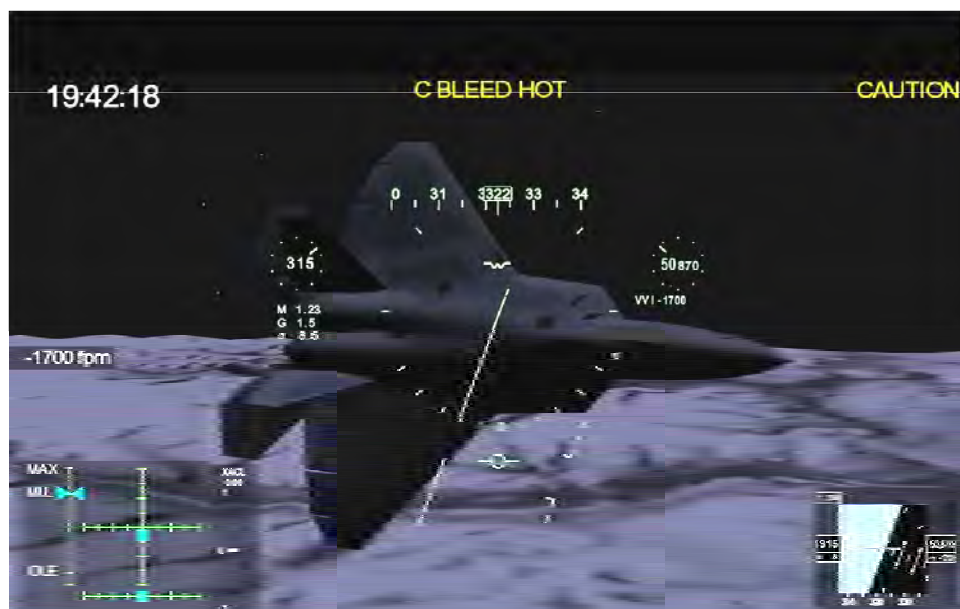
The MA was at 50,870 ft MSL, 315 knots calibrated airspeed (KCAS), 1.23 M, with an attitude of 1 degree nose up, 69 degrees right wing down (RWD), heading 323 degrees, 1.5 g, and with a vertical velocity indication (VVI) of -1,700 ft per minute (fpm). (Tab EE)

Figure 2 19:42:18 -- MA parameters at assertion of C BLEED HOT caution ICAW. (Tab EE) See Tab Z-10 for a diagram explaining the symbology in the Figures.
