INSPECTOR GENERAL

SEPTEMBER 30, 2014

Military Housing Inspections – Japan

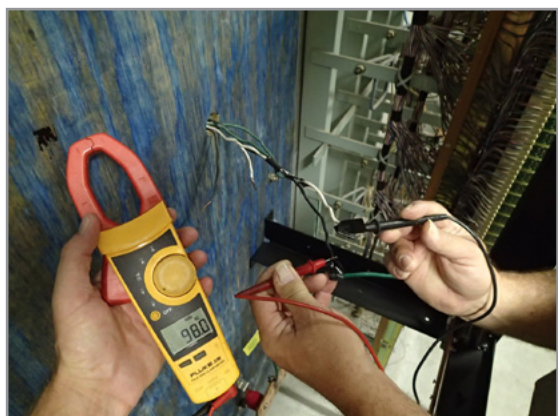
Figure 3. Live wires hanging out of wall without proper enclosure protecting from accidental contact (Deficiency No. ATS-EL-130917-018)
Source: DoD OIG

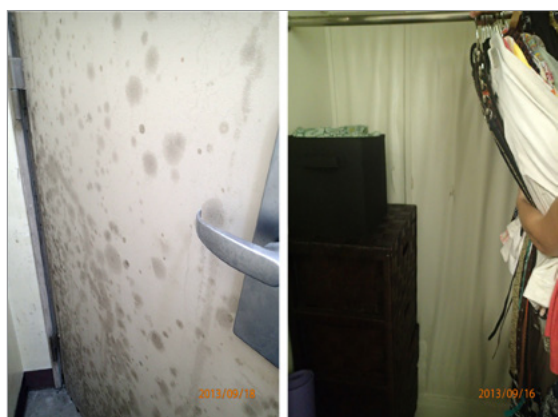
Figure 4. Left: Mold blooms inside barracks (Deficiency No. ATS-EN-130917-009A) Right: Warped paint from moisture/condensation inside single family housing unit (Deficiency No. ATS-EN-130917-008A)
Source: DoD OIG

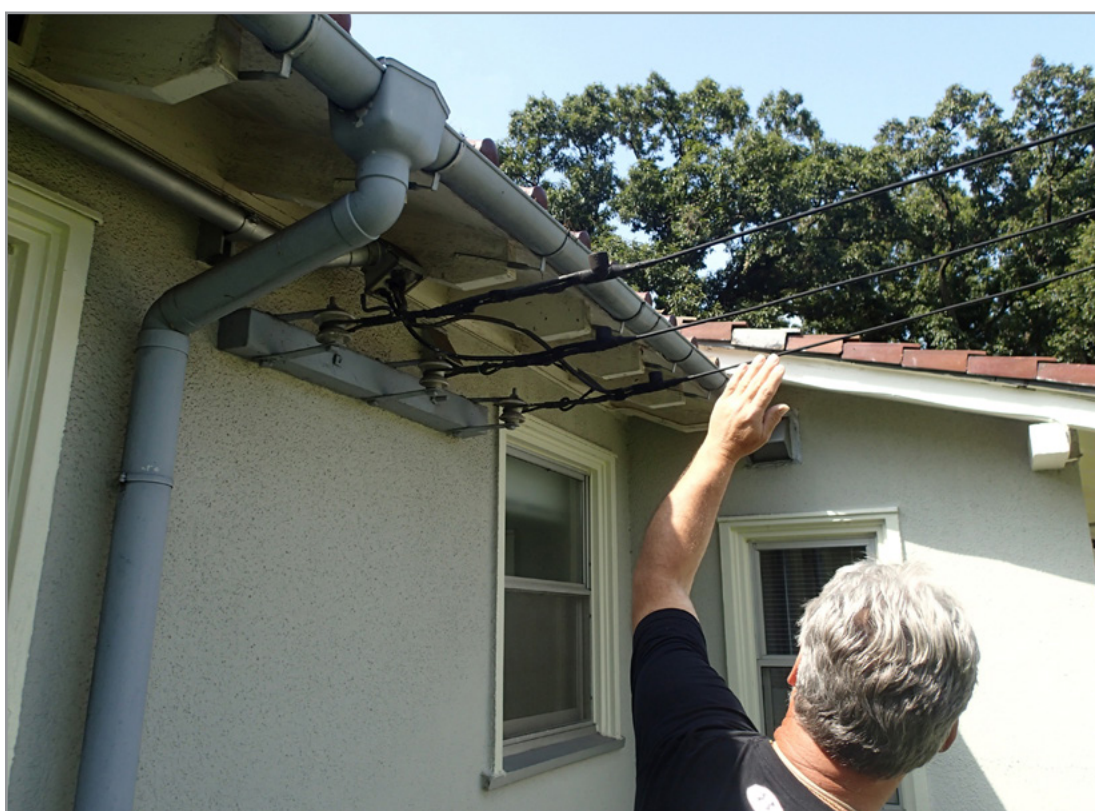
From September 23 through September 24, 2013, we inspected 29 units in 13 buildings of various types, including single family dwelling, multi-family dwelling, unaccompanied barracks, and enlisted/officers' quarters. On November 8, 2013, we issued a NOC that detailed 10 deficiencies requiring immediate action (out of the 40 deficiencies identified at Camp Zama). The most widely identified deficiencies included missing smoke alarms and smoke detectors in sleeping areas. We identified instances of low hanging electrical service drops that were installed at only 8 feet 7 inches off the ground rather than the 12-foot requirement, posing a safety hazard to the occupants (see Figure 5).

Figure 5. Example of low-hanging electrical service drops at housing units
(Deficiency No. ZAM-EL-130923-012)
Source: DoD OIG

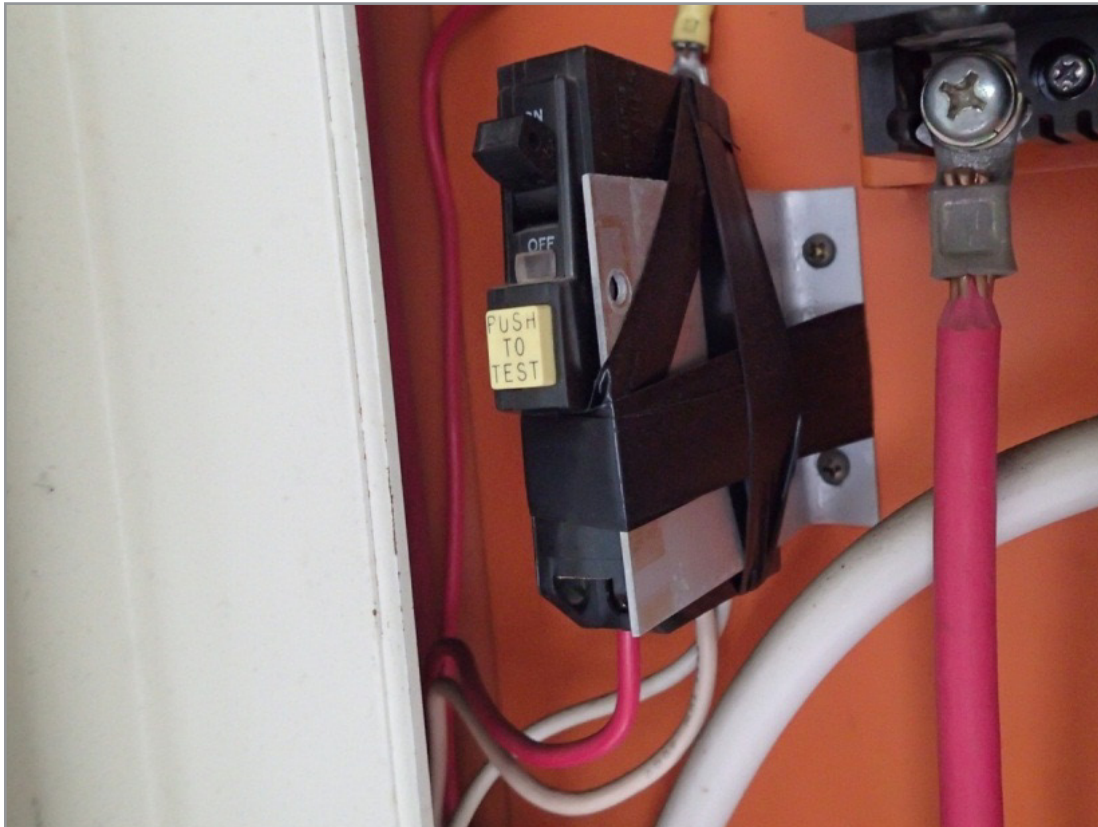
Figure 6. GFCI improperly secured in electrical panel (Deficiency No. YOK-EL-130925-005)
Source: DoD OIG

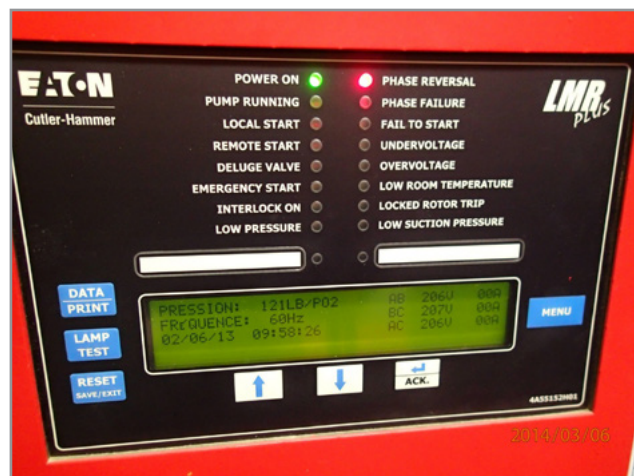
Figure 7. Fire pump controller electrical phase reversal fault rendering the fire pump and the sprinkler system completely out of service (Deficiency No. IWA-FP-140303-103)
Source: DoD OIG

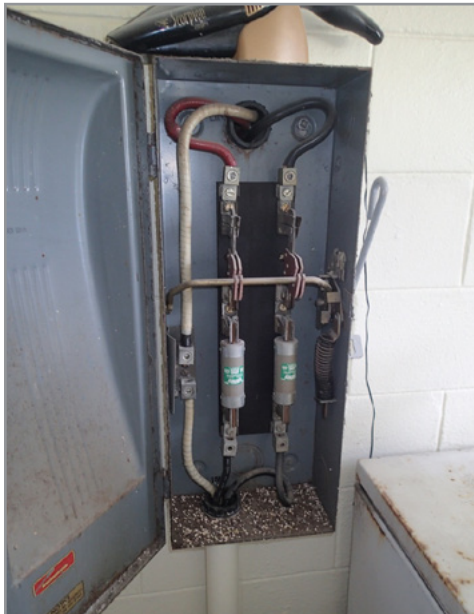
Figure 9. No earth grounding electrode conductor in service panel for single family house
(Deficiency No. FOS-EL-131104-057)
Source: DoD OIG

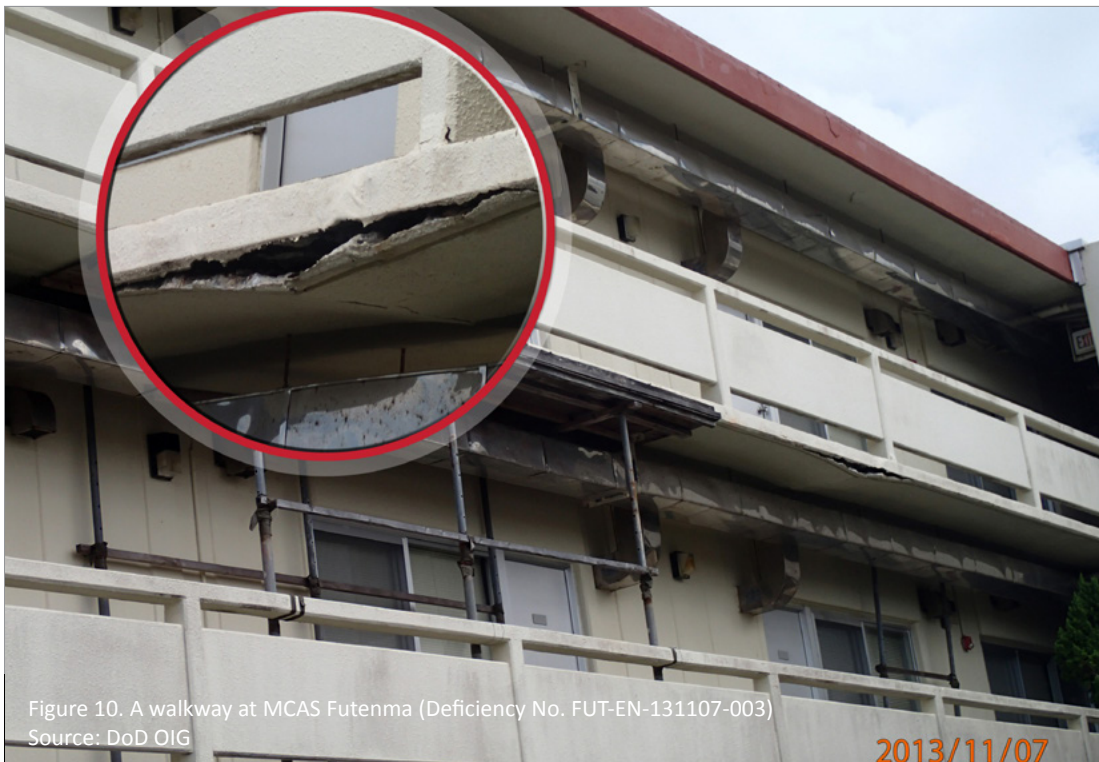
NOC deficiencies specific to some installations were noted. At Camp Schwab, we identified a hazardous electrical front panel cover, which could increase the risk of electrocution. We also identified ungrounded single family houses at Camp Foster (see Figure 9). At MCAS Futenma, we identified a critical deficiency due to a building with significant structural damage (deteriorated concrete exposing the steel reinforcements and rapidly corroding walkways), which presented a danger to building occupants of falling concrete debris and possible structural collapse. We also identified areas where concrete was separating from the underside of a walkway on the third floor as shown in Figure 10. The walkway had inadequate structural reinforcement

and no means of protection from debris and collapse. At Camp Courtney, we identified a damaged exterior railing, which created a falling hazard for the occupants. Also, our independent radon measurements identified two buildings with measurements in excess of EPA recommended levels; one at Camp Courtney, and one at MCAS Futenma.

Figure 10. A walkway at MCAS Futenma (Deficiency No. FUT-EN-131107-003)
Source: DoD OIG
