INSPECTOR GENERAL

SEPTEMBER 24, 2015

Continental United States Military Housing Inspections – Southeast

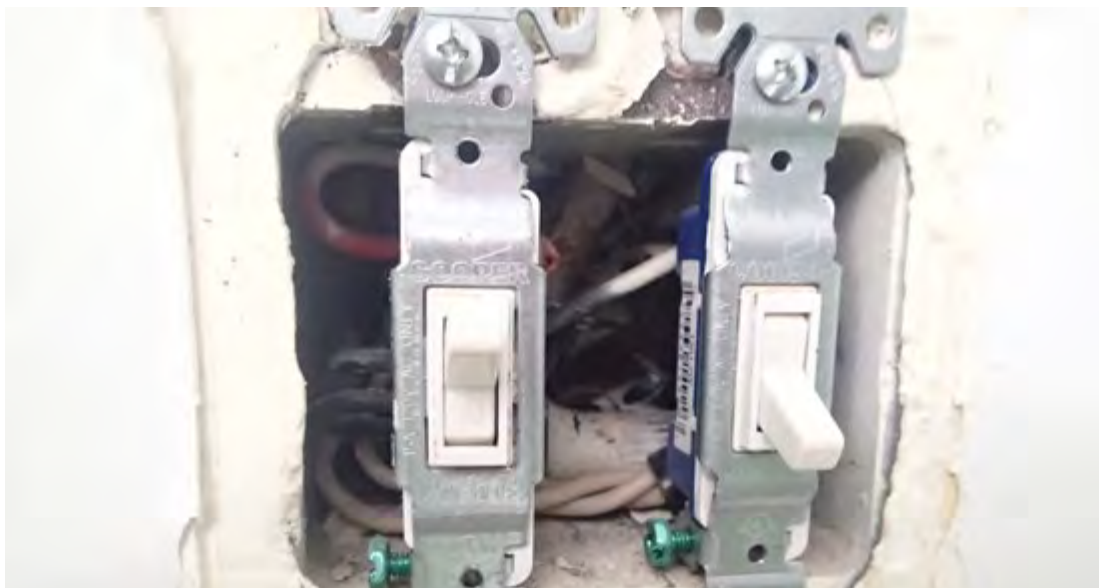
The most significant issue we found was the ground conductors on light switches (see Figure 13) were not connected throughout the homes inspected in the Gordon Terrace, McNair Terrace, and Olive Terrace neighborhoods. In the event of a short circuit to the metallic light switch body, the ground conductor would prevent an individual from being exposed to potentially lethal voltages. We also identified problems with electrical receptacles and wiring as well as the lack of GFCI-protected receptacles in the kitchen areas of a few homes inspected.

Figure 13. An ungrounded light switch in a Fort Gordon family housing unit.
(Deficiency No. FGN-EL-150309-085)
Source: DoD OIG
