INSPECTOR GENERAL

JULY 7, 2016

U.S. Military-Occupied Facilities Inspection—King Abdullah II Special Operations Training Center

U.S. Military-Occupied Facilities Inspection— King Abdullah II Special Operations Training Center

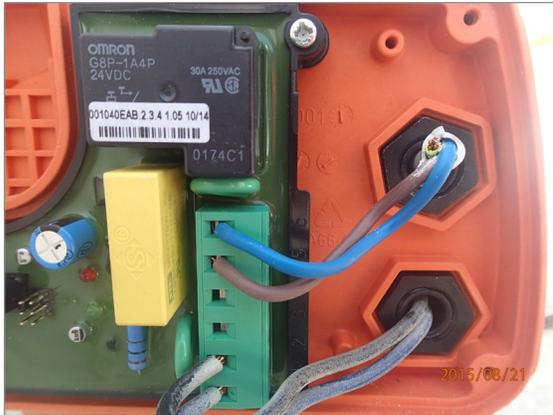
Figure 3. Water circulator motor with the ground conductor cut or missing (Deficiency No. KAS-EL-150828-023 Source: DoD OIG, PO-TAD)

One such critical deficiency included equipment ground conductors which were cut and not utilized, thus leading to potential shock or electrocution of tenants (see Figure 3).

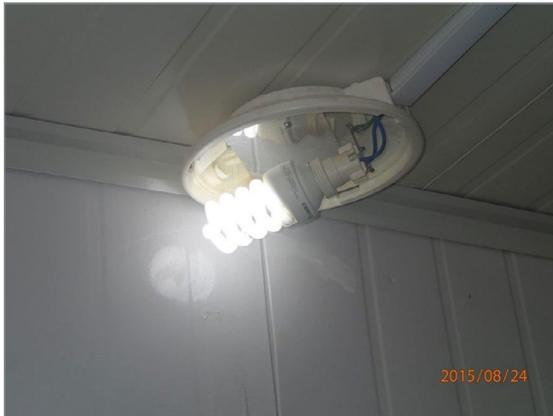
Many latrines, showers, and other bathroom areas had lighting fixtures that were not rated for use in areas that could be exposed to water or moisture. Without “wet labeled” or “damp labeled” indications, light fixtures are not suitable for use in damp conditions. If the fixtures are not designed for these conditions,

they increase the likelihood of electrocution. In many instances, light fixtures were also broken or were missing lens covers, thus exposing wiring to water, which increases the potential for electrical shock or electrocution (see Figure 4).

Figure 4. Light fixtures were missing lens covers and wiring was exposed (Deficiency No. KAS-EL-150828-076) Source: DoD OIG, PO-TAD

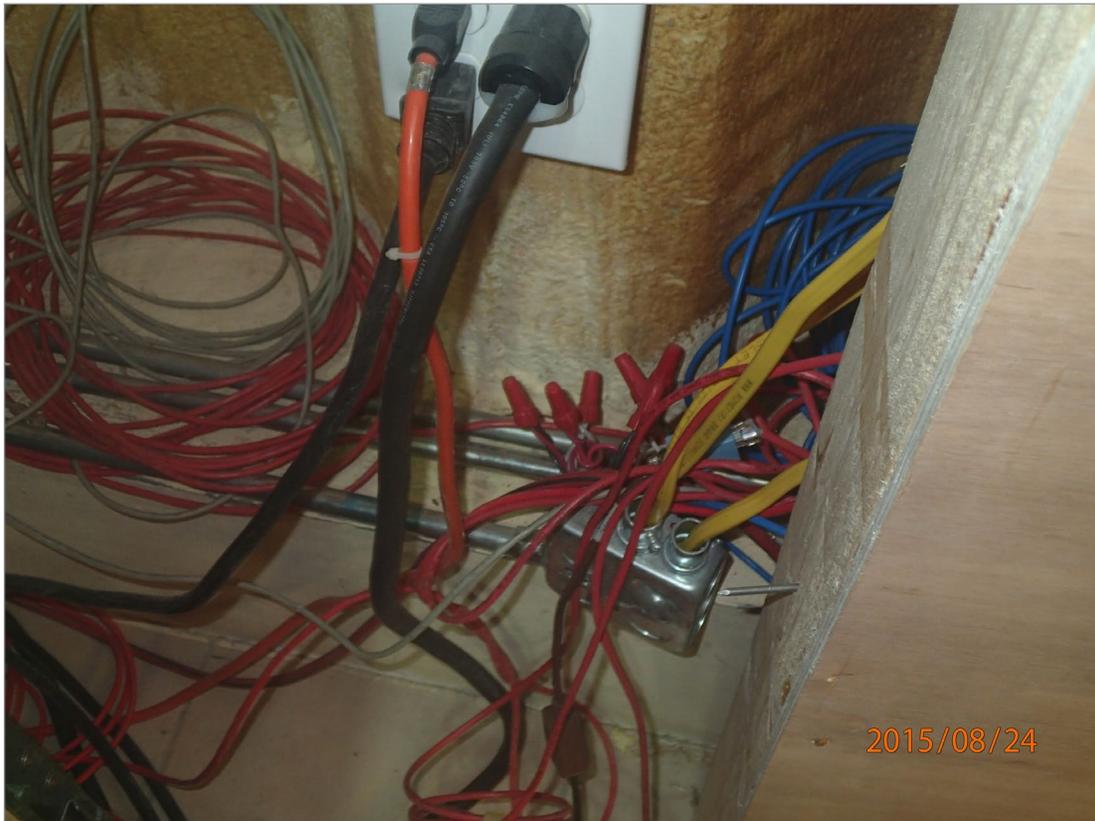
For personal protection deficiencies, we identified several receptacles where ground-fault circuit interrupter (GFCI)¹¹ protection was not used in the required areas, such as near the sink, washer, or water fountain. We also found energized wires that were not installed in junction boxes or they were installed in the junction box but were missing the covers. In addition, bare wires were connected to an electrical receptacle and electrical wire raceway covers were not installed or were broken, resulting in conductors that were lying on the floor or roof. Conductors lying loose on the floor posed a trip hazard and could be damaged, exposing bare wires, which could pose a fire hazard (see Figure 5).

Figure 5. Missing junction box with exposed energized wires (Deficiency No. KAS-EL-150828-074)
Source: DoD OIG, PO-TAD

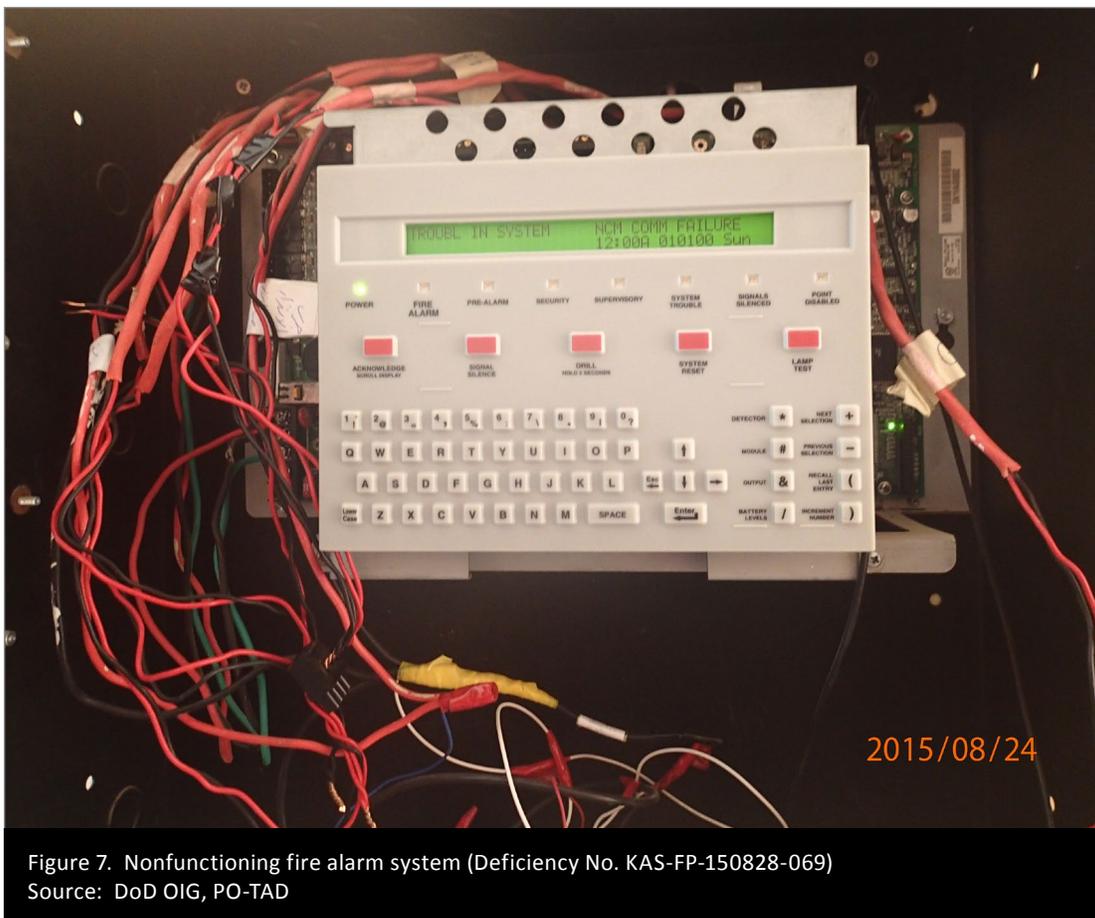
We found six facilities that were not equipped with fire alarm systems, three facilities with fire alarm systems that were completely off or out of service, and three facilities with partially-functioning fire alarm systems (see Figure 7).

Figure 7. Nonfunctioning fire alarm system (Deficiency No. KAS-FP-150828-069)
Source: DoD OIG, PO-TAD

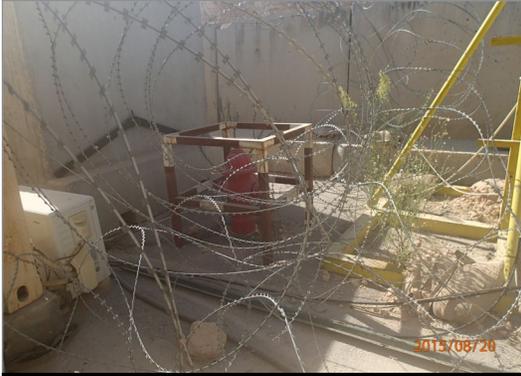
Figure 8A. Fire hydrant obstructed and inaccessible by concertina wire (Deficiency No. KAS-FP-150828-137)
Source: DoD OIG, PO-TAD

We found fire hydrants that were blocked by concertina wire, buried in concrete, placed below the ground surface, and/or tapped as a nonfire-related source of water (see Figures 8A and 8B). Also, there was a lack of fire hydrants in close proximity to several buildings.

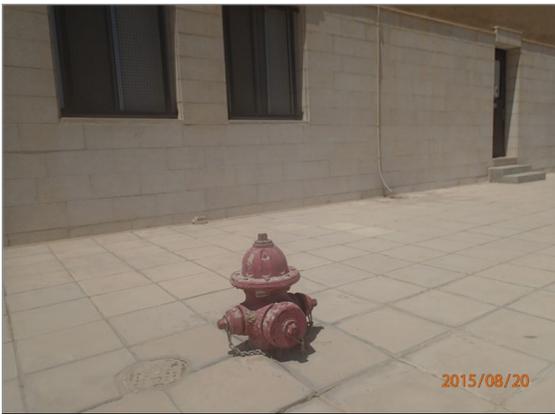
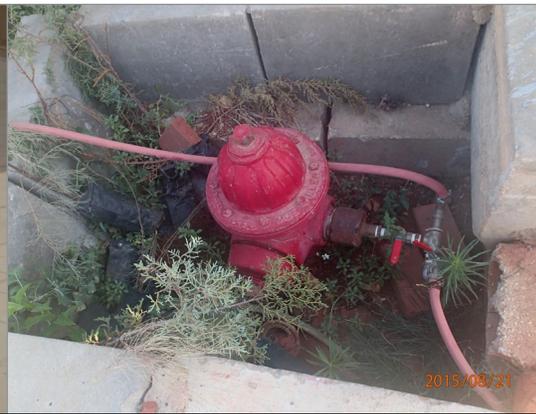
Figure 8B. Fire hydrant buried in concrete and tapped (Deficiency No. KAS-FP-150828-034)
Source: DoD OIG, PO-TAD

These compromised fire hydrants could significantly delay or prevent firefighter response in the event of fire.

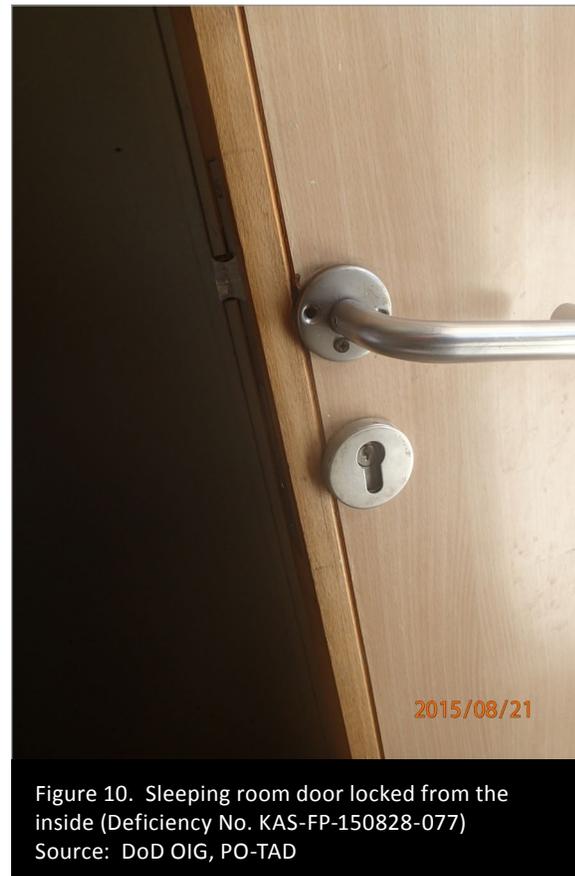
We also found that many doors from sleeping rooms required the use of a key to exit. The locked doors could potentially prevent a person from escaping in the event of an emergency (see Figure 10).

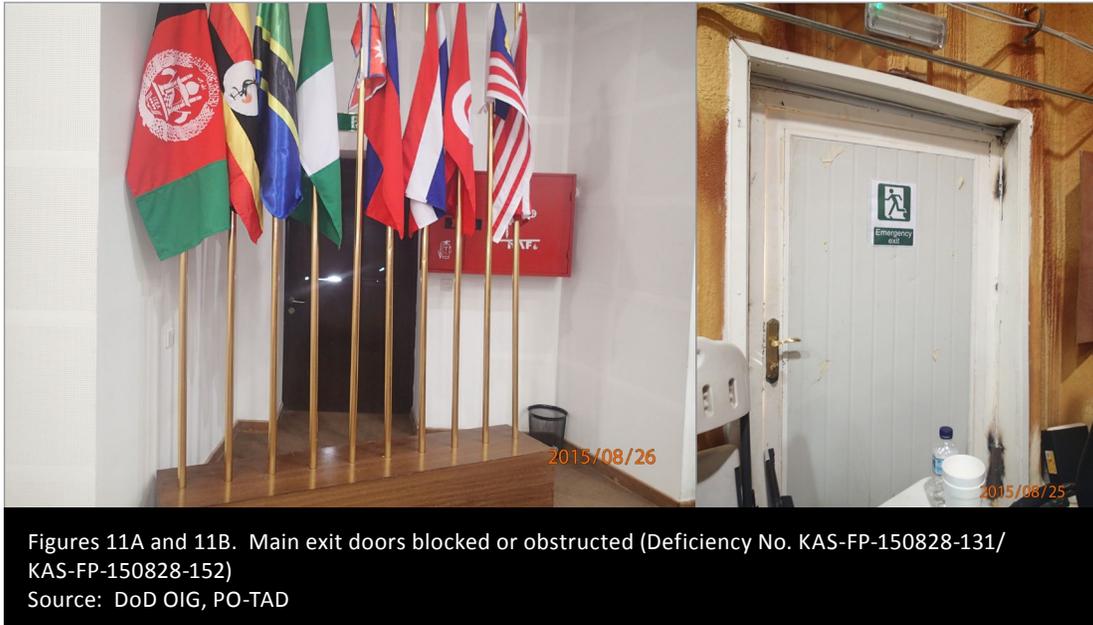
We found rear exits obstructed or blocked, which could slow the occupants' exit during a fire (see Figures 11A and 11B).

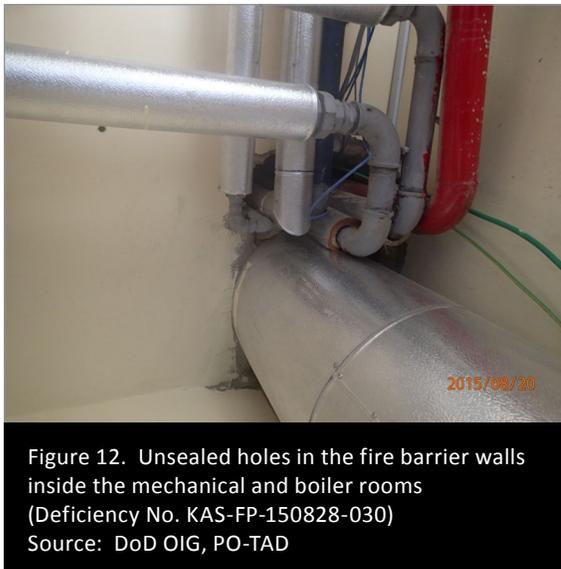
Throughout KASOTC, we found self-closing, fire-rated doors propped open and/or missing self-closure mechanisms, which could allow the rapid spread of fire and smoke throughout the building possibly rendering the exit hallway unusable. Also, many buildings had insufficient exit signage and inoperable emergency lighting, trip hazards over thresholds, and items stored underneath fire exit stairways, compromising the proper fire rating. Mechanical rooms

with diesel fuel equipment did not have carbon monoxide (CO) detection devices or exhaust fan systems. These issues impair the occupants' ability to be made aware of an emergency and safely exit the building in the event of an emergency. We also found numerous unsealed fire wall penetrations due to cable conduits routed through unsealed holes in fire barrier walls in mechanical and boiler rooms, creating a means for fire and smoke to propagate throughout the building (see Figure 12).

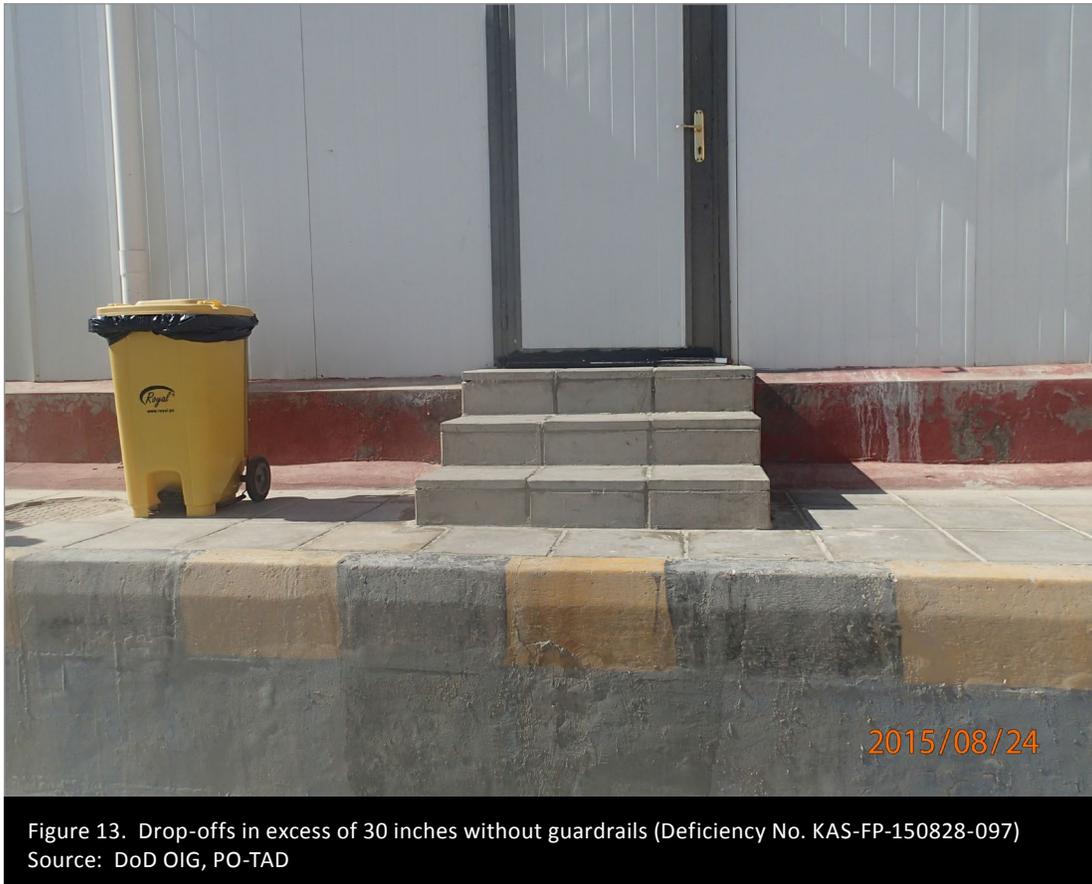
On one of the egress routes, we found drop-offs in excess of 30 inches without guardrails. Occupants could fall over the ledge and injure themselves (see Figure 13).

Figure 13. Drop-offs in excess of 30 inches without guardrails (Deficiency No. KAS-FP-150828-097)
Source: DoD OIG, PO-TAD
