INSPECTOR GENERAL

MAY 10, 2016

Followup Audit: Audit Recommendations From Report No. DODIG-2013-109 Were Not Fully Implemented, but Controls Were in Place to Prevent Unauthorized Access to Robert C. Byrd and Greenup Locks and Dams

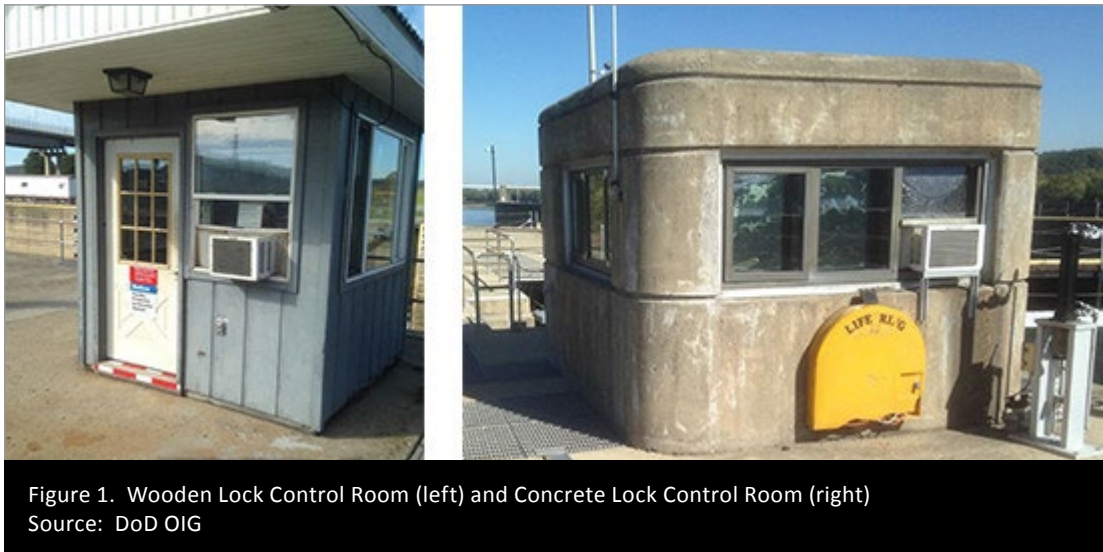
(FOUO) Huntington District personnel [REDACTED] at Greenup. Huntington District personnel determined [REDACTED]. According to Huntington District personnel, sufficient funding was not available to upgrade [REDACTED]

⁸ Although the previous audit recommended the installation of hardened windows at one lock control station, the USACE Huntington District personnel identified a second wooden lock control station that was in disrepair and initiated corrective action.

Huntington District personnel included estimates for upgrading [REDACTED] [REDACTED] as part of the FY 2016 Operation and Maintenance as agreed to in Recommendation A.2.c. However, USACE Huntington personnel stated that the Great Lakes and Ohio River Division did not [REDACTED] [REDACTED]. The Huntington District re-submitted the upgrade package as part of the FY 2017 budget to the Great Lakes and Ohio River Division for budget consideration. Meanwhile, Huntington District personnel installed a key mechanism that [REDACTED] [REDACTED]
