Subj: ATLANTIC AREA BEST PRACTICES: RIVET INSPECTION GUIDANCE

Subj: BEST PRACTICES SUBMISSION

Repair Techniques of Riveted Vessels

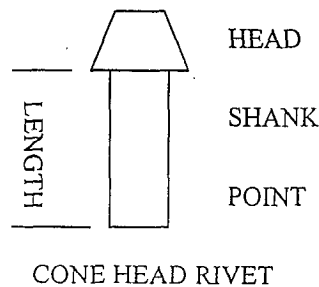
COUNTERSUNK PLATES

When the vessel is dry-docked for a hull survey, the inspection may reveal a variety of repair needs. The point and head of the rivet are examined for deterioration. The vessel may have deteriorated rivet points that are weeping, leaking or loose. Sprung caulking edges on the riveted lap of hull plates caused by minor groundings may be present. The internal survey will also give an indication of the condition of the rivet heads. This is valuable when rivet points on the exterior of the vessel are hard to see because of paint or rust. To test a loose rivet, a finger is placed on one side of the rivet head while tapping on the opposite side of the head with a small hammer. A loose rivet will move or vibrate.

The key areas on the rivet that deteriorate affecting the strength of the joint are the head and the countersunk point. If the head area is reduced in size greater than 20 to 25% of its original size, replacement is required for active ships. Sometimes scale or wastage must be removed to see the actual size of the rivet head. The rivet point acts like a wedge to hold the outside and inside lap tightly together. When this point deteriorates so that part of the point is gone and areas of the plate countersink are visible, rivet failure is possible. Rivet points also lose the ability to be tightened when they deteriorate because of the loss of this wedge portion of countersunk rivet.
