# **SS EL FARO Stability and Structures Preliminary Report Summary**

**Jeffrey W. Stettler, Ph.D., P.E.**

**February 6, 2017**

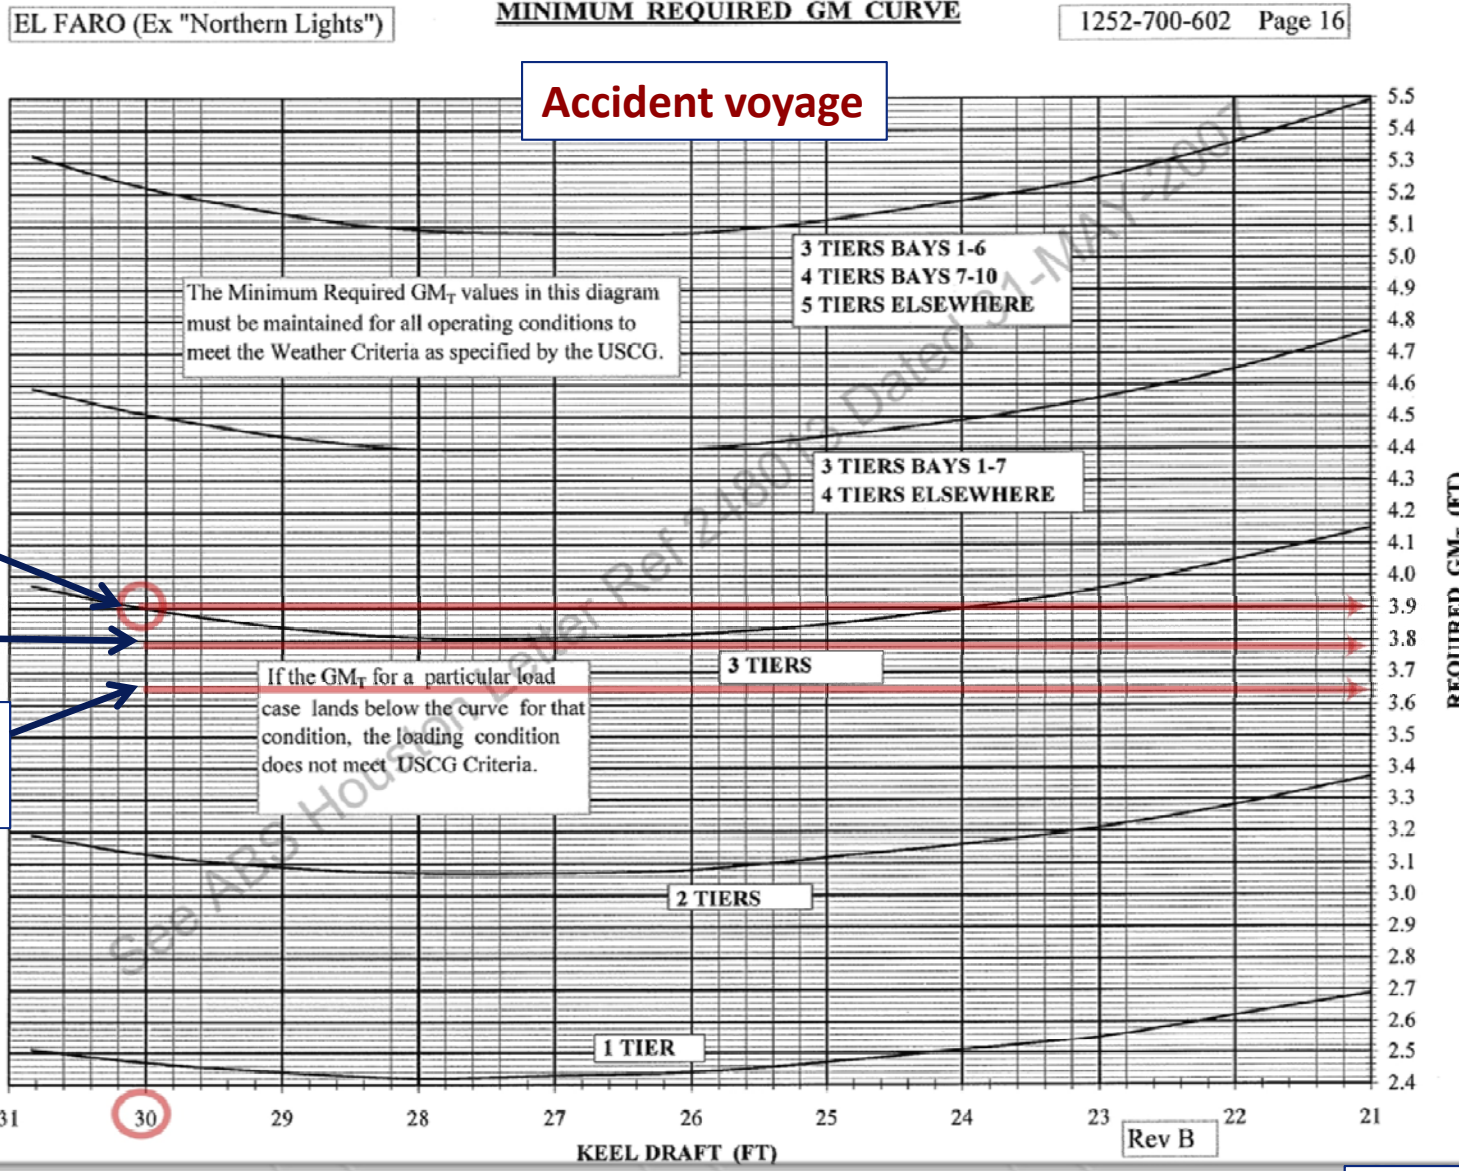
Figure 4-1 (annotated)

Applicable

T&S Booklet (3 tiers)

MSC GHS calculation

CargoMax "auto windheel" calculation

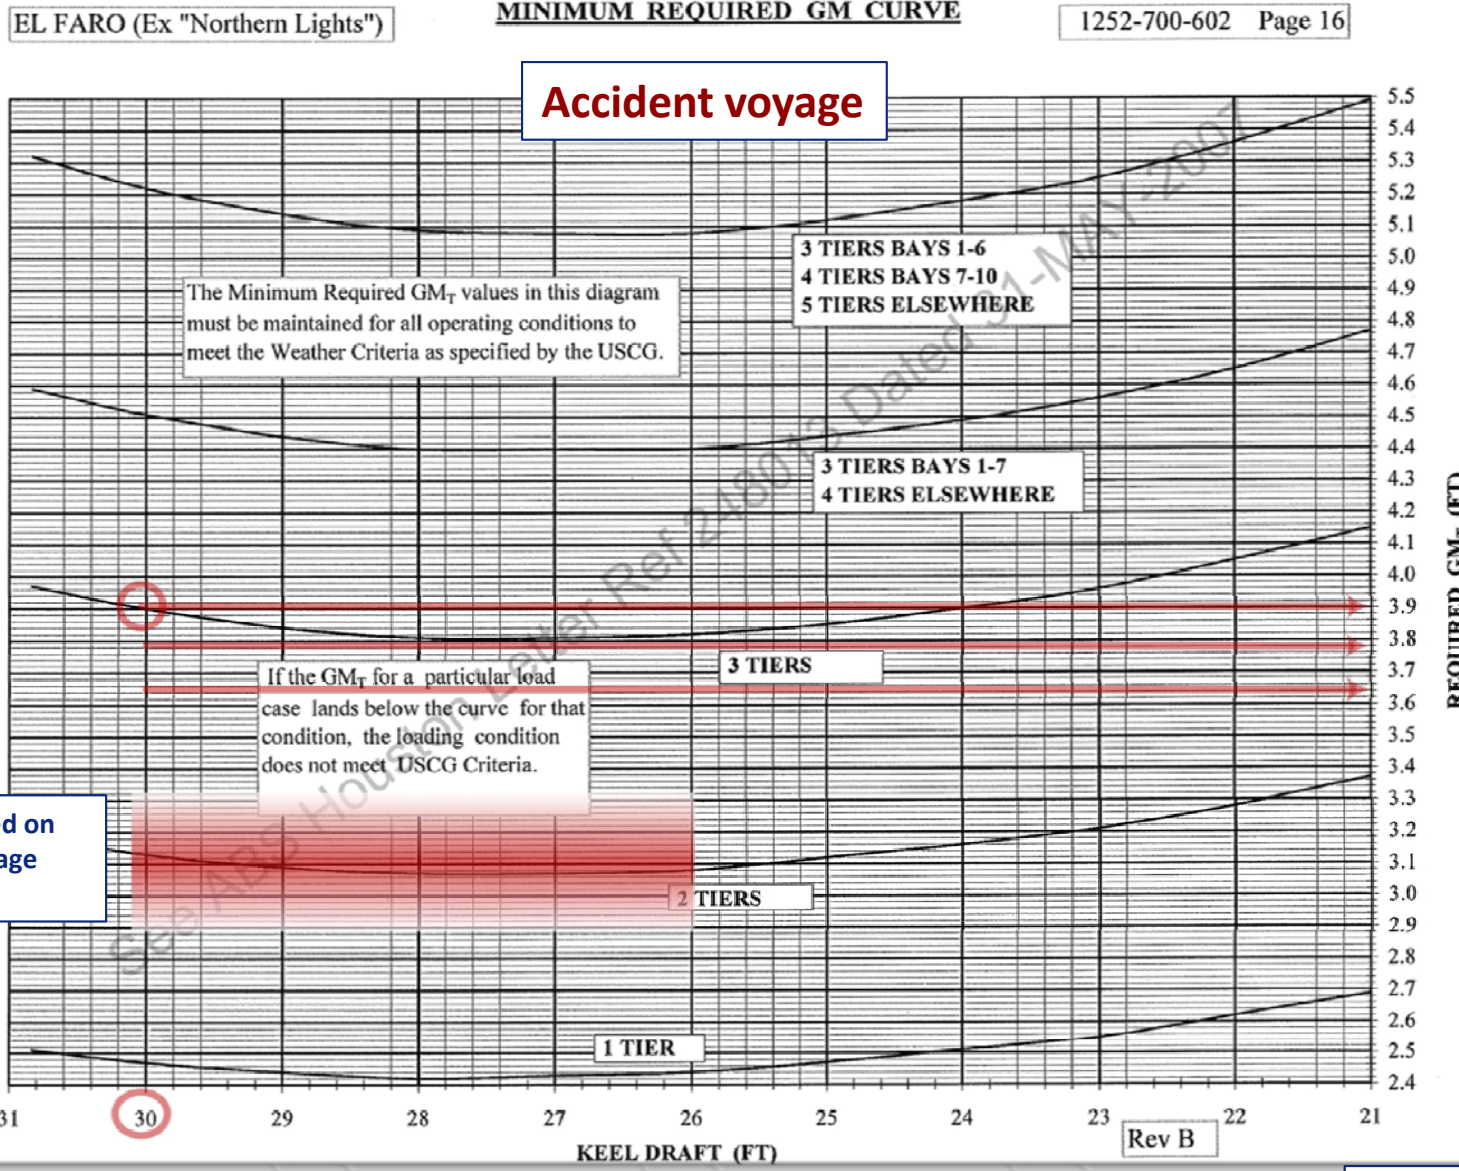
Figure 4-1 (annotated)

Applicable

Limiting GM based on SOLAS 1990 damage stability analyses

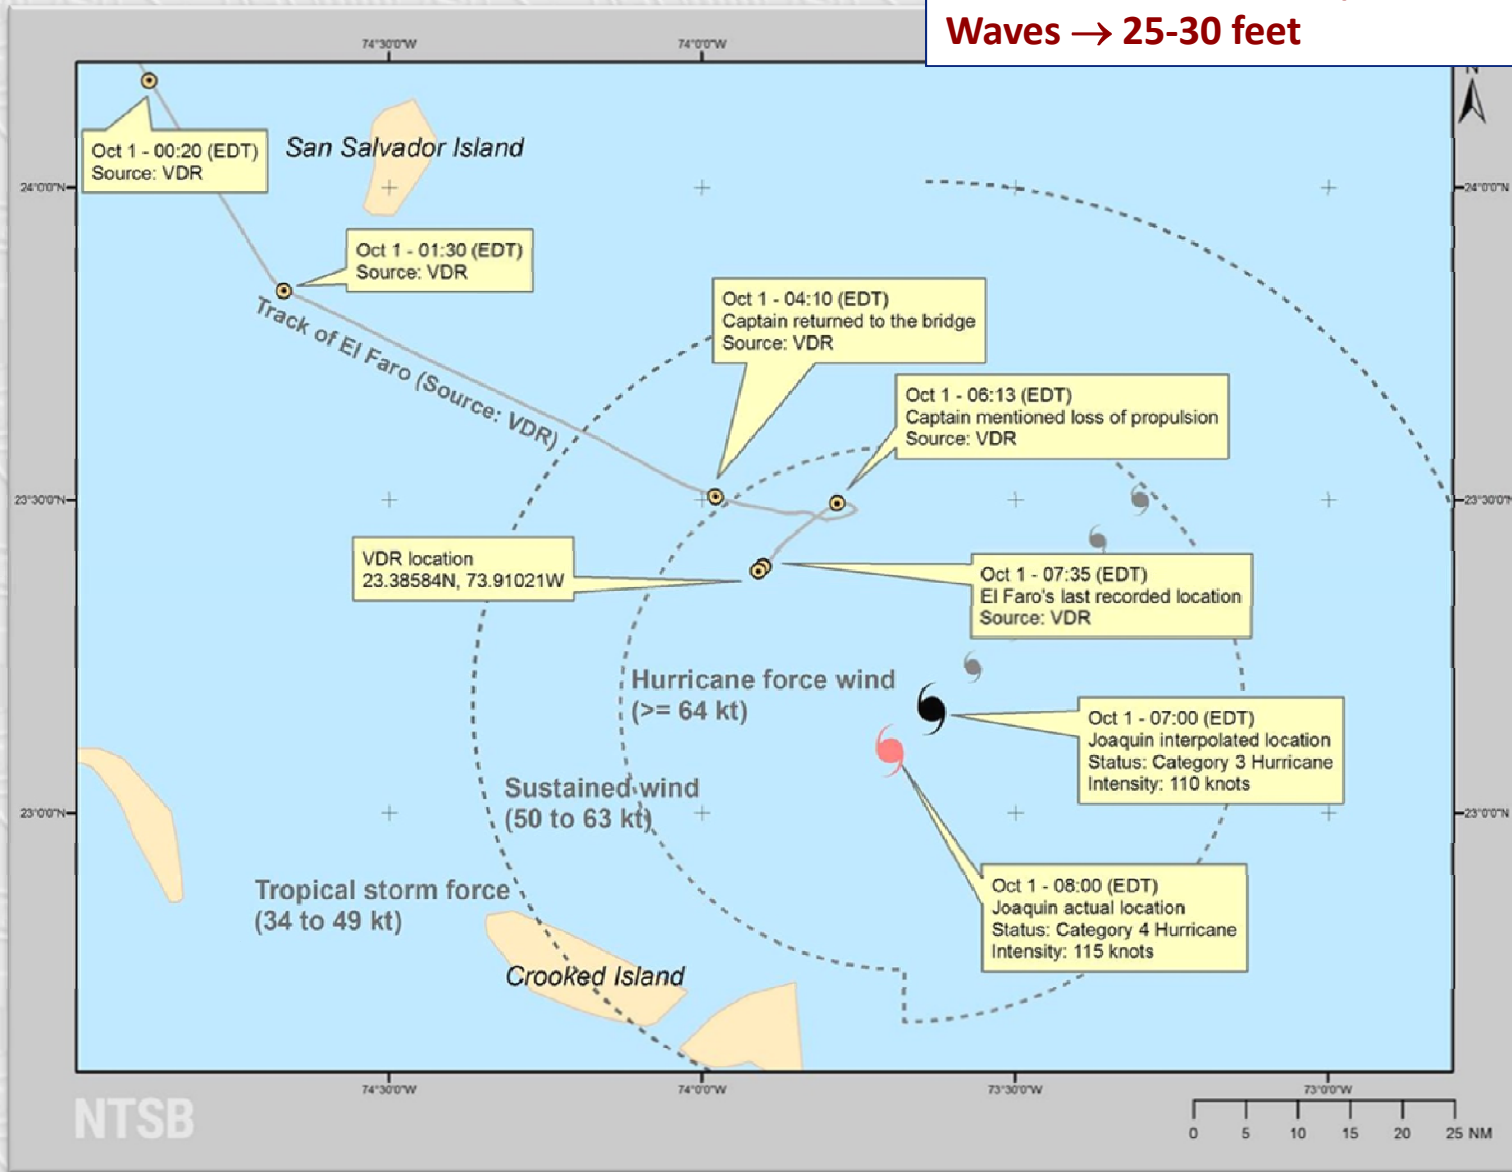
**Winds → 70-90 knots (sustained)**  
**Waves → 25-30 feet**

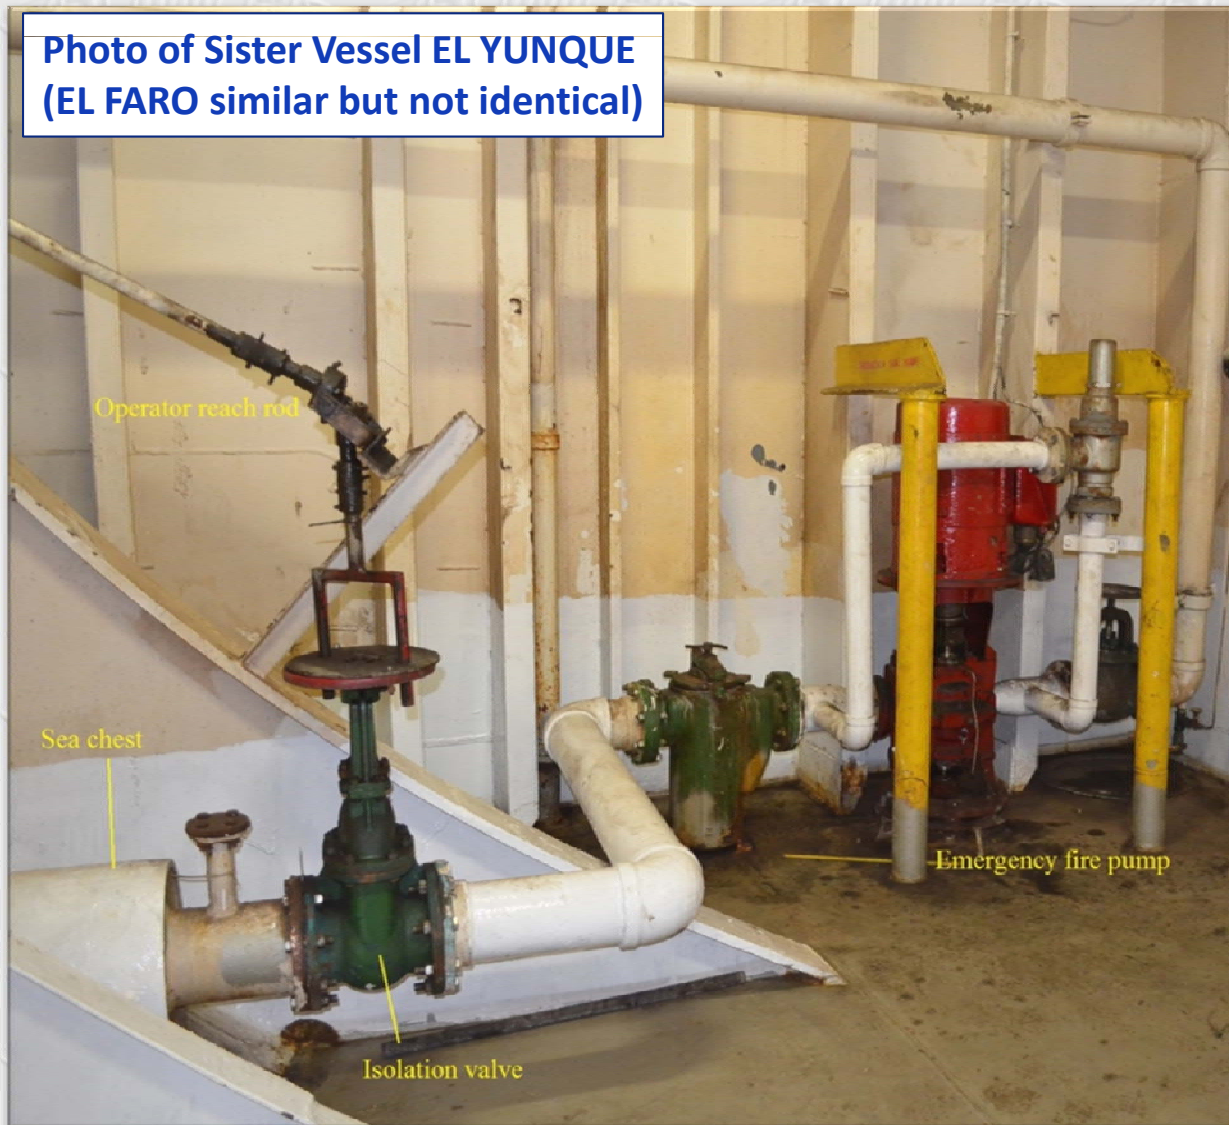
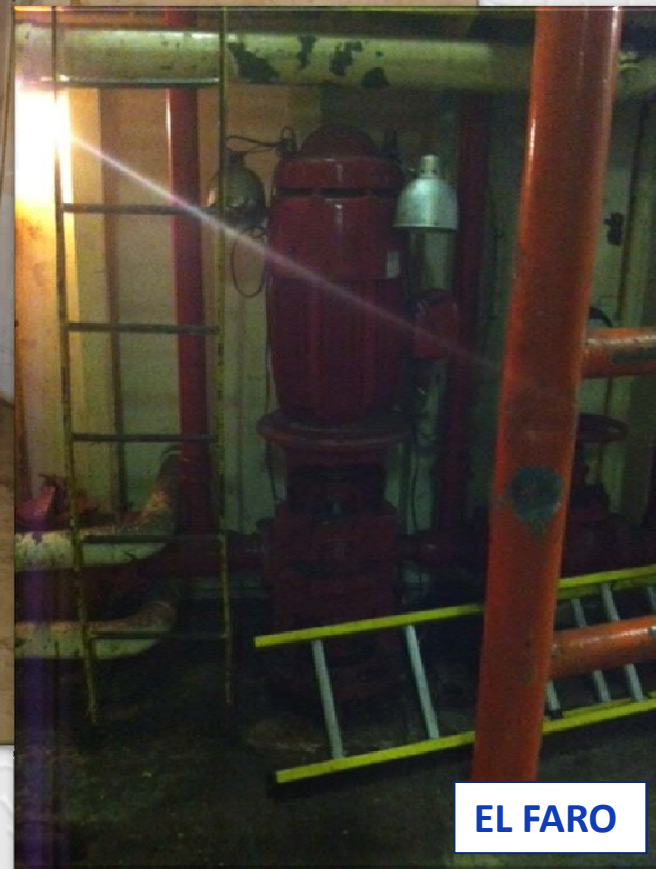
Figure 6-7

Photo of Sister Vessel EL YUNQUE  
(EL FARO similar but not identical)

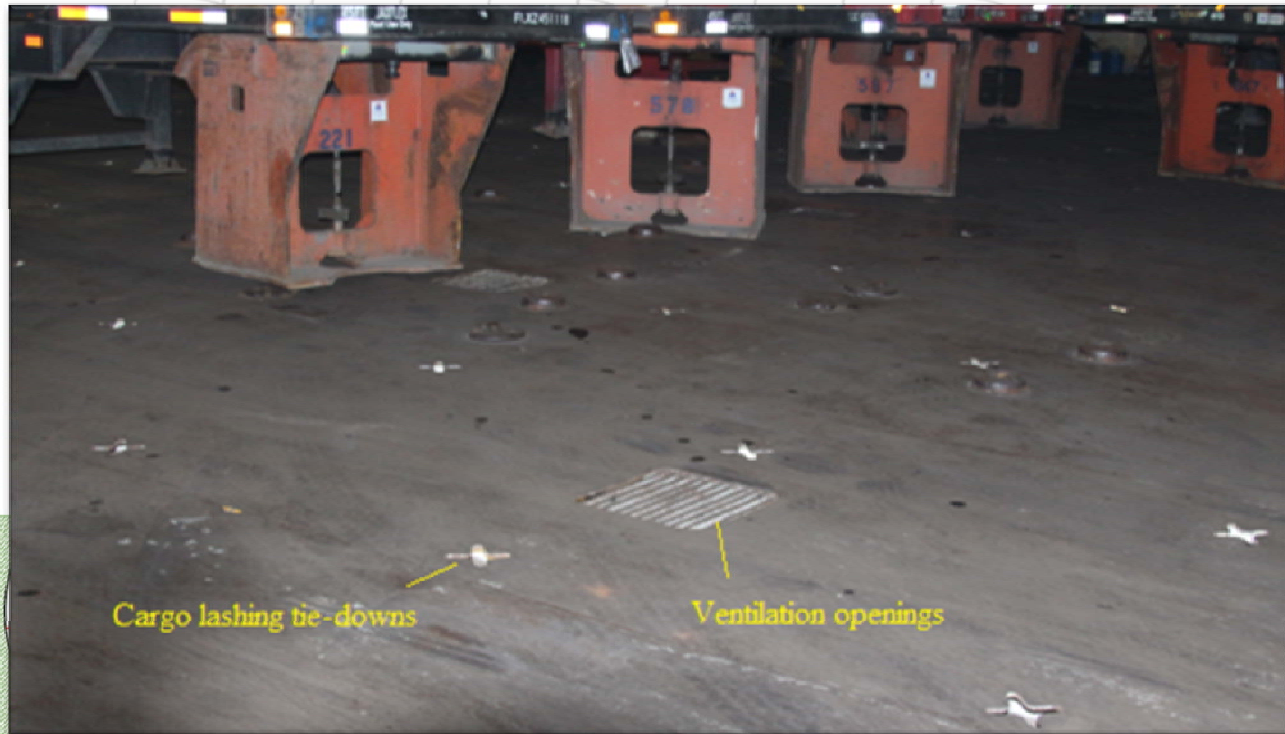
Frame 143  
Hold 3 ventilation supply  
Hold 3 flooded to 20%  
15 degree heel angle

Cargo lashing tie-downs

Ventilation openings
