INSPECTOR GENERAL

JUNE 2, 2017

U.S.-Controlled and -Occupied Military Facilities Inspection – Camp Lemonnier, Djibouti

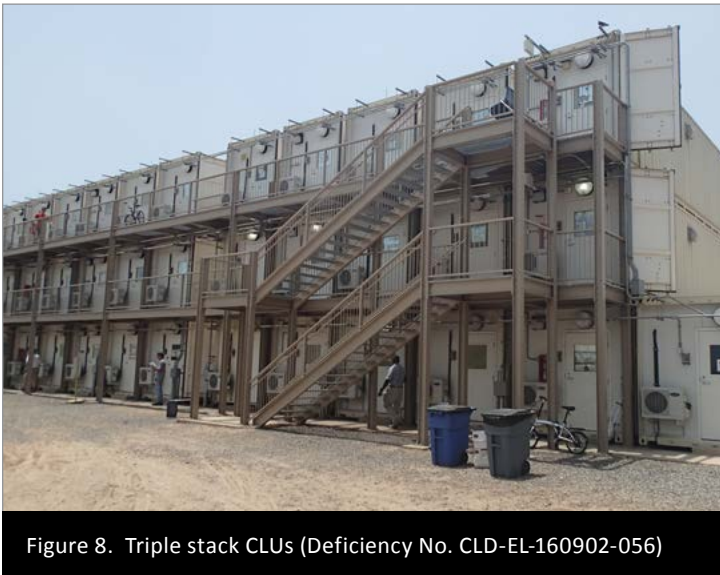
Figure 8. Triple stack CLUs (Deficiency No. CLD-EL-160902-056)

We found occupied containerized living units (CLUs) stacked three stories high with fire alarm systems that were not working and may not activate the sprinkler system. Figure 8 is a photograph of triple stacked CLUs. A CLU is a nonpermanent type of construction that UFC 1-201-01, section 3-3.1.5.1, limits stacking to four stories. However,

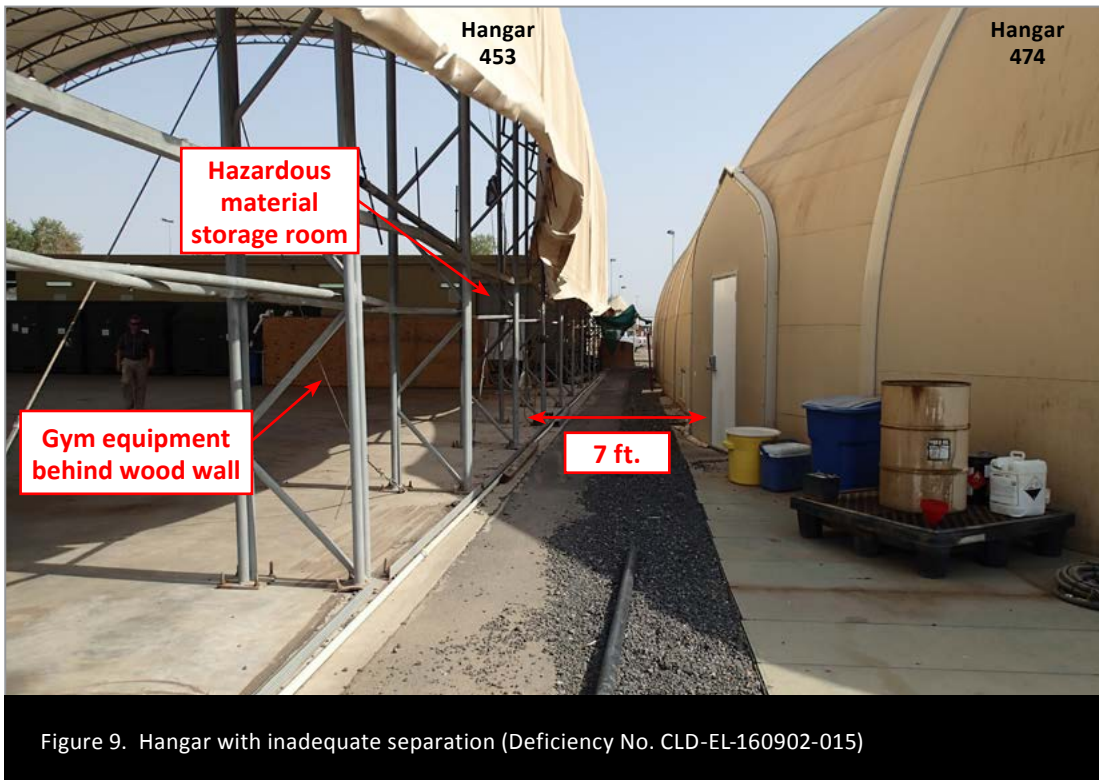
Figure 9. Hangar with inadequate separation (Deficiency No. CLD-EL-160902-015)

Two 13,000 square foot hangars (453 and 474) had inadequate separation. The distance between the two hangars was 7 feet (Figure 9). The UFC 1-201-01, “Non-Permanent DoD Facilities in Support of Military Operations,” requires hangars this size that are not separated by at least 50 feet to have fire protection as called for by UFC 3-600-01, “Fire Protection Engineering For Facilities.” Further, neither of the aircraft hangars had fire suppression systems and associated fire alarm as required by UFC 4-211-01N, “Aircraft Maintenance Hangars: Type I, Type II and Type III,” section 3-10. In hangar 474, we observed that an office had been constructed without code-required, fire-rated walls and doors. Fire-rated walls and doors prevent the risk of injury to occupants by allowing them ample time to escape during a fire.
