United States
Coast Guard

FINAL ACTION FOR THE MAJOR INCIDENT INVESTIGATION REPORT ON THE VESSEL KOLINA SAR RESPONSE

Subj: MAJOR INCIDENT INVESTIGATION (MII) INTO THE SAR RESPONSE ON 5
NOVEMBER 2015 APPROXIMATELY 20 NM SOUTH OF MAUI INVOLVING
THE SAILING VESSEL KOLINA AND ONE FATALITY

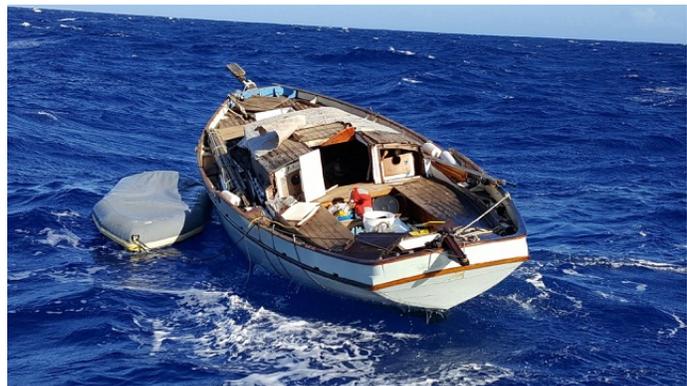
Figure 2: KOLINA Post-Mishap (Exhibit 80)

The mishap victim was harnessed to the mast and/or rigging when it broke, causing traumatic bodily injuries to the mishap victim's head and chest. This occurred aboard the sailing vessel and the mishap victim succumbed to his injuries prior to being pulled overboard.

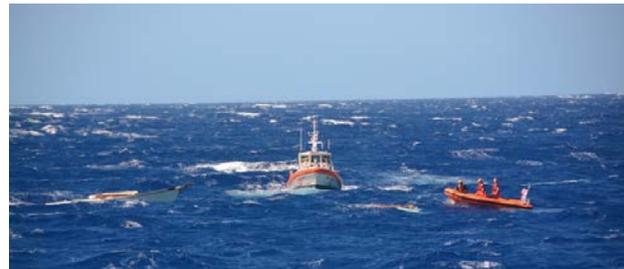
Figure 3: Post-mishap with KISKA cutter small boat and Station Maui RB-M on scene with KOLINA (Exhibit 82)

(d) At first light, Station Maui launched a RB-M to support the search efforts and assess whether they would be able to tow KOLINA (Exhibits 2-3). While the RB-M was maneuvering near KOLINA, the crew reported a significant amount of line and rigging in the water. Upon closer inspection, the RB-M crew discovered the mishap victim entangled in the line and rigging and submerged beneath the surface of the water (Exhibits 3, 25). The RB-M crew assessed the situation and determined they would not be able to recover the mishap victim from the water due to the risk associated with maneuvering the RB-M, outfitted with jet drives, near the debris field. KISKA CO assessed the conditions and informed SCC that KISKA would launch their cutter small boat to recover the mishap victim (Exhibits 3, 25).

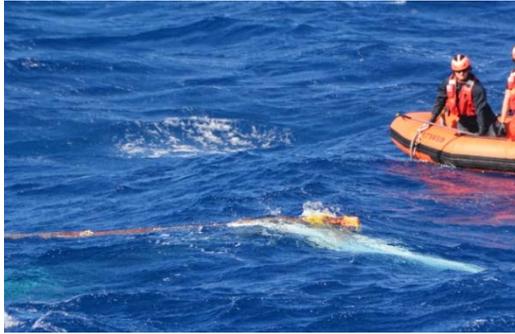
Figure 4: KOLINA mast in water with yellow heaving line wrapped around (Exhibit 81)

(a) KISKA launched the cutter small boat with three crewmembers. The coxswain maneuvered alongside the mast which was still floating and connected to KOLINA. The boat crew noted a significant amount of line and some cable in the water, including heaving line tied to the mast that was passed as part of the towline rig from KISKA to KOLINA (Exhibits 28, 32, 81). The mishap victim appeared to be approximately 15 feet below the surface and close to the splintered end of the mast (Exhibits 28, 32). While recovering the mishap victim, the cutter boat crew observed his left ankle entangled in a black line that was connected to a small cleat on a piece of wood that appeared to have broken off of KOLINA (Exhibit 28). In order to free the mishap victim, the cutter boat crew cut the line(s) that was wrapped around his ankle (Exhibits 28, 87). The cutter boat crew recovered the mishap victim for transport to KISKA.

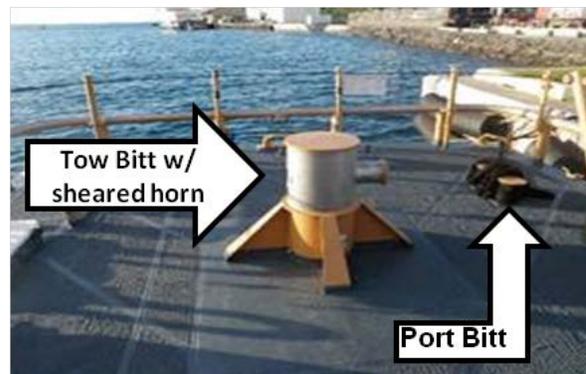
Figure 6: KISKA fantail (Exhibit 83)

(c) On 27 October 2015, KISKA experienced extreme surging from heavy weather while moored in homeport. An additional mooring line was made off to the tow bitt to provide additional protection for the ship. The force of the surging caused the starboard tow horn to shear from the tow bitt. KISKA documented the casualty in the Coast Guard's maintenance tracking system and notified Sector Honolulu. KISKA was classified as Partially Mission Capable due to the casualty (Exhibits 25, 27-28). Prior to designating KISKA as the response unit for the KOLINA case, KISKA CO, SMC, and CDO discussed the cutter's limitations given the tow bitt casualty, and determined the cutter could tow KOLINA (Exhibits 1-2, 18 (3:15, 25)).

(d) While rigging the fantail for the towing evolution, the 1LT and EPO noted a small crack located at the base of the aft starboard bitt. The crack was reported to KISKA CO and the 1LT and EPO rigged the towline to run from the unaffected aft port bitt (Exhibits 25, 27, 29).

(a) **KISKA:** The standard towing configuration for a 110-foot patrol boat was not used during this case. The starboard horn of the tow bitt sheared during heavy surging while moored in homeport on 27 October 2015. While underway enroute KOLINA, it was also noted that the aft starboard bitt, typically used for mooring lines, had a small surface crack. Though KISKA EPO and 1LT did not believe the crack to be structural, only the aft port bitt was used to mitigate risk. The aft port bitt on the fantail is typically used for mooring. An Amsteel bridge was shackled to the towline and passed by heaving line to the mishap victim (Exhibits 27, 29). KISKA faked out approximately 400 feet of towline on deck in advance of the tow and established tow with 325 feet made to the bitt (Exhibit 29, 37).

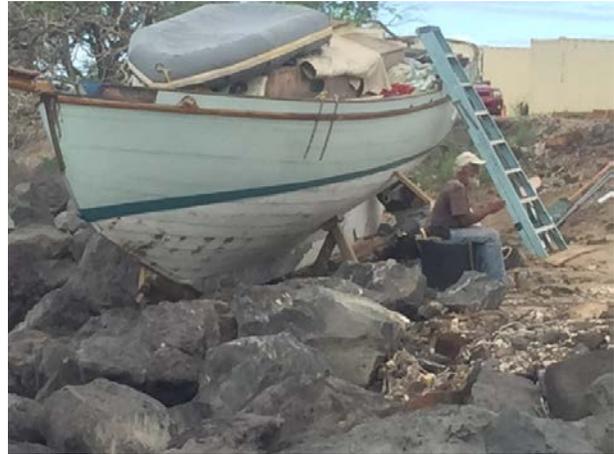
Figure 8: KOLINA on rock embankment at Kawaihae South Harbor (Exhibit 85)

(c) KOLINA's hull was constructed of teak planks that experienced significant drying while stored on land. In an effort to mitigate any sea keeping issues that may occur due to a prolonged period of time ashore, small pieces of softwood were inserted between the teak planks to expand and seal the seams when the vessel was put back in the water (Exhibits 70, 73). When KOLINA was initially floated, using a single point hoist, on 30 September 2015 at Kawaihae South Harbor, the vessel took on a significant amount of water and the mishap victim had no means of controlling the flooding. The flooding was observed between many seams between planks and, in at least one spot, through the middle of a plank (Exhibits 67, 72). After the failed attempt to float KOLINA, the hired crane operator removed the vessel from the water and positioned it on a rock embankment on the Kawaihae South Harbor property (Exhibits 68, 70-71). The mishap victim made efforts to restore the watertight integrity using caulk to seal and seawater to swell the planks of KOLINA (Exhibit 72). On 1 October 2015, the mishap victim received notification from DOBOR officials that dry storage was not authorized on the premise. Subsequently, the mishap victim received a written citation from DOCARE stating that his vessel needed to be removed or risk impoundment (Exhibits 58, 59-62).

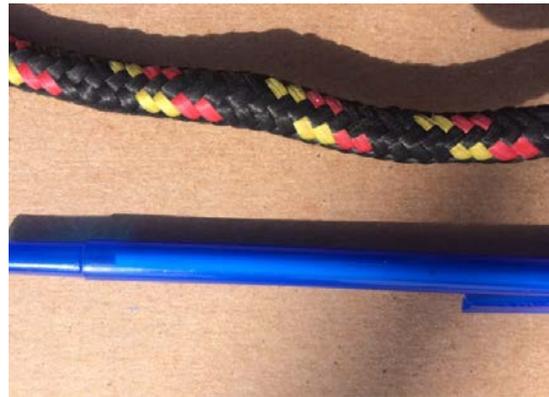
Figure 10: Actual line provided to mishap victim and used as standing rigging (Exhibit 87)

(f) The rigging to secure the mast and sail was also jury-rigged. KOLINA had five chain plates on each side to secure standing rigging; only one of which was used on each side. The mishap victim rigged one backstay that was approximately two-thirds wire rope and one-third polypropylene line secured in the vicinity of the cockpit on the starboard side (Exhibit 79). The forestay was rigged with the polypropylene line approximately half-way up the mast and secured to the base of the bulwark on the bow. The mishap victim received the polypropylene line used for the forestay and backstay from a fellow mariner at Kawaihae South Harbor. The line was 3/8" Everbilt Diamond Braid Poly Rope purchased from Home Depot (Exhibits 65, 68, 87). The manufacturer's specifications rate the polypropylene line with a breaking strength of 244 pounds. The manufacturer's specifications state that the line is not designed for shock (stress/jerk) conditions and the working load should never be exceeded (Exhibit 74). The mast was supported by one shroud on each side connected to one of the five chain plates mounted to each side of the hull (Exhibits 79, 86, 89). The shrouds composition appears to be white nylon line (Exhibits 63, 79, 86). The normal rigging practices call for sailing vessel standing rigging (i.e., shrouds and stays) to be composed of wire rope to handle the loads induced by sailing (Exhibits 73, 116). The composition and rated strength of the connection points on the mast and hull is unknown.
