September 24, 2017

**STEAM SHIP EL FARO (O.N. 561732)
SINKING AND LOSS OF THE VESSEL
WITH 33 PERSONS MISSING AND PRESUMED DECEASED
NORTHEAST OF ACKLINS AND CROOKED ISLAND, BAHAMAS
ON OCTOBER 1, 2015**

MARINE BOARD'S REPORT

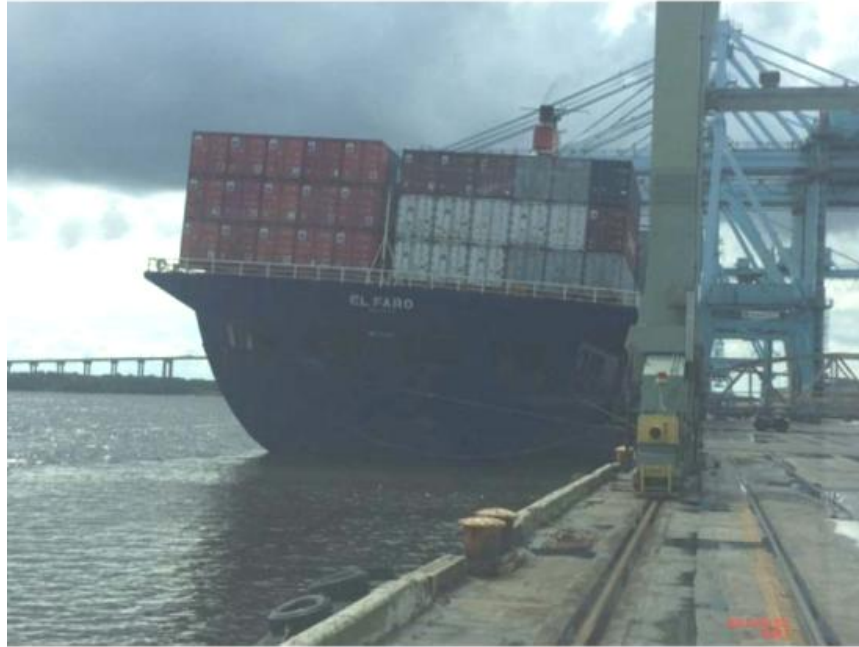
The C/M’s standing orders for loading and unloading operations required that the mates pay attention to any developing list during cargo loading, and to contact the C/M if the list exceeded 2.5 degrees. On the afternoon of September 29, the TMPR Terminal Manager noted a starboard list greater than he had ever observed during loading. As a result, the TMPR Terminal Manager took a photograph of the list and alerted the stevedores to immediately load containers onto the ship’s port side to correct the list. Later analysis of the photograph by a Coast Guard engineer determined the list was approximately four degrees. Based on the Terminal Manager’s alert, the stevedores loaded cargo on the port side and corrected the list before EL FARO sailed.

Figure 3. Photograph taken by TMPR Terminal Manager on September 29, 2015, showing starboard list of approximately 4 degrees during loading operations prior to the final voyage.

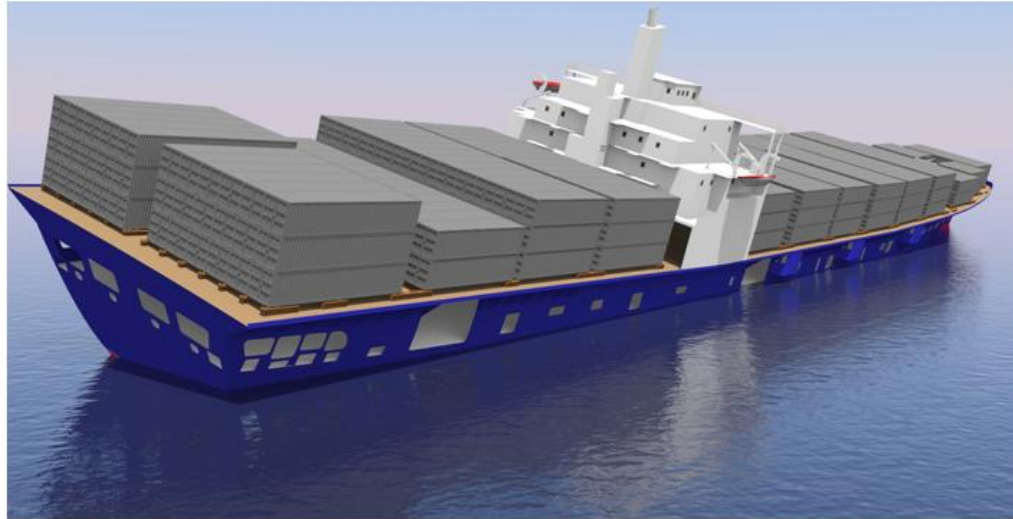
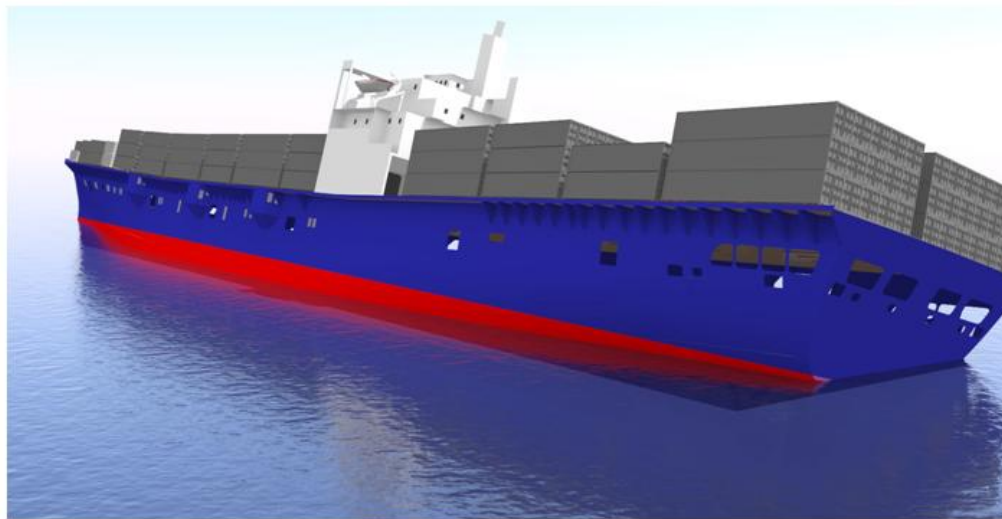
Figure 9. EL FARO computer rendering with 15 degree starboard list and trimmed down by the stern 5.8 feet, due to flooding of Hold 3 estimated at 20% and wind heel. Illustration produced by the USCG Marine Safety Center.

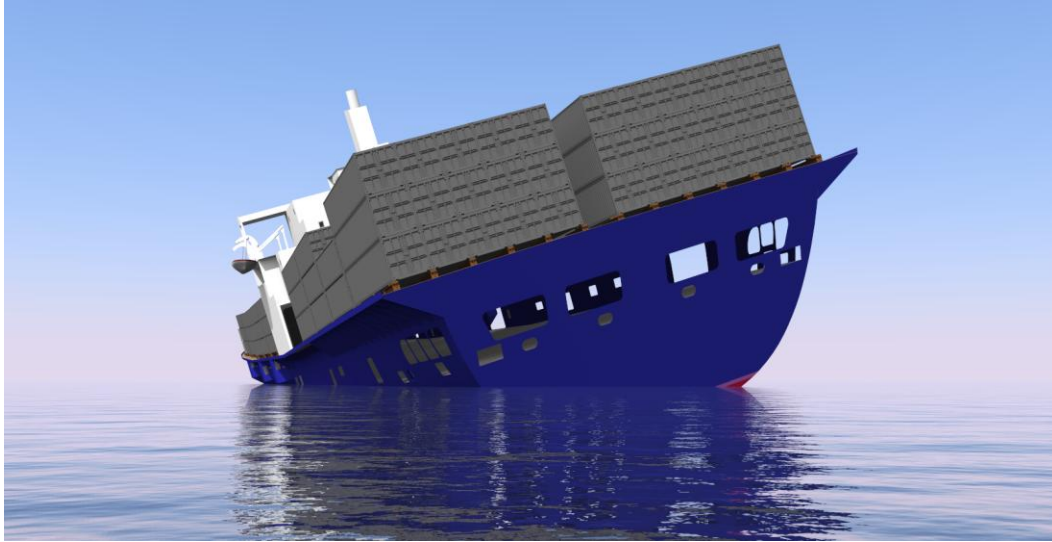
Figure 13. EL FARO computer rendering showing list to port of 18 degrees with departure trim 5.8 feet by the stern due to flooding of Hold 3 estimated at 20% and wind heel. Illustration produced by the USCG Marine Safety Center.

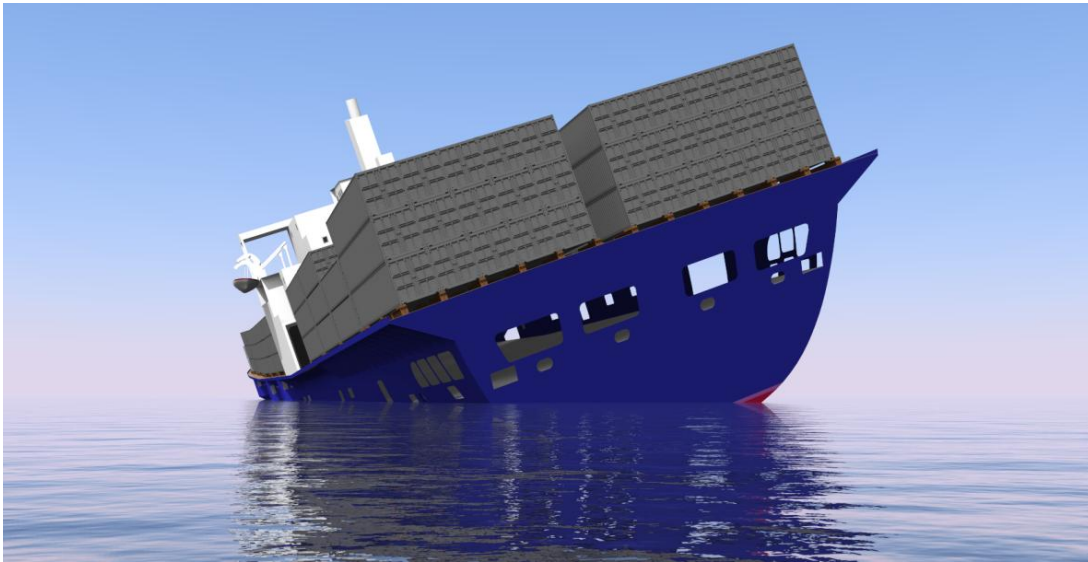
Figure 14. EL FARO modeling with 20 degree port list and departure trim down by the stern at 5.8 feet due to flooding of Hold 3 estimated at 20% and wind heel. Illustration produced by the USCG Marine Safety Center.

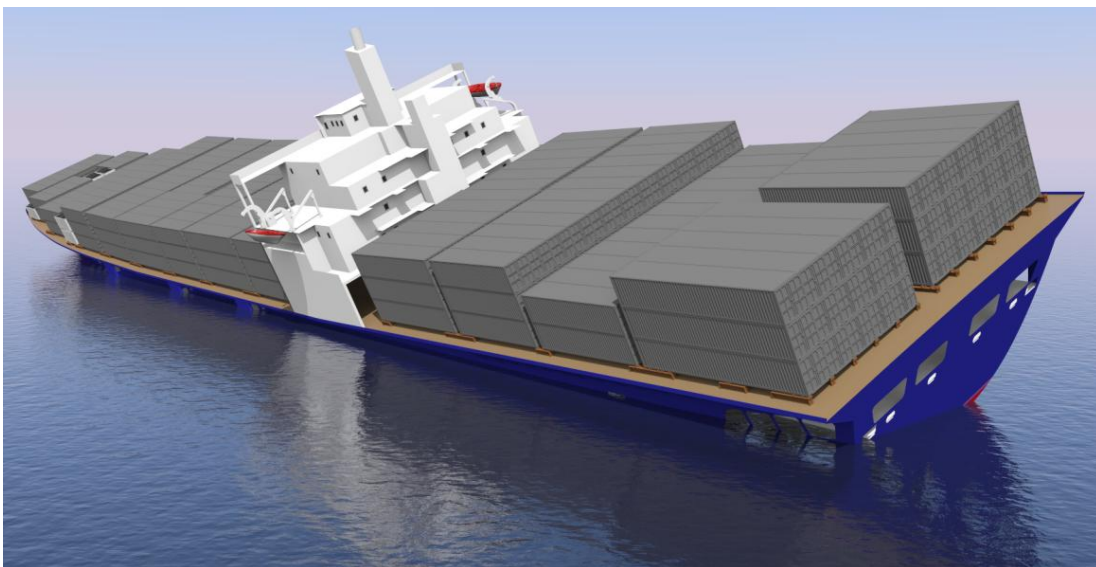
Figure 15. EL FARO computer rendering with 25 degrees port list and departure trim of down by the stern at 5.8 feet due to flooding of Hold 3 estimated at 20% and wind heel. Illustration produced by the USCG Marine Safety Center.

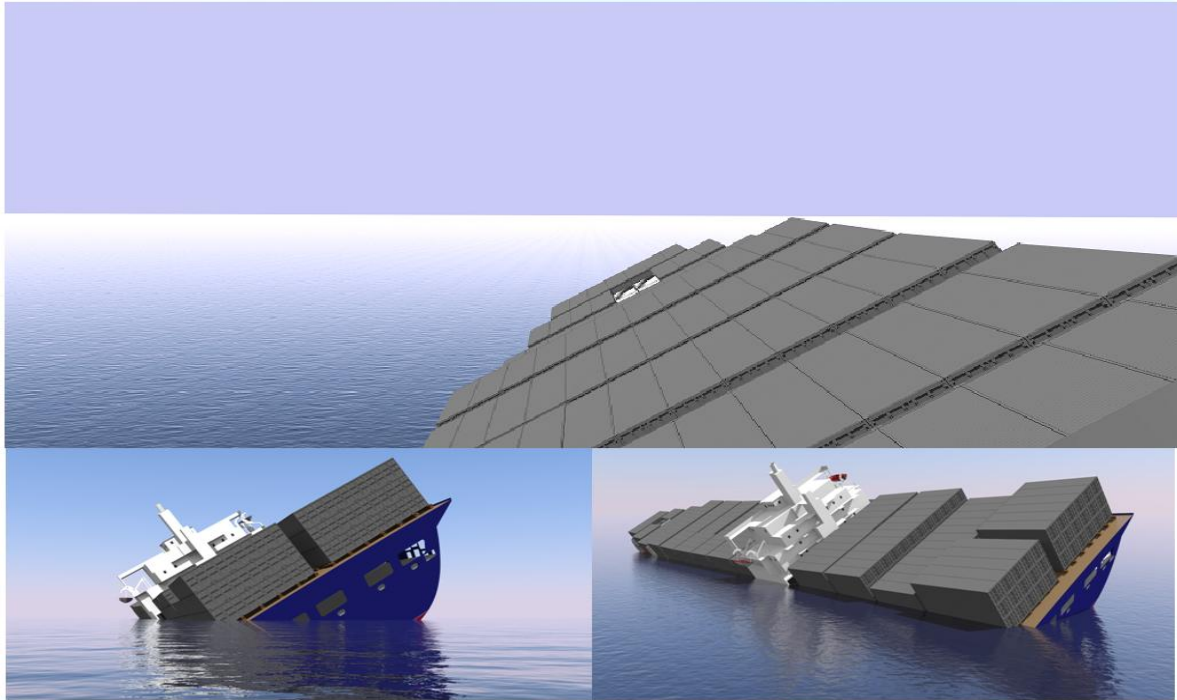
Figure 17. EL FARO computer renderings showing the vessel with progressive flooding and wind heel, listing to port at 35 degrees with 5.0 feet aft trim and 37.0 foot draft amidships. The upper illustration simulates a view forward from the starboard side of the navigation bridge which was the assumed location of the vessel Master when the Master makes the “bow is down” statement at 7:30 AM on the VDR audio transcript. Illustration produced by the USCG Marine Safety Center.

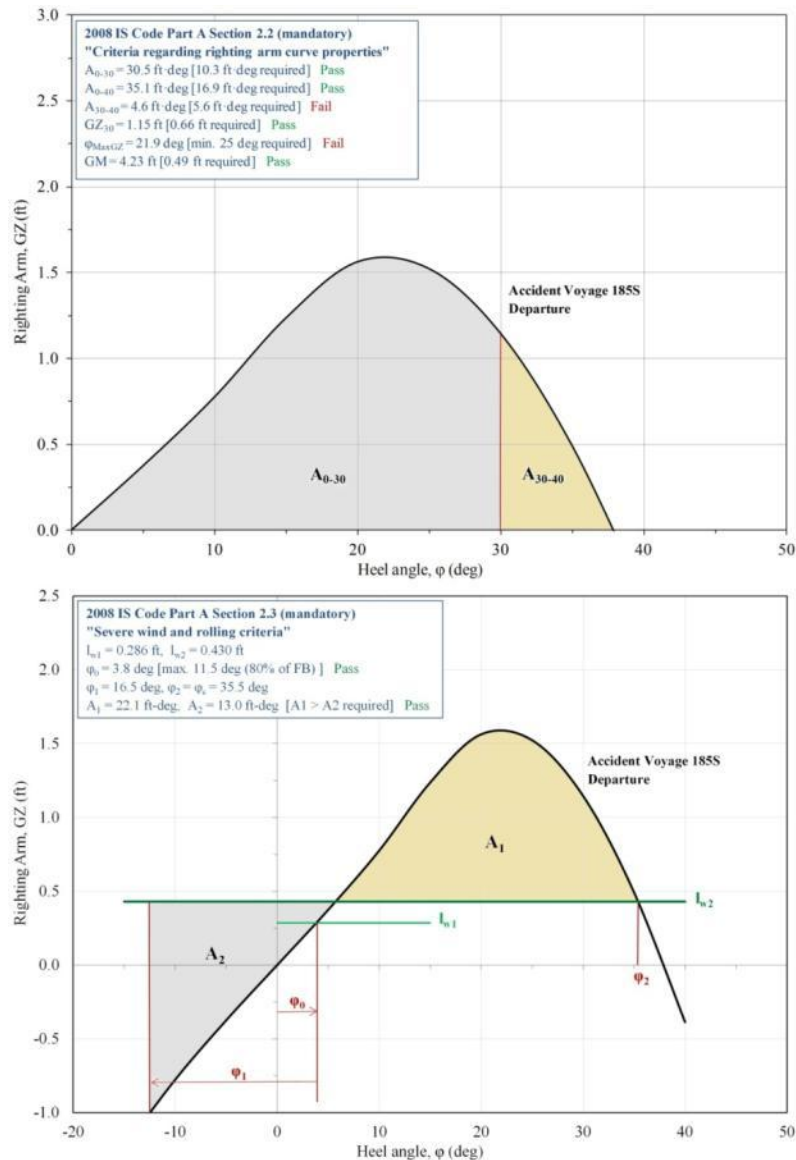
Figure 22. Application of 2008 IS Code righting arm criteria to the accident voyage departure loading condition. (Source: Figure 5-8 of the MSC report)

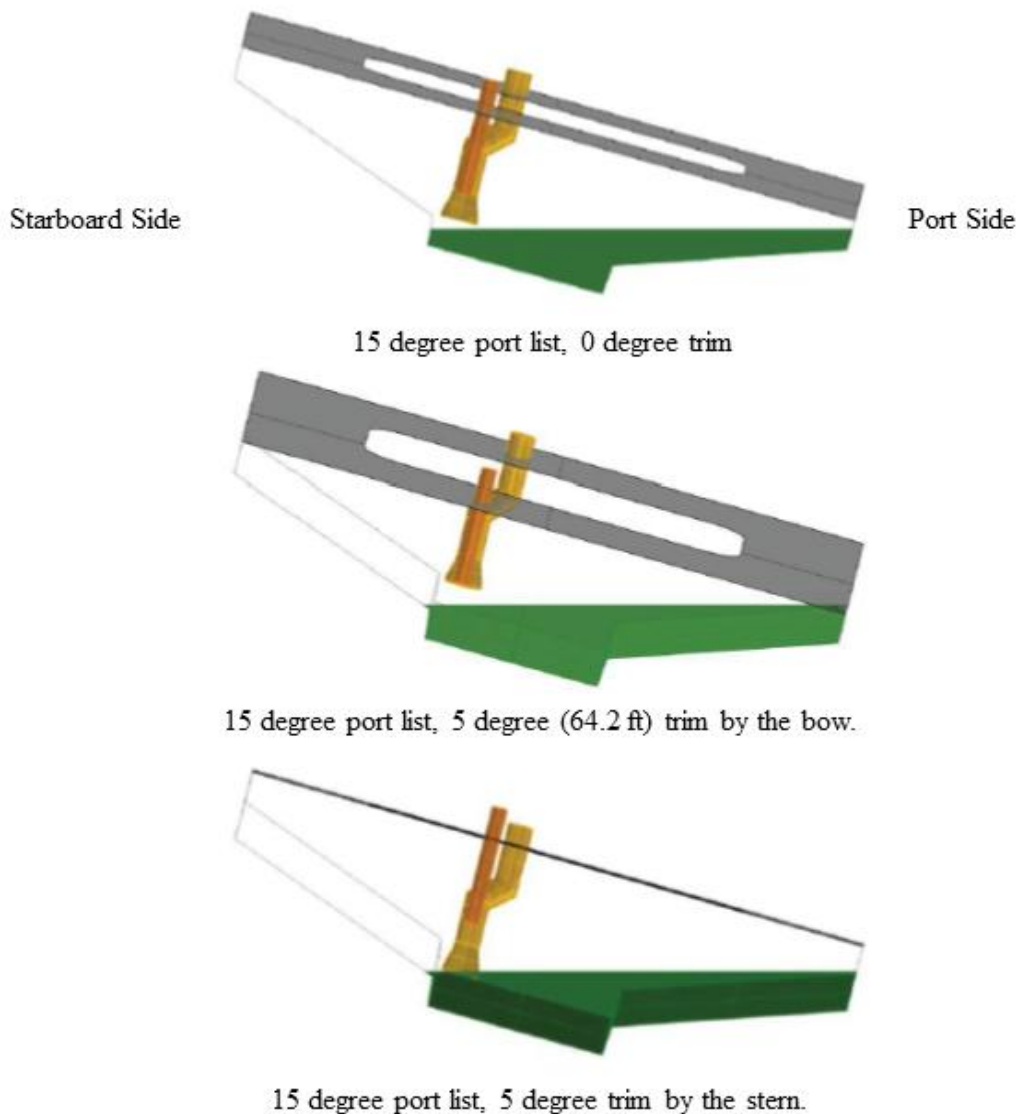
Figure 25. End views of the lube oil sump for the design low level capacity at 15 degree port list and differing trims.

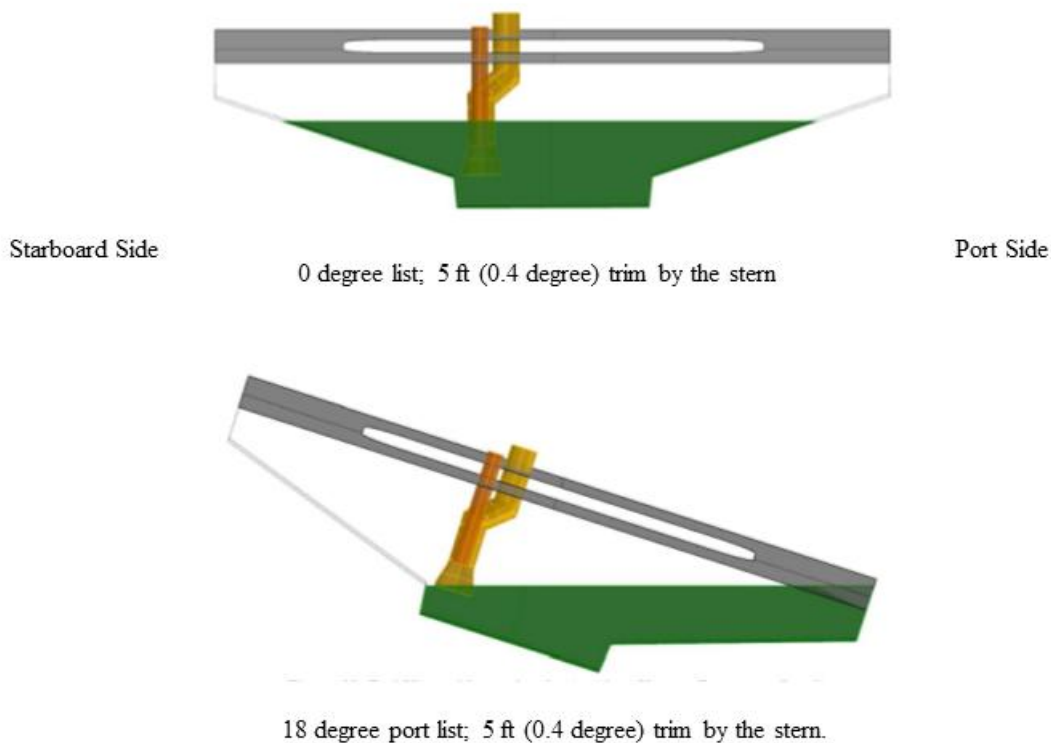
When EL FARO departed Jacksonville, the lube oil level in the sump that served the steam turbines and the main reduction gear was 24.6”. The recommended operating level in the Machinery Operating Manual was 27”, and the approved lube oil sump plan indicated that the operating range was 18”-33”. TOTE had no guidance or policy that required maintaining the recommended 27” operating level.

Figure 26. End views of sump for the accident voyage departure loading condition at 0 degree and 18 degree port list.

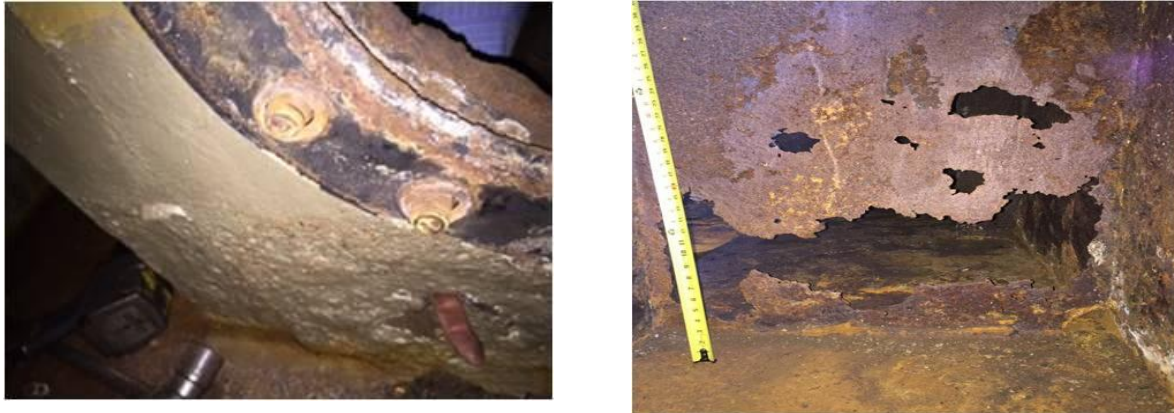
Figure 27. Examples of wastage found within an EL YUNQUE ventilation trunk that were found by Coast Guard Traveling Marine Inspectors during a February 1, 2016, DOC audit of TOTE.

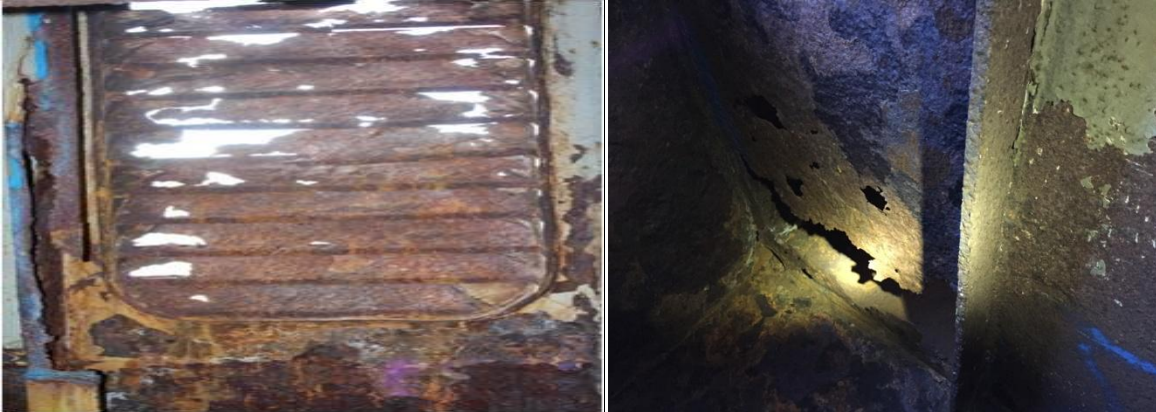
Figure 28. Photographs taken by Coast Guard Traveling Inspectors during an October 2016 visit to EL YUNQUE in Tacoma, WA showing examples of corrosion within the vessel’s exhaust ventilation trunks. (U.S. Coast Guard photographs)

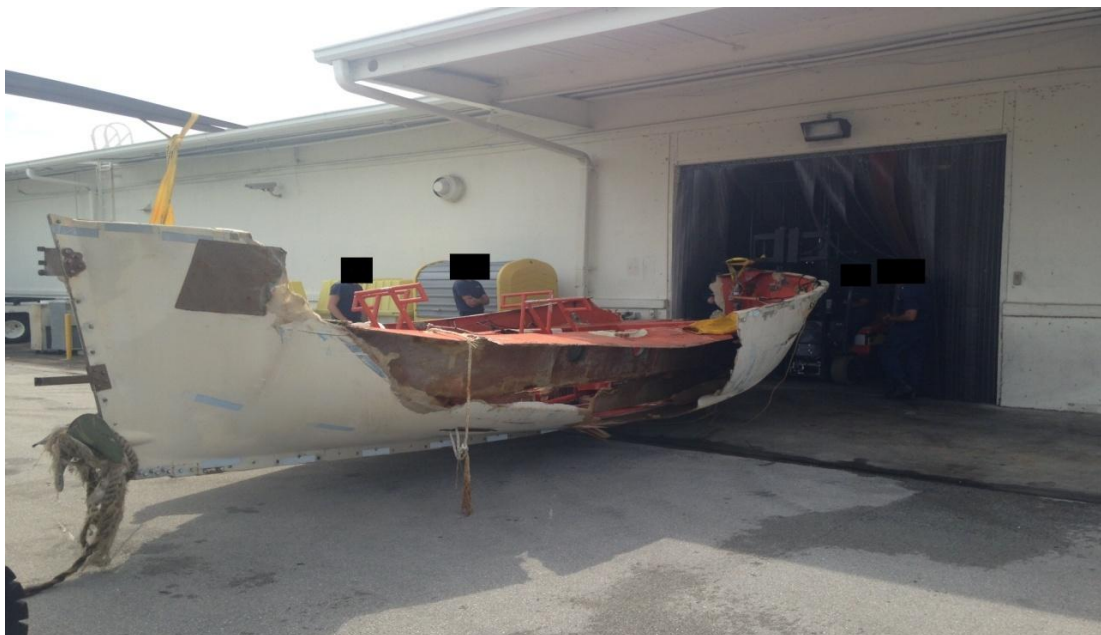
Figure 65. EL FARO Starboard Lifeboat. Heavy damage to the starboard side of the lifeboat is visible. Photo taken at Coast Guard Air Station Miami.

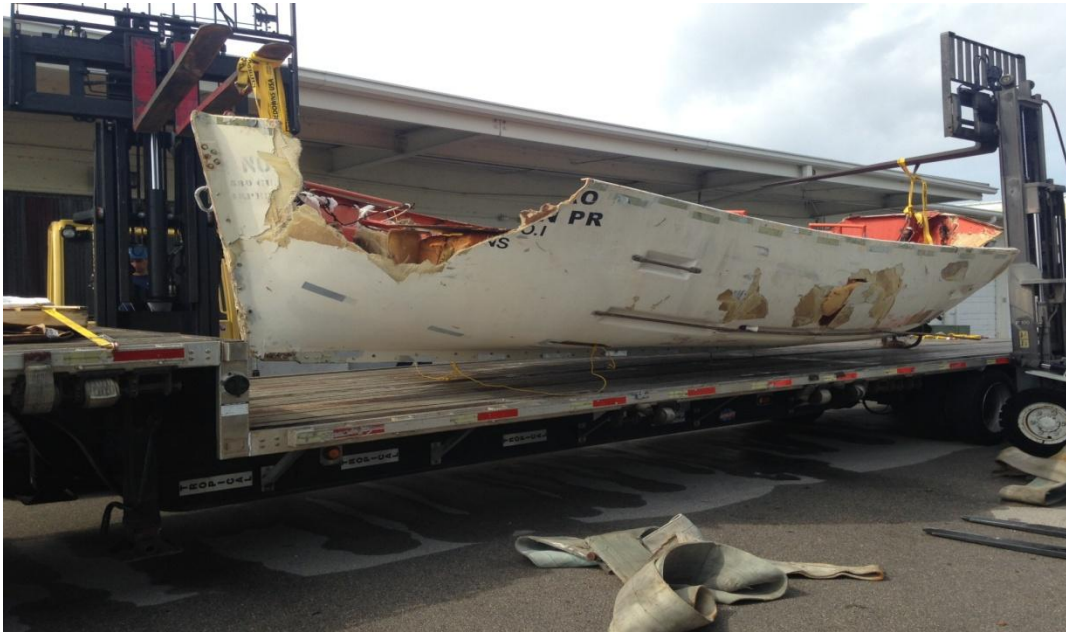
Figure 66. EL FARO Starboard Lifeboat. Damage to the port bow of the lifeboat is visible. Photo taken at Coast Guard Air Station Miami.

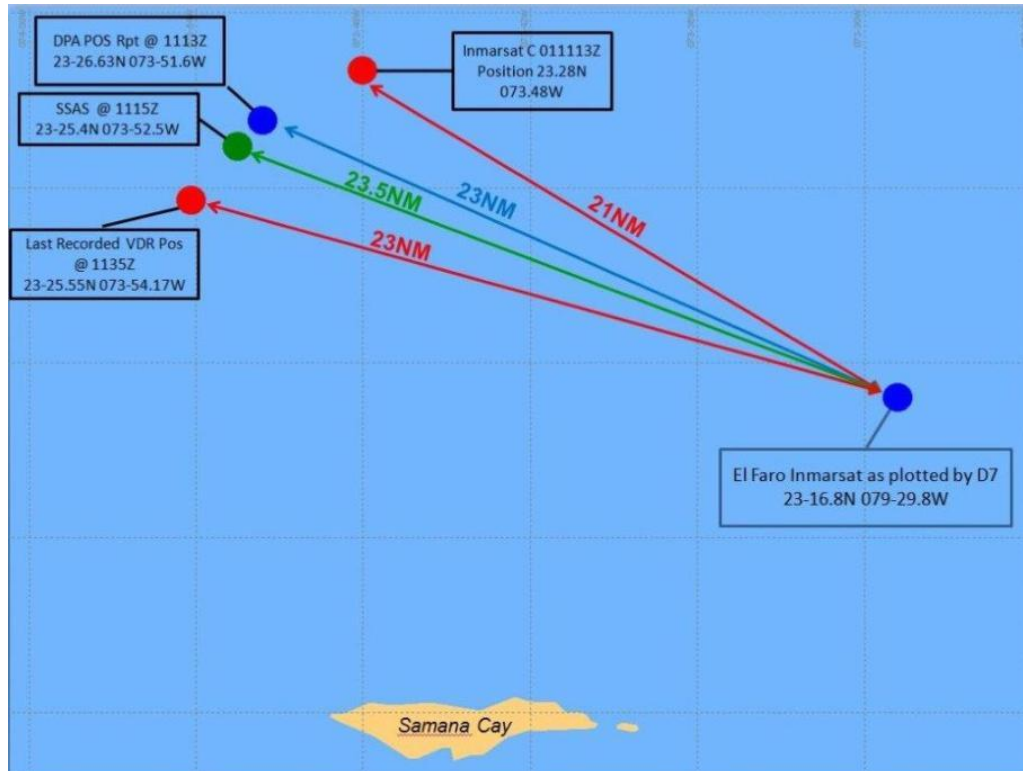
Figure 67. D7CC electronic alert plot SAROPS. The position entered into SAROPS (displayed on the right) was more than 20 nautical miles away from the actual last known position of EL FARO.

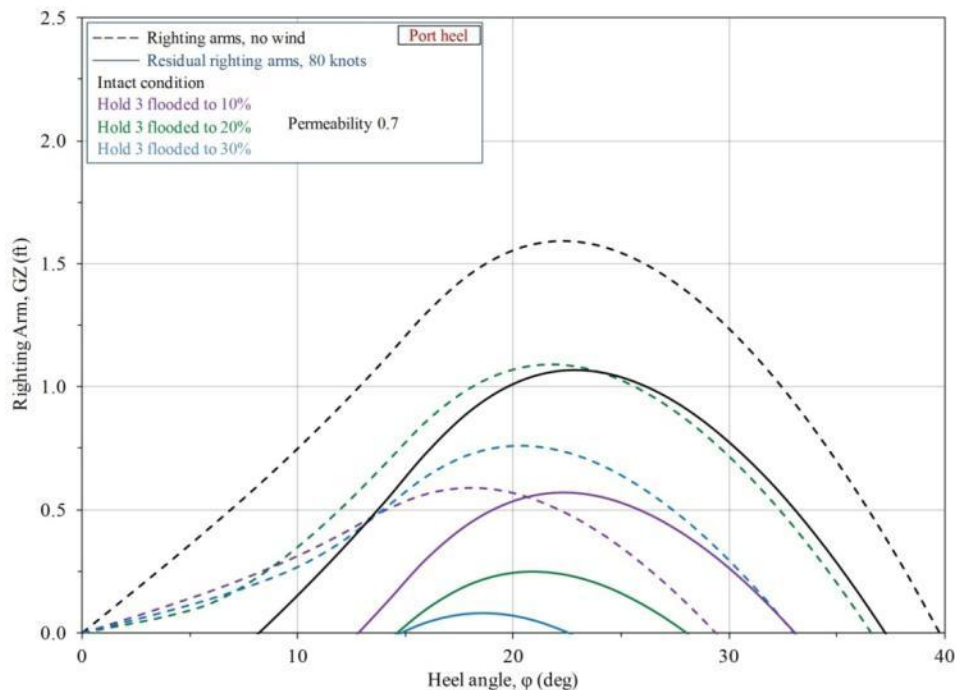
Figure 71. Righting arms (dashed curves) and residual righting arms (solid curves) with 80 knot beam winds with Hold 3 flooded to 10%, 20%, and 30%. Permeability is 0.7 (Figure 6-24 of the MSC report).

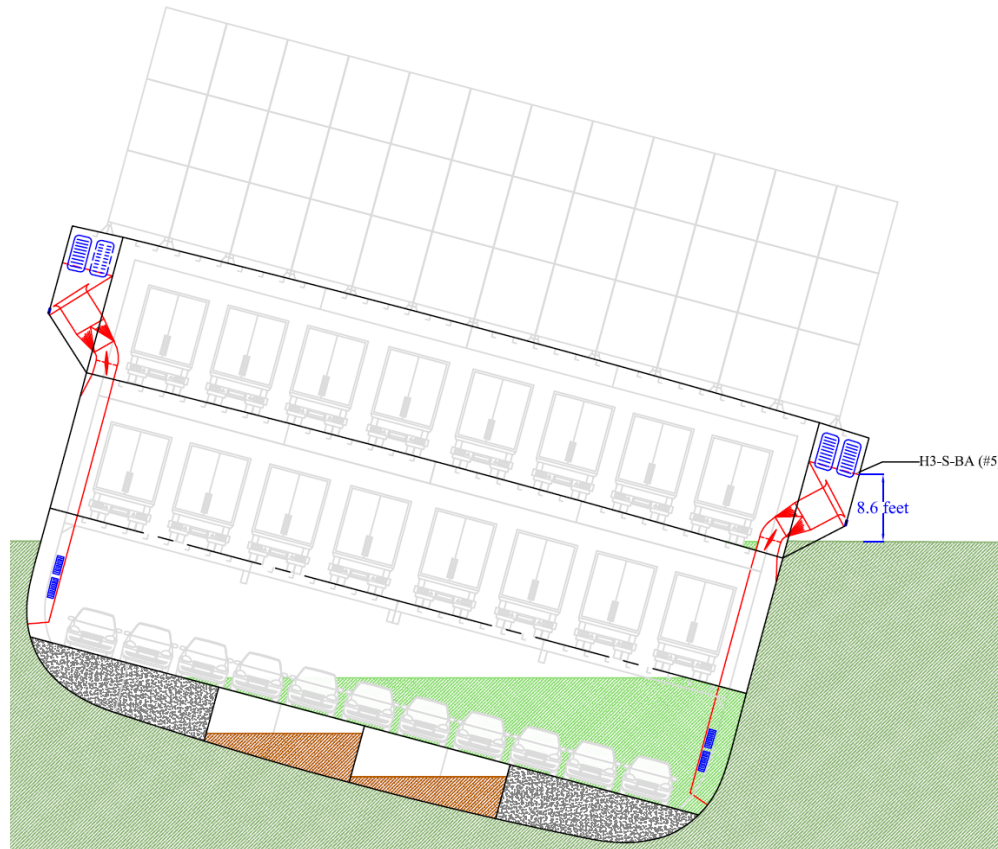
Figure 72. Section at frame 143 (Hold 3 ventilation supply trunk) with flooding of Hold 3 to 20% with heel angle 15 degrees. Downflooding point at the top of the vertical baffle plate is shown (Figure 6-18 of the MSC report).
