UNITED STATES AIR FORCE
AIRCRAFT ACCIDENT INVESTIGATION
BOARD REPORT

F-16C, T/N 93-0531 and F-16C, T/N 92-3899

LOCATION: LOUISVILLE, GEORGIA

DATE OF ACCIDENT: 7 JUNE 2016

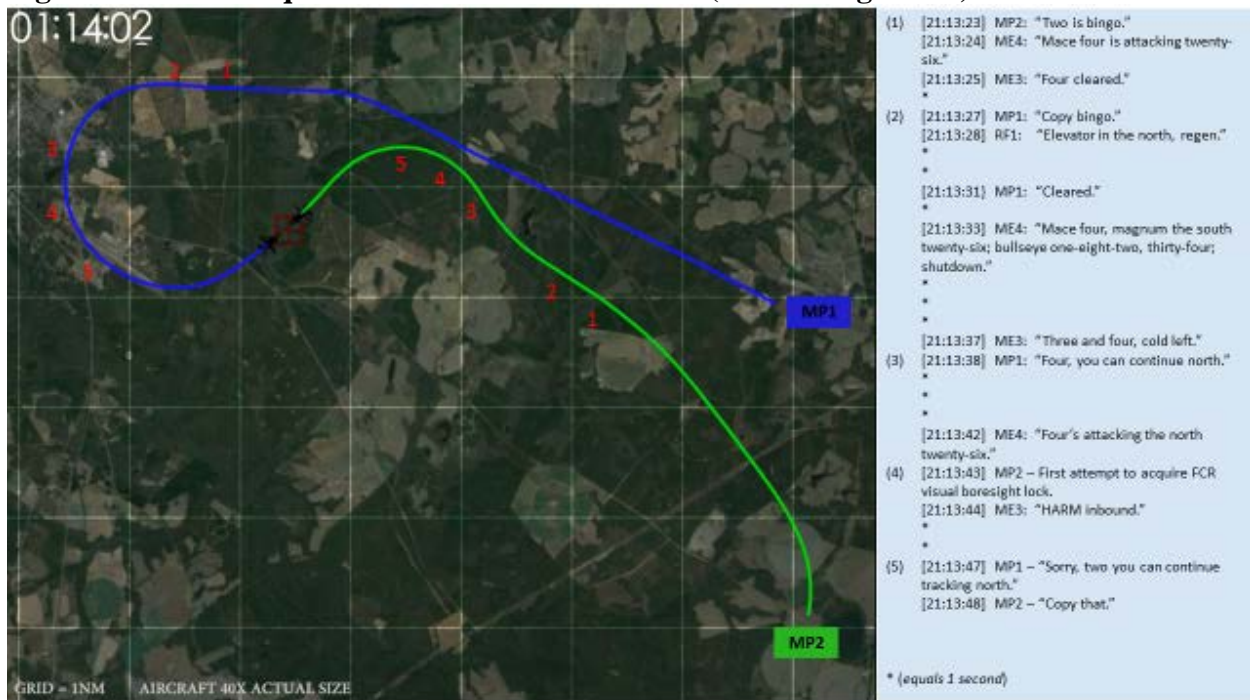
Figure 1a: Time Sequence of events from 21:13:23 (MP2 “Bingo” call) to 21:13:48

MA1 and MA2 flight controls first revealed significant control inputs approximately one second prior to the mishap (Tab J-17 and J-22).

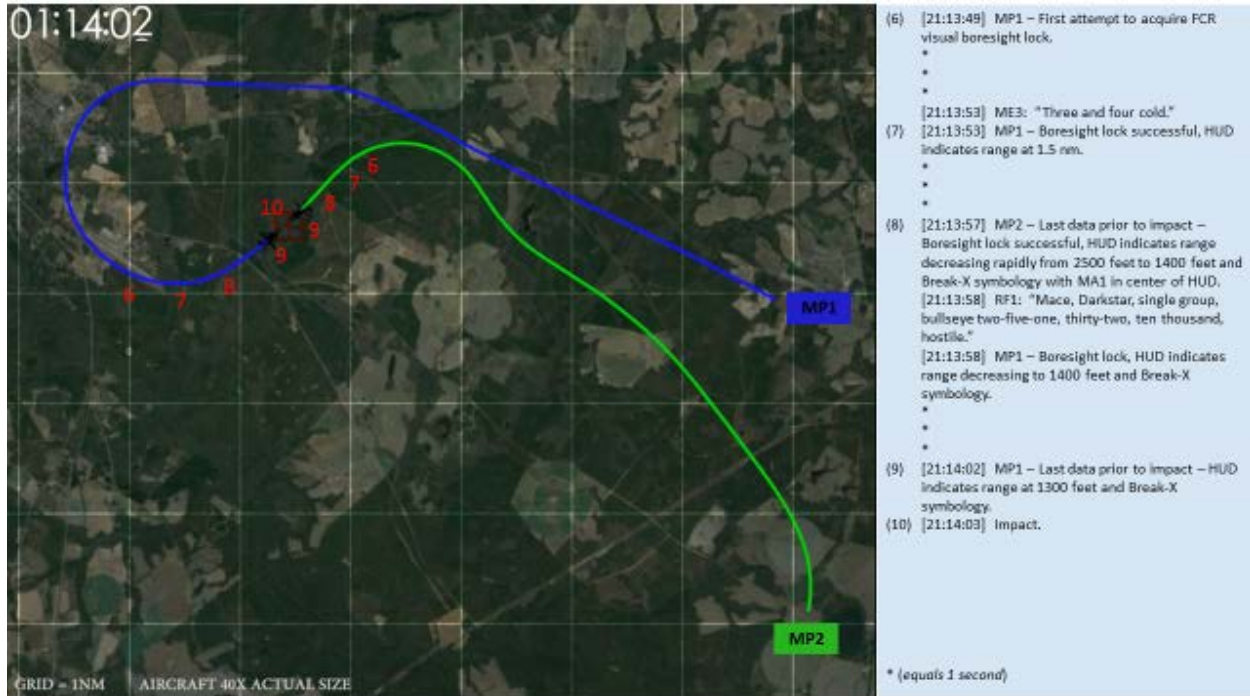
Figure 1b: Time sequence of events from 21:13:49 to 21:14:03 (Impact)

Lockheed Martin Aeronautics Company’s Technical Report assessed the probable collision altitude between approximately 15,245 MSL and 15,282 MSL (Tab J-17 and J-22).

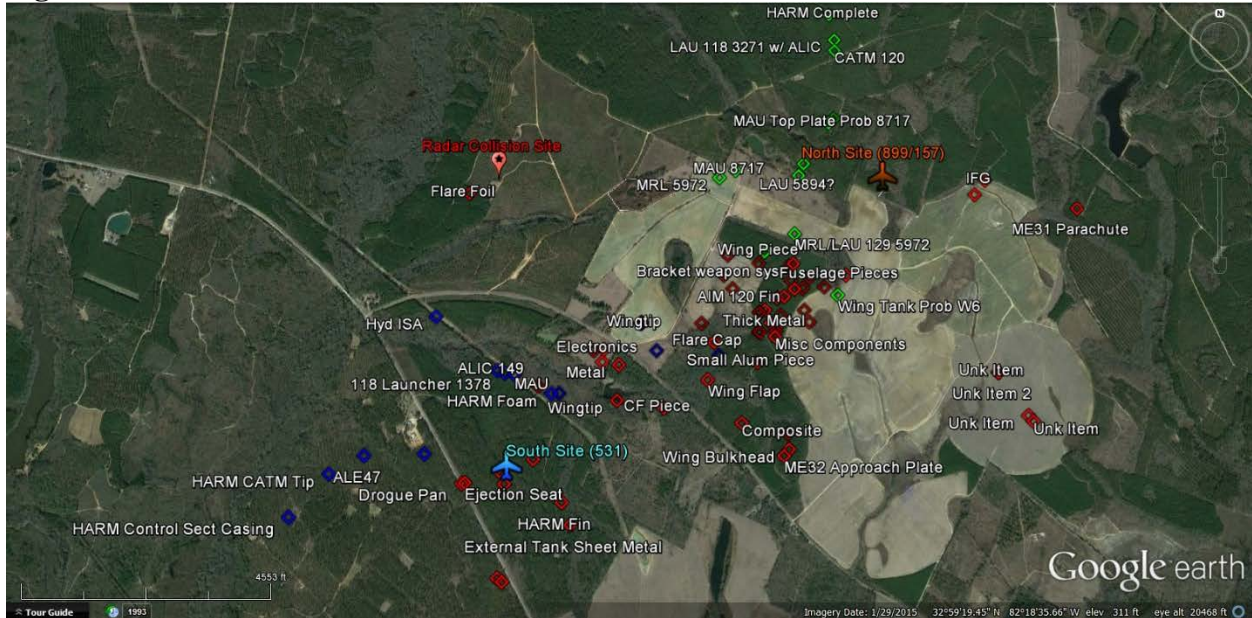
Figure 2: MA1 and MA2 crash sites and debris field

There were two primary crash sites located approximately 1.7 nm apart with the majority of aircraft debris contained at the individual crash sites (Tab J-7). Crash recovery teams located debris over an approximately four square mile area (Tab J-7).

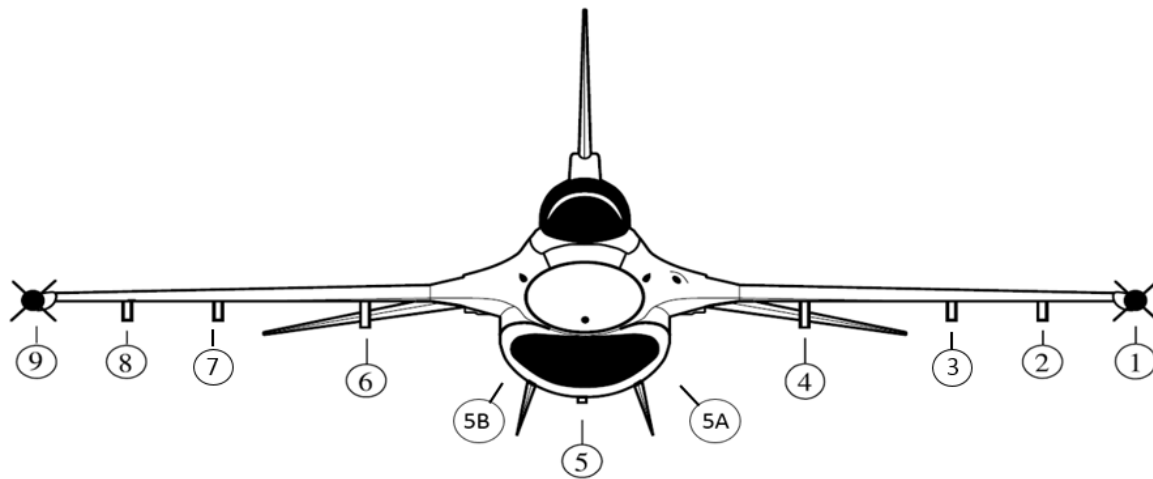
The leading edge of MA2's right wing exhibited a blunt force indentation in an upward direction near station seven (Tab J-12). There was insufficient physical evidence to conclusively determine impact geometry on MA1 (Tab Z-34).

Figure 3: MA1's and MA2's mishap sortie configuration: MA1 impact near Station 7; MA2 impact undetermined. (Tab J-12)

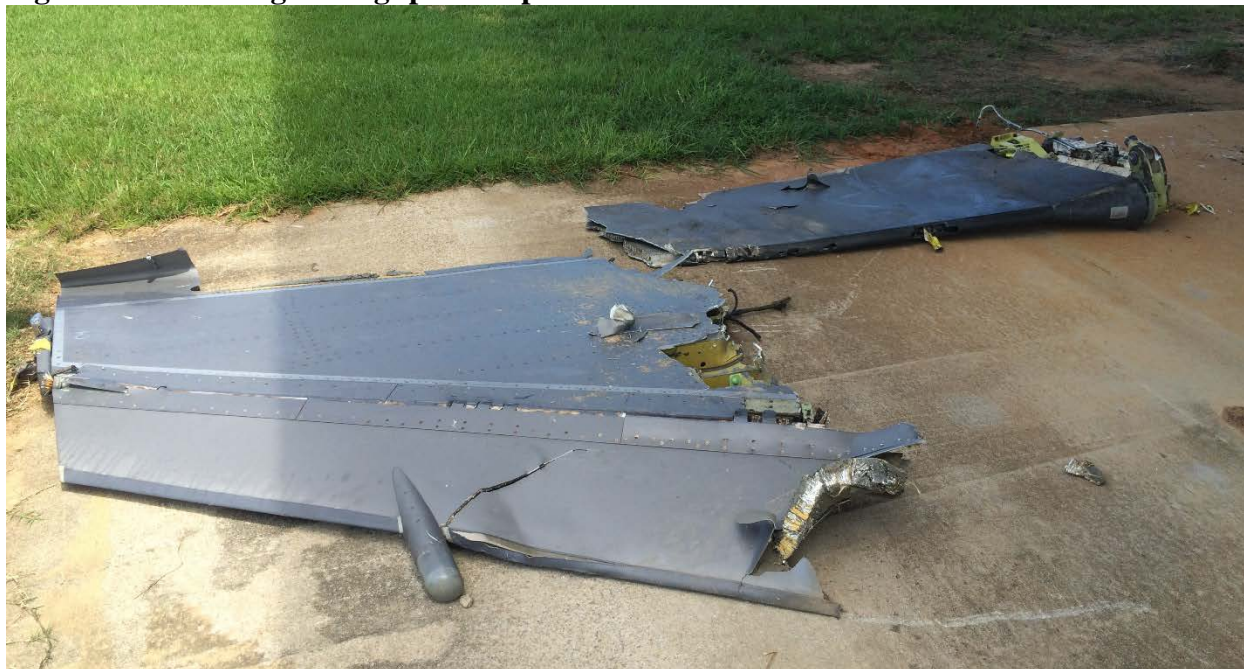
Figure 4: MA2's right wingtip with upward blunt force indentation

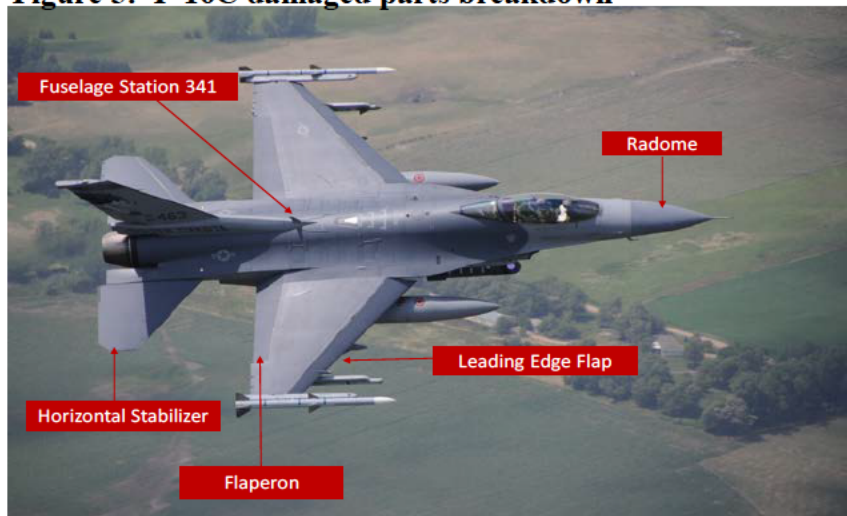
Figure 5: F-16C damaged parts breakdown

MA1 received damage during the midair collision to its right leading edge flap, the right outboard wing, the outboard flaperon, and the right horizontal stabilizer (Tab J-37). MA1 upon impact broke into two sections near the Fuselage Station 341 just forward of the installed engine (Tab J-7). Post impact analysis deemed MA1 a total loss (Tabs J-5 and P-4).
