UNITED STATES AIR FORCE
AIRCRAFT ACCIDENT INVESTIGATION
BOARD REPORT

T-38C, T/N 64-3213

**87TH FLYING TRAINING SQUADRON
47TH FLYING TRAINING WING
LAUGHLIN AIR FORCE BASE, TEXAS**

DATE OF ACCIDENT: 20 NOVEMBER 2017

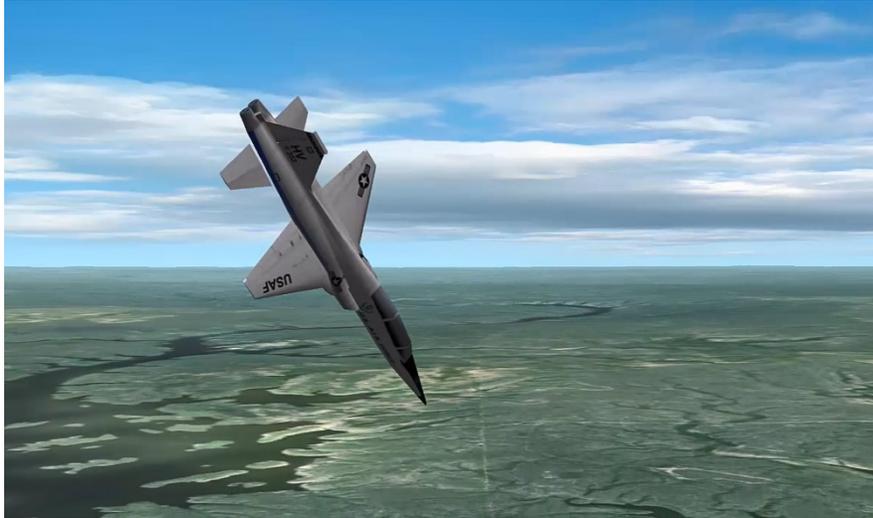
Figure 2: Aircraft Orientation at Impact (Tab Z-3)

Aircraft ground scarring was consistent with a steep impact angle (estimated 60-70 degrees nose down) and right wing down (90 degrees) (Tab H-10).

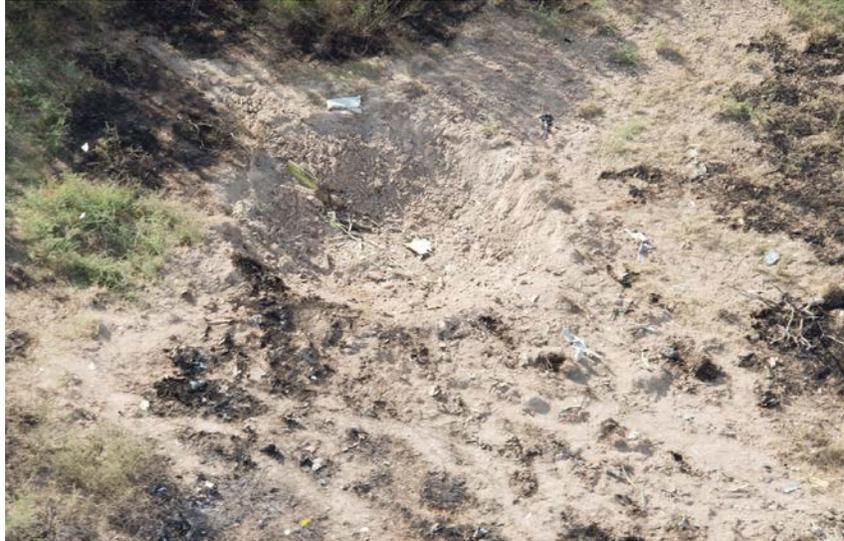
Figure 4: Aerial View of Impact Crater (Tab S-3)

The impact crater created was round, measuring 15 feet in diameter and four feet deep (Tab H-10). A relatively small amount of wreckage was contained in the crater, with the majority of wreckage being small broken pieces (Tab H-10). Debris was found scattered over a 400-yard diameter debris field (Tab H-10). Large mass items (engines with attached structure) were located approximately 50 yards north from the impact crater (Tab H-10). The majority of small wreckage pieces were scattered in the northeast direction of the debris field (Tab H-10).

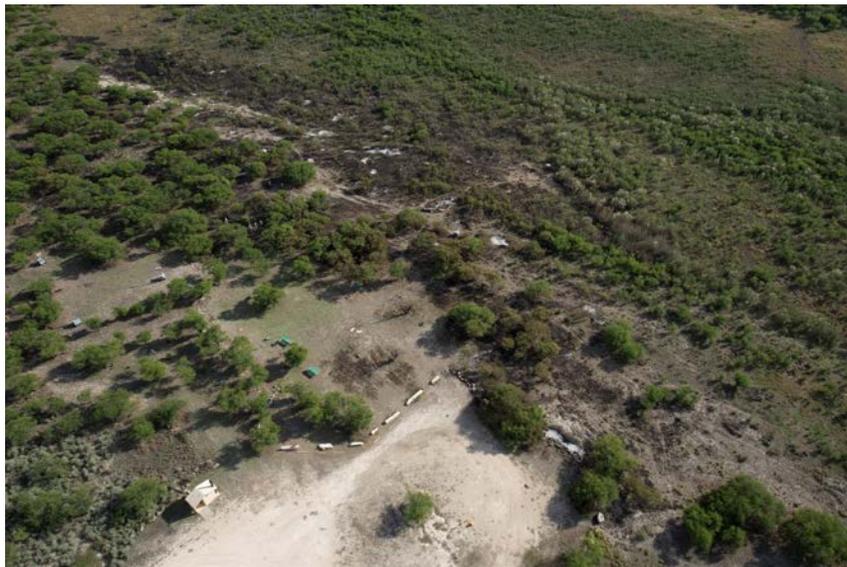
Figure 5: Aerial View of impact site looking South (Tab S-2)

The MIP landed approximately 800 yards south of the crater; the front canopy was located 1,000 yards south of the crater (Tab H-10).

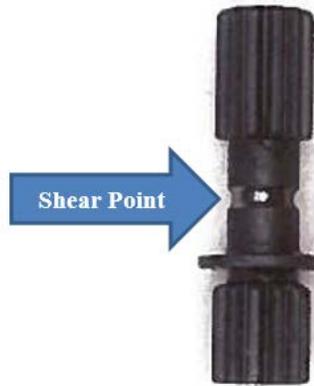
Figure 8: Designed Shear Point (Tab J-73)

Within each coupling on the engine gearbox, or “input” end of the gearbox drive shaft, there is a splined shaft designed to shear at a given location in the event of a torsional overload (Figure 8 (Tab J-16, J-68 and J-73)). The shear point is an intentional failure point designed to limit damage to the electrical and hydraulic systems (Tab J-62). Manufactured to shear within a range of 1,900-2,200 inch-lbs, the coupling shafts are integrated into the power transfer drive assembly for each engine (Tab J-19).

During the MS, the MA's left engine coupling shaft experienced a shear when torsional loading exceeded designed limits during a power reduction (Tab J-16, J-19 and J-64 to J-65). The coupling shaft experiences peak torsional loads during engine RPM changes that transit the shift range (65 – 75% RPM) of the gearbox (Tabs J-22 and BB-38). When the MA's left engine coupling shaft sheared, it caused an associated loss of electrical power and hydraulic pressure to the utility system, thus reducing flight control response (Tab J-20 to J-21). The electrical system and hydraulic system of the right side airframe mounted gearbox is designed to accept the additional torsional load and compensate for the loss (Tab J-22 and J-25).

The MA's right side system accepted the additional torsional load from the left side adding to the torsional load of the right engine's coupling shaft (Tab J-22 and J-25). This torsional load appears to have been in excess of the designed shaft capacity, which was unable to accommodate the increased load (Tab J-19 to J-20 and J-35). While the system is designed to be able to handle this loading, the right side gearbox and generator system had pre-existing degradation (Tab J-21, J-25 to J-26 and J-35). As outlined below in Section 5 Electrical, the right side generator demonstrated evidence of a single phase short, which would have created increased torsional loading on the right side prior to the introduction of the left side loading (Tab J-21, J-25 to J-26, and J-35). Additionally, subsequent systems program office (SPO) analysis of the gearbox revealed the presence of significant wear on internal components of the right airframe mounted gearbox, which would have also created an increase in torque (Tab J-22). These two conditions combined would have been sufficient to increase the torsional load on the coupling shaft (Tab J-22). These two pre-existing conditions, along with the introduction of the torsional load from the failed left side, cumulatively exceeded the design limits of the coupling shaft causing it to shear (Tab J-22). The condition created by dual gearbox coupling shear resulted in the total loss of hydraulic pressure (Tab J-2 and J-21). Without available hydraulic pressure, control of the aircraft is not possible (Tabs J-2, J-21, and V-9.8).

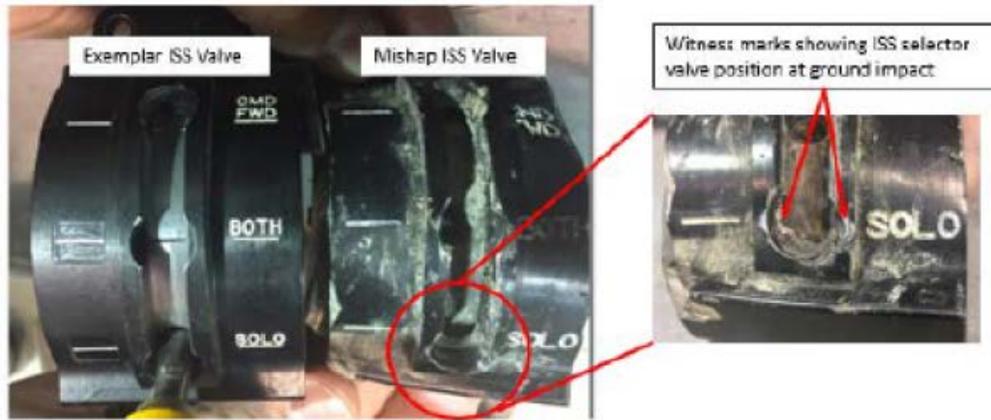
Figure 9: Exemplar and Mishap ISS Valve with Witness Marks (Tab H-18)

Analysis of the MRP's seat revealed identifying witness marks (scratches and indentations) indicating the ISS mode selector was set in the SOLO mode position instead of BOTH at the time of impact (Figure 9 (Tab H-18)). The expected position of the ISS for dual-pilot operations is BOTH (Tab BB-28 and BB-34 to BB-35). Additionally, witness marks on the Arming Lever indicate the MRP seat was in SAFE mode and not ARMED at the time of impact (Figure 10 (Tab H-16)). The improper position of ISS mode selector and arming lever would have prevented the seat from successfully ejecting from the aircraft despite the ejection handle being pulled in either seat (Figure 10 (Tab H-16 to H-18)).

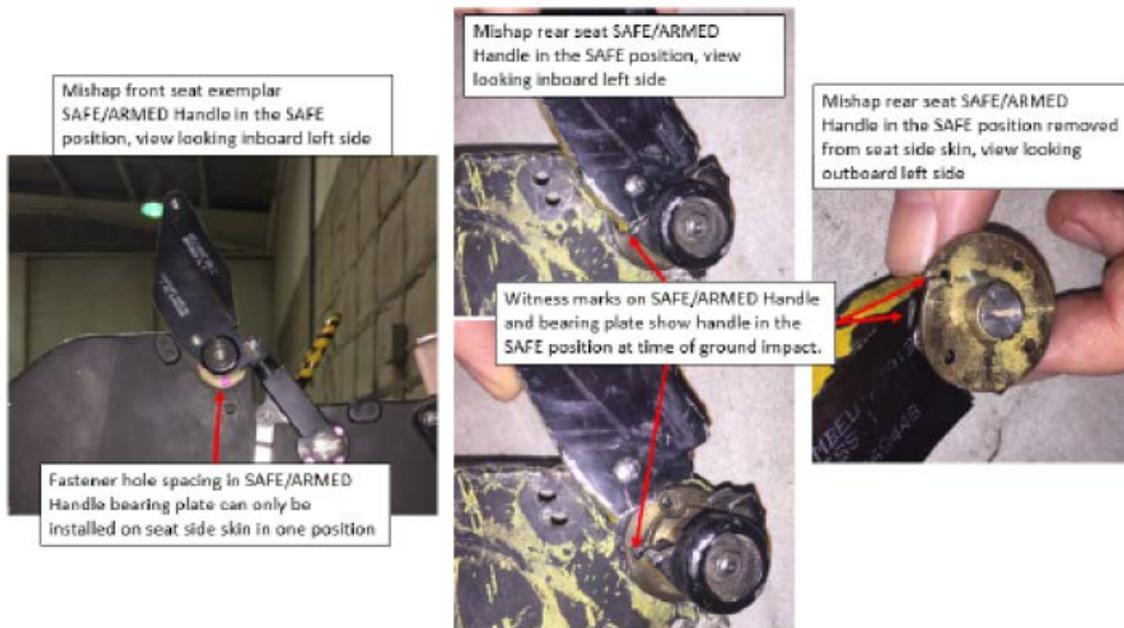
Figure 10: Arming Lever with Witness Marks (Tab H-16)

Witness marks (scratches and indentations) on the Arming Lever of the MRP’s ejection seat at the crash site indicated the arming lever was improperly placed in the “SAFE” mode, preventing self-initiated ejection (Tab H-16 to H-19). Damage analysis of other related seat components confirmed the seat was in the “SAFE” mode at ground impact (Tab H-16 to H-19). Additionally, the ISS mode selector, located in the rear cockpit, improperly remained in the “SOLO” mode, preventing the MIP in the front cockpit from initiating ejection for himself and the MRP, possible even with MRP’s seat in the “SAFE” mode (Tab H-3 to H-8 and H-16 to H-19).

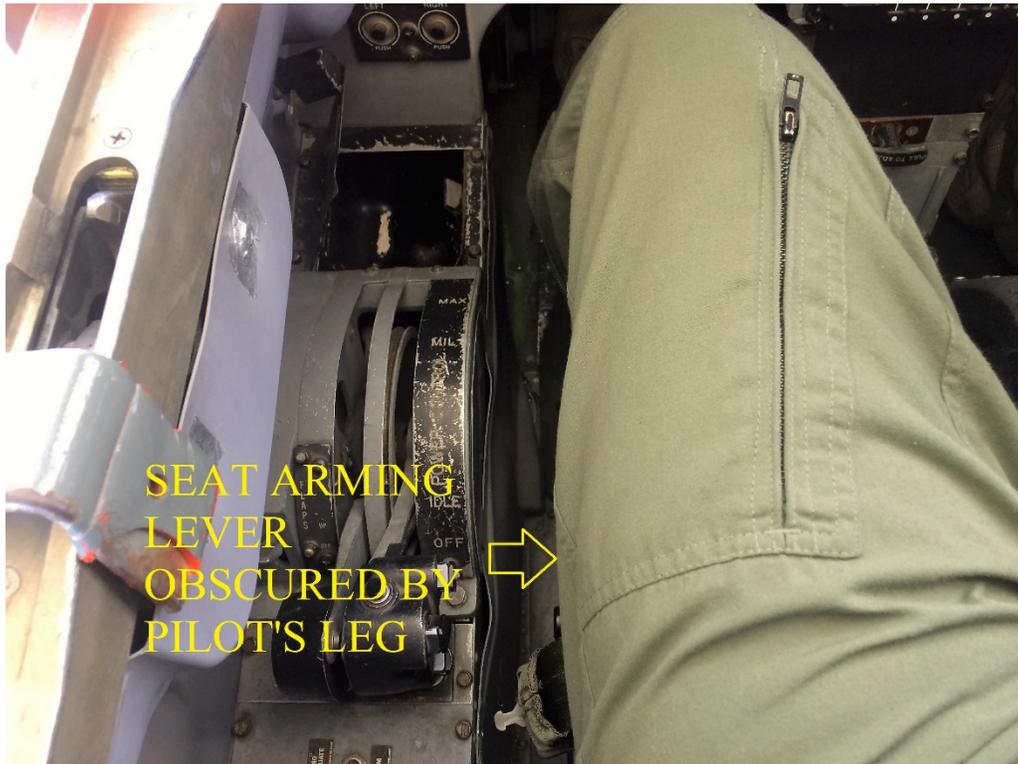
Figure 12: Seat Arming Lever Location in Rear Cockpit.

The only indication that the ejection seat is not armed is the position of the arming lever on the left side of the seat (Tab H-17). During flight, unless the pilot looks down at the lever, the mistake is not visibly apparent (Figure 12). In addition, the arming lever is at least partially obscured, if not completely obscured, by the pilot's leg when the seat is occupied (Figure 12). Furthermore, the CSU-13B/P anti-G-suit would limit tactile feedback that a pilot may sense from the lever being in the "up" or "SAFE" position.

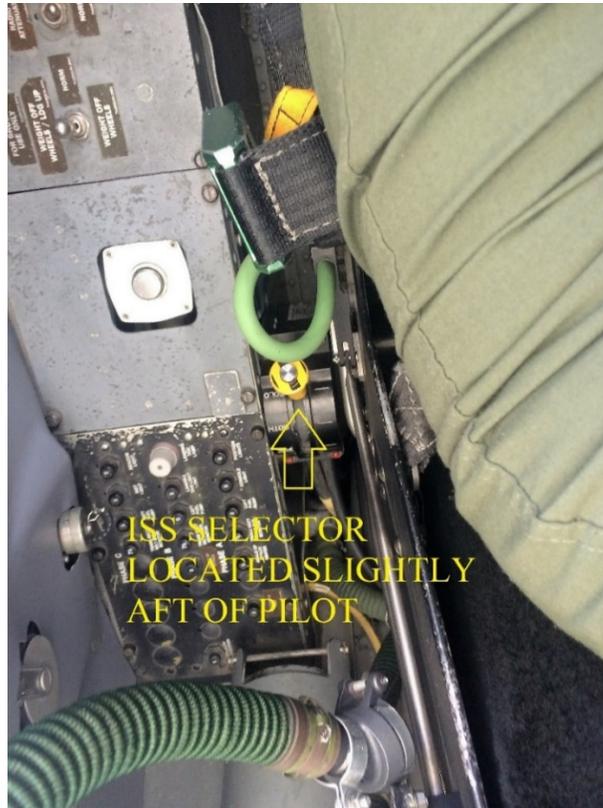
Figure 14: Location of ISS Mode Selector.

In addition, the ISS mode selector is not ergonomically located, as it is behind the pilot, requiring a deliberate action to change the mode (Figure 14).
