UNITED STATES AIR FORCE
AIRCRAFT ACCIDENT INVESTIGATION
BOARD REPORT

WC-130H, T/N 65-0968

**LOCATION: 1.5 Miles Northeast of Savannah/Hilton Head
International Airport, Georgia**

DATE OF ACCIDENT: 2 May 2018

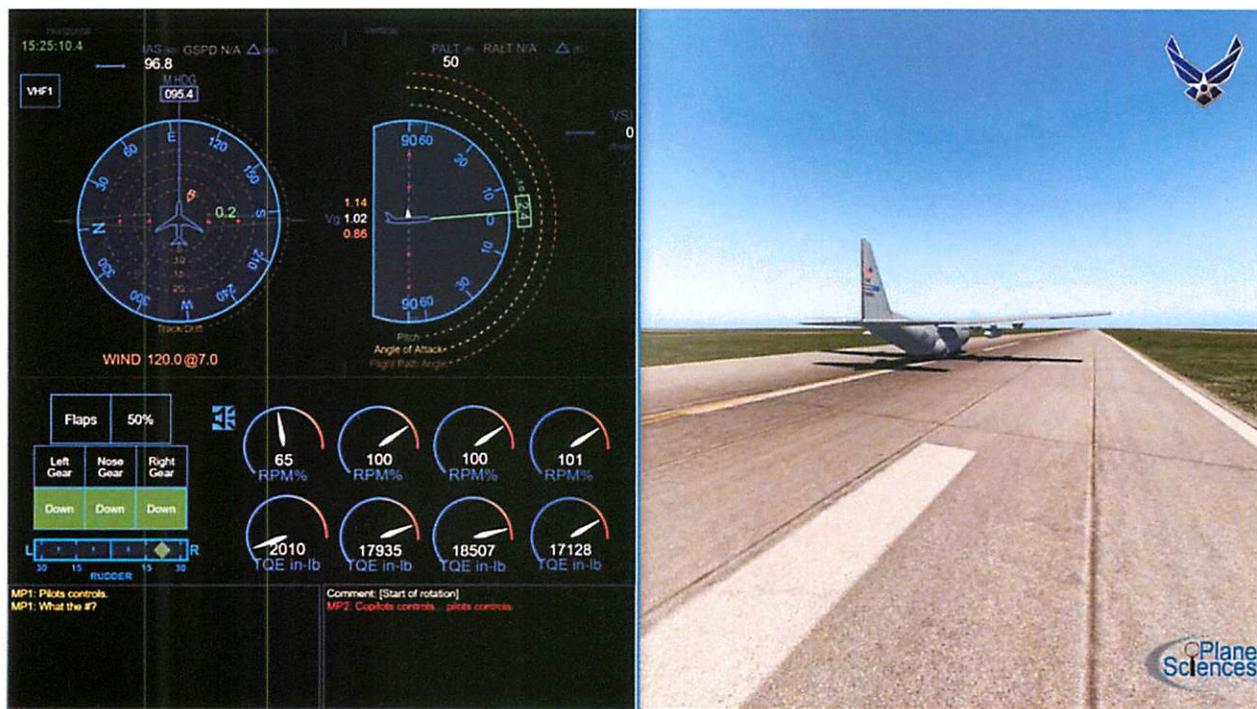
Figure 2 - MP1 Call for "Pilot's Controls" (Tab Z-66)

Moments before rotation, with the MA traveling at approximately 94 KIAS, MP1 applied a right rudder input just above 25-degrees (maximum rudder deflection is 35-degrees⁹⁵) to keep the MA

At aircraft rotation, MP1 called for "pilot's controls," communicating he had moved his hands from nose wheel steering (which was no longer effective) to the yoke and was taking control from MP2 (see Figure 2).⁹⁹ As MP1 made the call, he verbalized something was wrong with the MA, but he was not specific.¹⁰⁰ As soon as the nose wheel lifted from the ground, the MA veered to

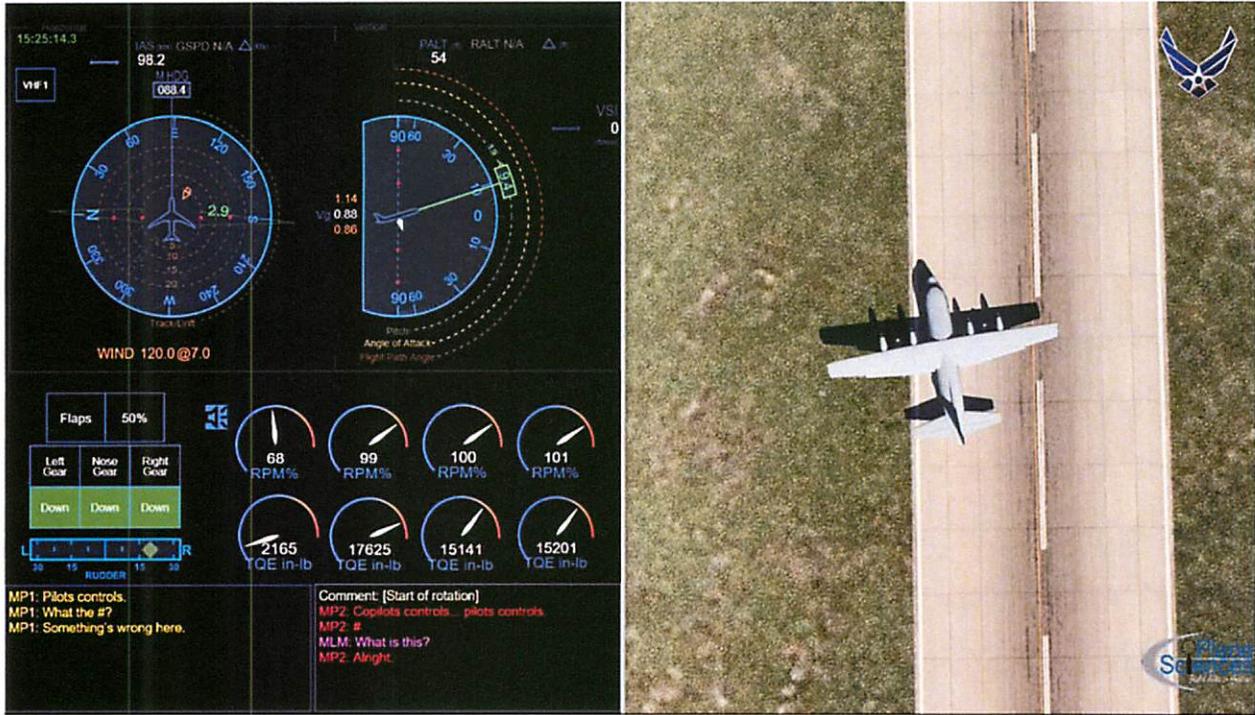
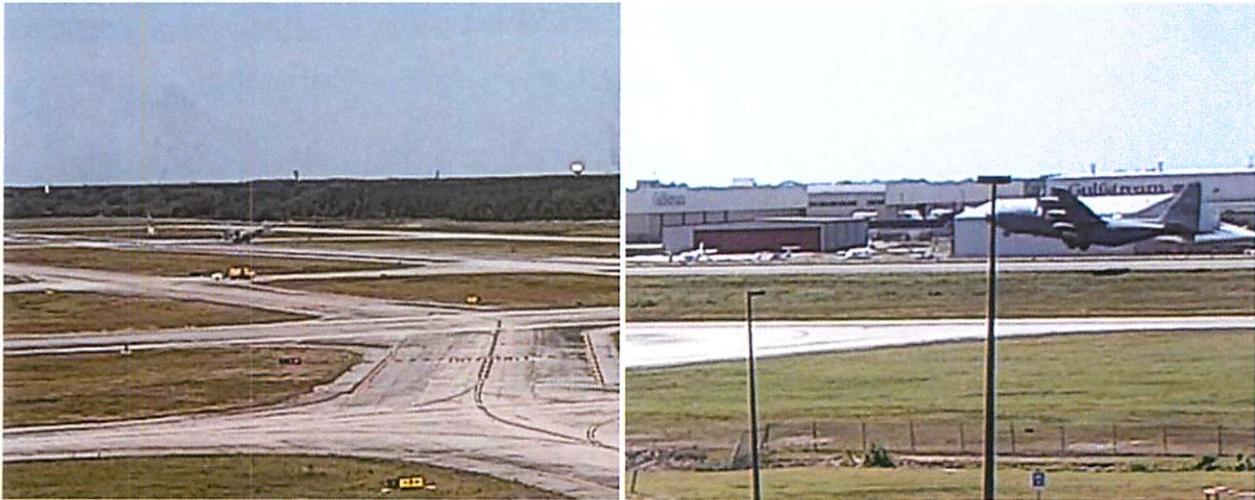
Figure 3 - MA Veered Left at Rotation (Tab Z-175)

Figure 4 - MA Position at Takeoff (Tab Z-16 and Z-20)

the left and nearly departed the runway into the grass before the MA achieved flight at approximately 1125L (see Figures 3 and 4).¹⁰¹

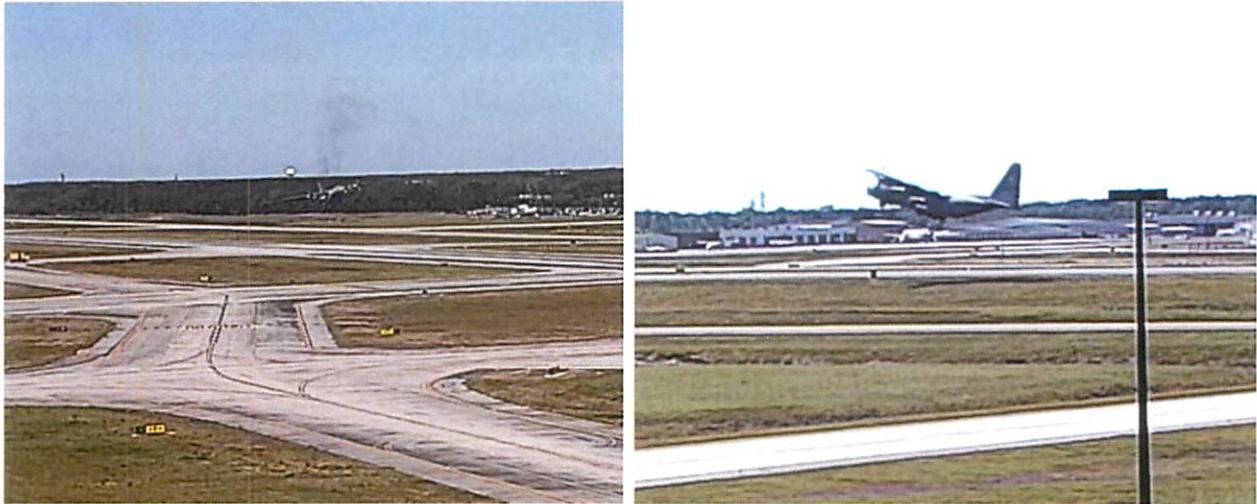
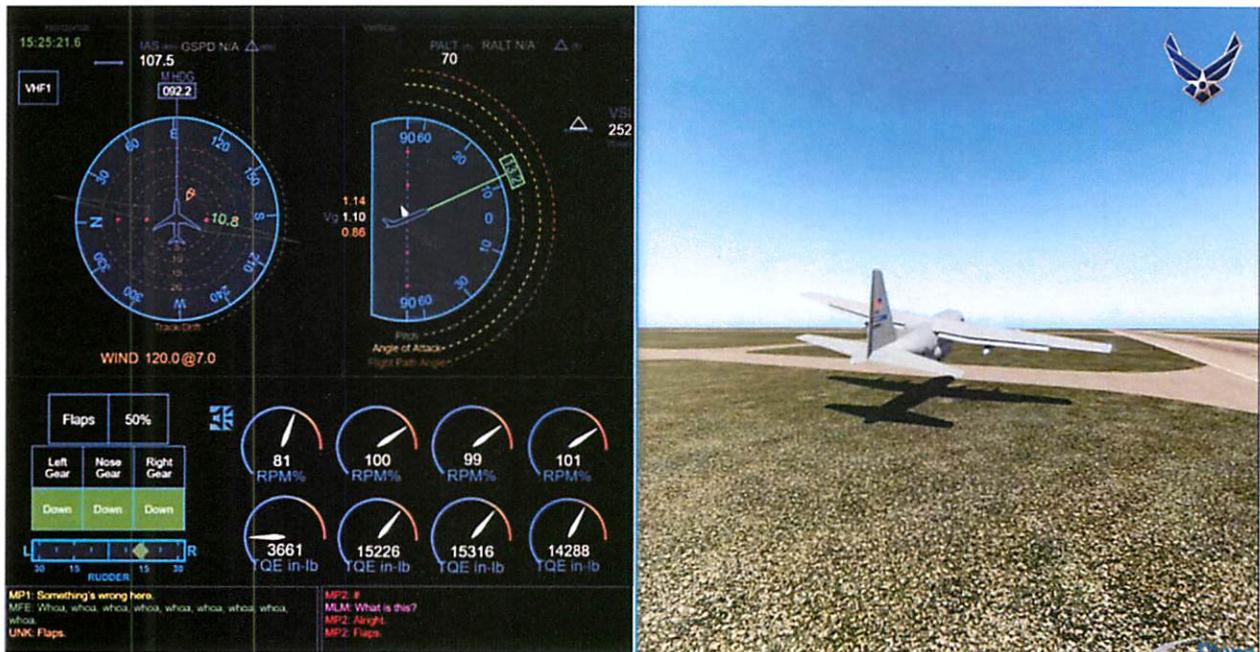
Once airborne, MP1 banked right to maintain runway centerline (see Figures 5 and 6).¹⁰² This bank angle away from engine one, toward the right, was also in compliance with the Flight Manual, which directs a 5-degree bank angle away from a failed engine if an outboard engine fails near minimum controllable speed during takeoff or in flight.¹⁰³ KSAV ATC noted the unusual banking of the MA and contacted the MC.¹⁰⁴ The MC responded and indicated they had a mechanical malfunction.¹⁰⁵

Figure 5 - MP1 Banking Right After Takeoff (Tab Z-18 and Z-22)

Figure 6 - MP1 Bank Right After Takeoff (Tab Z-75)

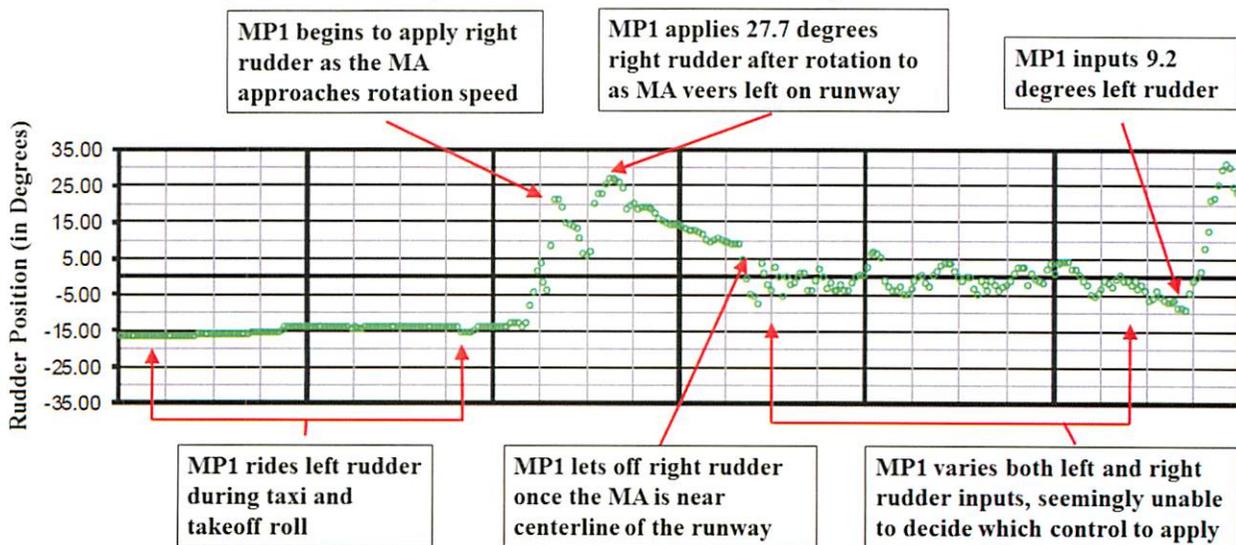
Figure 7 - Rudder Position Directed by MP1 (Tab Z-32)

MP1 continued to climb and turn left toward engine one.¹²⁵ Throughout the turn, MP1 varied both left and right rudder inputs (see Figure 7).¹²⁶ According to the Flight Manual, when one engine is inoperative, the listed minimum control speeds require maximum available rudder deflection, limited by 180 pounds (lbs) pedal force, or maximum rudder surface deflection, whichever occurs first.¹²⁷ In addition, a 5-degree adverse bank angle (into the inoperative engine) requires a speed increase of 20 KIAS above the minimum control speed at 80,000 pounds and 37 KIAS at 140,000 pounds.¹²⁸ Thus, the Flight Manual states that a crew should avoid banked turns into an inoperative engine because of this effect.¹²⁹

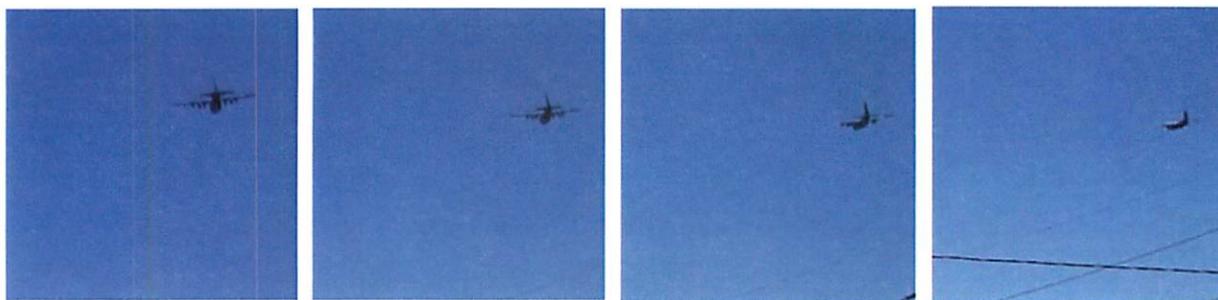
Figure 8 - MA in an Uncoordinated Left Turn (Tab Z-26 to Z-29)

As MP1 continued to climb and turn left, the MC never retracted the MA's flaps, the MA never achieved three-engine climb speed (the maximum speed obtained was 131 KIAS), and the MA's adverse bank angle exceeded 10-degrees (see Figure 8).¹³⁵ Although this banked turn into the failed engine was well below the minimum air speed needed for proper control of the aircraft, the MA did still have enough airspeed to maintain flight.¹³⁶ However, as the MA reached approximately 900 feet MSL and banked up to 19-degrees left, MP1 increasingly input left rudder over nine degrees in the direction of the inoperative engine, contrary to the directives of the Flight Manual (see Figure 9).¹³⁷ As soon as he reached nine degrees, the MA skidded left (i.e., the right

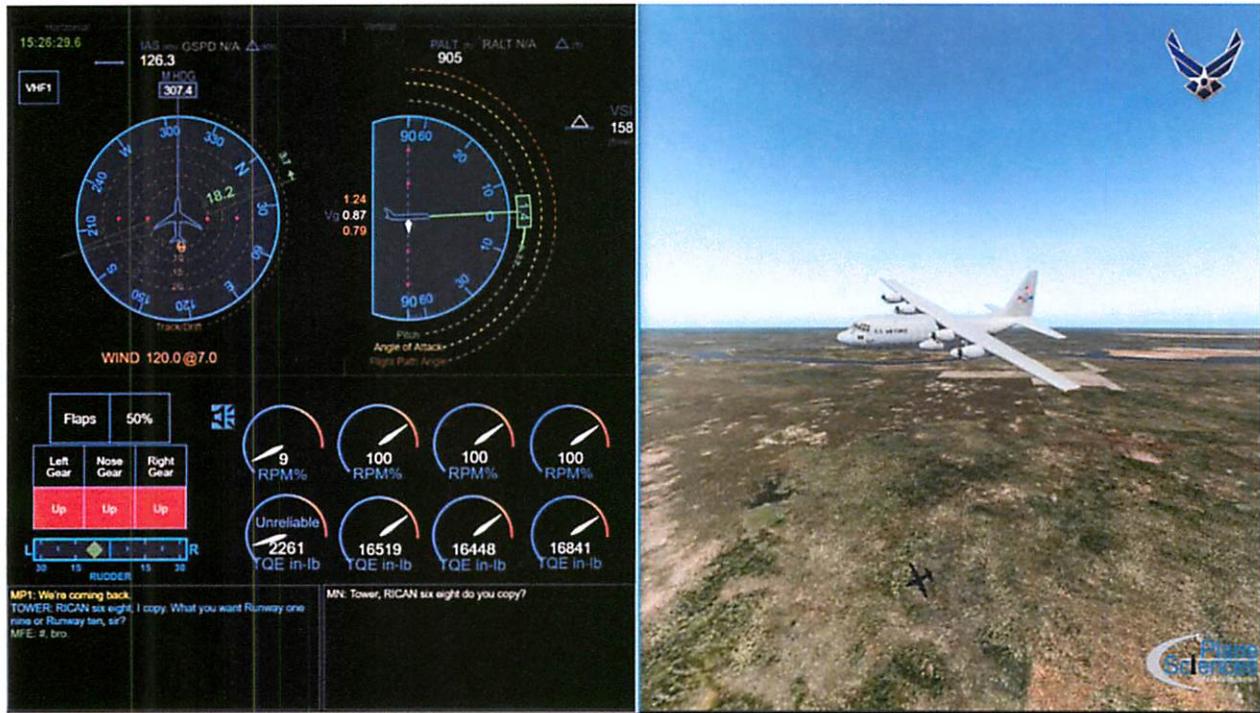
Figure 9 - MA Just Before Departure from Controlled Flight (Tab Z-135)

side of the aircraft was in front of the left side), the left wing lost lift and stalled, and the MA departed controlled flight.¹³⁸

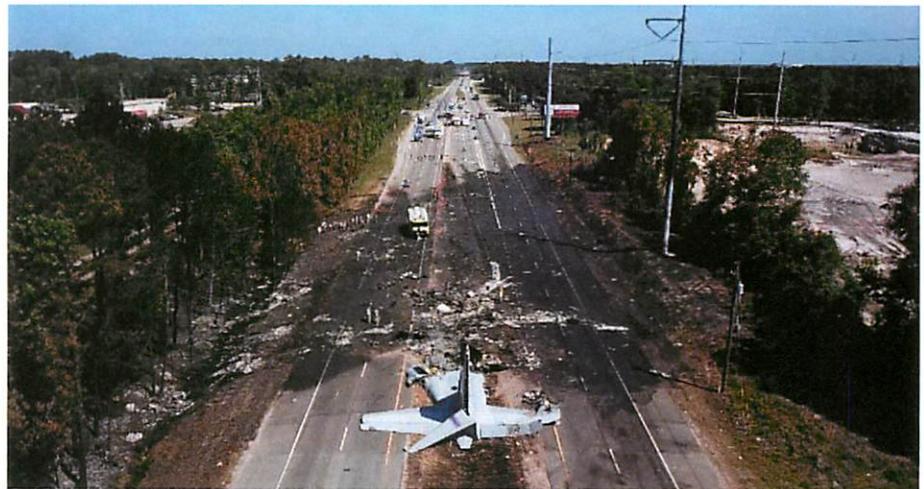
Figure 10 - MA Crash Site on Georgia State Highway 21 (Tab S-3)

The MA obtained a maximum of 52.2 degrees nose-low attitude, did a left hand barrel roll, and crashed on a northerly heading.¹³⁹ The MA impacted the ground less than two minutes after takeoff, at approximately 1127L, on Georgia State Highway 21, East-North East of KSAV, approximately 1.5 miles from the airport.¹⁴⁰ The MC and Mishap Airmen all died instantly upon impact.¹⁴¹

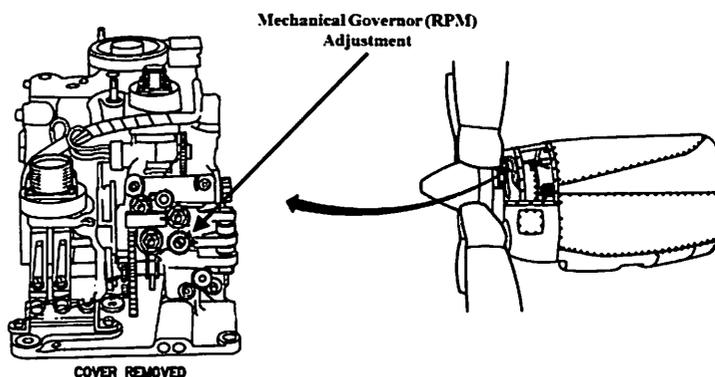
Figure 12 - Location of Valve Housing Assembly on Engine and RPM Adjustment (Tabs DD-69 and Z-33)

When engine speed on the T56-A-15 does not perform at 100% RPM, Air Force maintainers are required to troubleshoot the issue.¹⁸⁸ In many cases, the remedy is a slight adjustment to the engine's valve housing assembly, which can be performed by unit level maintainers. To adjust the valve housing, an Air Force maintainer adjusts the mechanical governor, which has a click type adjustment, with a basic screwdriver (see Figure 12).¹⁸⁹ Each click adjustment changes engine speed by approximately 0.25%.¹⁹⁰ Clockwise rotation increases engine

When an adjustment to the mechanical governor does not resolve the performance issue, an Air Force maintainer is not permitted to disassemble the valve housing at the unit level.¹⁹³ Rather, the aircraft must not be dispatched and the maintainers must remove the valve housing assembly and replace it with a new or refurbished component. Only an overhaul facility equipped with specialized equipment can repair or refurbish a failed valve housing.¹⁹⁴

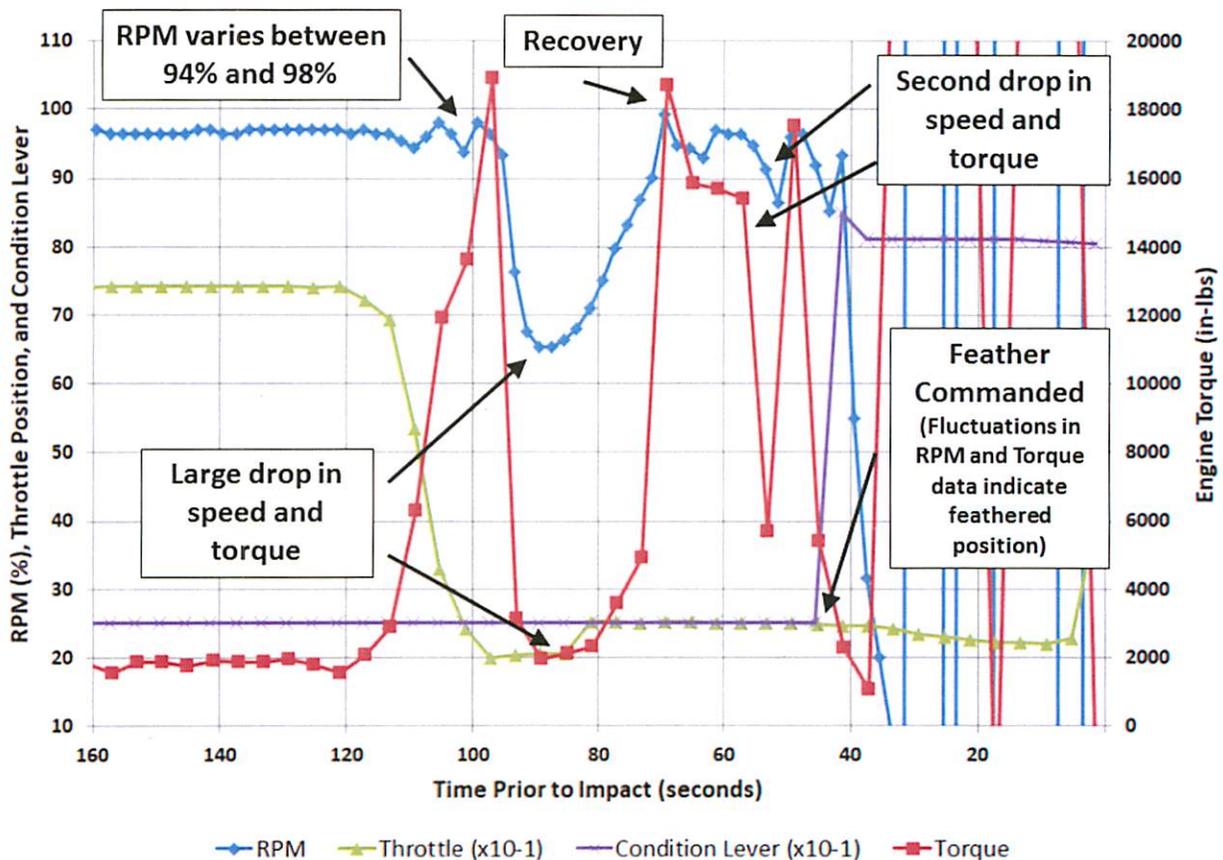
Figure 16 - Engine One Parameters (Tabs J-113 and Z-34)

This speed instability continued until shortly before aircraft rotation, when at just below 94%, engine speed and power rapidly dropped.²⁹³ A rapid drop in engine power below 94% speed is consistent with the compressor bleed valves opening. At aircraft rotation, engine one speed and power bottomed at approximately 65.2% and 1971 in-lbs torque. This torque drop is equivalent to a drop in engine power from nearly 4,000 horsepower to under 300. As the MA started to climb, engine one recovered to takeoff power and 99% RPM, resulting in a 20% overshoot in power for the given throttle setting. Engine one power then reduced to typical levels although engine speed remained somewhat unstable and less than 100%. After approximately 12 seconds of semi-stable operation, engine one power and speed again dropped significantly and became more unstable.²⁹⁴ After another 12 seconds of unstable operation, the MC shut down engine one and commanded the propeller to feather (see Figure 16).²⁹⁵

A comprehensive review of the engine one hardware did not identify an engine specific condition that could explain the abnormal operational behavior of the number one engine/propulsion system.³⁰¹ However, a low governing RPM, as identified in the DFDR, affects a valve housing assembly's ability to decrease propeller blade angles and correct under-speed conditions.³⁰² Thus, the decrease in engine speed identified on engine one is consistent with a valve housing assembly's failure to correct propeller and ultimately engine under-speed. Due to extensive damage to the engine one valve housing assembly, there is no way to determine from the remnants what precisely failed. However, based on engine one behavior in various modes of operation (as noted on the DFDR), the actions taken by the Mishap Maintainers, and analysis of all engine one components ruling out everything except the valve housing, the most likely reason for the engine one malfunction was a failure of the valve housing assembly.
