United States Air Force Accident Investigation Board Report

F-22A Mishap, Naval Air Station Fallon, NV

F-22A, T/N 07-4146
90TH FIGHTER SQUADRON
3RD WING
Joint Base Elmendorf-Richardson, Alaska

EXECUTIVE SUMMARY
UNITED STATES AIR FORCE
AIRCRAFT ACCIDENT INVESTIGATION
F-22A, T/N 07-4146
Naval Air Station Fallon, NV
13 April 2018

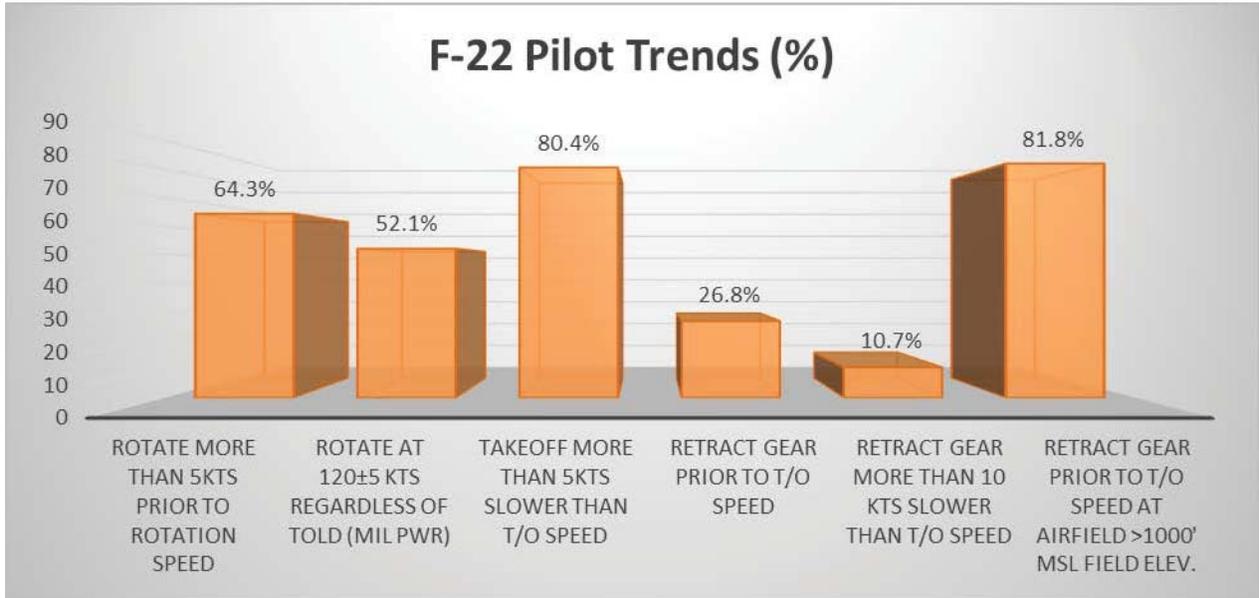
Figure 1: F-22 Pilot Trends. Data includes 56 sorties analyzed by the AIB.

This technique of rotating early does not appear to be limited to the MP. Data from multiple sorties flown by 90 FS pilots are presented in Figure 1 and Figure 2. The data shows that in 64.3% of sorties, rotation was initiated greater than 5 knots prior to the calculated rotation speed; in 52.1%, rotation occurs at 120 ± 5 KCAS (Tab CC-3, Figure 1). In 80.4% of these sorties, takeoff was accomplished greater than 5 knots prior to takeoff speed (Tab CC-3, Figure 1). All pilots who were interviewed noted that they check their TOLD before takeoff (See, e.g., Tab V-5.1, V-9.1, V-13.1). After the mishap, at a pilot meeting attended by 20 to 30 F-22 pilots, about half noted that they consistently use an early rotation technique (Tab V-2.16, V-4.14, V-4.17). There is a clear trend of rotating early among a significant number of F-22 pilots, including the MP, despite being aware of computed TOLD.

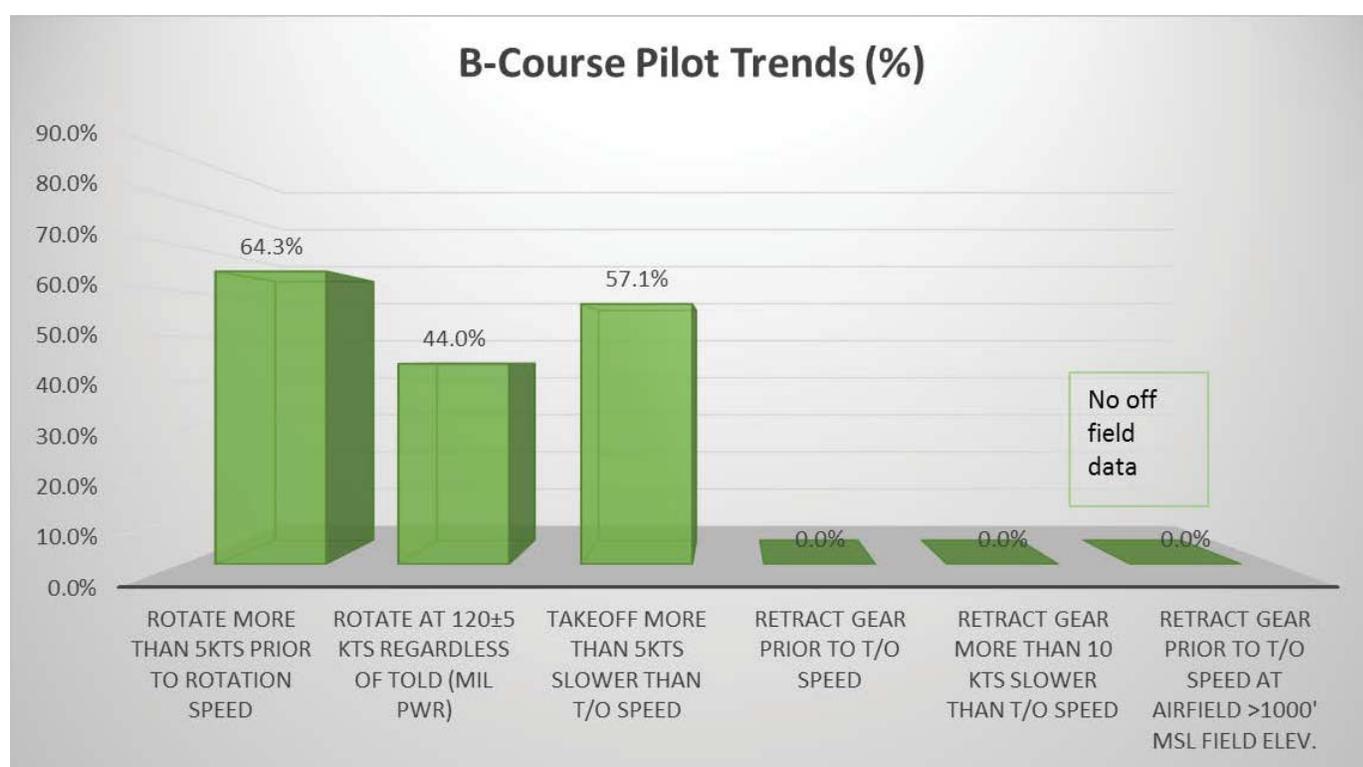
Figure 3: B-Course F-22 Pilot Speed Trends during Takeoffs. Twenty-eight sorties analyzed by the AIB.

Formal Training is a factor when one-time or initial training programs, upgrade programs, transition programs or other training that is conducted outside the local unit results in undesirable outcomes. The F-22 B-Course teaches pilots the fundamentals of flying the F-22. Data from multiple sorties from two recent B-Course classes was analyzed by the AIB and is shown in Figure 2 and Figure 3 (Tab CC-3 to CC-4). This sample set showed that 64.3% of the students rotated greater than 5 knots below the computed rotation speed and 44.0% rotated at 120 ± 5 KCAS. The data shows that 100% of the students retracted their LG after achieving takeoff speed (Tab CC-3 to CC-4). There is a clear trend of rotating early among a significant number of F-22 student pilots at the B-Course.
