UNITED STATES AIR FORCE
AIRCRAFT ACCIDENT INVESTIGATION
BOARD REPORT

RQ-4B, T/N 07-2029

LOCATION: NEAR LONE PINE, CALIFORNIA

DATE OF ACCIDENT: 21 JUNE 2017

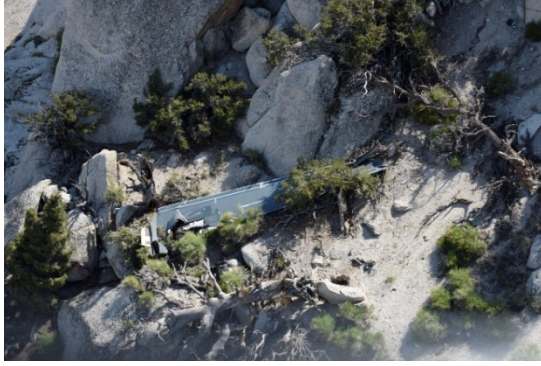
Figure 1 (Tab S-5)

After losing links with the MRPA and receiving the last data packet, MMC contacted Joshua Tree Center who had no radar returns from the MRPA (Tab R-20 and R-48). Video of the mishap and photographs of the wreckage show the MRPA suffered structural failure in flight (Tabs S-4 to S-6 and FF-28 to FF-29).

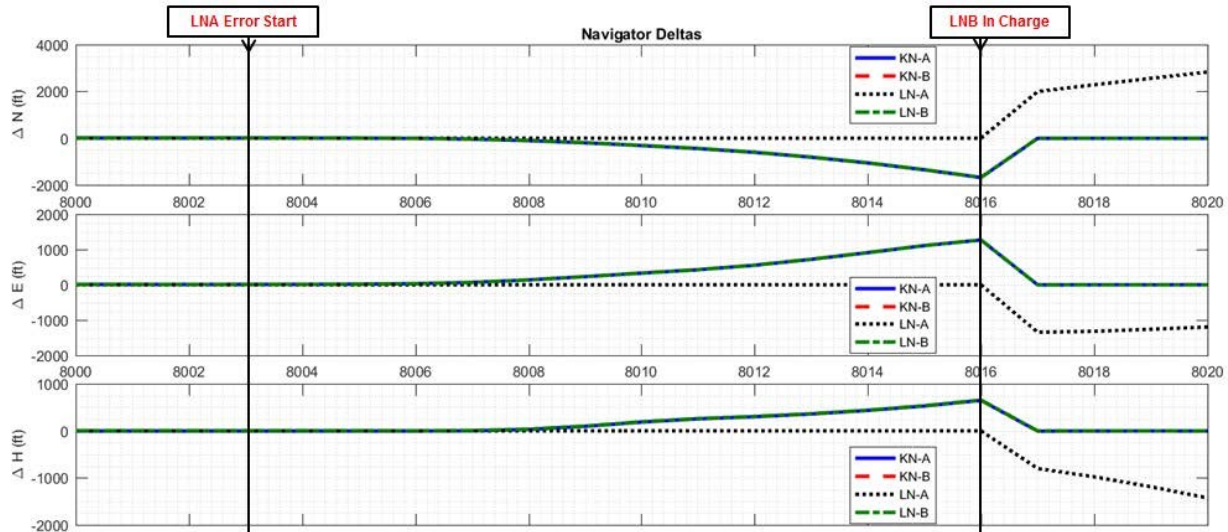
Table 2 (Tab DD-35)

Data recovered indicated how all four navigators were performing during the mishap sortie (Tab DD-32 and DD-35). Three navigators were operating normally (Tab DD-32 and DD-35). Because KNA and KNB were disabled at the time of the mishap, LNA was the "in-charge" navigator (Tab DD-18). LNA provided erroneous data, deviating from the other navigators (Tab DD-32 and DD-35). The RQ-4 is designed to detect erroneous data within the navigational

system (Tabs V-13.6, V-15.4, and DD-16 to DD-18). During the mishap sortie, the MRPA’s navigation system did not detect LNA’s erroneous data (Tab DD-32). Post-mishap analysis and testing of LNA, and same-type devices, were unable to determine the root cause of LNA’s erroneous navigational data (Tab DD-40 to DD-41).
