UNITED STATES AIR FORCE
AIRCRAFT ACCIDENT INVESTIGATION
BOARD REPORT

F-16C, T/N 90-0760

LOCATION: LAKE HAVASU CITY AIRPORT, ARIZONA

DATE OF ACCIDENT: 24 APRIL 2018

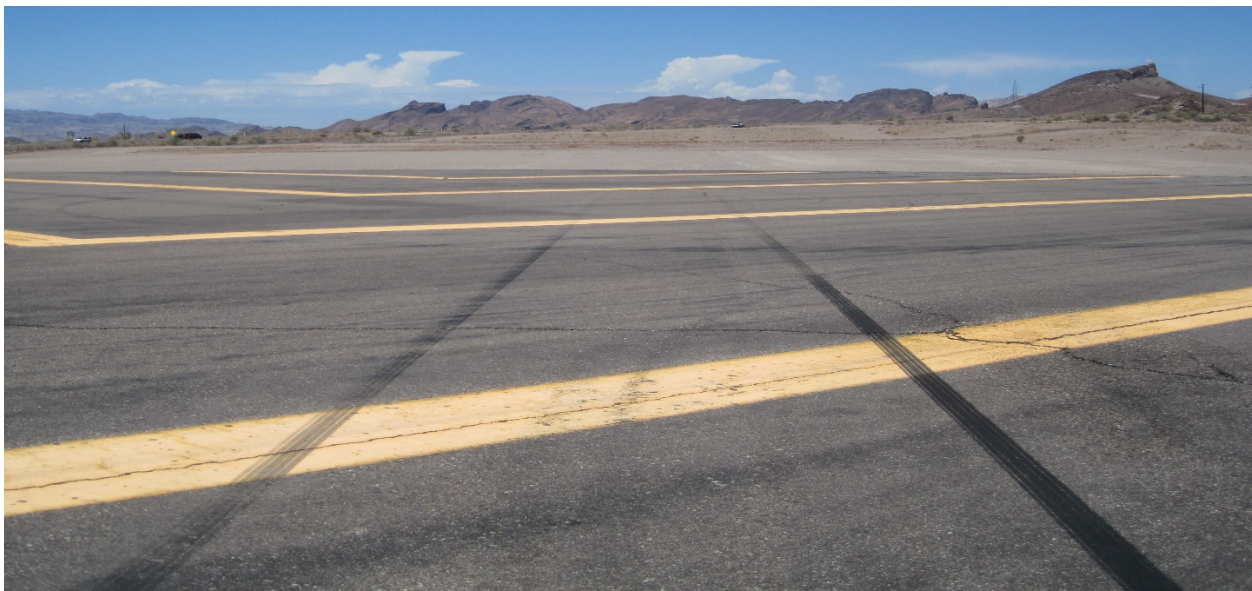
MIP's directives (Tab V-34.12). The MA's excess airspeed resulted in it touching down approximately 4,400 feet down the 8,000 foot runway at 180 kts (Tabs CC-8 and J-11). The MP attempted to increase the angle of attack (AOA) on the MA to decelerate faster; however, when the MP pulled back on the control stick to raise the nose of the MA, the excess airspeed caused the MA to lift off the ground (Tab CC-8).

The MA touched down a second time approximately 5,300 feet down the runway with 2,700 feet remaining at 165 kts (Tab CC-8 and J-22). The MIP radioed "Max braking...max braking" (Tab CC-10). The MP used maximum aerodynamic and mechanical braking but did not have enough runway remaining to stop the MA (Tab CC-8). Approximately 100 feet from the end of the runway, the MIP radioed "Eject, eject, eject" (Tab CC-8). The MP ejected from the MA as it overran the end of the runway at 93 kts (Tab CC-8).

Figure 1: MA Tire Tracks Departing Runway (Tab Z-3)

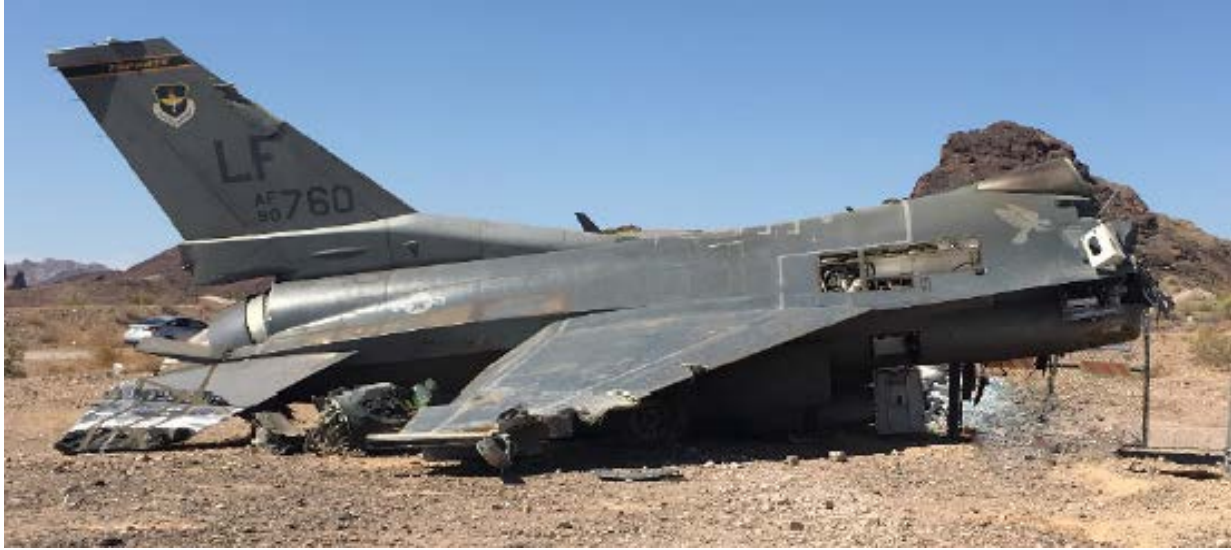
After departing the runway, the MA traveled approximately 1,000 feet on relatively flat terrain before continuing up a 10-degree incline for approximately 300 feet (Tab J-11). Based on the absence of tire tracks, the MA became airborne at the top of the incline and traveled another approximately 300 feet through the air before impacting the perimeter fence (Tab J-22). Subsequently, the MA hit the ground, shearing off the nose of the MA, the nose landing gear and the right main landing gear (Tab J-22). At 10:27:33, the MA collided with another section of the fence and spun clockwise approximately 130 degrees where it came to rest (Tab J-22). After impacting the ground, dirt and rocks were ingested by the intake causing the engine to shut down (Tabs J-22 and U-10).

Figure 2: MA Wreckage (Tab J-10)

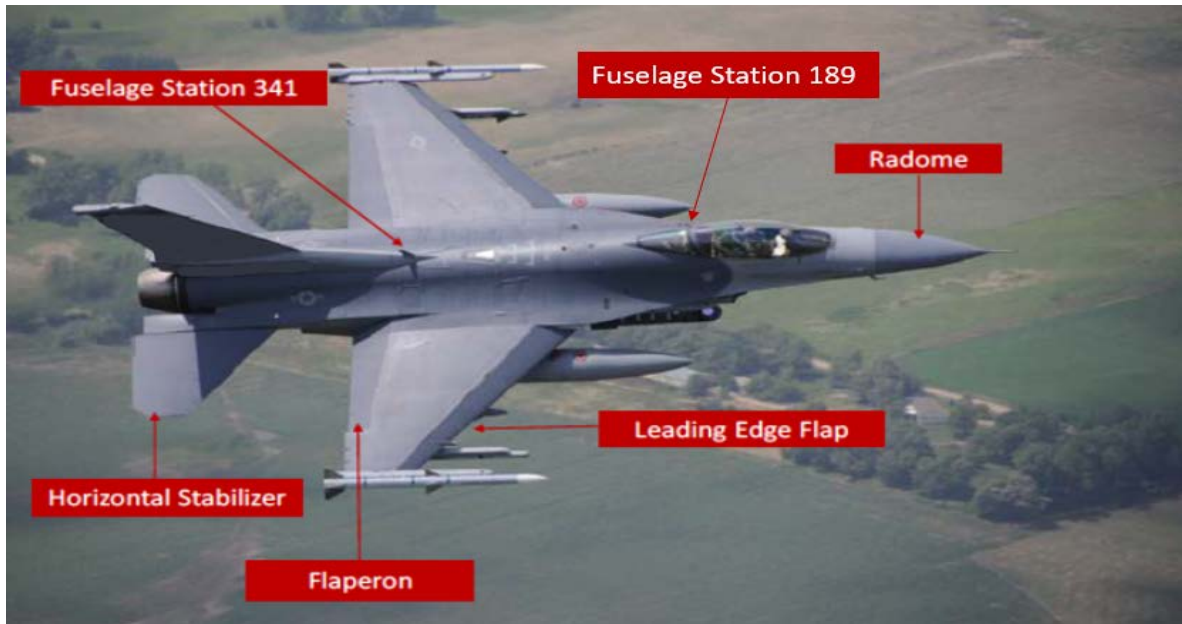
The MA received extensive damage upon impact with the perimeter fence (Tabs J-17 to J-22). The forward portion of the aircraft at the forward manufacturing breaking point and fuselage station 189 separated in line with the engine inlet (Tabs J-17 to J-22). The left and right wings, to include all flight control surfaces on the wings, landing gear and stabilizers all received extensive damage during impact (Tabs J-17 to J-22). Additionally, the engine exhaust nozzle and the centerline external fuel tank located on station 5 incurred severe damage. Post impact analysis deemed the MA a total loss (Tabs J-17 to J-22).

Figure 3: Labeled F-16 Diagram (Tab Z-5)
