**UNITED STATES AIR FORCE**  
**AIRCRAFT ACCIDENT INVESTIGATION**  
**BOARD REPORT**

**T-38C, T/N 68-8181**

**50TH FLYING TRAINING SQUADRON  
14TH FLYING TRAINING WING  
COLUMBUS AIR FORCE BASE, MISSISSIPPI**

**DATE OF ACCIDENT: 23 MAY 2018**

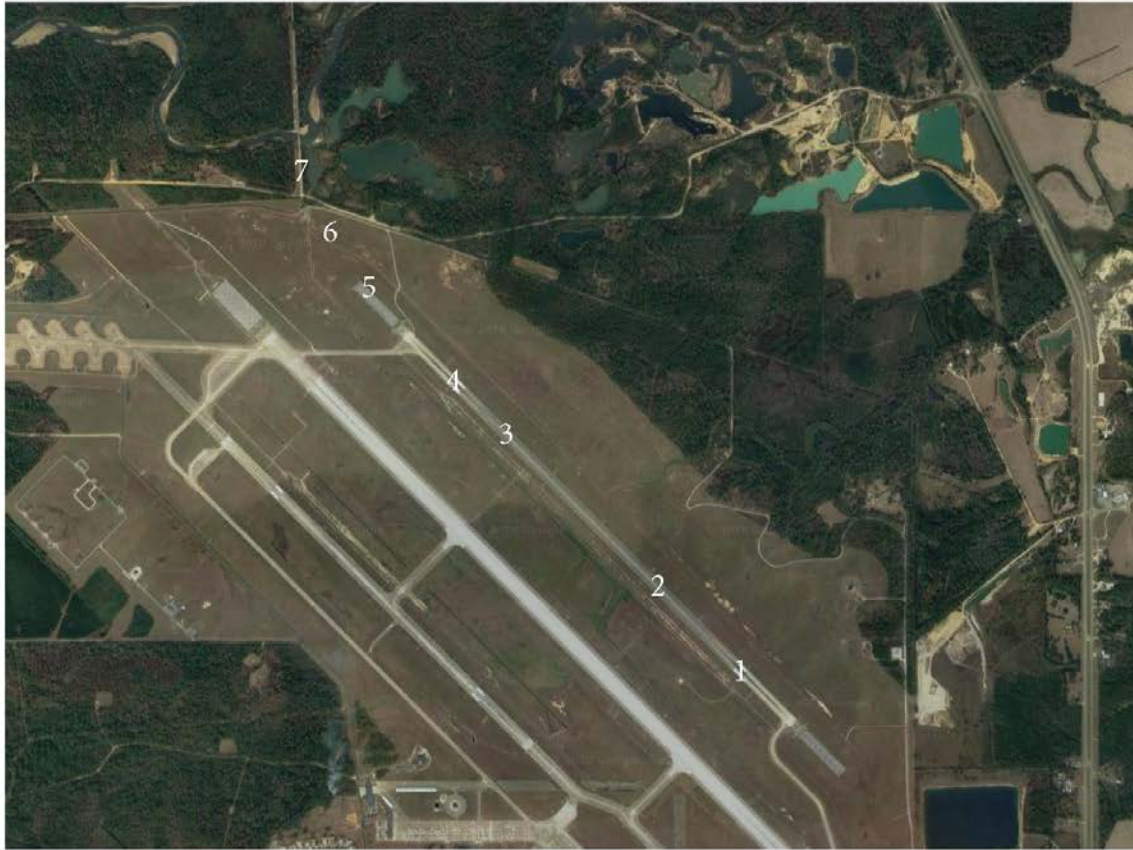
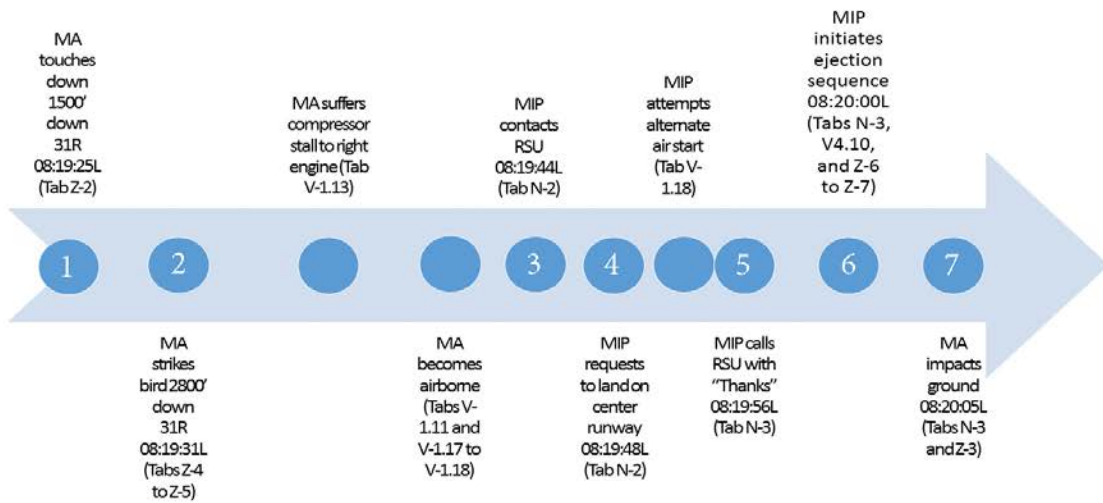
Figure 1 (Tabs DD-26 to DD-27 and DD-33)

a stalled condition (Tabs R-5 and BB-19). While simultaneously working to regain right engine thrust, the MIP made three radio calls to the Runway Supervisory Unit (RSU) in the span of 12 seconds to coordinate for a landing on runway 31 center (31C) (Tab N-2 to N-3). Although the MIP stated he did not recall reducing left engine thrust below MAX, in the course of making large right throttle movements while keying the radio switch on the throttle, left engine thrust was reduced to minimum afterburner (MIN AB) where it remained through impact (Tabs J-59 and V-1.19). The aircraft avionics produced visual and aural warnings that the aircraft was approaching stall, and the MIP noted airspeed of 143 KIAS (Tabs R-8 and R-24). Based on flight simulations, it was determined the MA slowed below the stall speed of 139 KIAS due to insufficient thrust needed to sustain normal climbout pitch while overcoming the drag of a fully configured aircraft (Tabs BB-22 and DD-24 to DD-25). The MA then stalled, causing a rapid and uncontrolled roll to the right followed by a slower, uncontrolled roll to the left at approximately 200 feet above the ground (Tabs R-24, R-44, and DD-24 to DD-25). At approximately at 08:20:00L, the MIP initiated a sequenced ejection while the aircraft was in left bank and continuing to roll left (Tabs R-24, S-8, and DD-26).
