UNITED STATES AIR FORCE
AIRCRAFT ACCIDENT INVESTIGATION
BOARD REPORT

T-38C, T/N 68-8152

**87TH FLYING TRAINING SQUADRON
47TH FLYING TRAINING WING
LAUGHLIN AIR FORCE BASE, TEXAS**

DATE OF ACCIDENT: 13 November 2018

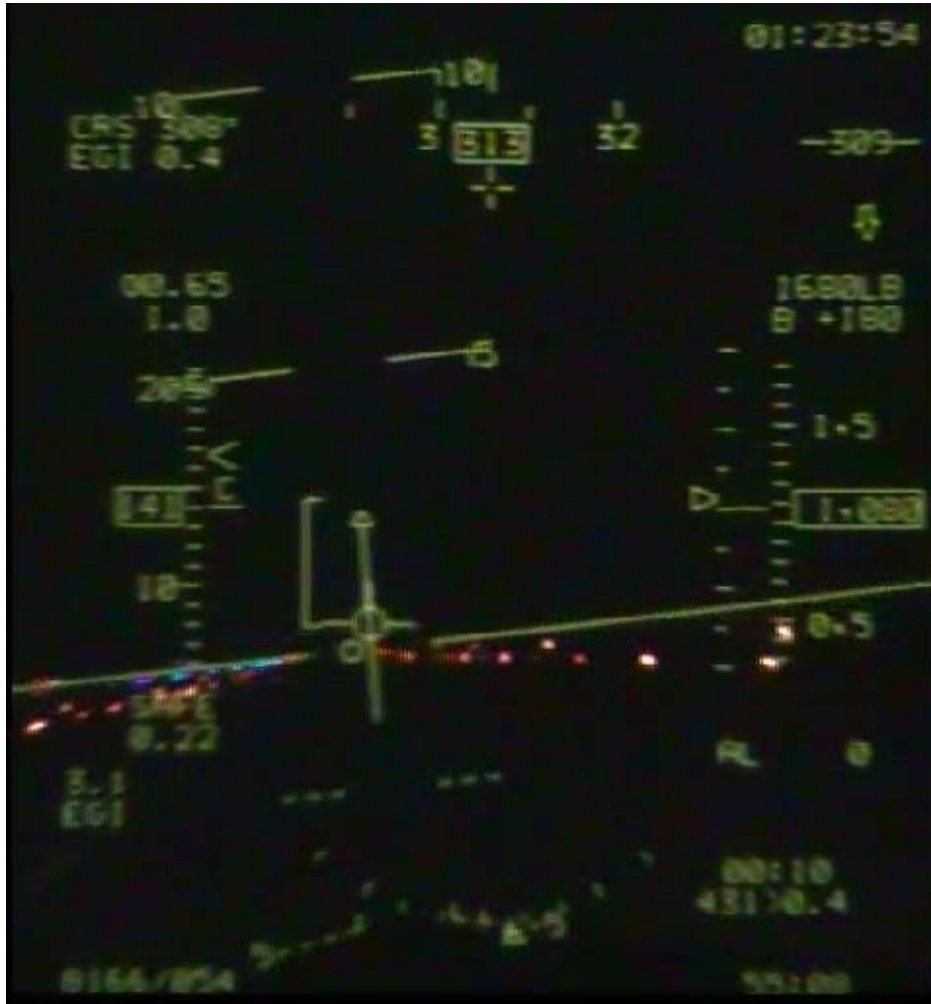
Figure 1 - MIP1 Assumes Control of Aircraft (Approximate) (Tab Z-5)

At 19:23:55.1, MIP2 noted a right bank and moved the stick to the left, but MIP1 reiterated that he had control of the aircraft (Tabs V-13.3 and DD-17). At 19:23:56, aural, head-up display (HUD), and multi-function display (MFD) stall indications began and continued for the next four seconds as the aircraft continued to roll to the right (Tab DD-17). According to the Global Positioning System (GPS), at 19:23:57.9, the MA drifted over the edge of the runway with approximately 20 degrees angle of bank and 13 degrees off runway heading as shown in Figure 2 (Tabs Z-6 and DD-18). The landing light illuminated the grass at approximately 19:23:58.9, which coincides with MIP1 exclaiming “Dude” and making a small correction to bring the bank angle of the aircraft back to 8 degrees, but the MA returned to 12 degrees of bank to the right (Tabs V-13.4 and DD-18). Throughout this time, the MA failed to accelerate appreciably, the aerodynamic stall warning continued, and the maximum height reached was less than 10 feet above ground level (AGL) (Tab DD-18).

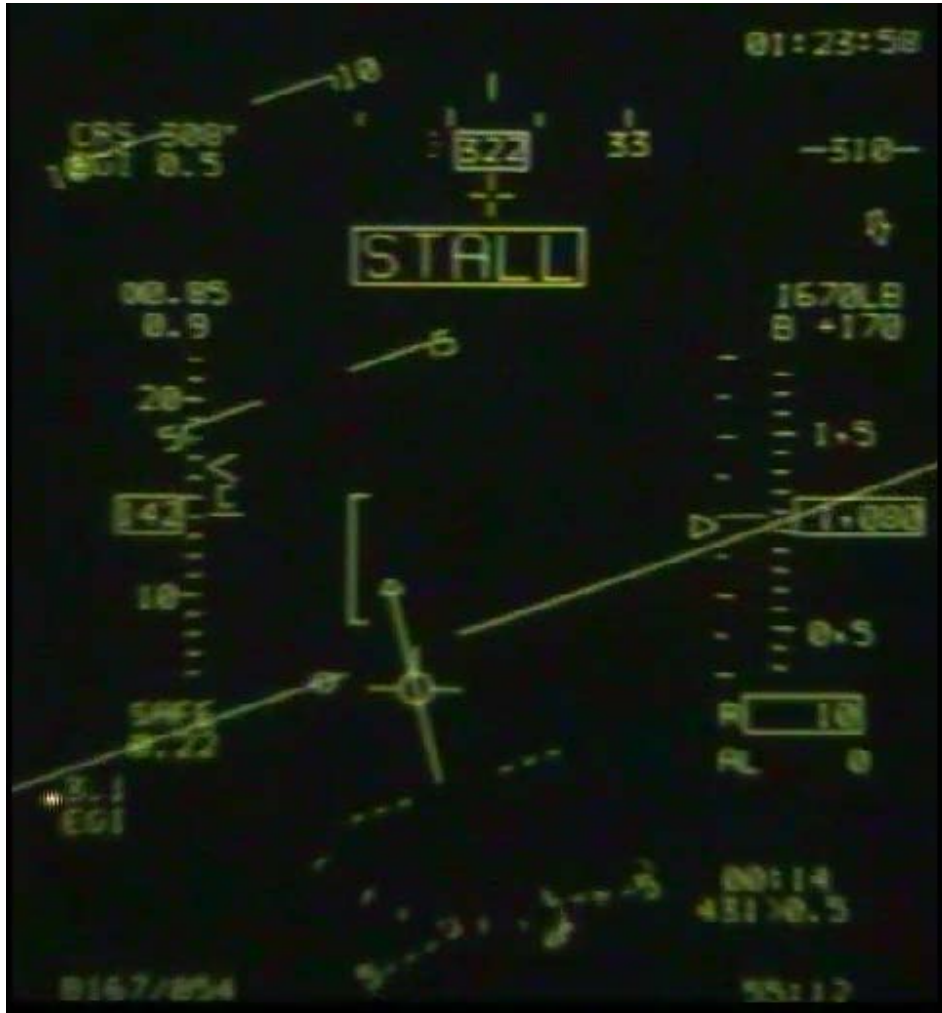
Figure 2 - Aircraft Overflying Edge of Runway (Tab Z-6)

At 19:24:00, the aircraft touched down on the grass approximately 55 feet from the runway surface as shown in Figure 3, with the right tire first, followed by the left tire approximately 175 feet later, which leveled the wings, travelling approximately 13 degrees off runway heading (Tabs J-4, Z-7, and DD-18). The MA's high pitch and the landing light's downward angle when airborne limited the illumination of the ground until sufficient bank and proximity allowed the MC to see the grass (Tab DD-18). The MA traveled approximately 350 feet more during which time the aerodynamic stall warning subsided as MIP1 relaxed aft stick pressure (Tab DD-19). At 19:24:01.5, MIP1 pitched up the nose, and the left engine went to MAX power at 19:24:02.0 (Tab DD-18 to DD-19). This was the first selection of MAX power on either engine since the compressor stall (Tab DD-19). The MA became airborne at 19:24:02.5 (Tab DD-19).

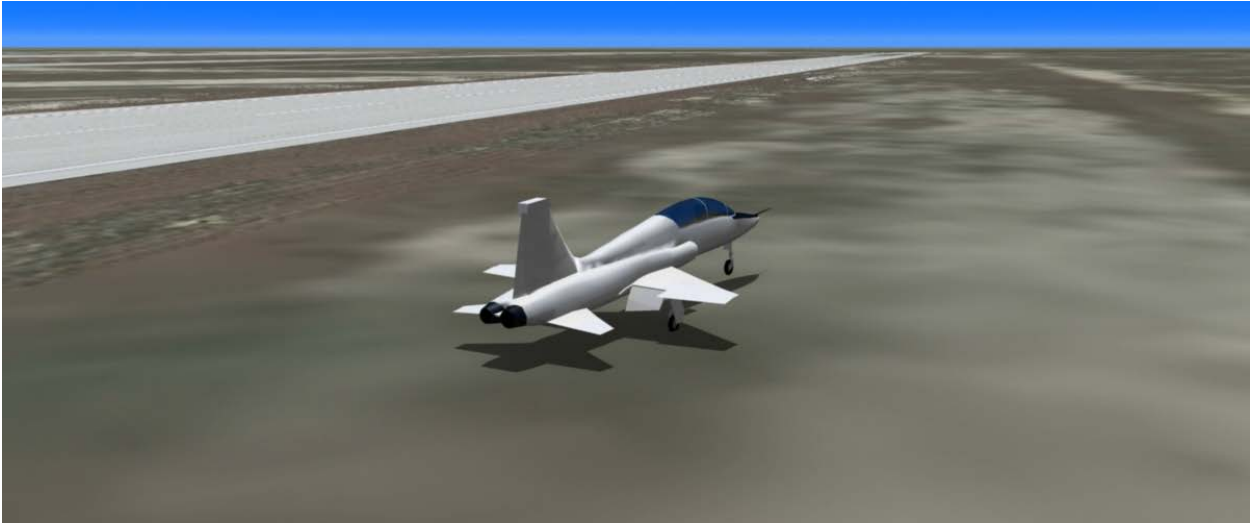
Figure 3 - Aircraft Touchdown in Grass (Tab Z-7)

At 19:24:03.2, as the aircraft reached its maximum pitch, MIP1 commanded ejection (Tab DD-19). Simultaneously, the MA reached full aerodynamic stall and rolled to the right as the nose dropped (Tab DD-19). The MA angle of attack indicates that MIP1 released the stick as he finished commanding ejection approximately one second later (Tab DD-19). Figure 4 shows the parameters of the aircraft at 19:24:04.9, immediately prior to ejection and impact, with a slightly nose low attitude, 45 degrees of right bank, a descent rate of 500 feet per minute, and an airspeed of 147 knots (Tabs Z-8 and DD-19). The MC initiated ejection (Tab J-25). MIP2 successfully ejected and sustained minor injuries (Tab J-25). However, impact interrupted MIP1's ejection sequence after the canopy departed but before the forward seat ejected (Tab J-25 and J-40).
