INSPECTOR GENERAL

SEPTEMBER 30, 2013

DoD Is Not Properly Monitoring the Initiation of Maintenance for Facilities at Kandahar Airfield, Afghanistan

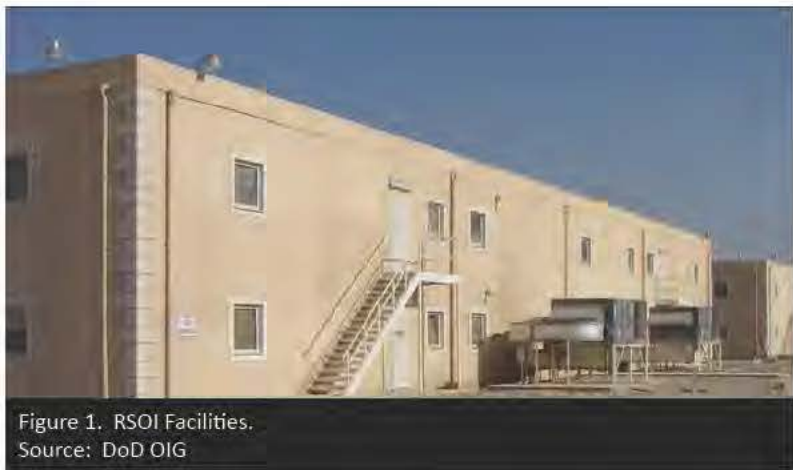
Figure 1. RSOI Facilities.
Source: DoD OIG

~~(FOUO)~~ In 2012, the RSOI facilities, which cost about \$12.1 million to construct, required repairs that cost an estimated \$5.6 million, or 46 percent of the construction cost, before they could be added to the Density List. The RSOI facilities (see Figure 1) had construction deficiencies that required repairs from the LOGCAP contractor and a TF POWER contractor before they could be added to the Density List. Additionally, the fire suppression system and fire detection system did not meet fire code requirements, and both were inoperable, as of January 7, 2013. Although LOGCAP contractor personnel added the RSOI facilities to the Density List in 2012, they did not accept the fire suppression system and fire detection system.

The RSOI facilities required an estimated \$5.6 million in repairs before they could be added to the Density List: \$3.2 million for repairs performed by the LOGCAP contractor and \$2.4 million in electrical repairs performed by a TF POWER contractor. When U.S. military personnel initially occupied the RSOI facilities in 2009, the facilities were not added to the Density List. During the year the facilities were occupied, they deteriorated significantly. The personnel were later evacuated due to electrical deficiencies that posed a safety threat (U.S. military personnel occupied the RSOI facilities off and on from 2009 to 2012).

In addition, in June 2012, TF POWER reviewed the entire facility's electrical system and found the external feeder cables, interior wiring, electrical panels, raceways, and electrical devices consisted of nonlisted materials. The electrical system, from the power house through the entire RSOI facilities, did not meet standards and was deemed unsafe. Therefore, on July 30, 2012, TF POWER used the USACE-Philadelphia District to contract the electrical repairs to Inglett & Stubbs International, which cost \$2.4 million, according to the Deputy Director, TF POWER.

(FOUO) According to the USACE-TAD deficiencies log for the RSOI facilities, the USACE-TAD quality assurance official documented that the construction contractor repaired the fire detection and fire suppression systems on August 22, 2009. However, on March 24, 2010, the Chief Fire Inspector, KAF Fire Department, documented that the fire detection system did not function properly and could not give a letter of acceptance. On April 21, 2010, the Chief Fire Inspector signed a memorandum documenting a partial acceptance of the RSOI facilities that stated:

(FOUO) On July 29, 2011, the LOGCAP contractor conducted a technical inspection of the RSOI facilities compliance with fire safety regulations. The LOGCAP contractor inspectors identified 506 fire safety deficiencies. Specifically, the LOGCAP contractor inspectors identified improper sprinkler head spacing, improper smoke detector spacing, and an inadequate number of fire extinguishers.

(FOUO) In May 2012, DoD OIG Technical Assessment Directorate engineers performed an inspection of the fire protection system at the RSOI facilities and identified major deficiencies which significantly increased the risk to life and safety. These deficiencies included a required automatic fire sprinkler system that was not operational, a fire department connection that was obstructed, and a fire detection system that was out of service. The technical assessment directorate engineers concluded that the inoperative fire sprinkler system and fire detection system provided a false sense of security and posed significant life, health, and safety risks to building occupants. On May 21, 2012, the engineers briefed the RSG at KAF about the RSOI facilities' inoperative fire automatic sprinkler system and fire detection system.

~~(FOUO)~~ USFOR-A should expedite repairs to the fire suppression system at the RSOI facilities. Additionally, USACE-TAD should review the actions of the official(s) that conducted contract oversight and approved the inoperative fire suppression system and fire detection system at the RSOI facilities; and, as appropriate, initiate corrective measures and actions to hold personnel accountable.

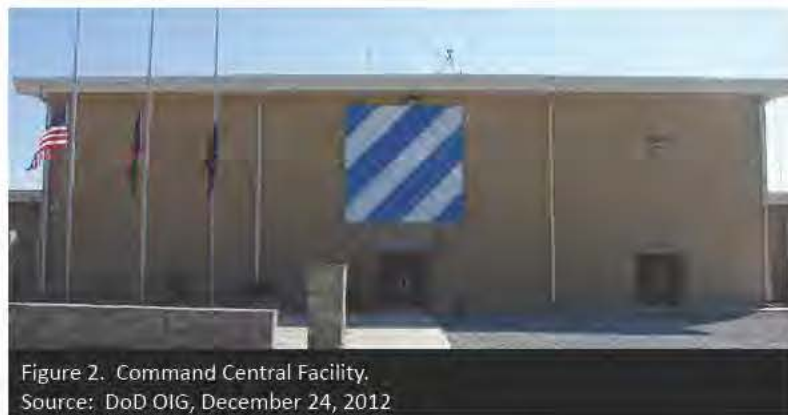
Figure 2. Command Central Facility.
Source: DoD OIG, December 24, 2012

On October 31, 2011, the Command Central facility was added to the Density List without the required repairs; however, the facility would receive repairs later in 2012. The facility was not occupied until the 3rd Infantry Division deployed to KAF in July 2012 (see Figure 2). After the facility was occupied, tenants experienced chronic HVAC system deficiencies due to poor quality construction by the USACE-TAD construction contractor.

During the summer of 2012, the HVAC system was not cooling sections of the facility. Command Central officials stated that the facility was usually 100 to 120 degrees inside during the summer, and the temperature of the commanding general's office was higher than the outside temperature.⁹ Therefore, on July 10, 2012, the tenants contacted the LOGCAP contractor to repair the Command Central facility's HVAC system, but contractor personnel provided only a temporary repair.

On July 26, 2012, USACE-TAD assessed the HVAC system and identified that the compressors were unworkable; USACE-TAD contacted the construction contractor to make the necessary repairs under warranty. The USACE-TAD construction contractor did not repair the HVAC units. On October 17, 2012, the USACE-TAD contracting officer signed a memorandum stating:

The repair and or replacement of the HVAC at the [Command Central] building cannot be done under warranty because the warranty was voided by the local maintenance firm (DynCorp) making unauthorized repairs on the [air-handling units] and failing to perform regular maintenance. The system cannot be warranted by the manufacturer without replacement of the existing components. USACE cannot direct the construction contractor to affect any further repairs or inspections without having a new contract in place because the system is not under warranty.

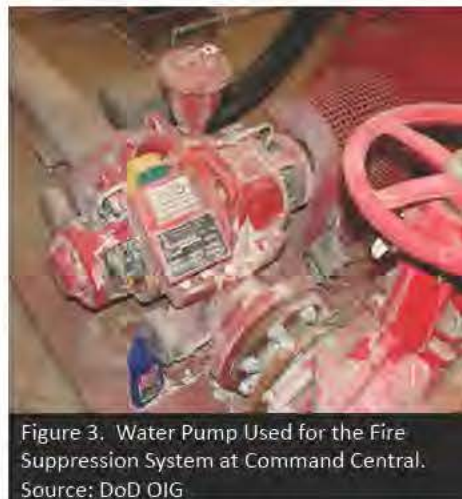
Figure 3. Water Pump Used for the Fire Suppression System at Command Central.
Source: DoD OIG

~~(FOUO)~~ The fire detection system and the fire suppression system in the Command Central facility were not operational. On October 28, 2011, the LOGCAP contractor performed a technical inspection on the Command Central facility and identified several fire safety deficiencies. The LOGCAP contractor's technical inspection identified that there were no test records of the fire detection system and that it did not appear to meet standards. Additionally, the LOGCAP contractor's inspector noted that he was unable to walk through the entire facility because USACE-TAD personnel rushed him through. Consequently, the LOGCAP contractor rejected the fire protection system from inclusion on the Density List, even though the facility was added to the Density List on October 31, 2011.

~~(FOUO)~~ On June 27, 2012, the LOGCAP contractor fire inspectors reviewed the Command Central facility and noted several fire deficiencies. The LOGCAP contractor's fire inspectors identified that the facility did not have enough smoke detectors, and if the fire alarm goes off, the security system will lock the doors and impede exit and entry into the facility. After the inspection, the LOGCAP contractor installed single station battery-operated smoke detectors in the facility.

~~(FOUO)~~ On a December 23, 2012, visit to the Command Central facility to verify the problems reported by the LOGCAP contractor, a DCMA fire subject matter expert found that the fire detection system and fire suppression system were not operational.

Figure 3 shows the poor condition of the water pump used for the fire suppression system at the Command Central facility. Specifically, when the fire alarm was pulled, nothing happened. In addition, the interior doors appeared to have had their locking mechanisms removed, which would prevent the doors from locking unexpectedly upon alarm activation. The tenants did not know that the fire detection system and fire suppression system did not work; therefore, the DCMA official instructed the facility managers to change their standing operating procedures and notify the occupants.

(FOUO) Upon identification of the inoperative fire detection system, the USFOR-A Theater Deputy Fire Chief stationed at KAF was notified and called for a systems review and input. He confirmed that the fire detection system and fire suppression system were out of service in the Command Central facility. On January 3, 2013, the USFOR-A Deputy Fire Chief informed us that the fire detection system in the Command Central facility did not work because the USACE-TAD construction contractor did not install the fire detection system correctly. The USACE-TAD construction contractor exchanged a wireless transceiver control unit, purportedly connected to the fire detection system that they purchased from Monaco Enterprises Inc. This equipment's intended use is to transmit a wireless signal to the fire department in the event of a fire alarm activation; however, the receiving equipment for the signal does not exist on KAF. In addition, the transceiver equipment contained a manufacturer's ID label on the inside of the panel dated January 2011, but after examination by the USFOR-A Deputy Fire Chief, it was determined to be a device, manufactured in 1996, that was removed from a base in Incirlic, Turkey due to noncompliance with existing NFPA and DoD standards. Many of the wires were not connected to the fire control panel and the fire control system was not operational. The fire detection panel did not show that there were any errors in the fire control system and its indicator light showed that the fire control system was working properly. However, when the USFOR-A Deputy Fire Chief tested the pull stations and installed detectors, it was determined that no connectivity existed with the fire detection panel other than the mass notification device that was interconnected to the fire detection panel. The replacement cost for the fire suppression system at the Command Central facility was unknown according to the USFOR-A Deputy Fire Chief.

(FOUO) On January 16, 2013, the Director, TF POWER, stated that TF POWER planned to repair the fire suppression system and the fire detection system at the Command Central facility. USFOR-A should expedite repairs to the fire suppression system and the fire detection system at the Command Central facility. Additionally, USACE-TAD should review the actions of the official(s) that conducted contract oversight and approved the inoperative fire suppression system and fire detection system at the Command Central facility; and, as appropriate, initiate corrective measures and actions to hold personnel accountable.

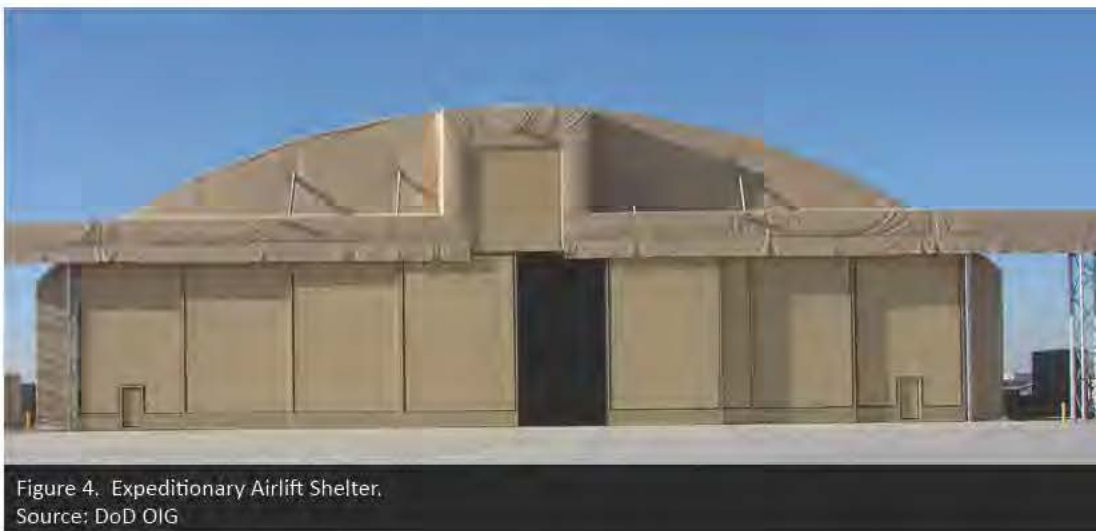
Figure 4. Expeditionary Airlift Shelter.
Source: DoD OIG

The LOGCAP contractor rejected the Expeditionary Airlift Shelter (see Figure 4) from inclusion on the Density List because they identified construction deficiencies in the electrical and HVAC system. The LOGCAP contractor performed two technical inspections on the Expeditionary Airlift Shelter in August and October 2012, which identified electrical deficiencies, such as an unapproved conduit method for primary and secondary transformers, improperly protected grounding electrode conductors, and two grounds terminated under a lug designed for one. HVAC deficiencies included two large units that were not operational, an absent fire damper, and the wall penetration was not rodent proofed. The LOGCAP contractor requested correction to these construction deficiencies before adding the Expeditionary Airlift Shelter to the Density List. As of March 22, 2013, the Air Force was not using the Expeditionary Airlift Shelter because it would not accept the facility until it was added to the Density List.

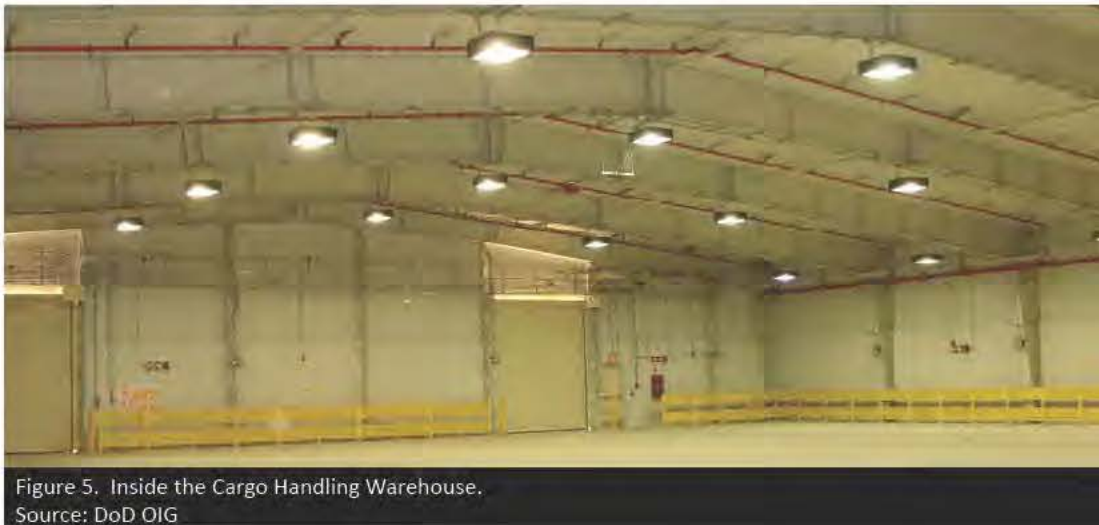
Figure 5. Inside the Cargo Handling Warehouse.
Source: DoD OIG

LOGCAP contractor personnel also rejected the Cargo Handling Warehouse from inclusion on the Density List because they identified construction deficiencies with its electrical and HVAC systems. The LOGCAP contractor performed two technical inspections in September and November 2012 and identified that electrical panels did not have proper working clearances, individual conductors were too small for the cable trays, and the conductors in the cable tray inside the fire pump house needed to be derated. In addition, the LOGCAP contractor identified that the HVAC unit was inoperable and had safety hazards. The LOGCAP contractor requested correction to these construction deficiencies before adding the Cargo Handling Warehouse to the Density List. On January 4, 2013, we conducted a walkthrough of the vacant warehouse before the

facility was accepted by the Air Force (see Figure 5). On February 4, 2013, the Air Force partially accepted the Cargo Handling Warehouse from USACE-TAD because of mission needs. The Air Force uses the warehouse only for temporary storage, according to a 451st ECES official. However, on March 22, 2013, we visited the warehouse and it was empty.

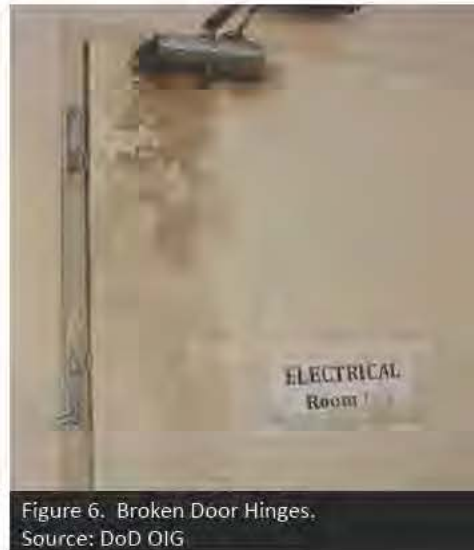
Figure 6. Broken Door Hinges.
Source: DoD OIG

For example, on December 24, 2012, one facility had two doors that were off their hinges. The USACE-TAD construction contractor previously repaired the two doors, but they required additional repairs. In an undated performance evaluation of the construction contractor at 98 percent completion, the USACE resident engineer wrote that the contractor did not immediately correct deficient work after it was identified by USACE personnel.

Later on January 4, 2013, a 451st ECES official stated that facilities were not up to the LOGCAP contractor's standards for placement on the Density List. The doors of one facility we visited were off their hinges (see Figure 6) and its latrines did not work because of a broken water line. On a subsequent walkthrough on January 25, 2013, we identified two other facilities with several doors that had broken hinges. When we performed the walkthroughs, the facilities were about a year old, according to a 451st ECES official.
