UNITED STATES AIR FORCE
AIRCRAFT ACCIDENT INVESTIGATION
BOARD REPORT

T-38C, T/N 68-8206

**25th FLYING TRAINING SQUADRON
71st FLYING TRAINING WING
VANCE AIR FORCE BASE, OKLAHOMA**

DATE OF ACCIDENT: 17 AUGUST 2018

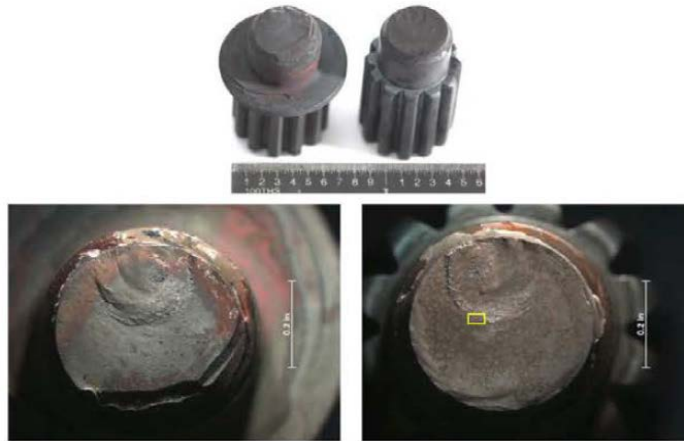
Figure 1: Right PTO Input Drive Coupling Shaft (Tab J-127)

Examination of the fractured PTO input drive coupling shaft showed macroscopic features indicative of torsional overload (Tab J-127). No evidence of pre-existing defects, such as corrosion or fatigue cracking, were identified and the coupler sheared at the designed point (Tab J-127).

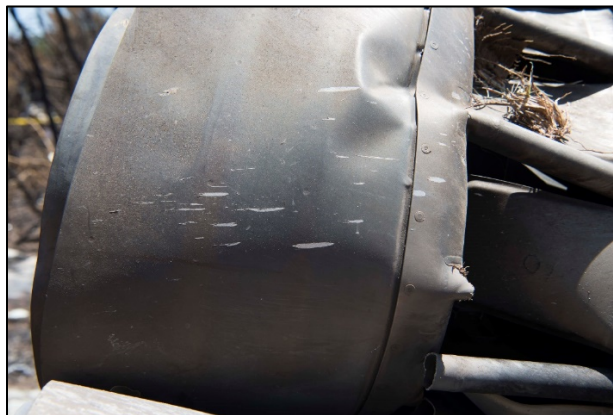
Figure 2: Aluminum Splattering on the Ejector Assembly (Tab J-19)

Fire damage was found on the right half of the bottom of the boat tail skin (Tab J-18). The melting point of this aluminum specification is between 935° to 1,180° Fahrenheit (F) (Tab CC-17). Melted aluminum streaks were found on the bottom right half of the engine exhaust ejector assembly (Tab J-18). These streaks were found from the ejector assembly forward to fuselage station 516 (Tab J-18).

Evidence indicates the fire damage to the boat tail skins, underlying structure, and hydraulic lines occurred in-flight prior to ground impact (Tab J-19).

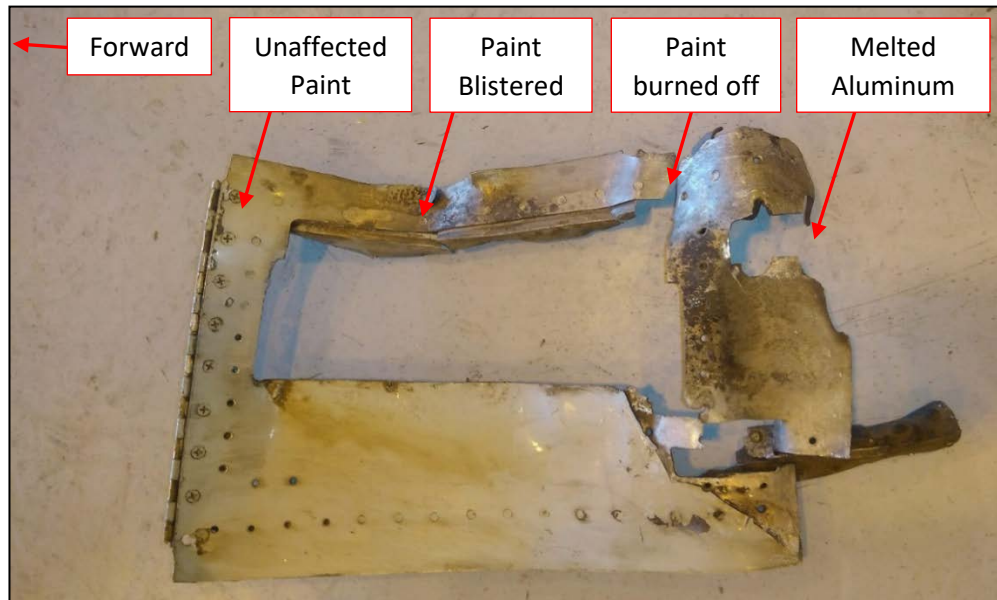
Figure 3: Fire Exit Point on the Right Annulus Door (Tab J-21)

The wreckage was inspected to determine where the fire exited the aircraft (Tab J-20). The right annulus door had fire damage which indicated the fire originated inside the door and exited through the door to the aft of the aircraft (Tab J-20).

The aircraft fuel and hydraulic systems were analyzed to determine the source of a fire that would produce a flame that could exit the annulus door and burn the bottom boat tail skin (Tab J-21). The fuel system is the only source capable of producing a sustained flame sufficient to melt aluminum skin (Tab J-21).

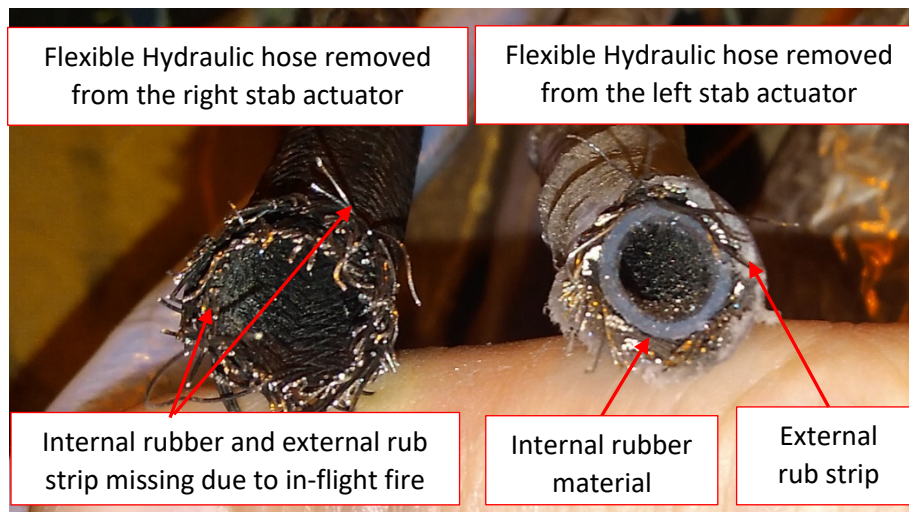
Figure 4: Right Stab Flexible Hydraulic Lines (Tab J-23)

The right horizontal stabilizer actuator flexible Flight Control and Utility System hydraulic hoses were located in the area of the in-flight fire (Tab J-22). These lines are rated for temperatures from -65°F to +400°F (Tab J-22). The in-flight fire melted through the aircraft skin and exposed the four hoses to extreme heat (Tab J-22). The lines were inspected and found to have all the internal rubber material and external rub strips melted away (Tab J-22).
