UNITED STATES AIR FORCE
AIRCRAFT ACCIDENT INVESTIGATION
BOARD REPORT

T-6A, T/N 05-6209

559TH FLYING TRAINING SQUADRON
12TH FLYING TRAINING WING
JOINT BASE SAN ANTONIO (JBSA)-RANDOLPH, TEXAS

DATE OF ACCIDENT: 18 SEPTEMBER 2018

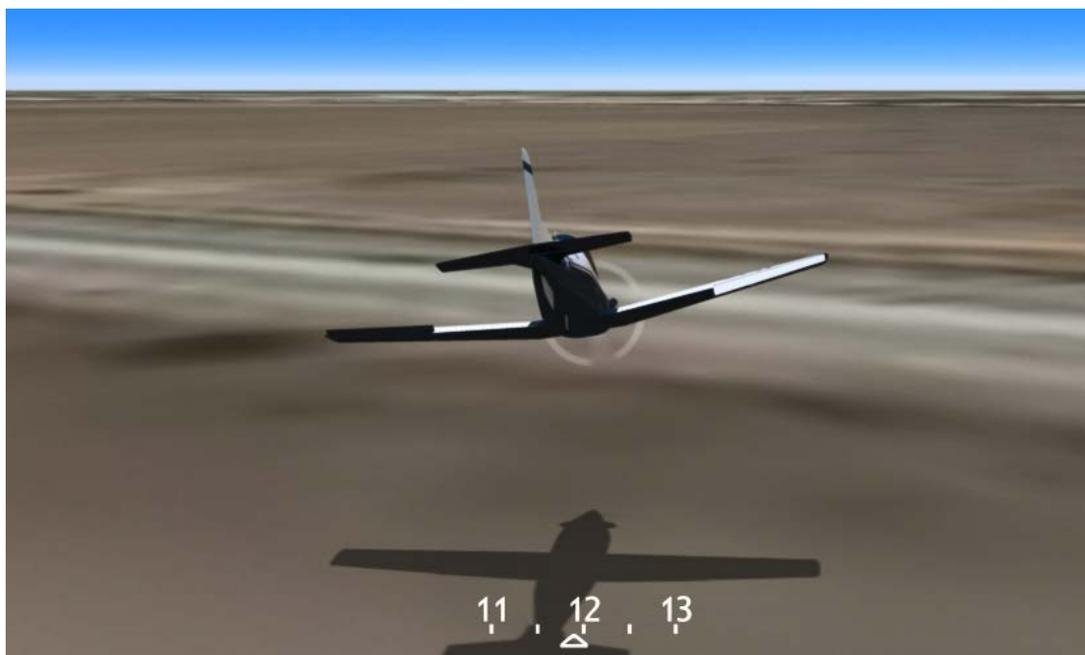
Figure 2: Impact Attitude (Tab S-4)

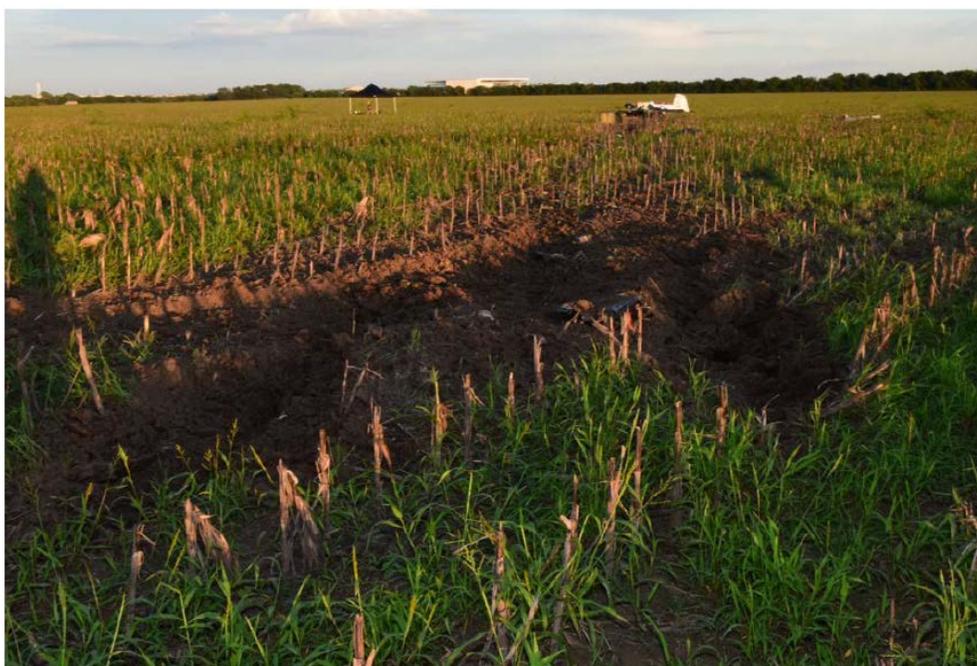
The majority of the wreckage was located within a few hundred feet of the where the fuselage came to rest. The wings and empennage separated from the fuselage shortly after impact, stopping about 40 yards northwest of the fuselage section (Tab S-10).

Figure 3: Ground View looking southeast (Tab S-5)

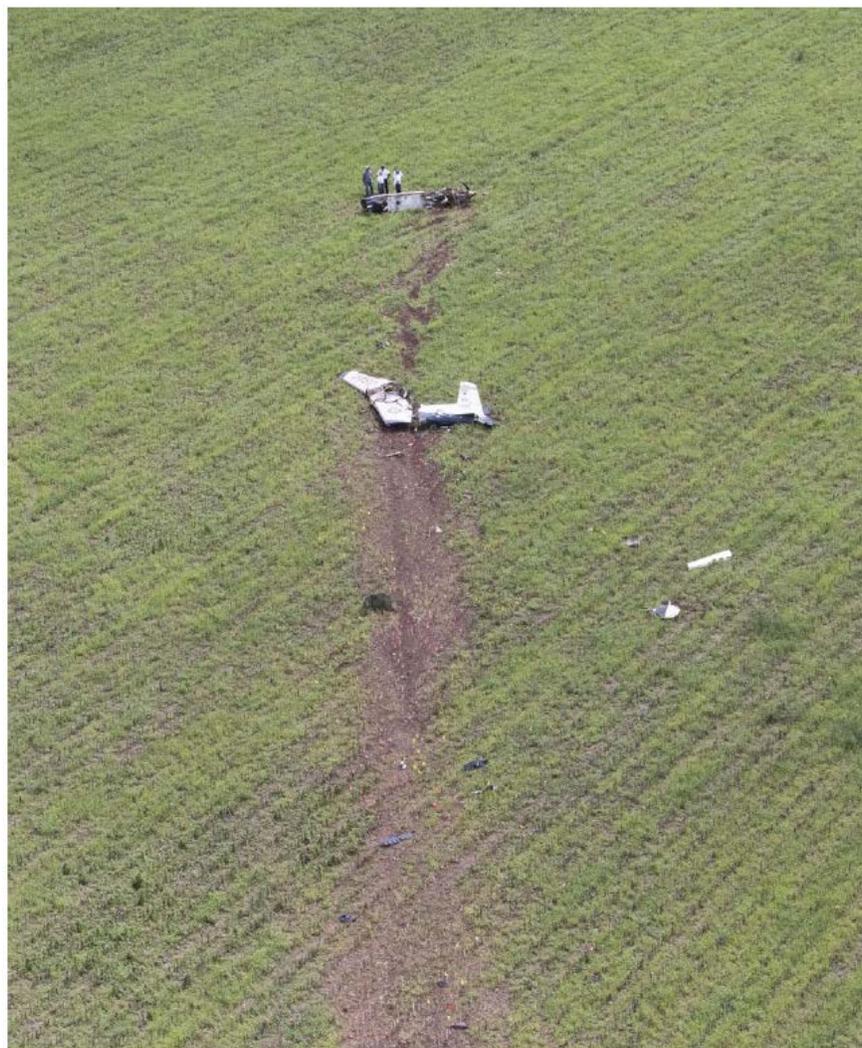
Figure 4: Aerial View looking southeast (Tab S-4)

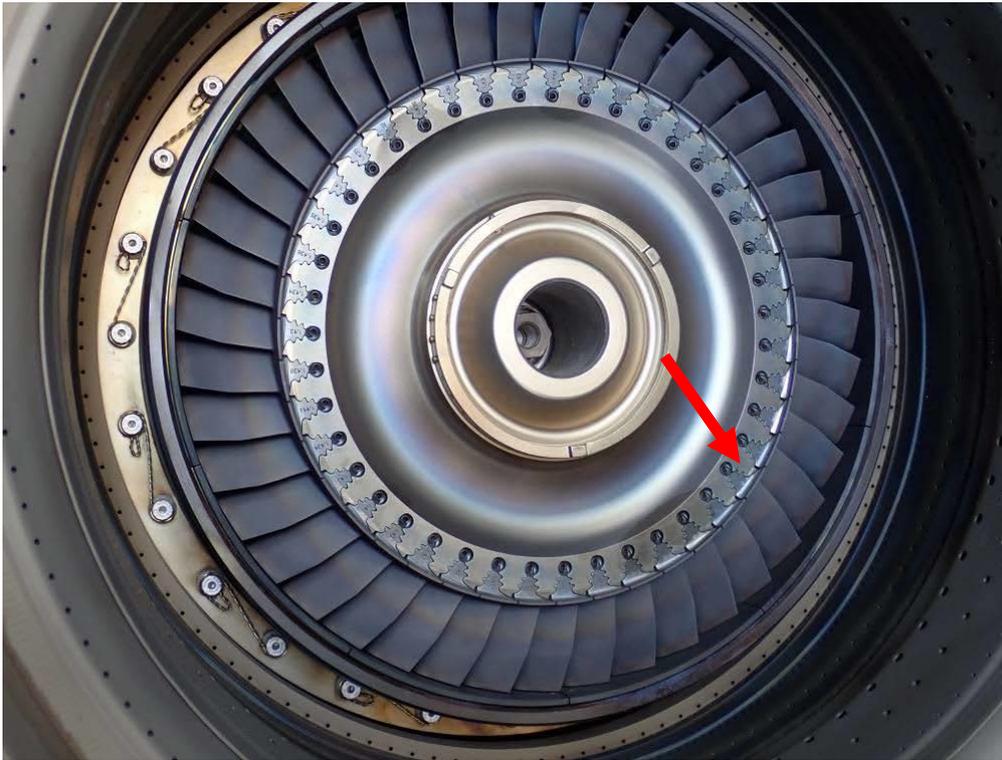
The ME was recovered and analyzed by Pratt & Whitney Canada, which provided a complete report of the engine. The report stated that circumferential marks on the compressor turbine disc/blades (Fig 5) and the bending of all the propeller blades indicate that the engine was rotating slowly at impact (Tab J-24).

Figure 5: ME compressor turbine disc with rub marks (Tab J-29)

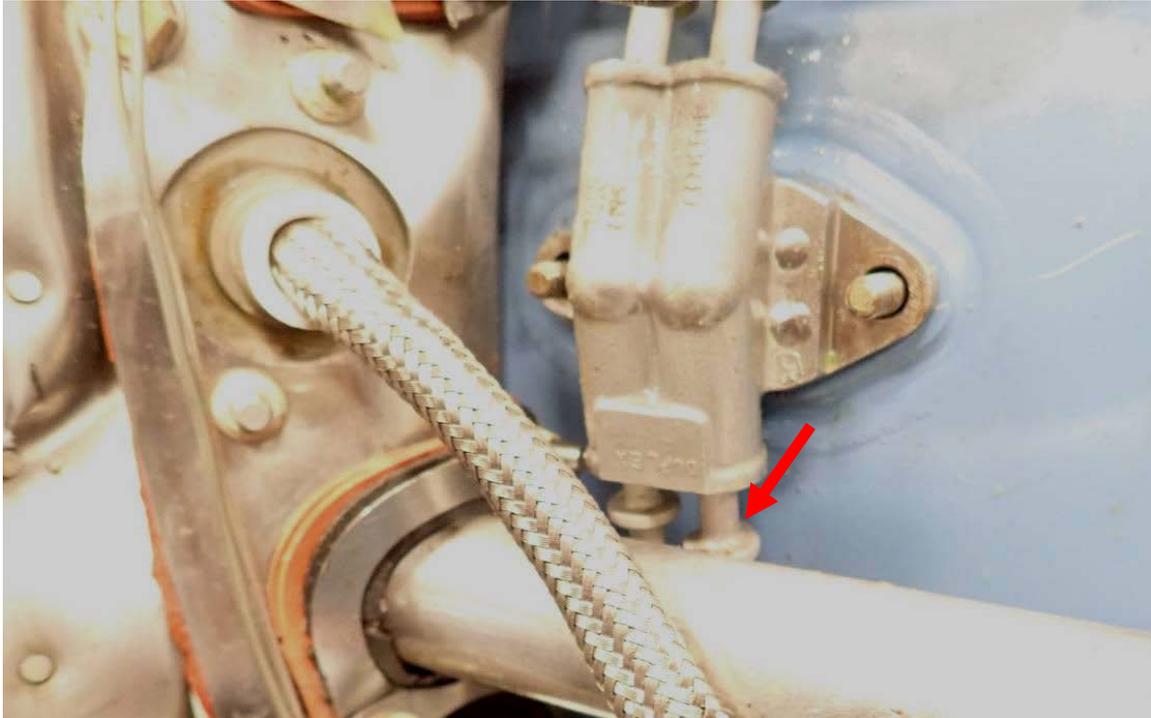
was being transferred through the fuel nozzles and no external leaks were detected. The No. 9 fuel nozzle transfer tube retention bracket was bent adjacent to the retention points” (Tab J-35). The lead Pratt & Whitney Canada investigator, WIT 9, testified that the fuel transfer tube locking plate displacement could not have occurred during ground impact (Tab V-13.2).

Figure 6: ME fuel transfer tube (locking plate removed) not properly seated and extended from nozzle (Tab J-37)

The incorrectly installed locking plate allowed the fuel transfer tubes to migrate out of position during operation, resulting in a substantial fuel leak. The engine subsequently failed due to loss of adequate fuel supply to sustain operation. Upon recognition of engine failure, the MA was at an airspeed and altitude that made ejection the only viable option.

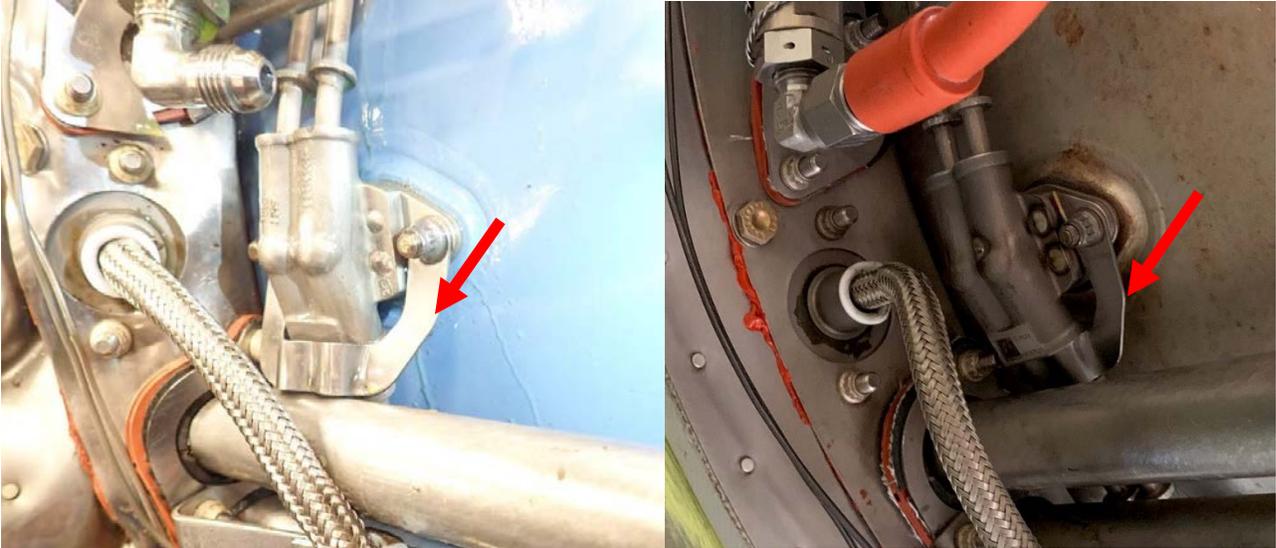
Figure 7: Left; ME fuel transfer tube locking plate (Tab J-36). Right; normal (non-ME) fuel transfer tube locking plate (Tab Z-6)

I find, by a preponderance of evidence, the cause of the mishap to be a fuel transfer tube locking plate that was improperly installed during a contracted 4500 hour engine overhaul. This resulted in engine failure while the aircraft was not in a position to land safely.

transfer tubes in the proper position, was improperly installed, thereby allowing the transfer tubes to move. The transfer tubes being out of position resulted in fuel leaking out of the system prior to injection into the engine. Ultimately, despite increased fuel flow, the volume actually reaching the engine was not enough to sustain normal operation, resulting in unrecoverable engine failure.

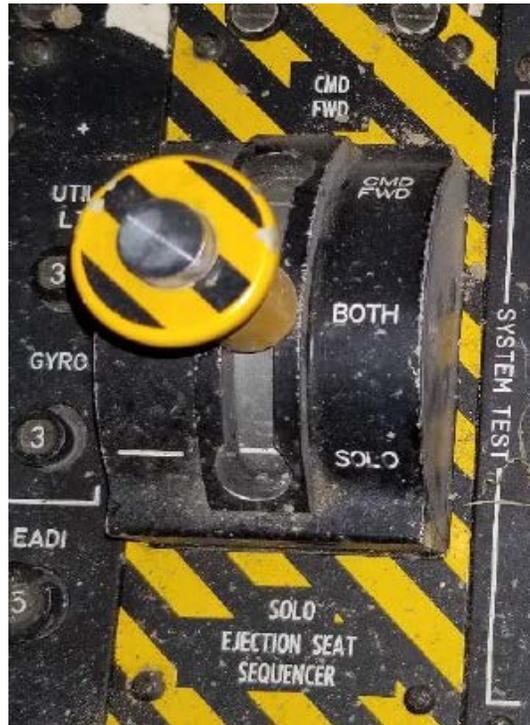
The position of the ISS selector valve was found in the “BOTH” position, consistent with flight guidance for this type of sortie (dual rated personnel and aircraft having completed TCTO 13A5-69-518 (Tab J-92). Both seats were recovered with their manual ejection handles in the up “fired” position (Tab J-92). Video evidence of the ejection events recovered from a distant security camera indicates that the interval between aft and forward ejections was consistent with ISS timing (Tabs J-92, J-93 and S2.2). The emergency escape system and all of its subcomponents appeared to have operated as intended (Tab J-93).

Figure 8: ISS selector valve post mishap (Tab J-89)

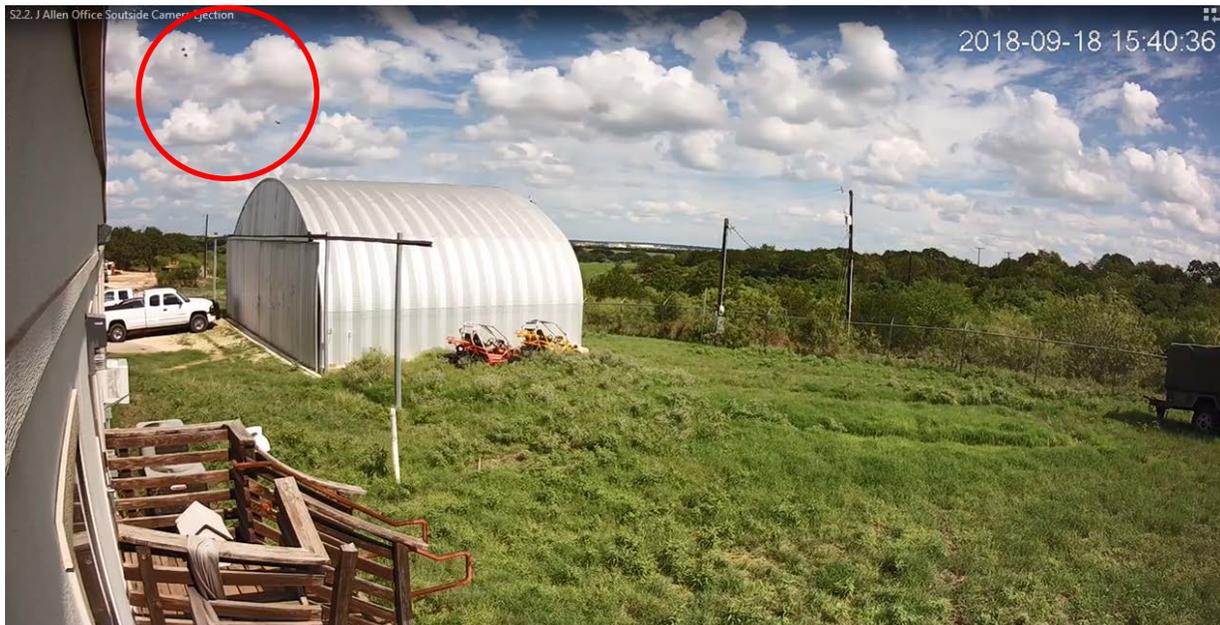
Figure 9 shows the weather immediately after ejection of the aircrew from the MA (visible in upper left corner of figure). At the time of the mishap, the environmental conditions were full daylight with a fully discernible horizon and no impediment to visibility.

Figure 9: Screen capture of video during MC ejection (MA and both parachutes top left) showing weather conditions (Tab S-2.2)
