### FINAL ACTION OF MAJOR INCIDENT INVESTIGATION REPORT INTO THE CIRCUMSTANCES SURROUNDING THE FATALITY OF A MEMBER ASSIGNED TO CGC HICKORY IN HOMER, ALASKA, ON 31 JAN 2019

Subj: MAJOR INCIDENT INVESTIGATION (MII) BOARD REPORT ON THE  
CIRCUMSTANCES SURROUNDING THE FATALITY OF A USCGC HICKORY  
(WLB-212) CREWMEMBER IN HOMER, AK ON 31 JAN 2019

**2. Executive Summary:** On the afternoon of 31 January 2019, at the U.S. Coast Guard Cutter (CGC) HICKORY (WLB-212) buoy yard in Homer, Alaska, numerous crewmembers were conducting a variety of yard clean up, maintenance and repair, and organization tasks prior to a planned underway period. A two person team was operating the Shuttlelift crane car, hereinafter referred to as the Mishap Crane (MC), to move four distinct loads of Aids to Navigation (ATON) equipment from the top of Container Express (CONEX) boxes to a location on the ground where they were subsequently moved via forklift to alternate locations. The team was comprised of a rigger and crane operator, hereinafter referred to as the Mishap Rigger and Mishap Operator respectively. Neither of these members were qualified to perform these duties. During movement of the fourth load,

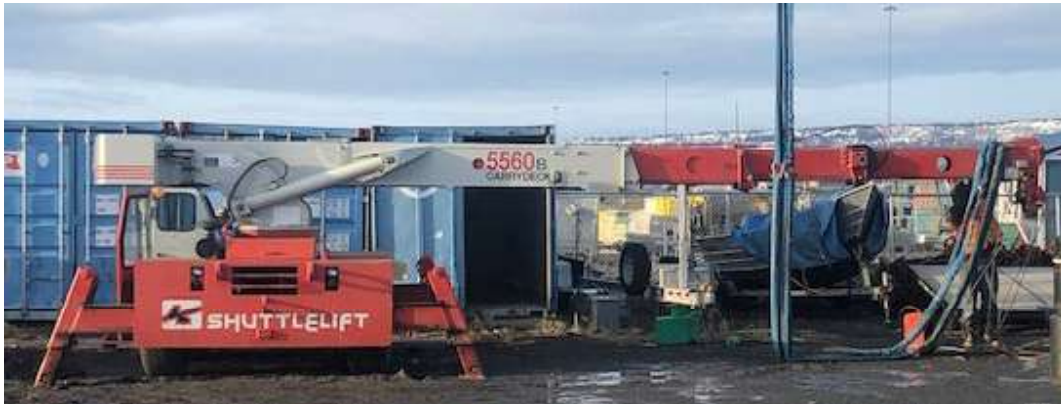
*Mishap Crane after Righting with Outriggers Extended and Down*

- 9) MC was fully functional following the mishap with the exception of boom retraction due to deformation and, “visible structural damage on the third section of the four-section boom. The boom nose (i.e. boom tip) and anti-two block device appeared to have visible damage as it was the primary impact point when the crane overturned.” (Exhibits 47, 48, 54, 55, 66)

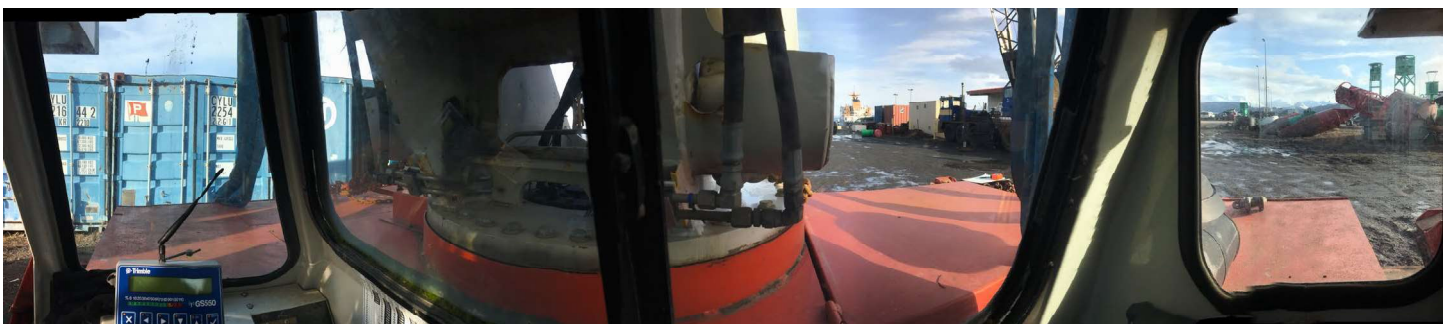
*Panoramic View from MC Operators Seat*

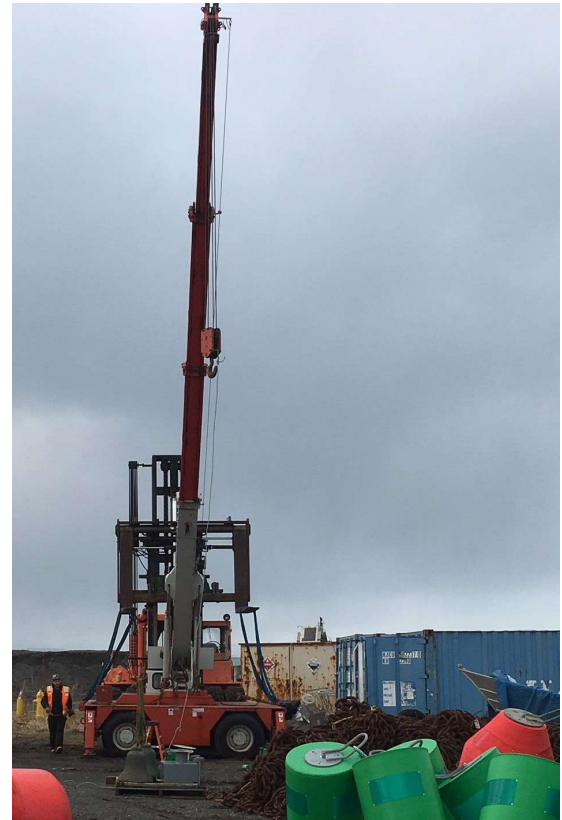
*View of Buoy Yard and CONEX Boxes Looking West*

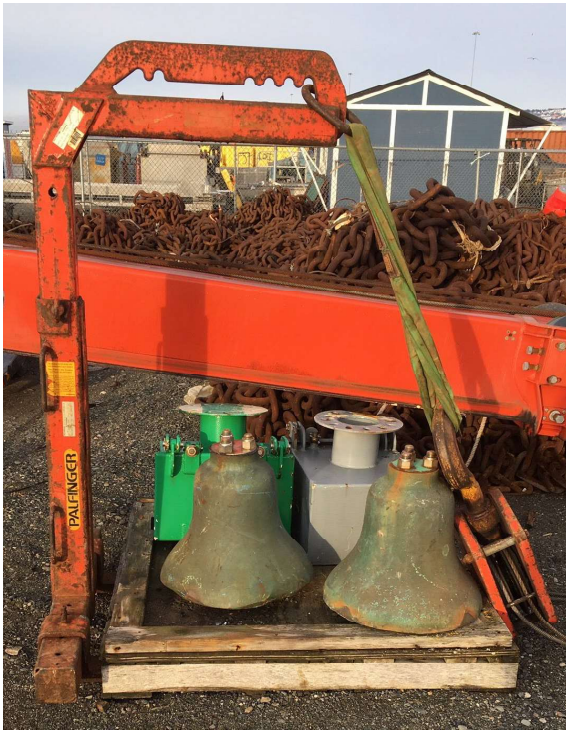
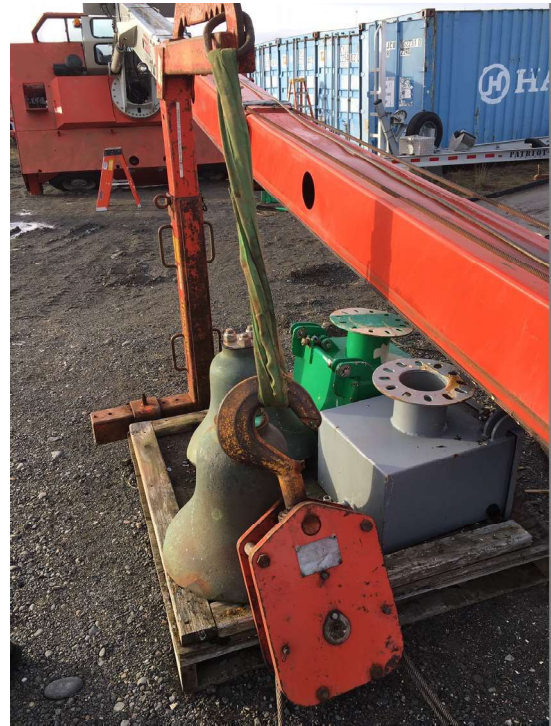
*Mishap Load Profile and Elevation Views*

- 39) The ML was not balanced on the pallet. The two bells with bell stands on one side of the pallet were more than double the weight of the battery boxes on the opposite side of the pallet. (Exhibits 43, 53)

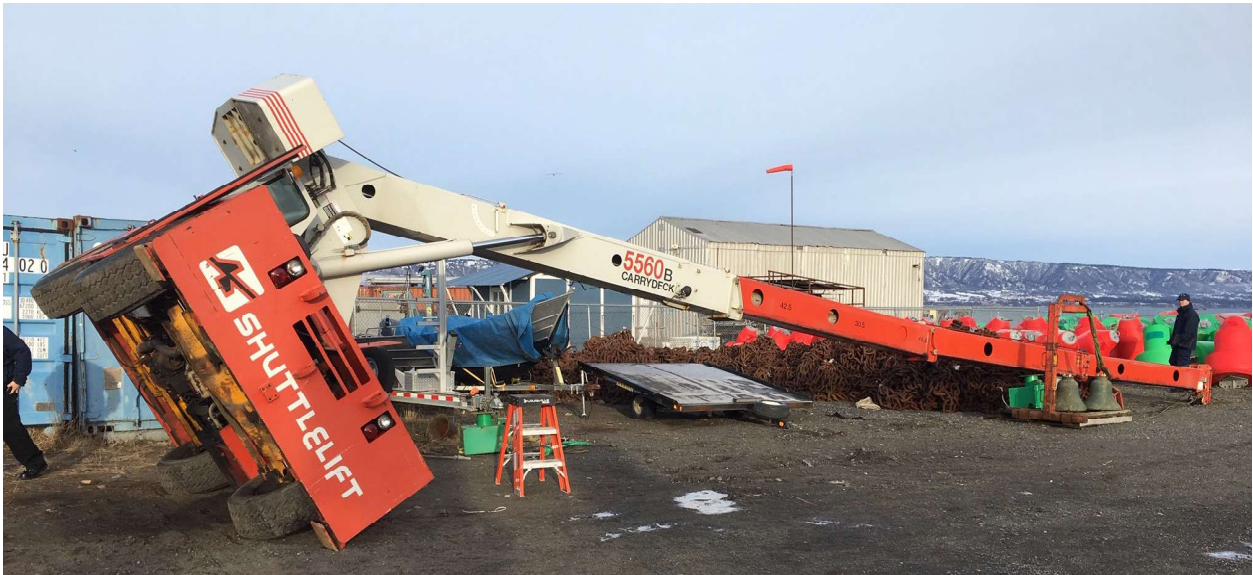
*Overturned Mishap Crane*

- 51) The boom's impact with the ground caused permanent deformation of the boom at the beginning of the third extension. (Exhibits 54, 66, 72, 73)
- 52) The boom tip dug into the ground approximately 6 inches. (Exhibits 55, 64, 65)
