United States
Coast Guard

**SUBSURFACE PROPERTY DAMAGE INVOLVING THE ARTICULATED TUG
CLYDE S. VANENKEVORT AND BARGE ERIE TRADER ON APRIL 1, 2018**

**CLYDE S. VAN ENKEVORT (O.N. 1232691) and ERIE TRADER (O.N. 1238380) Anchor
Strike Which Damaged Subsurface Transmission Cables and Pipelines
In the Straits of Mackinac Michigan on 01 April 2018**

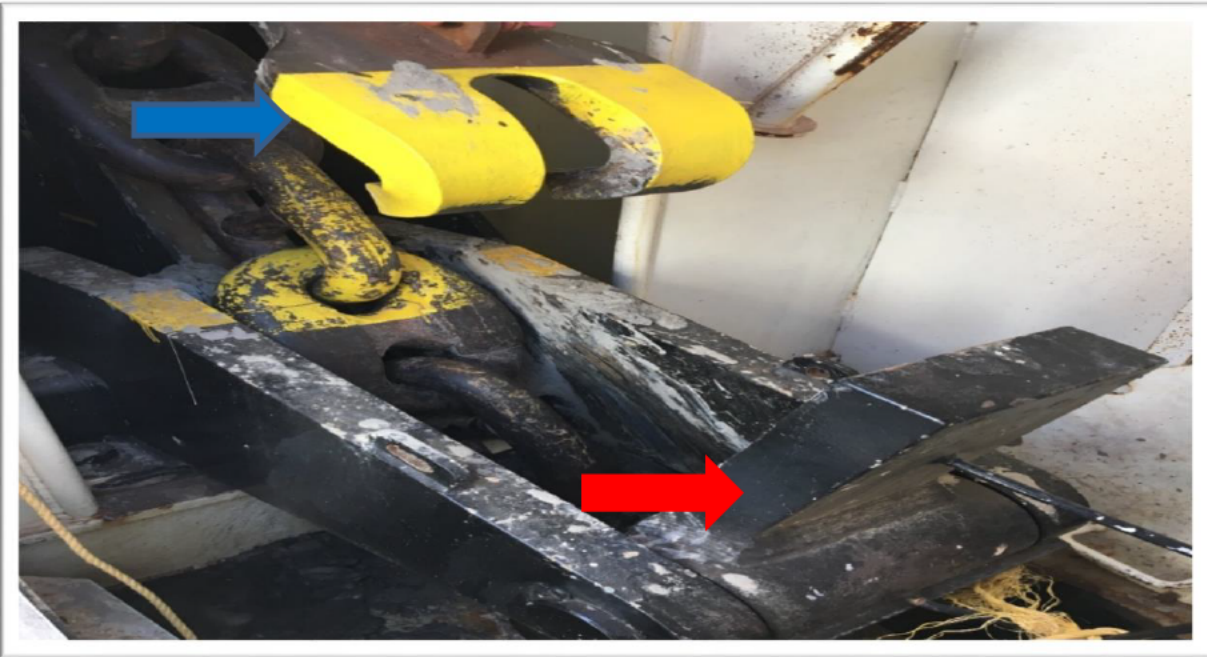
Figure 4-4 The starboard claw and paw on the ERIE TRADER. In this image both devices are un-engaged. The claw (indicated by blue arrow) is tied off to the cleat on the bulkhead. The paw (indicated by red arrow) is pulled back and into an upright position.

- 4.39 3 April 0022- Mr. [REDACTED] opened the starboard hawespipe locker hatch that provided access to the paw and the claw and observed that both devices were disengaged from the anchor chain. The claw was disengaged and was manually tied off to a cleat on the bulkhead securing it up and away from the chain. Mr. [REDACTED] powered up the starboard windlass and brought up the anchor. Approximately 4 shots, or 360 feet of anchor chain were recovered. When the anchor stock came into sight, Mr. [REDACTED] discovered that the anchor flukes were missing and reported this to the bridge (see figure 4-11).

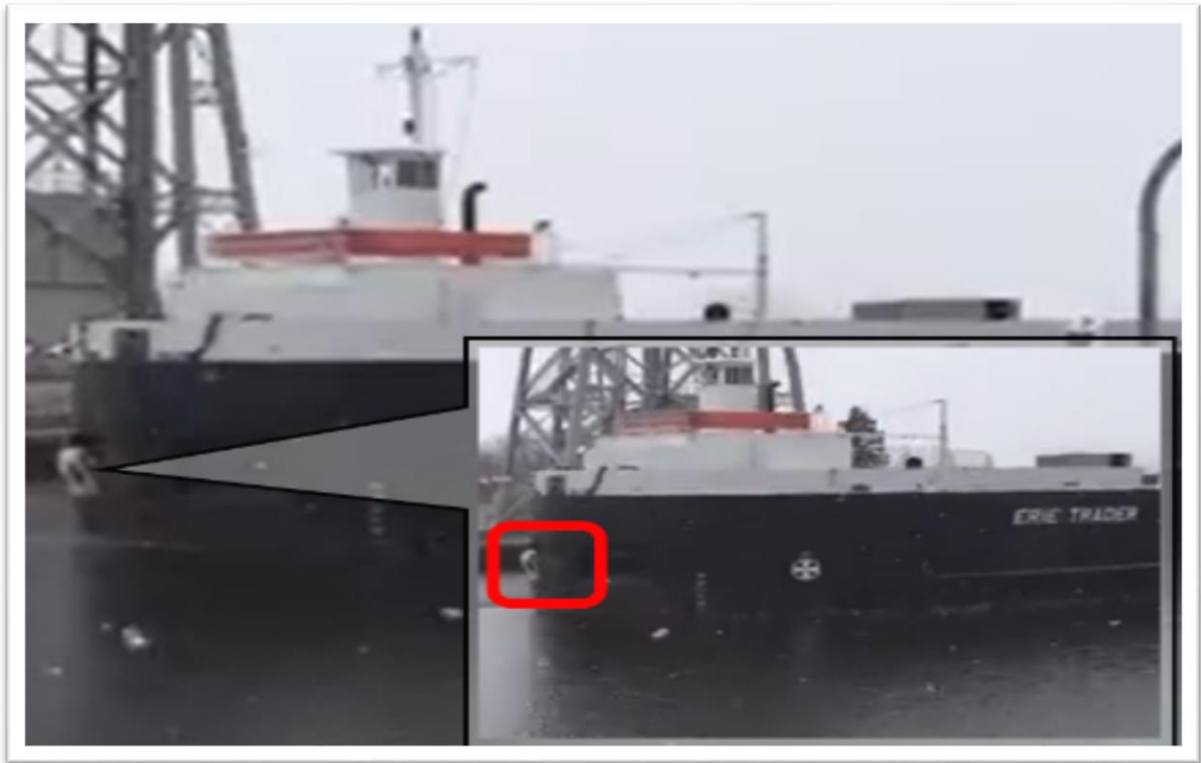
- 4.21 20 March 2018- The ATB sails from Duluth, MN to Detroit, MI and then back to Duluth without incident.
- 4.22 30 March 2018 at 1100- The CLYDE S. VANENKEVORT and the barge ERIE TRADER departed Duluth en route to Indiana Harbor, IN. The starboard anchor is protruding from the hawespipe by approximately 1-2 feet. Ice could be seen forming on the starboard anchor (see figure 4-6).

Figure 4-6 The ERIE TRADER departing Duluth MN on 30 March 2018. The Starboard anchor is seen covered in ice and hanging out of the anchor pocket. (Image taken from video by J. Herrick on youtube.com)

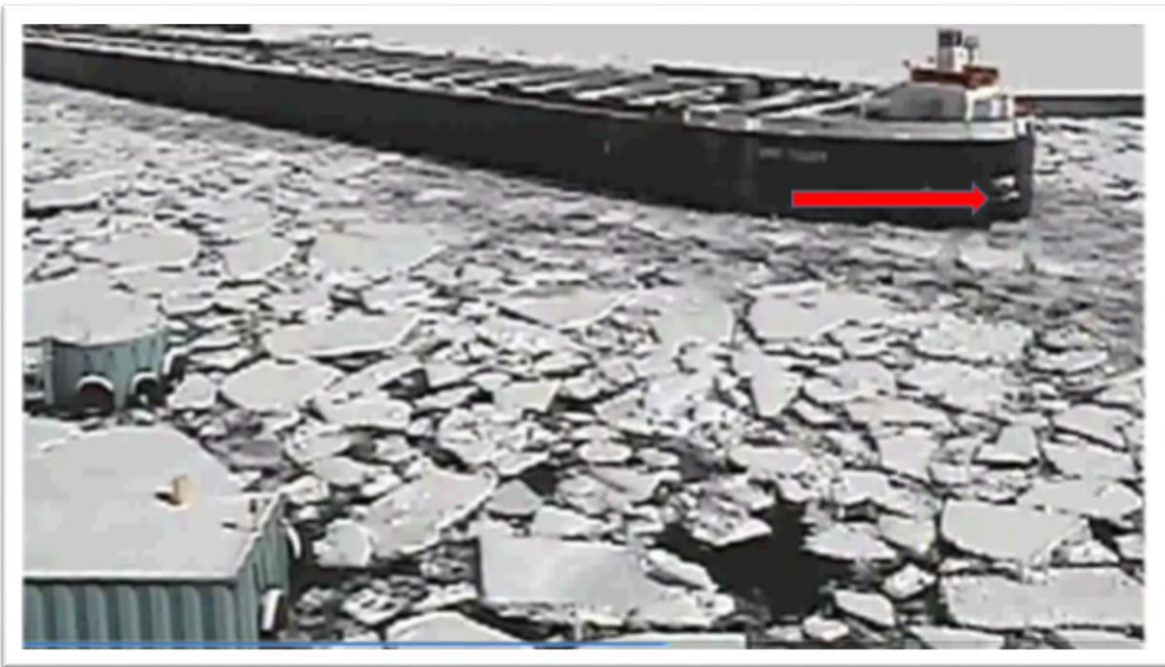
- 4.28 1 April 2018 at approximately 1000- Coast Guard Sector Sault Sainte Marie Vessel Traffic Service (VTS) cameras captured video of the starboard anchor protruding from the hawsepipe of the ERIE TRADER at Mission Point and Rock Cut, west of Neebish Island in the St. Marys River. Despite the significant ice conditions, the ATB experienced no abnormal maneuverability issues during this transit. Water depth was approximately 28 feet (see figure 4-7).

Figure 4-7 The ERIE TRADER in the St Marys River at Rock Cut west of Neebish Island on 1 April 2018. Image captured by Coast Guard VTS cameras depicts significant ice conditions. Red Arrow points to ice on the starboard anchor hanging below the anchor pocket.

Video footage of ERIE TRADER was captured from a VTS camera as the ATB came thorough Rock Cut west of Neebish Island in the St. Marys River on 1 April 2018. This video shows the significant ice conditions the ATB was subjected to while transiting the St Marys River. It also shows the starboard anchor hanging out of the pocket just below the hawsepipe with the weight of ice that had formed on it (see figure 4-7).

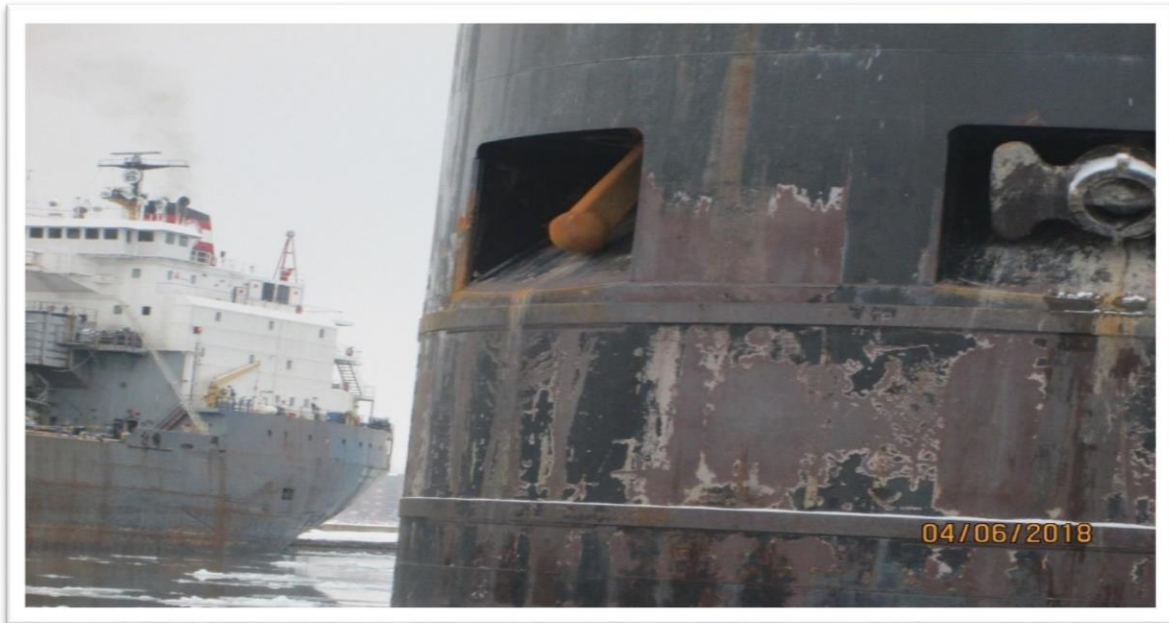
- 4.41 6 April 2018- As part of the Coast Guard's preliminary investigation, Investigating Officer (IO) LCDR [REDACTED] boarded the ERIE TRADER and CLYDE S. VANENKEVORT at the South East Pier of the Sault Lock in Sault Sainte Marie, MI. Upon arriving to the vessel, the he immediately observed that the flukes of the starboard anchor on ERIE TRADER were missing.

Figure 4-11 ERIE TRADER missing flukes on starboard anchor 6 April 2018 at South East Pier St. Marys River

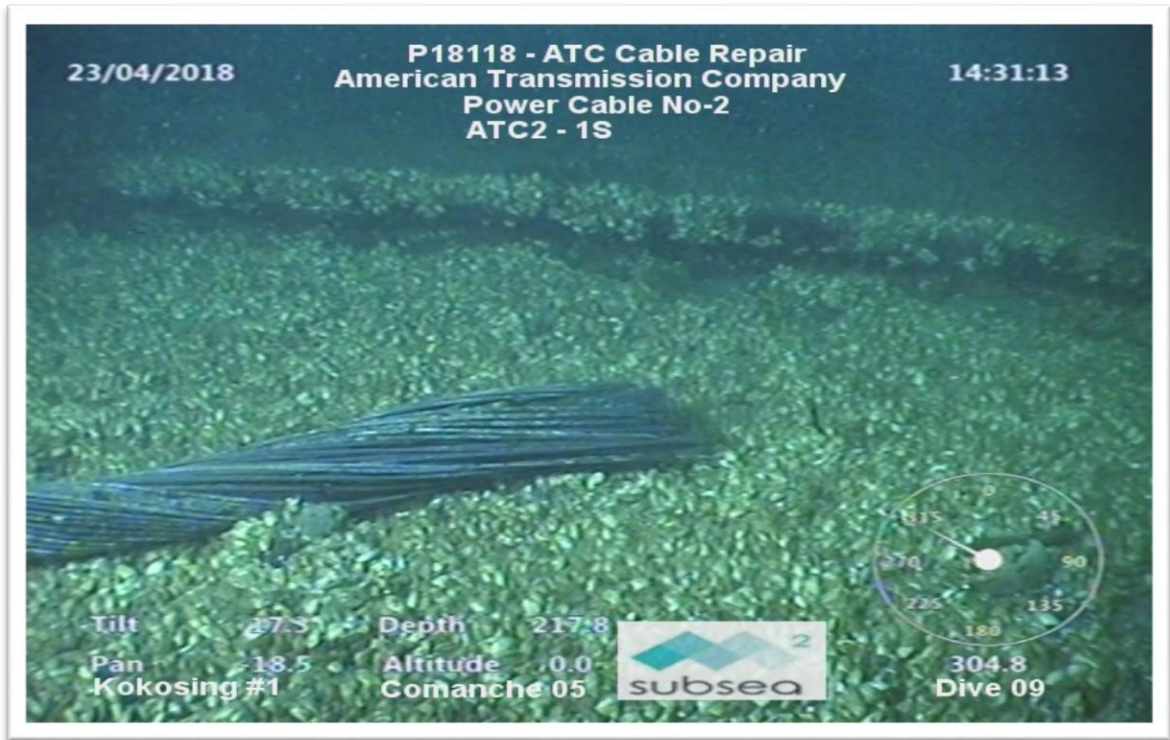
- 4.44 22 April 2018- ATC contracted Durocher Marine and T&T Subsea to use an underwater remotely operated vehicle (ROV) to inspect its subsurface cables. ROV visual imagery confirmed damage to 3 of the 6 submarine cables. Two cables were severed completely and the third was damaged but determined to be salvageable (see figure 4-12).

Figure 4-12- Severed ATC transmission cable No-2. ROV imagery provided by ATC.

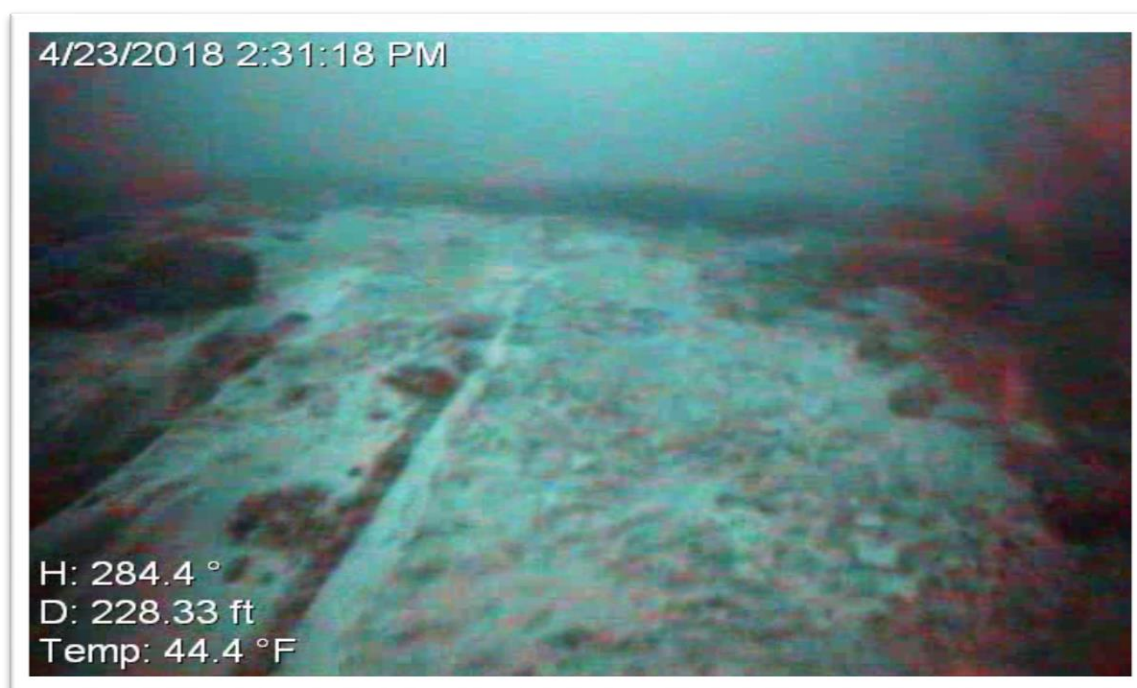
- 4.45 23 April 2018- Enbridge Inc. contracts with Ballard Marine to employ an ROV to inspect their dual pipelines in the Straits of Mackinac. The dual pipelines remained intact and structurally sound, however multiple dents and gouges were discovered. The ROV obtained visual imagery that displays two discernable drag marks in the sea bed just before the Enbridge west pipeline (see figures 4-13, 4-14, 4-15).

Figure 4-13 Drag marks in the seabed just before the Line 5 Pipeline. The marks depicted were not measured. ROV Image provided by Enbridge Inc.

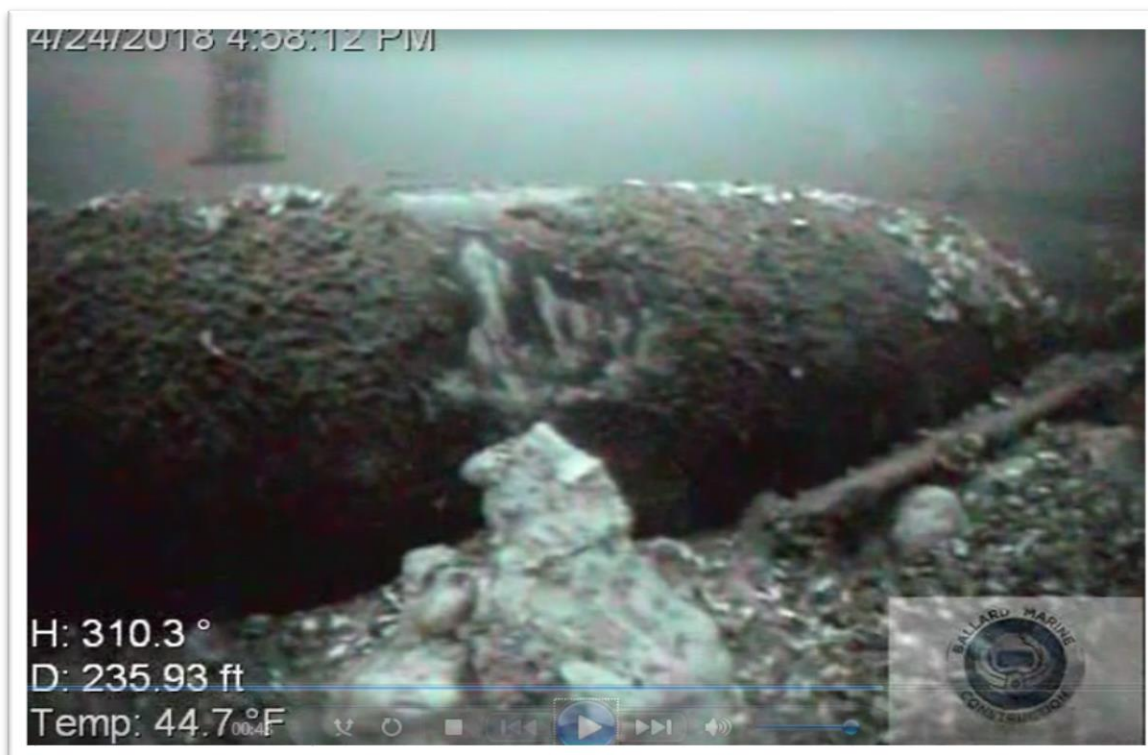
Figure 4-14 Dent and impact marks west pipeline. ROV imagery provided by Enbridge Inc.

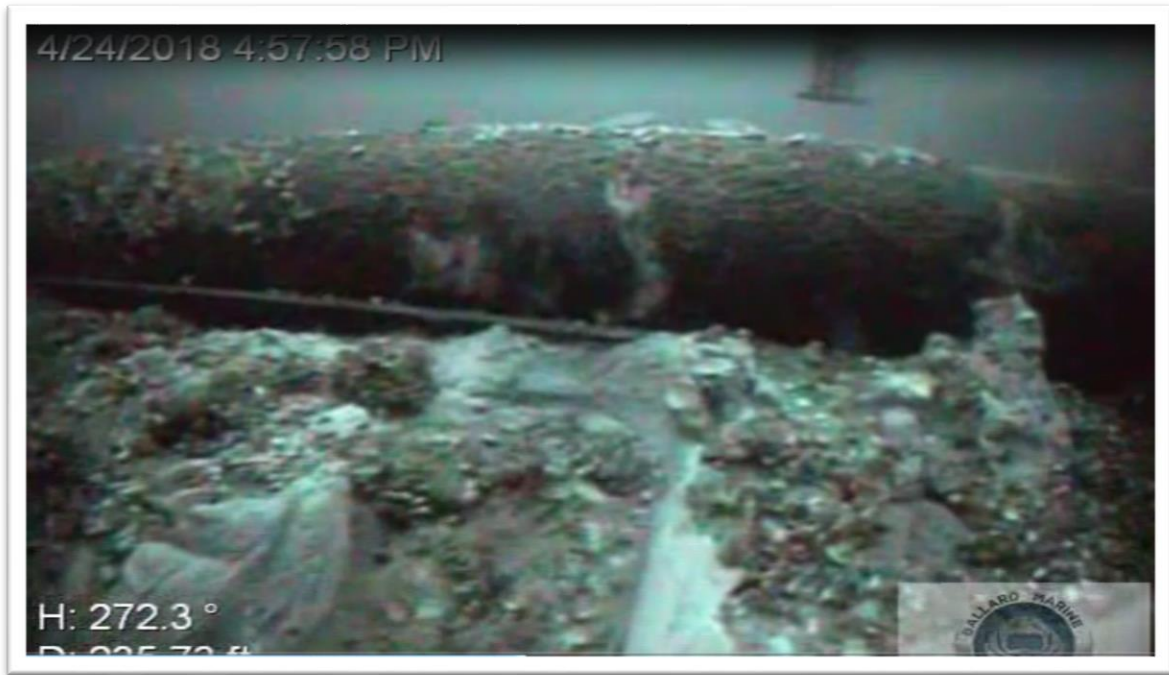
Figure 4-15 Gouges in Enbridge's west pipeline. ROV imagery provided by Enbridge Inc.

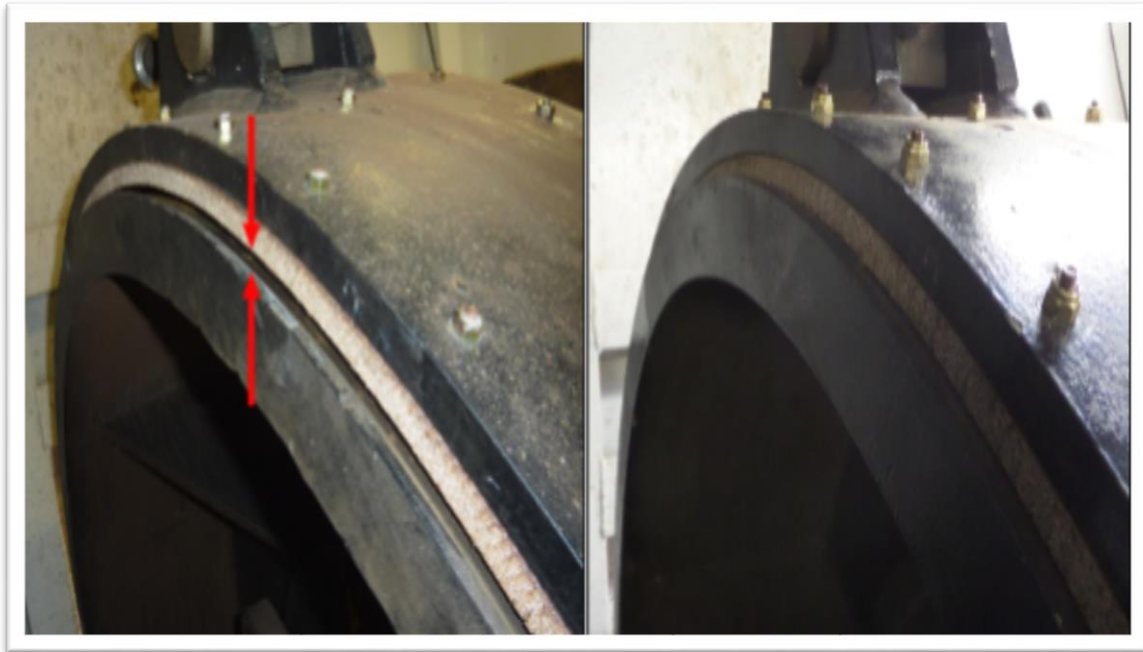
Upon initial inspection and before disassembly, there was a noticeable gap between the starboard windlass brake drum and the liner at both the top and forward of the top brake band and liner. At the widest gap at the top, there was a 0.8 cm (0.314 inches) gap which was measured with a caliper. When installed correctly there is no gap when the brake is engaged. The brake band was comprised of an upper and lower half (see figure 5-1).

Figure 5-1 Left: Post accident photo of the upper brake band liner for the starboard anchor with the brake engaged. The red arrows highlight the noticeable gap at the top between the drum and liner.

*Right: Photo of the starboard anchor upper brake band liner with the brake closed after installation of new liner and adjustment by technician. *Notice that there is no gap between the brake band liner and the drum.*

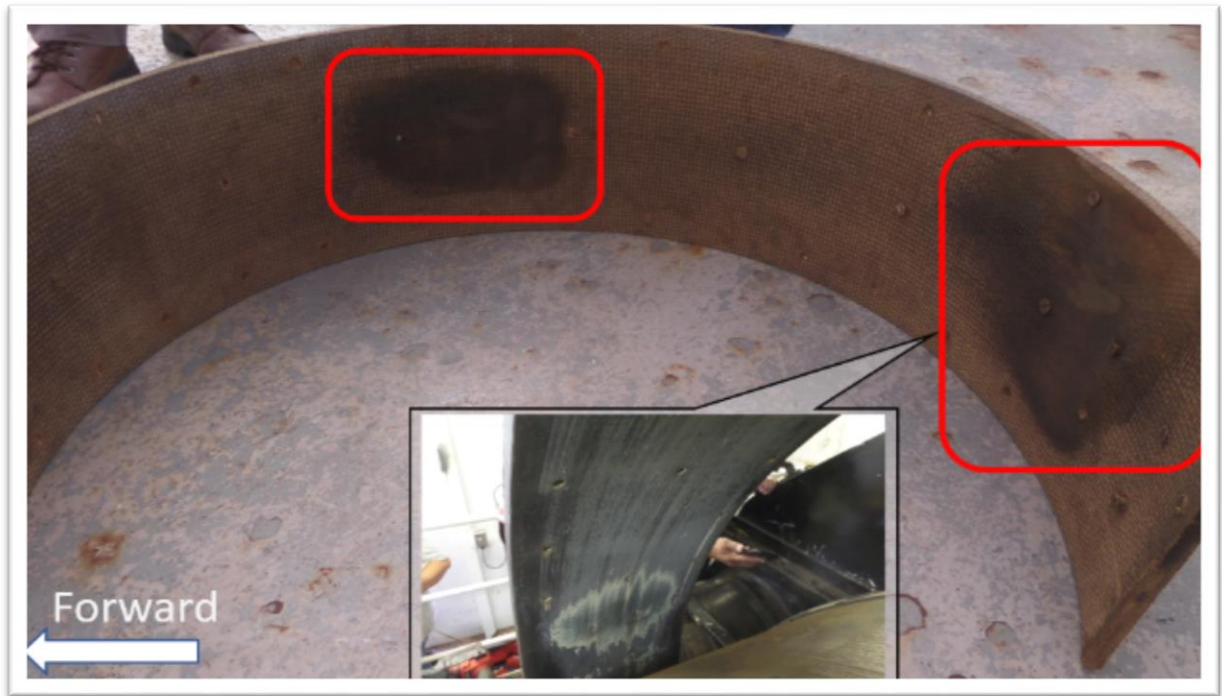
- 5.1.1 Noticeable friction spots were discovered on the upper band portion near the top of the liner and at the aft end of the liner near the edge. Nothing unusual or significant was found on the bottom portion of the brake liner. It was also noted that on the brake band liner inner surface housing paint was burned away in line with the friction markings on the upper brake band itself (see figure 5-2).

Figure 5-2 The upper brake band liner for the starboard anchor. Highlighted in red are the friction spots on the liner. The inset shows the paint worn from the heat accumulation through the liner aft section of the upper band.

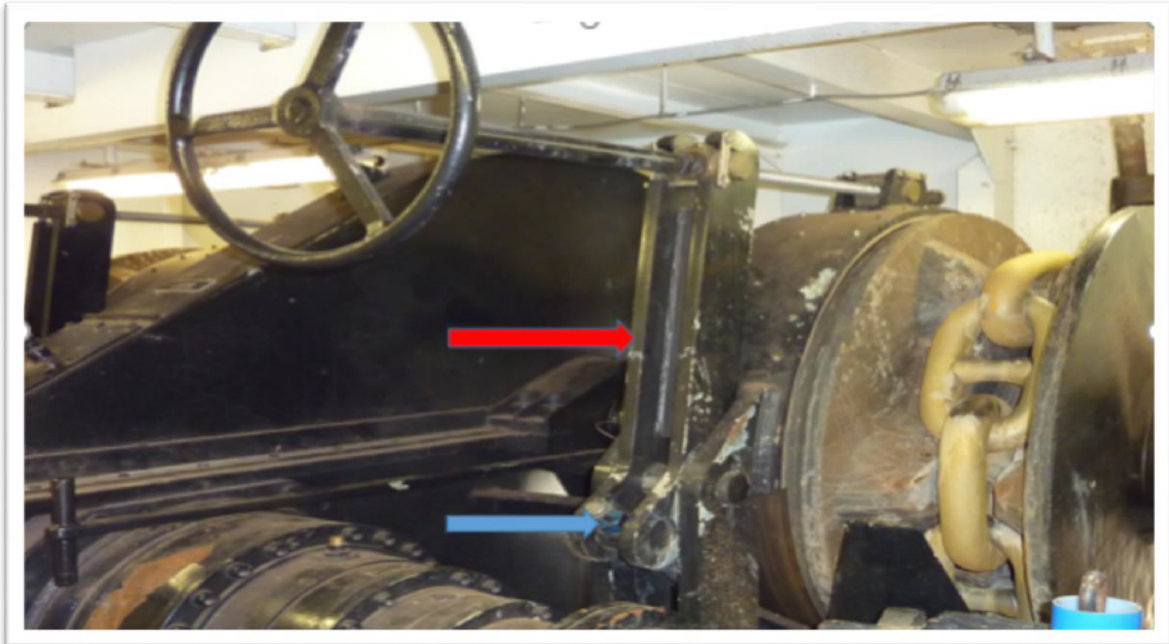
- 5.1.2 During an inspection of the starboard windlass and brake it was confirmed by the CMEI technician that when fitted and torqued properly the brake bar should be in a completely vertical position. The inspection found that with the brake fully engaged there was about 5.2 degrees off vertical (angle to aft bulkhead) on the starboard brake bar. Rub markings in the paint were found on the starboard brake bar. These markings indicated that at one time, there was a 10 degree off vertical deflection of the top bar when the brake was engaged. This degree of vertical deflection indicates that the brake nut was torqued past manufacturer specifications (see figure 5-3). This caused the upper brake band to not be fully seated in contact with the upper portion of the wildcat. This dramatically reduced the capacity of the brake alone to hold the full weight of the anchor and chain.

It was also noted during U.S Coast Guard post casualty interviews that both Mr. [REDACTED] and Mr. [REDACTED] found that the hand wheel was much more difficult to turn when engaging the starboard windlass brake. This was most likely caused by the over torquing of the brake band nut. When engaging the brake via hand wheel, the upper band was being warped slightly upward. This added tension caused the hand wheel to become difficult to turn in order to fully engage the brake.

Figure 5-3 ERIE TRADER- brake vertical bar, brake band nut, brake band hand wheel. Red arrow indicates the vertical bar. Blue arrow indicates the brake band nut.
