**UNITED STATES AIR FORCE**  
**GROUND ACCIDENT INVESTIGATION**  
**BOARD REPORT**

**Mine Resistant Ambush Protected All-Terrain Vehicle (M-ATV),  
S/N 10L00282**

**386th Expeditionary Security Forces Squadron  
386th Air Expeditionary Wing  
Ali Al Salem Air Base, Kuwait**

**TYPE OF ACCIDENT: Motor Vehicle Accident  
LOCATION: Ali Al Salem Air Base, Kuwait  
DATE OF ACCIDENT: 12 September 2020**

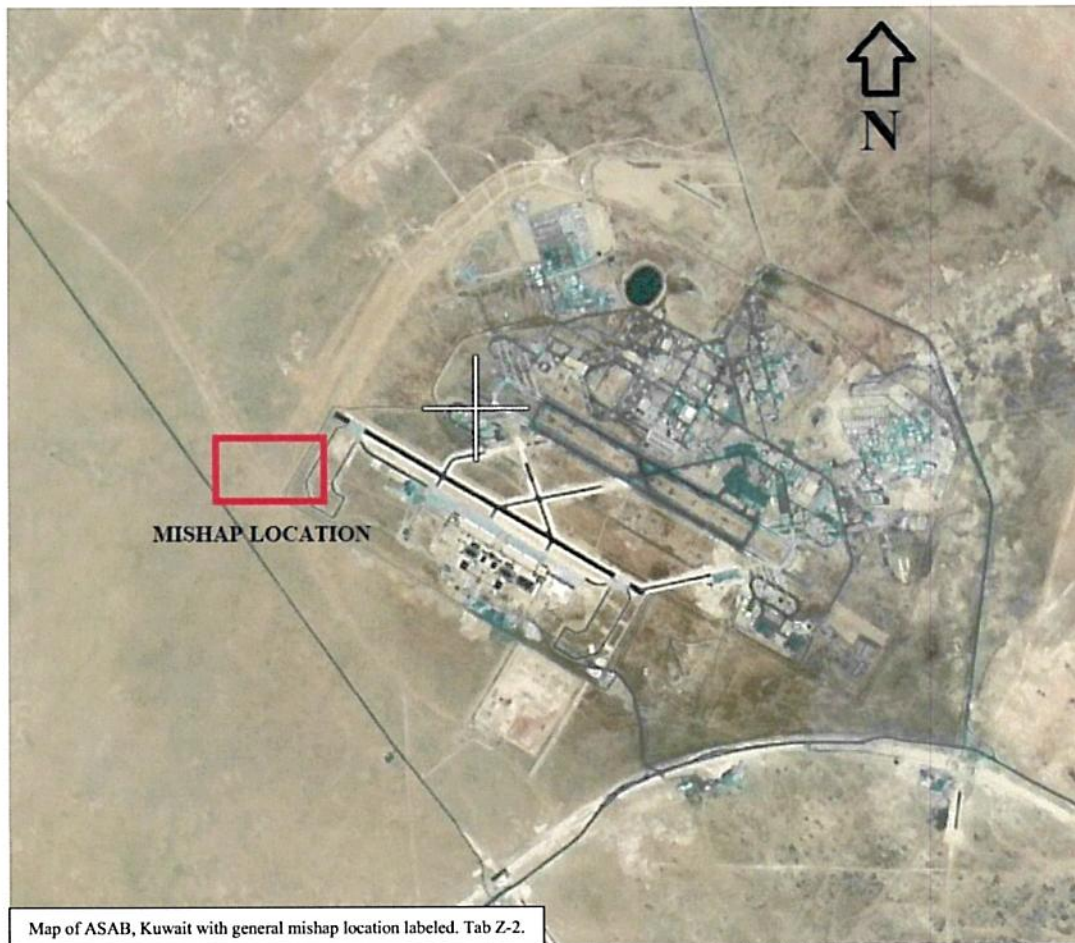
Approximately 15 minutes later, at about 0900, the MT was driving southeast on the mishap road, a straight, sandy and rocky road with a very gentle slope. (Tabs V-4.12 to V-4.13, V-6.4, V-8.4, GG-7). Shortly thereafter, approximately 1-2 minutes after the MT turned onto the mishap road, the MD stated she felt a pulling effect from the M-ATV steering her to the right side, as if the truck was getting stuck in the sand. (Tabs V-2.12, V-2.18 to V-2.19, V-2.25). She continued to press down on the gas pedal, which she recalled from her training was a key to avoid getting stuck in sand, while she tried to steer to the left to compensate for the M-ATV pulling to the right. (Tabs V-2.6, V-2.20). At some point the M-ATV responded and veered towards the direction she was steering, which was to the left. (Tabs V-2.12, V-2.20). The MD then lost control of the M-ATV. (Tabs V-2.20, V-9.4, GG-3).

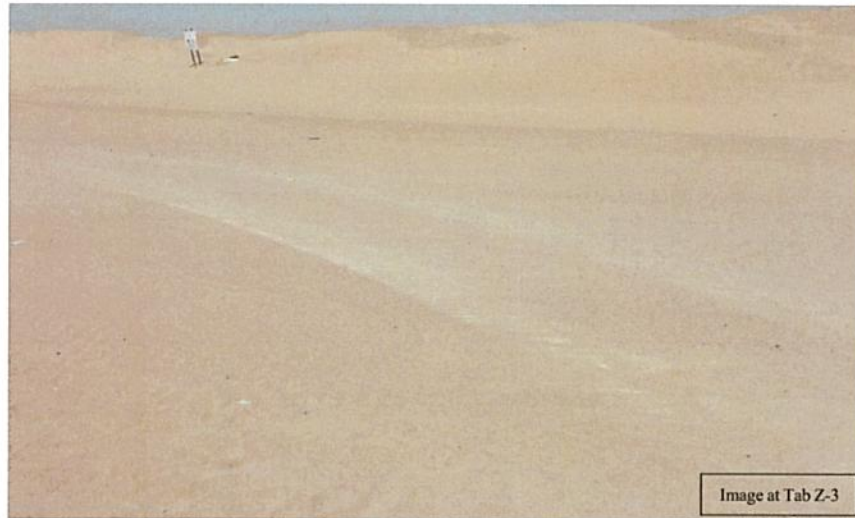
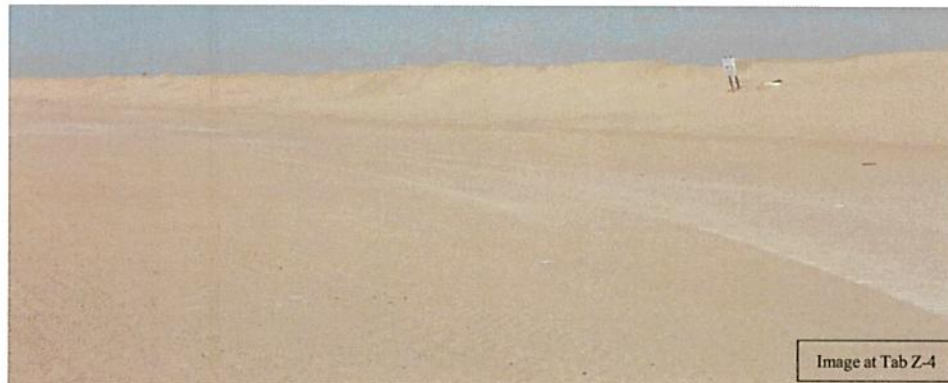
Witness testimony indicated that the MD told others she thought the M-ATV's brakes were not working properly as she lost control of the vehicle. (Tabs V-4.16, V-7.6 to V-7.7). The MD and MTC also reported audible alarm tones sounding inside the truck and at least one light flashing on the dashboard during the mishap sequence. (Tabs R-64, V-2.12). A steady light would be expected from the normal functioning of the ATC system, a flashing light is consistent with the overspeed indicator, and the audible tones are consistent with indicators from the overspeed and rollover warning systems. (Tabs R-20 to R-21, CC-63, CC-68, CC-75, FF-7). The brakes were functioning at the time of the mishap. (Tab GG-7). Approximately 100-200 yards from the mishap M-ATV's final resting place, the M-ATV began to swerve, which left several serpentine tire marks noted on the roadway leading up to the vehicle impact point, which is where the vehicle began its rollover sequence. (Tabs GG-3, GG-6). These serpentine tire marks were noted in photographs taken on the day of the crash, and by witnesses and first responders to the scene. (Tabs V-4.14 to V-4.15, V-8.4, V-14.5, Z-3, Z-4, GG-6).

The M-ATV rolled approximately 1.25 rotations, and came to a stop resting on its driver's side, facing northwest, the opposite direction from the way they had been traveling. (Tabs V-3.9, V-4.14, GG-3). During the mishap sequence, the MA was ejected from the M-ATV through the rear driver's side door, which opened during the rollover. (Tabs X-2, GG-7). The MA landed on hard-packed sand three to five feet from the overturned M-ATV, and suffered immediate fatal injuries, due to the unplanned ejection from the vehicle. (Tabs X-2, GG-7). The MTC was able to exit the vehicle through the turret, and then helped the MD exit through the turret as well. (Tabs R-64 – R-65, V-2.12, V-2.22). Both sustained injuries to include lacerations, mild TBIs, and bruising. (Tabs X-3, X-4).

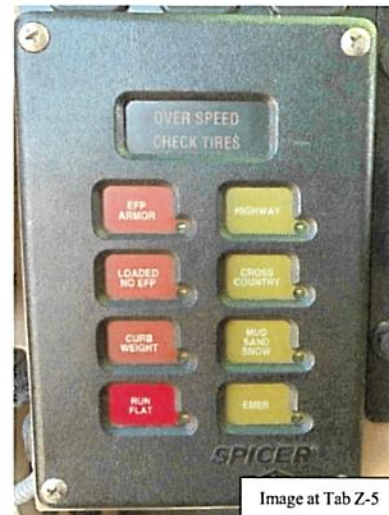
As described in the MD's and MTC's interviews, there were audible tones and flashing lights coming from the dashboard. (Tabs R-64, V-2.26). One light that would have been steadily illuminated in CC mode is the ATC light. (Tab CC-75). The ATC system is disabled in all CTIS settings, except for HWY. (Tab CC-75). In CC mode the light would have been illuminated yellow on the dash. (Tab CC-75). The flashing lights were likely attributable to the overspeed and rollover warning systems. (Tab U-31).

To confirm the CTIS was working properly at the time of the mishap, this GAIB applied power to the mishap M-ATV to confirm the system would properly pressurize. (Tab GG-4). Power had not been applied to the mishap M-ATV since it was turned off at the mishap scene on 12 September 2020. (Tab GG-4). Unfortunately, due to the extent of the damage from the mishap, the vehicle automatically shut down before it could fully pressurize. (Tab GG-4). The vehicle did continue to pressurize until it shut down. (Tab GG-4). Based on all available evidence, the CTIS was working properly at the time of the mishap, and it was properly set in CC mode. (Tab GG-4).

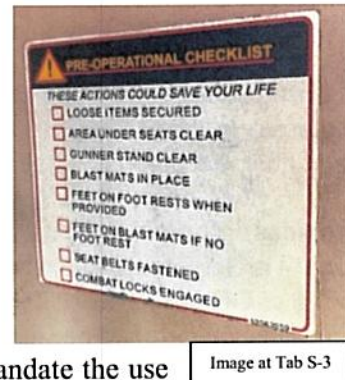
None of the MT members were wearing their 5-point safety belts at the time of the mishap. (Tab R-66). AFI 91-207, *The US Air Force Traffic Safety Program*, paragraph 3.5.1 mandates the use of installed seat belts while operating or riding in a motor vehicle. (Tab BB-28). The MT deviated from this requirement.

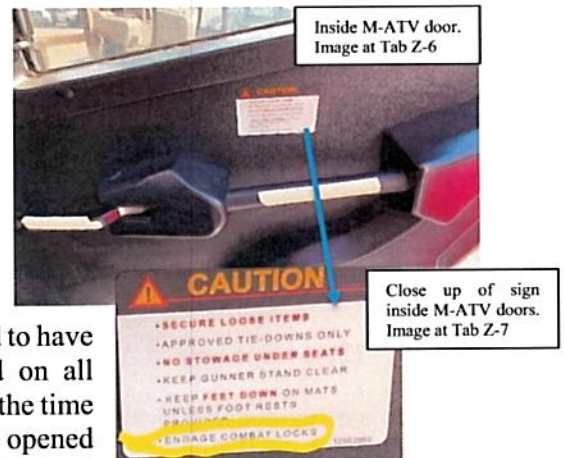
The only door that was possibly combat locked was the driver's door. (Tab V-2.23). Due to the fact the rear passenger door opened during the rollover, it was likely not combat locked at the time of the mishap. (Tabs U-30, V-6.7).

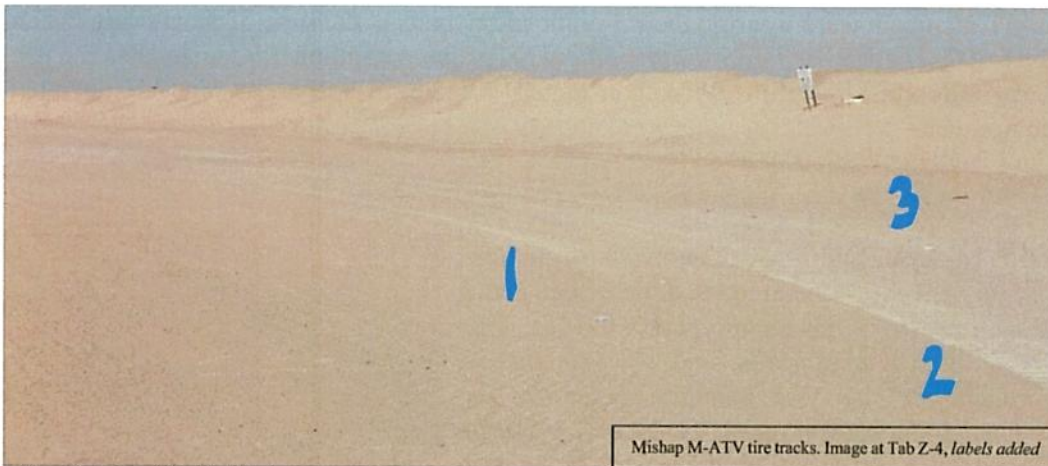
Unfortunately, full scene preservation was difficult due to the sandy surface of the road, and the requirement for MEDEVAC to respond to the mishap scene. (Tab V-8.4). The first responders were able to record the serpentine tire marks closest to the final resting place of the M-ATV before MEDEVAC arrived, and some were also visible 2 days later when the accident investigator who provided information to the Interim Safety Board (ISB) arrived to take measurements. (Tab V-9.5). The serpentine tracks were followed immediately by yaw skid marks in the roadway. (Tabs GG-6 to GG-7, GG-8). The vehicle had 100% braking efficiency throughout the skid, which was able to be determined because each of the four tires left individual skid marks. (Tabs GG-7, GG-8). While the tires left three visible track marks in the sand during the skid, the front driver's side tire and rear passenger tire followed the same track and left an overlapping skid. (Tabs GG-6 to GG-7, GG-8).

1. Front Passenger Side Tire Track
2. Front Driver Side Tire Track and Rear Passenger Side Tire Track
3. Rear Driver Side Tire Track

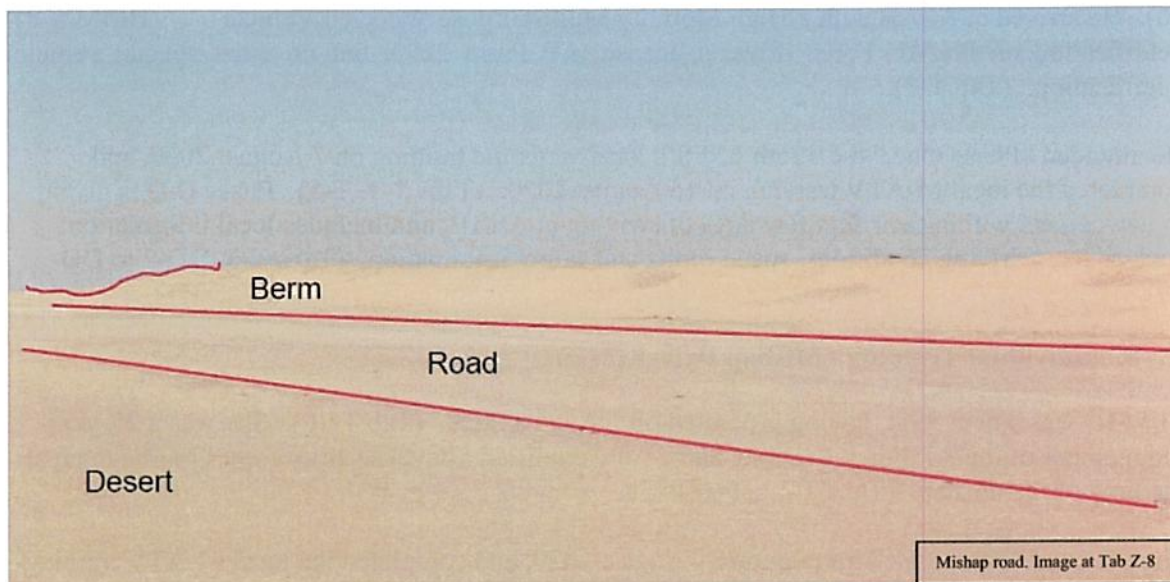
Some witnesses described a rock sticking out of the ground when they viewed the accident scene, and others specifically stated there was nothing in the roadway sticking out of the ground. (Tabs R-66, V-3.14, V-4.15, V-8.4, V-9.3, V-9.5, V-13.10). Three days after the mishap, the MTC was interviewed and specifically stated that she observed nothing abnormal in the roadway. (Tab R-66). This GAIB did not observe anything in the road consistent with the rock described by some witnesses, except for the gouge caused by the M-ATV itself during the rollover. (Tab GG-7). The mishap road is surrounded by mostly flat desert on one side, and a sand berm separating the road from more desert on the other side. (Tabs V-7.4 to V-7.5, V-13.10, Z-8).
