# Fifth Five-Year Review Operable Units A and B-1 Former Adak Naval Complex

## **Naval Air Station Adak**

**Fifth Five-Year Review  
Operable Units A and B-1  
Former Adak Naval Complex  
NAVAL AIR STATION ADAK, ADAK ISLAND, ALASKA**

**December 2021**

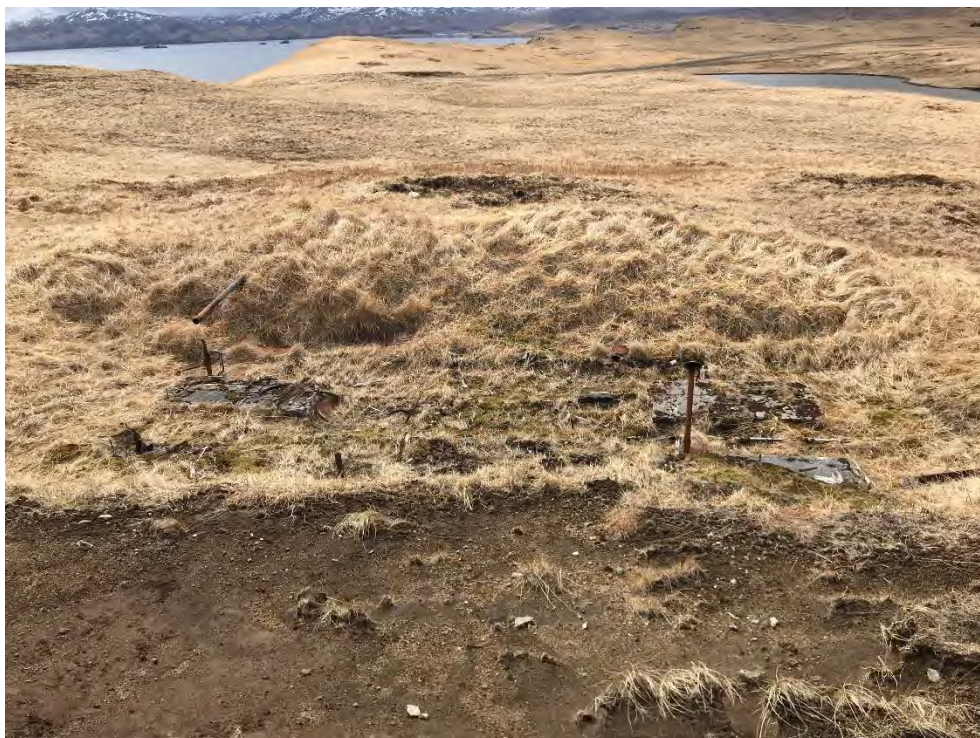
Concrete pad/former  
structure layout. Metallic  
debris (piping, scrap  
metal, drums) scattered  
throughout site. Exposed  
rusted wire conduit  
coming out of south berm.

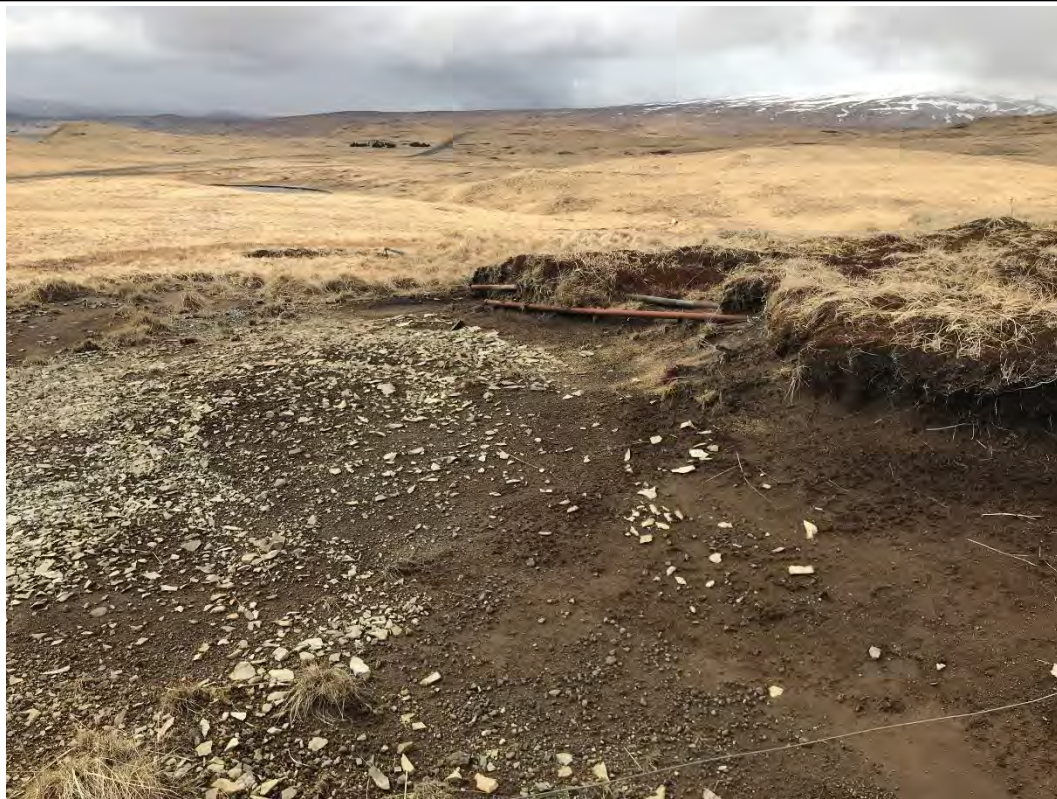
**Description:** Bare  
patches of vegetation  
upgradient of concrete  
pad/former structure.  
Rusted pipes/conduits  
surfacing from the ground,  
erosion present on  
sidewalls.

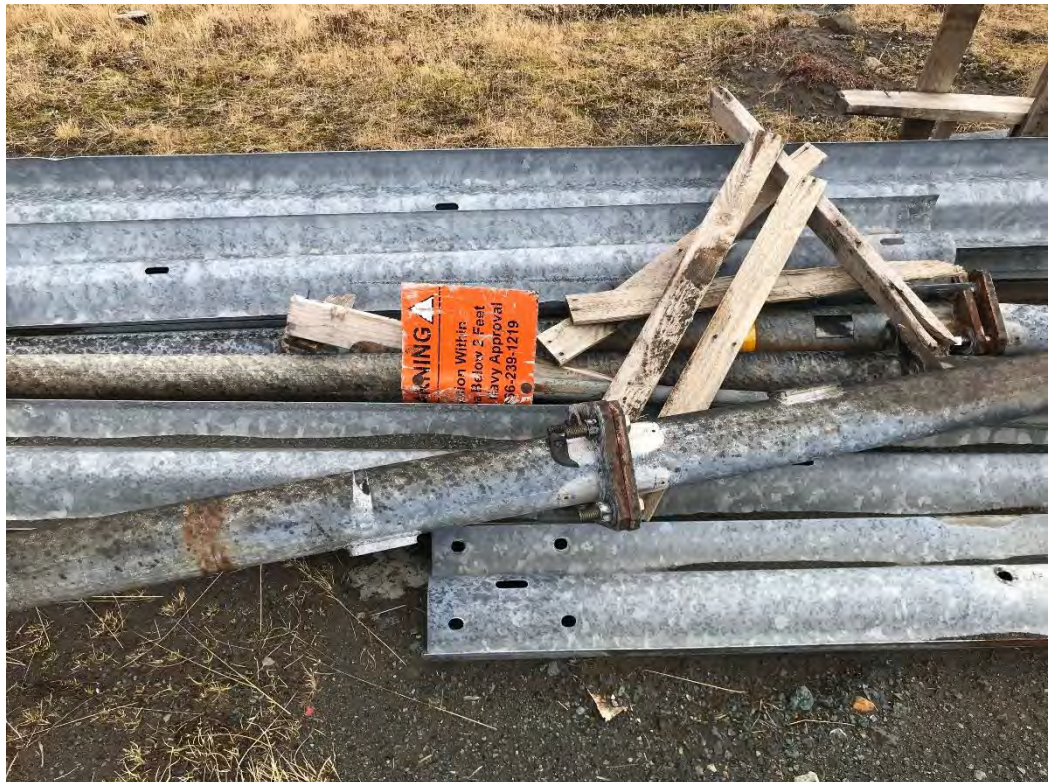
**Description:** Institutional  
control signage damaged  
and in pile of metallic  
debris on the east side of  
the new baler building.

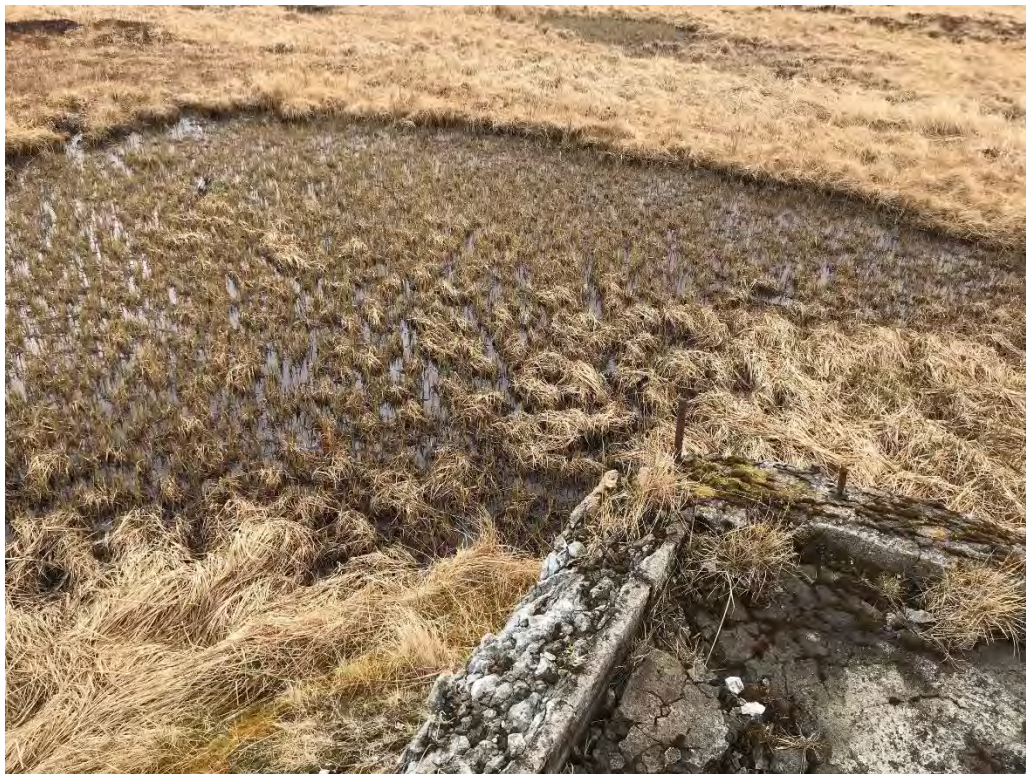
**Description:** Surface  
water pooling near  
southwest corner of  
concrete pad.

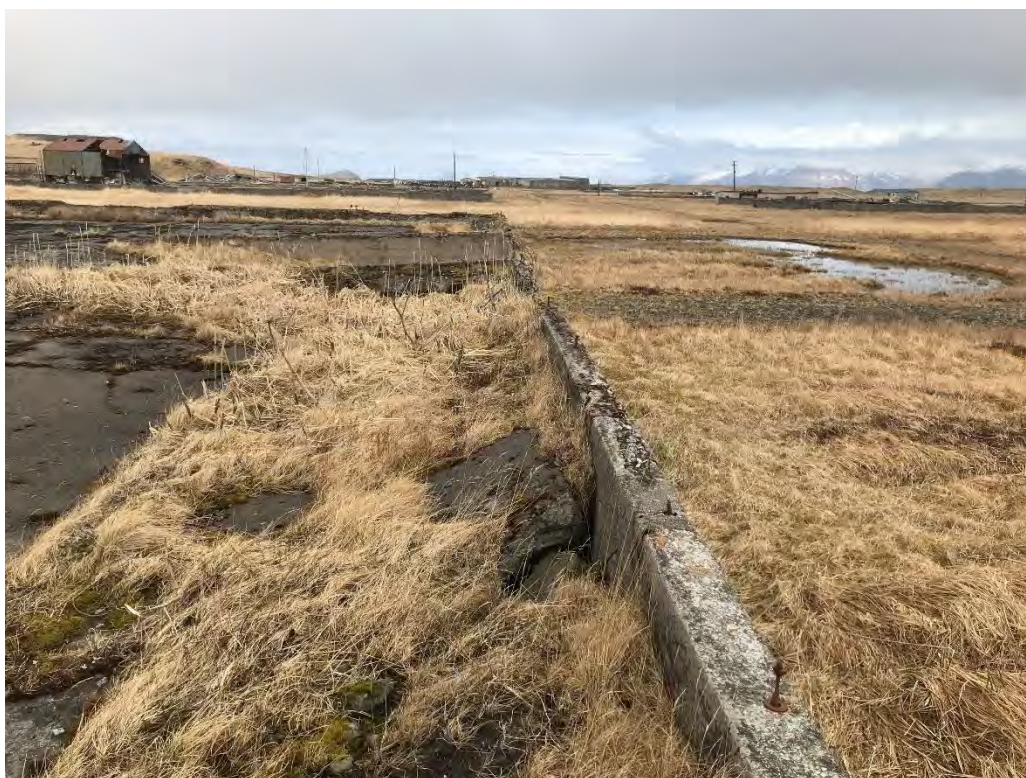
**Description:** UST  
excavation location  
directly off sidewall of  
concrete pad according to  
figures and historical  
references. Stressed  
vegetation near sidewall  
and heavy machinery  
tracks observed.

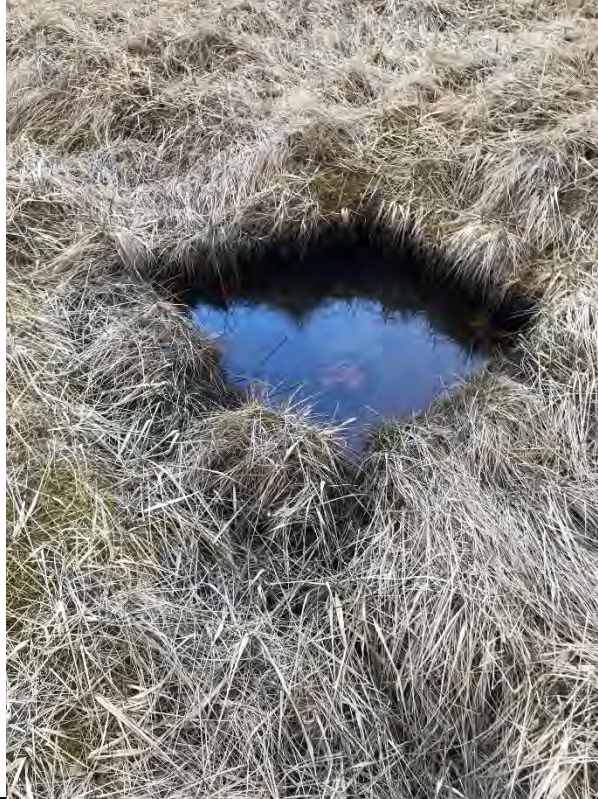
**Description:** Surface  
water pooling within  
vegetation south of  
concrete pad/foundation.

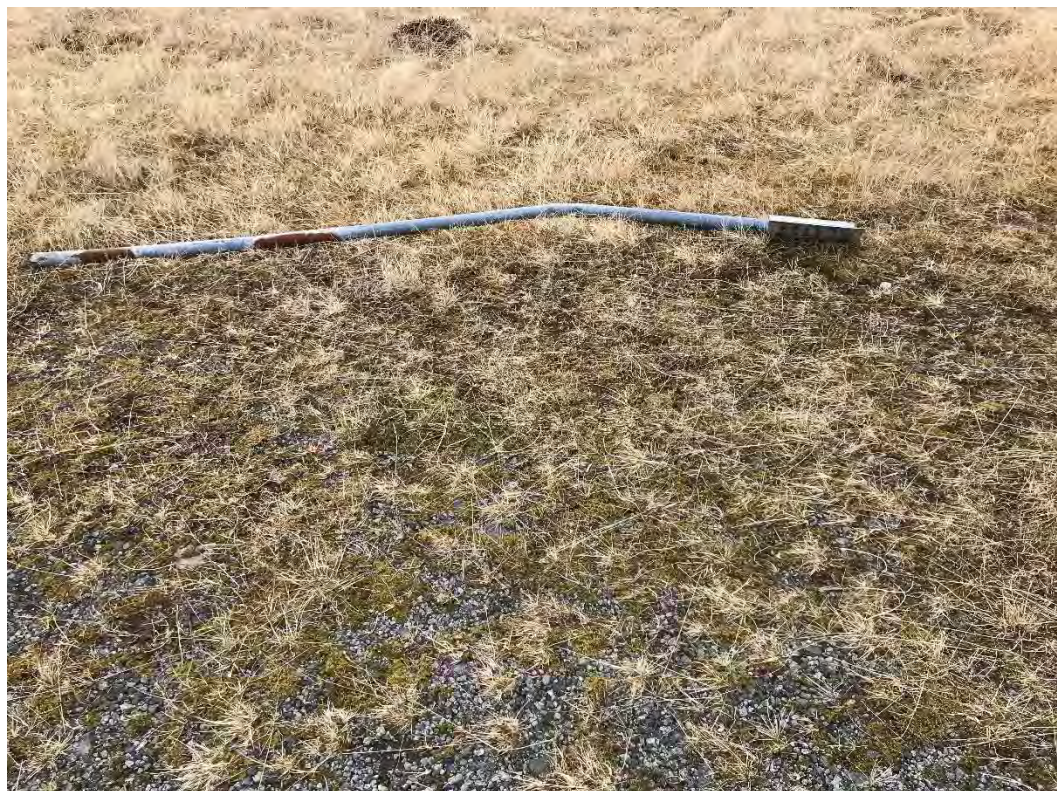
**Description:** Institutional  
control signage damaged  
within monitoring well  
field.

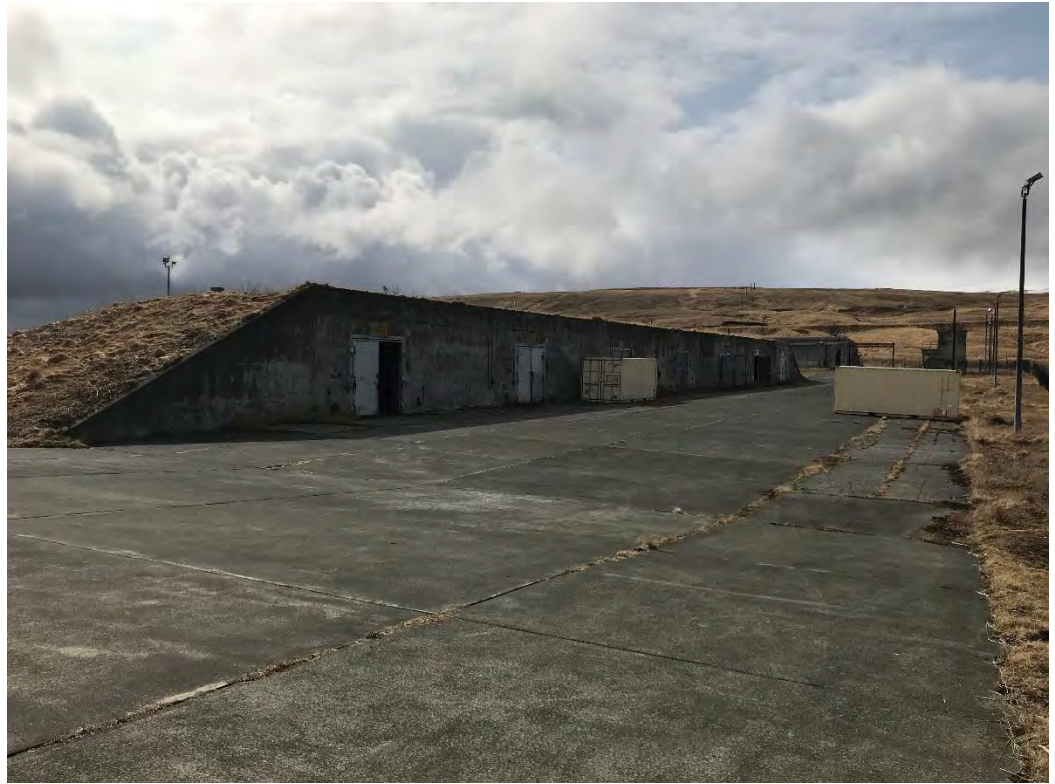
**Description:** Bomb  
storage bunkers looking  
west. Subcontractor  
Conex's containing  
hazardous materials  
locked and stored outside  
bunker doors.

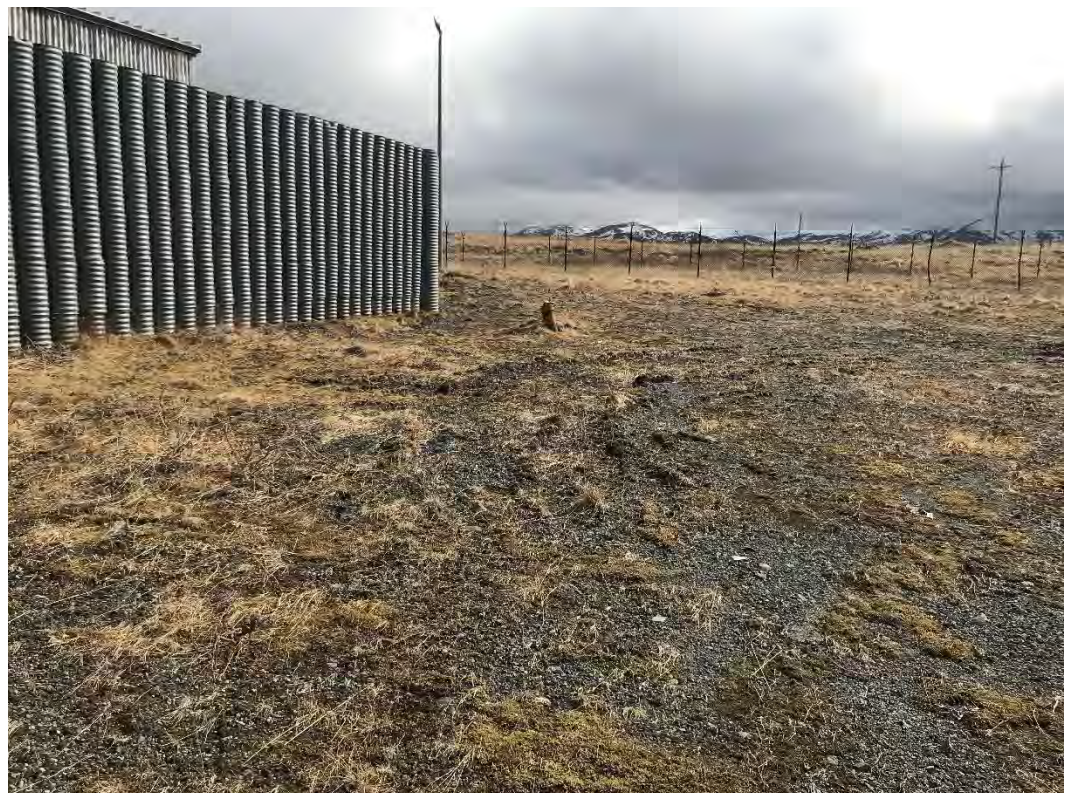
**Description:** Former UST  
excavation location.  
Heavy machinery tracks  
on surface visible. Utility  
tie-off observed near  
southwest corner of  
building.

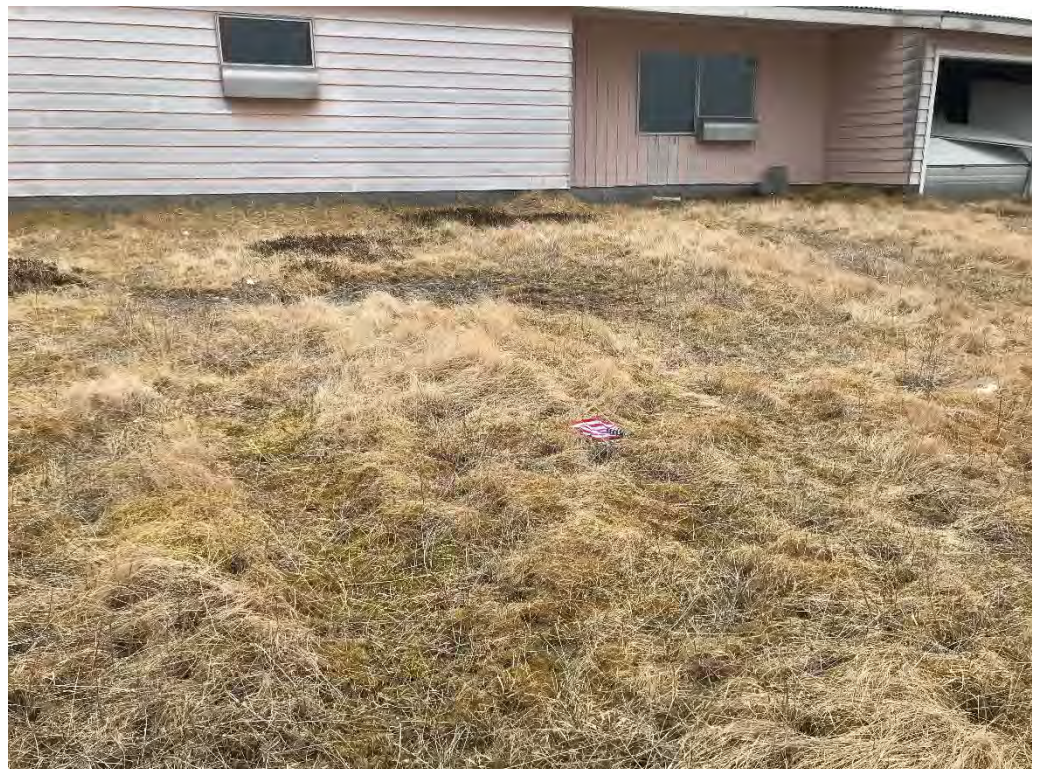
**Description:** Southeast  
corner of housing  
structure where former  
UST excavation was  
located. Distressed  
vegetation and fill material  
observed in area.

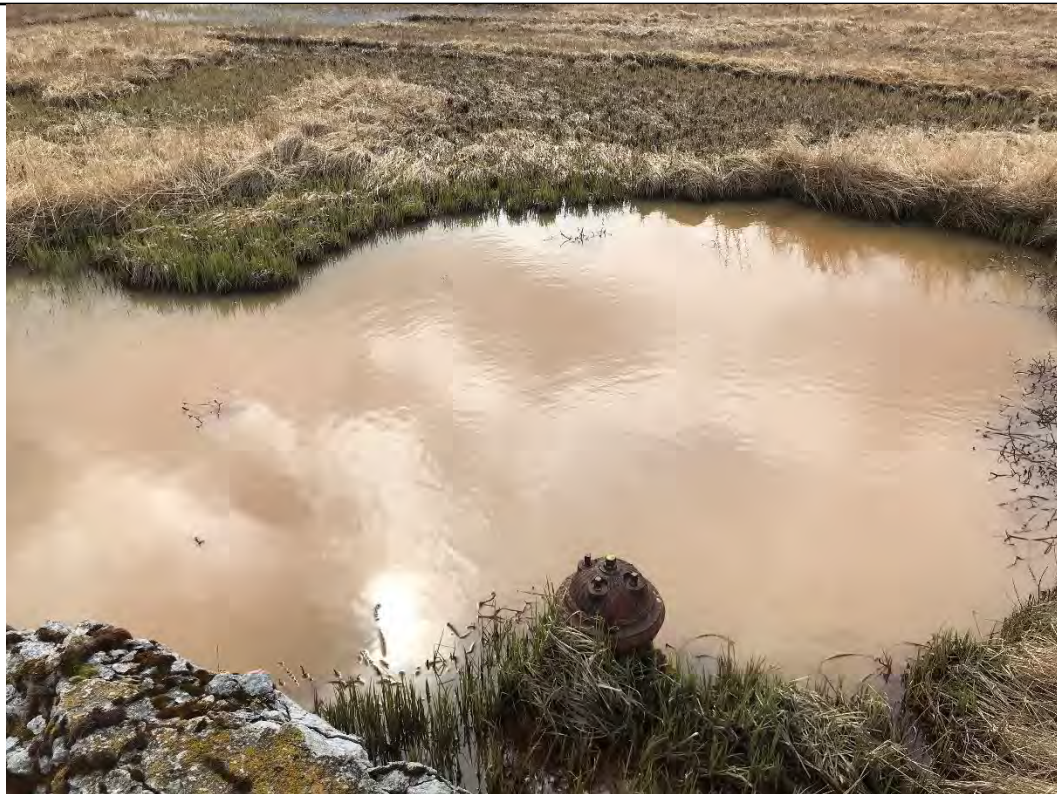
**Description:** Surface  
water pooling observed in  
the southwest corner of  
the site.

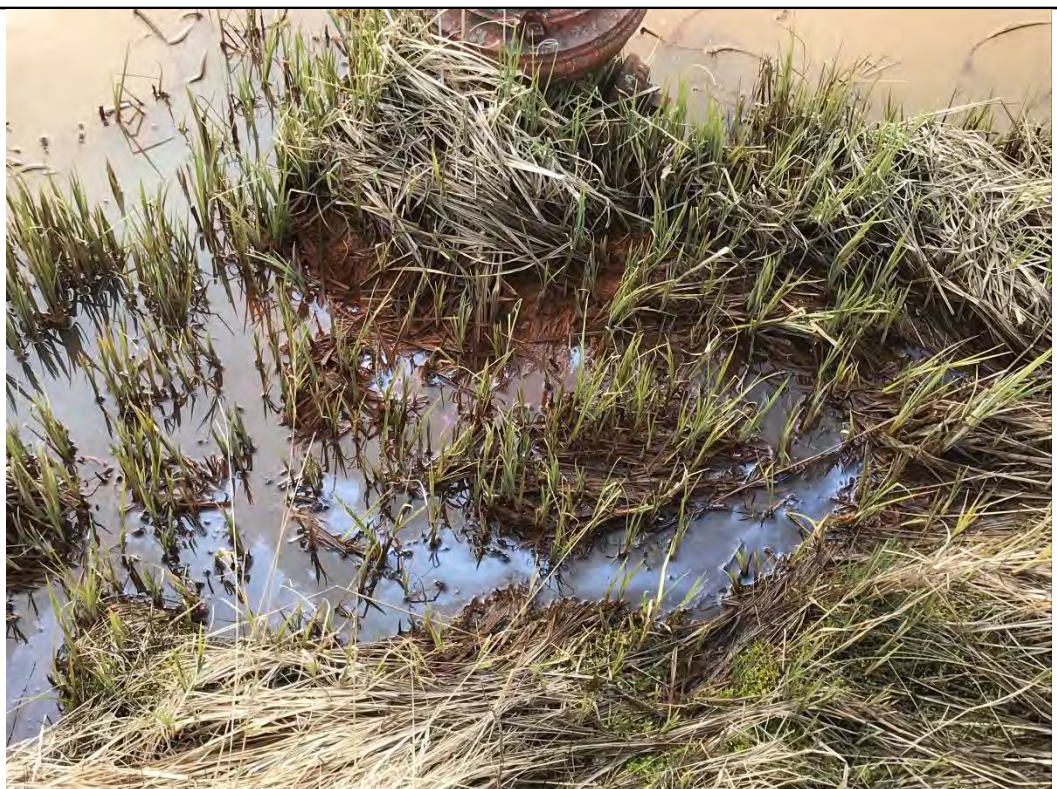
**Description:** Visible  
biological identified sheen  
observed within surface  
pooling in southwest  
corner of site.

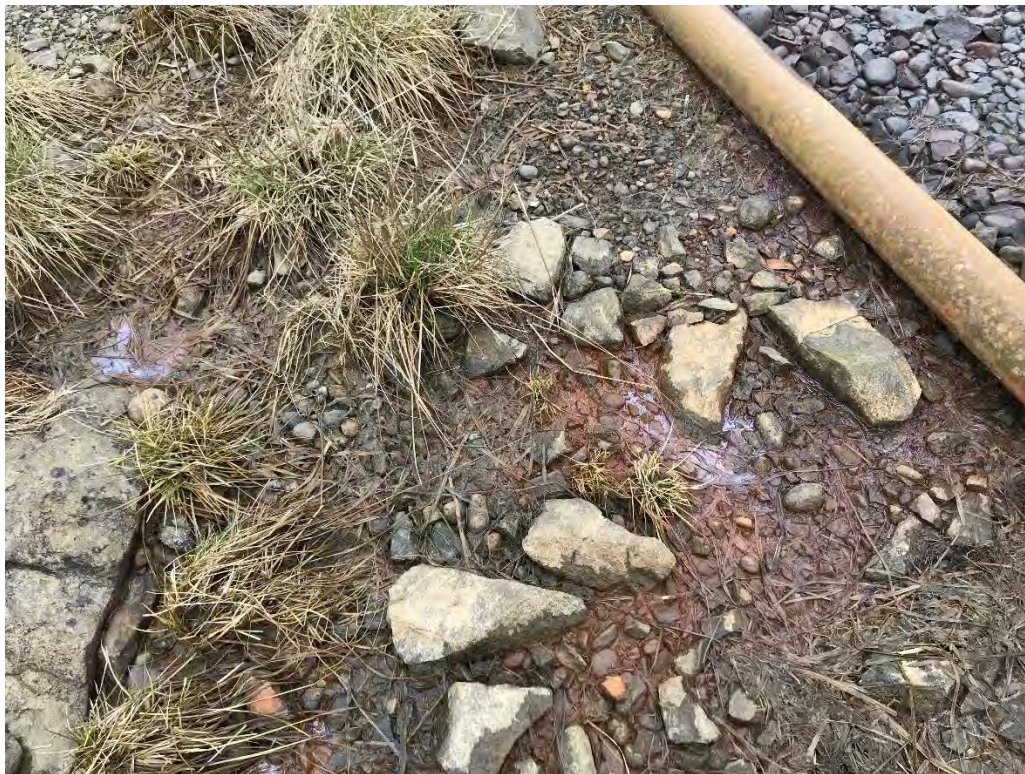
**Description:** Sheen  
observed down slope of  
excavation restriction sign  
adjacent to Amulet  
Housing Well AMW-706  
Area.

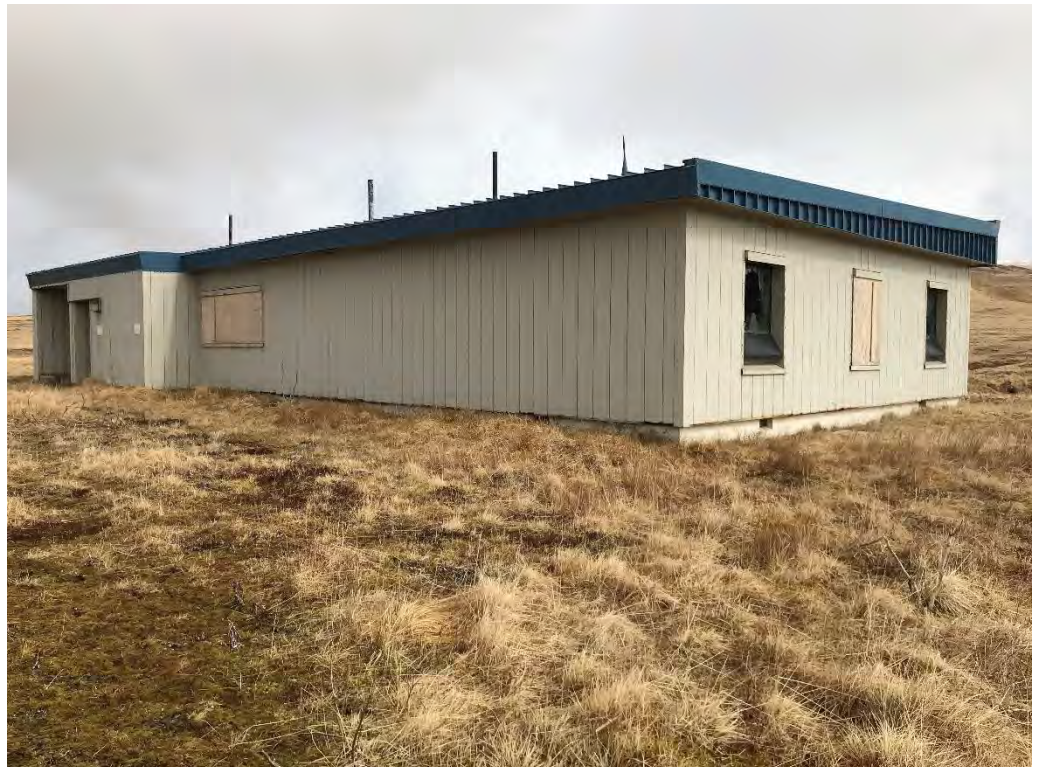
**Description:** Southeast  
corner of north P-80\_81  
building. Visual evidence  
of damaged windows and  
debris scattered  
throughout site.

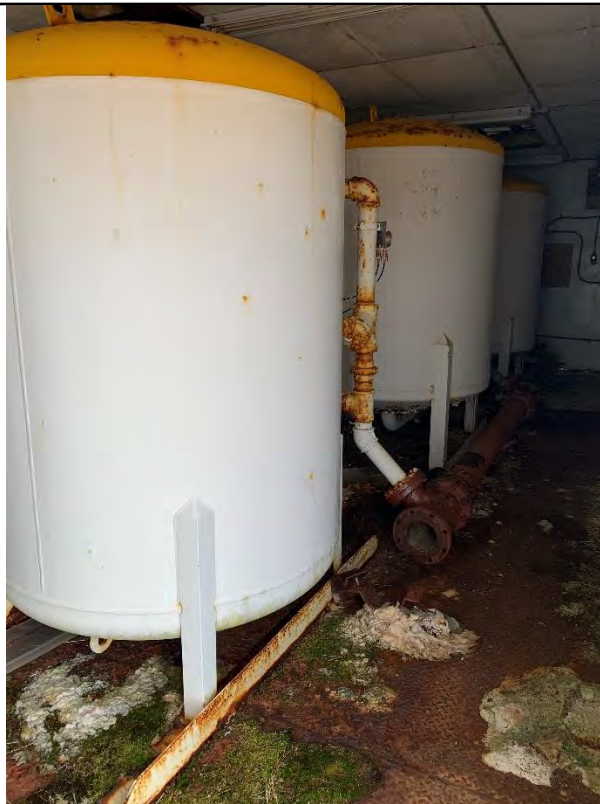
**Description:** Interior of  
chlorine tank building.  
Vegetation growing inside  
building on floor, visible  
chemical damage beneath  
chlorine tanks.

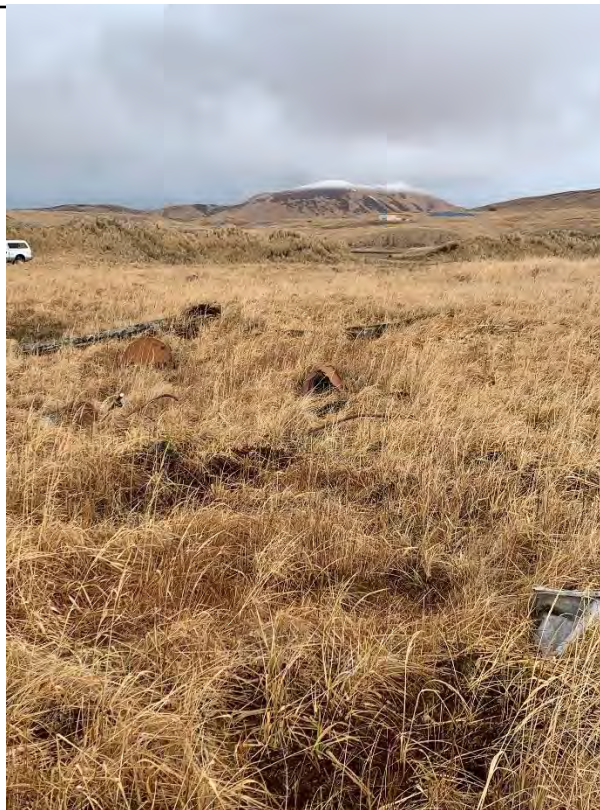
**Description:** Metallic  
debris (55-gallon drum,  
vehicle parts, etc.) present  
in northern portion of  
landfill.

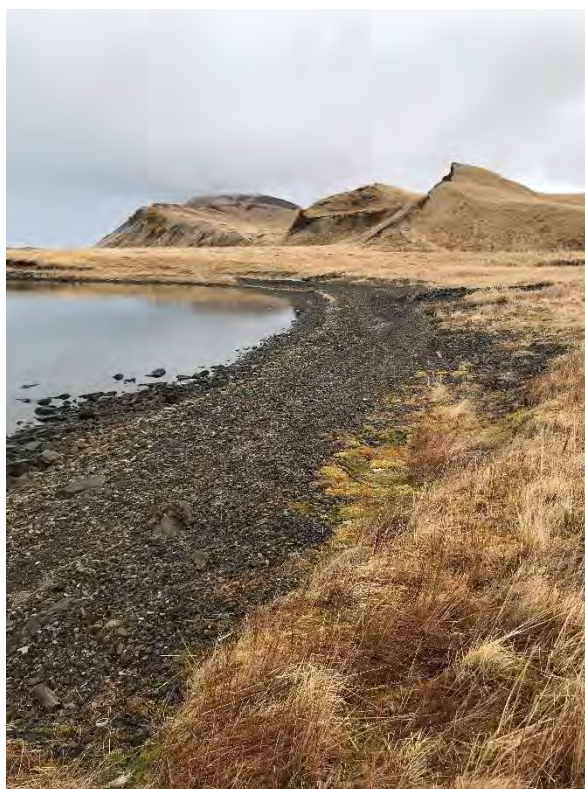
**Description:** Shoreline of  
landfill looking northwest.  
Various metallic debris  
observed on shoreline  
including rusted tools and  
Marston mat material.

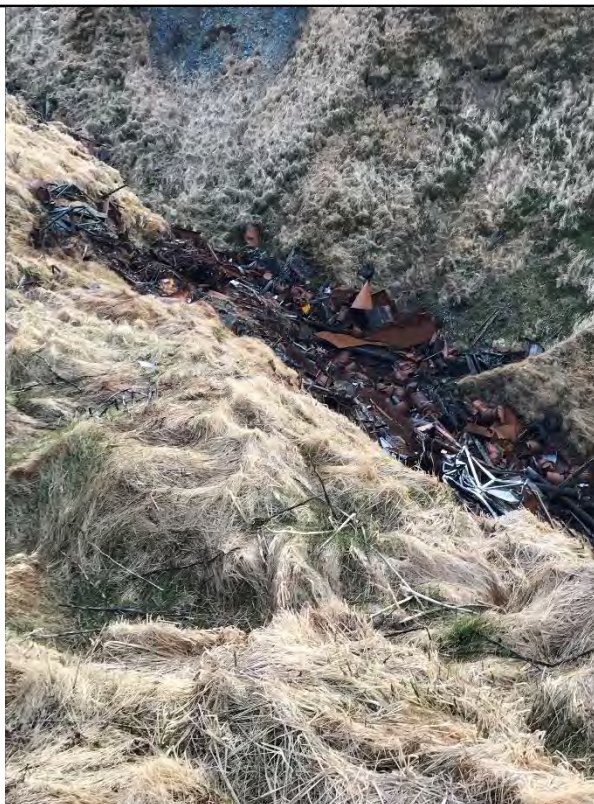
**Description:** Exposed  
metallic debris in landfill  
gully. Observed metallic  
debris has migrated from  
gully to mouth of gully and  
Kuluk Bay.

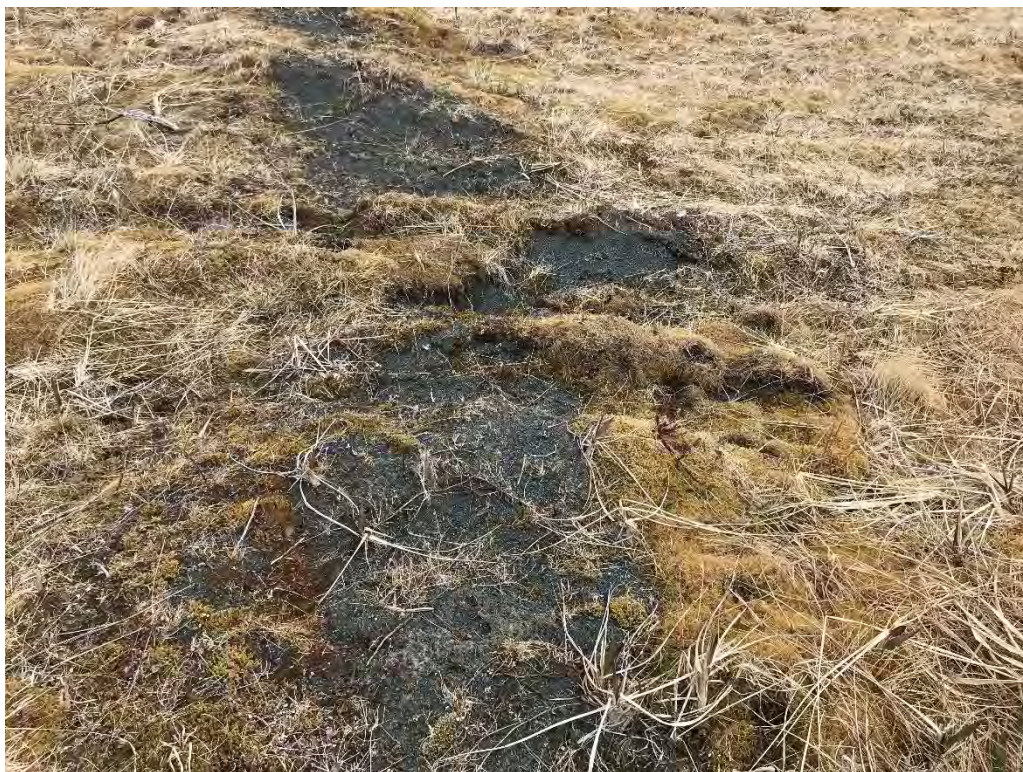
**Description:** Visual  
evidence of damaged  
tundra within monitoring  
well field from heavy  
machinery. Gravel fill  
material observed  
periodically throughout  
site.

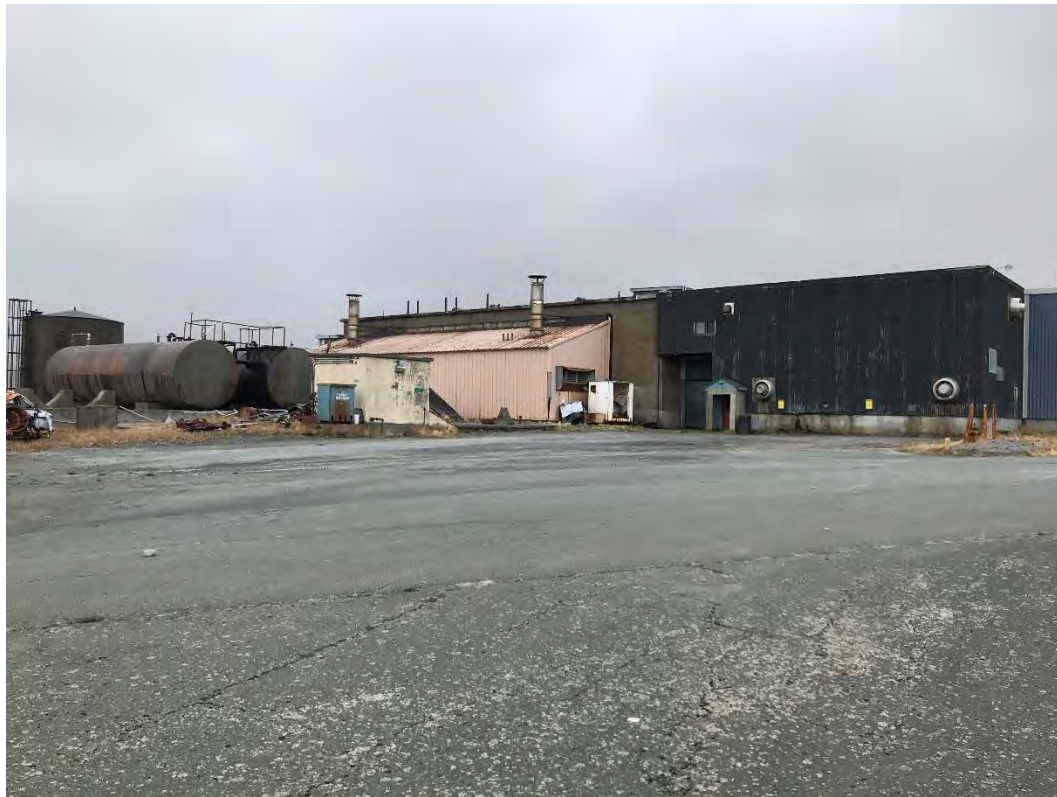
**Description:** North side of  
power plant building. Poor  
housekeeping on east  
side of building noted.  
Large amounts of metallic  
debris, and trash  
throughout site not  
affiliated with power plant.

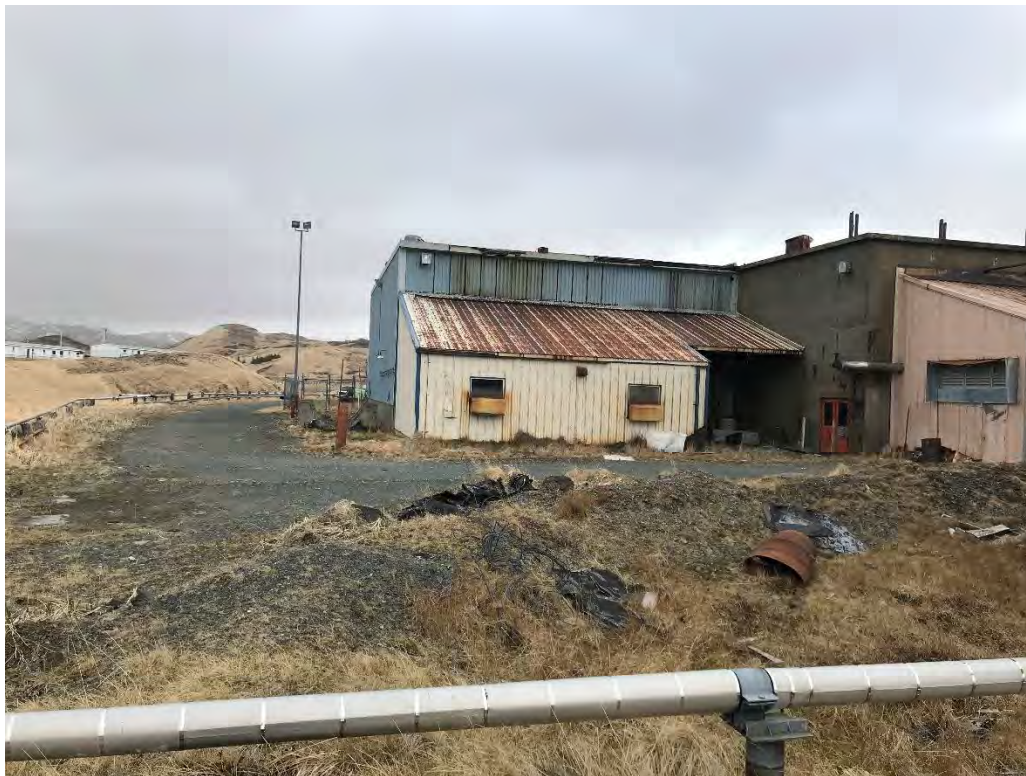
**Description:** Northeast corner of power plant building. Metallic debris present (rusty 55-gallon drum).

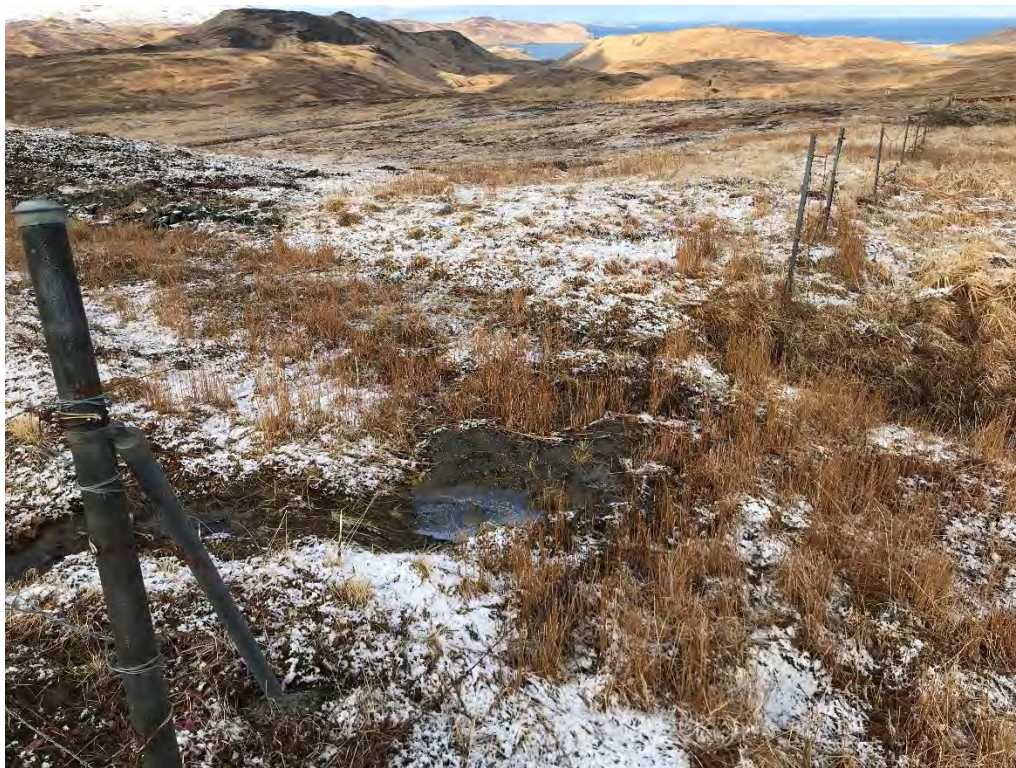
**Description:** Damaged  
barbed wire fencing on the  
north side of landfill  
boundary.

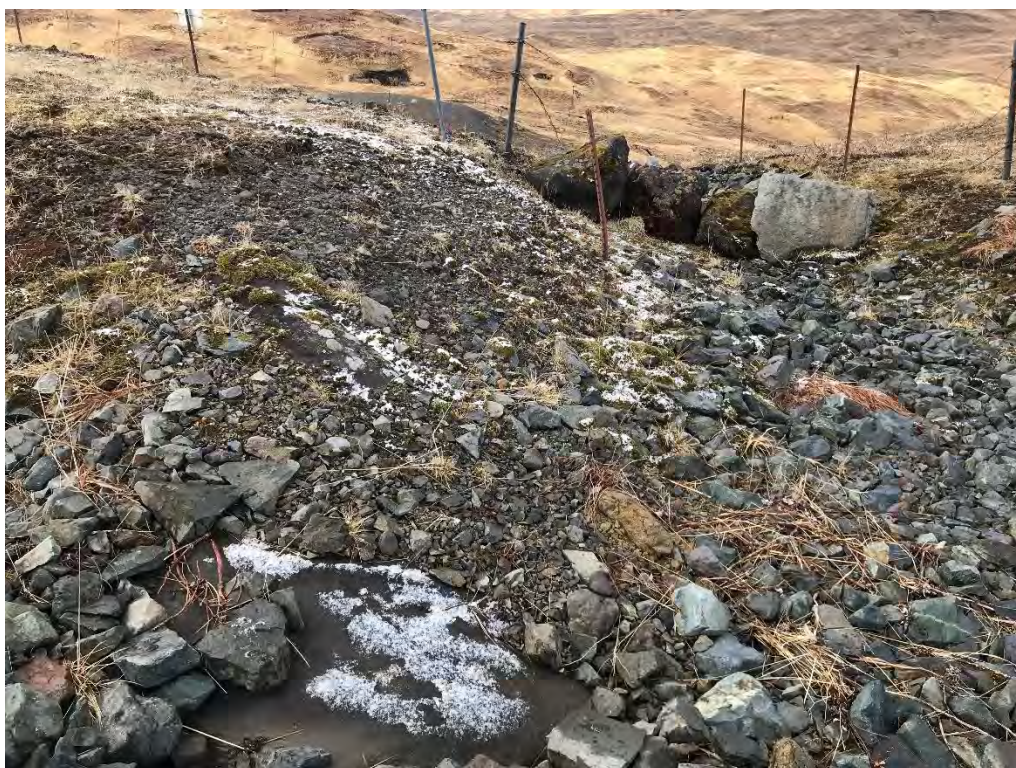
**Description:** Damaged  
barbed wire fencing and  
exposed liner near east  
corner of landfill.

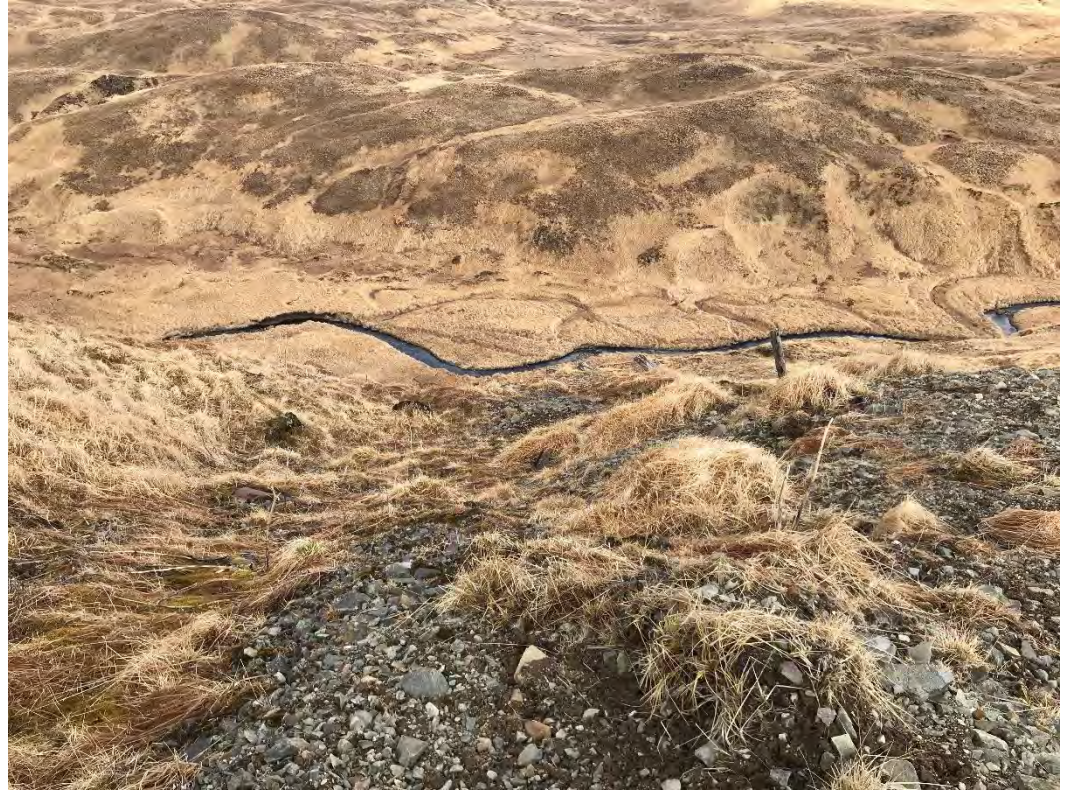
**Description:** Disposal  
area looking down  
towards trout creek. Minor  
erosion observed along  
bluff where metallic debris  
is present.

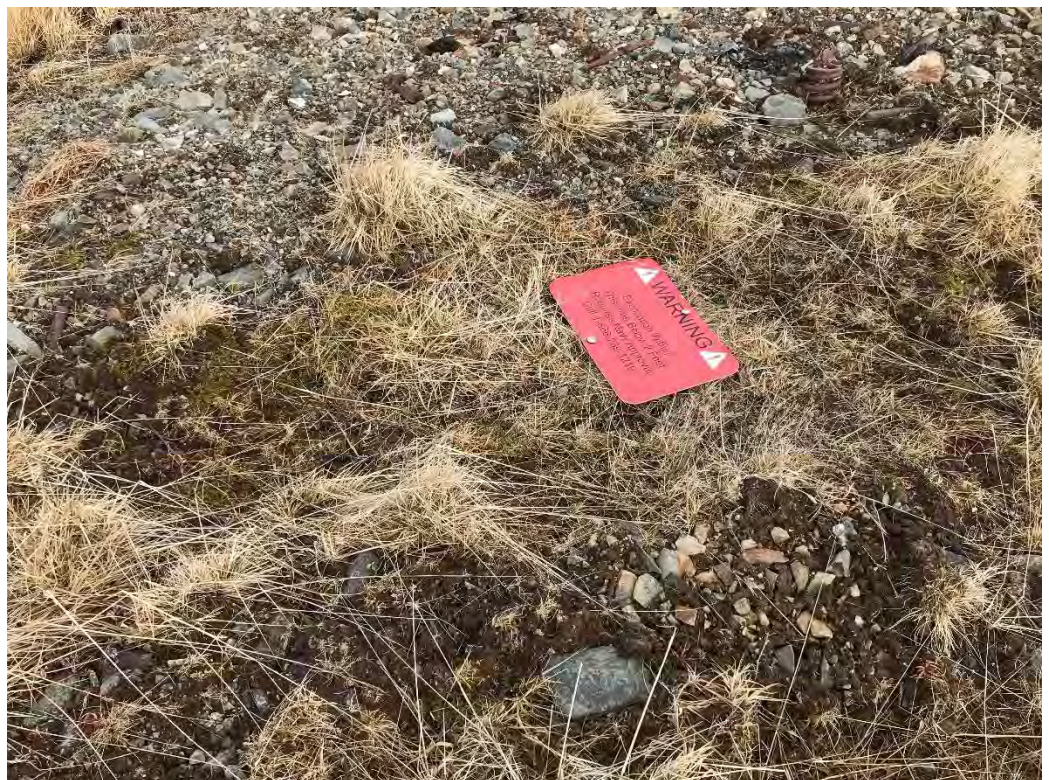
**Description:** Institutional  
control signage damaged  
and left on ground of bluff  
near site.

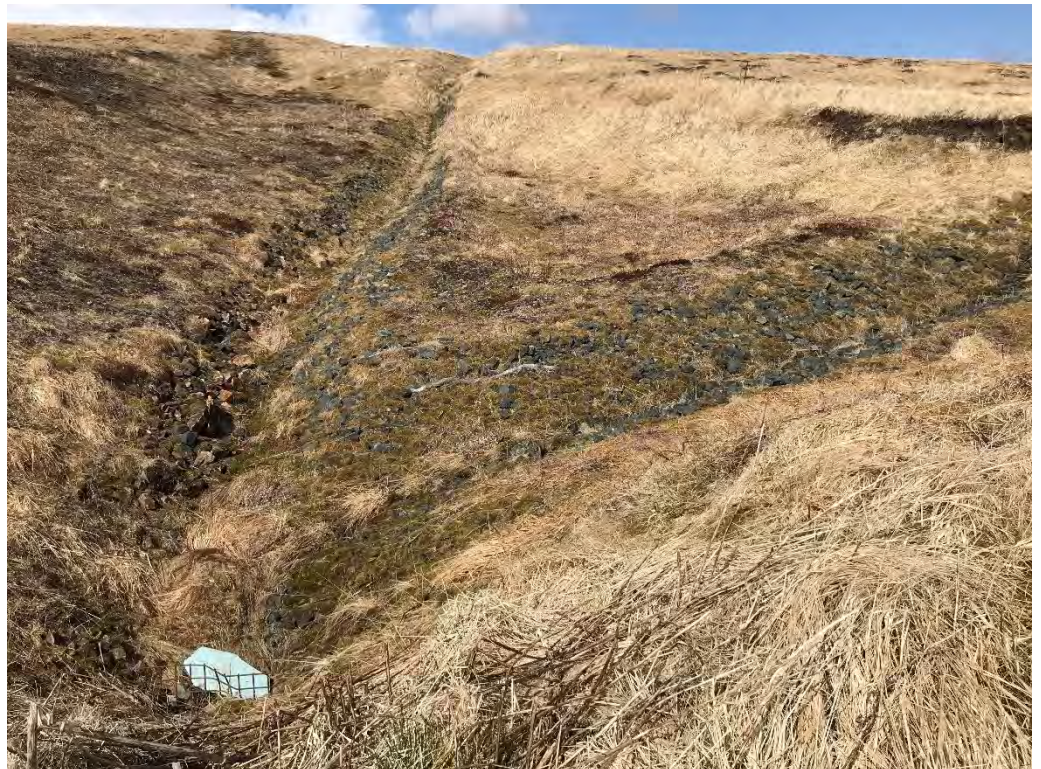
**Description:** Culvert  
drainage in the southeast  
portion of the landfill.  
Observed debris at bottom  
of culvert.

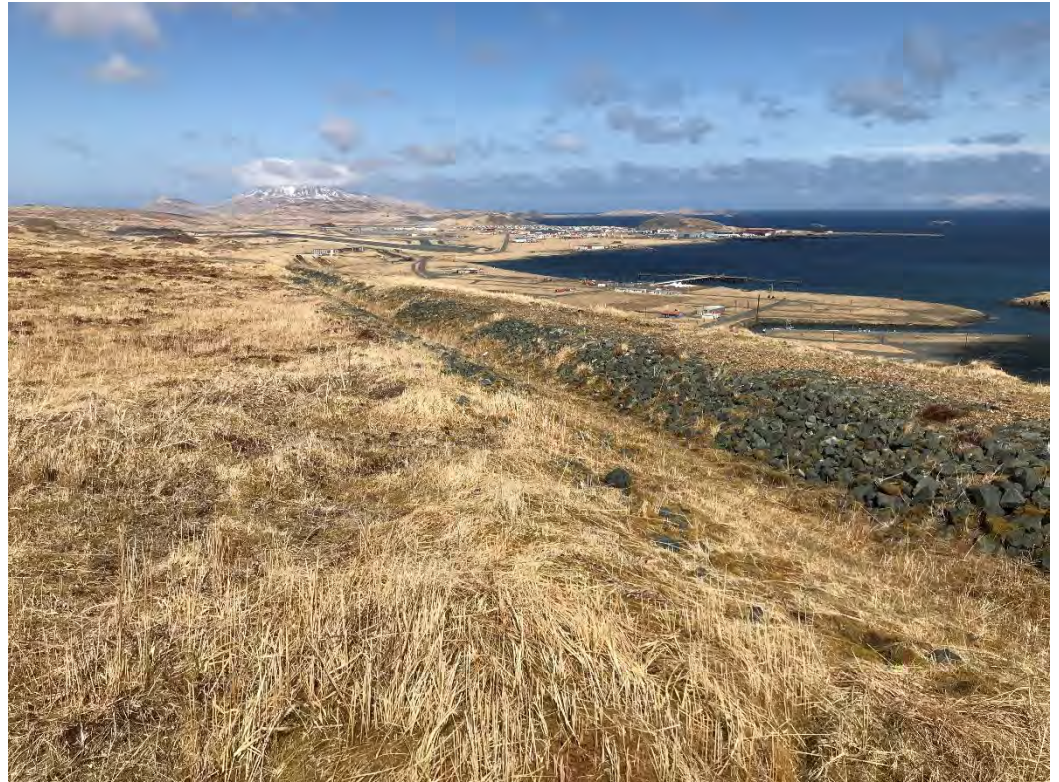
**Description:** Site  
overview looking  
northeast. Observed  
culvert with visible  
damaged to construction.

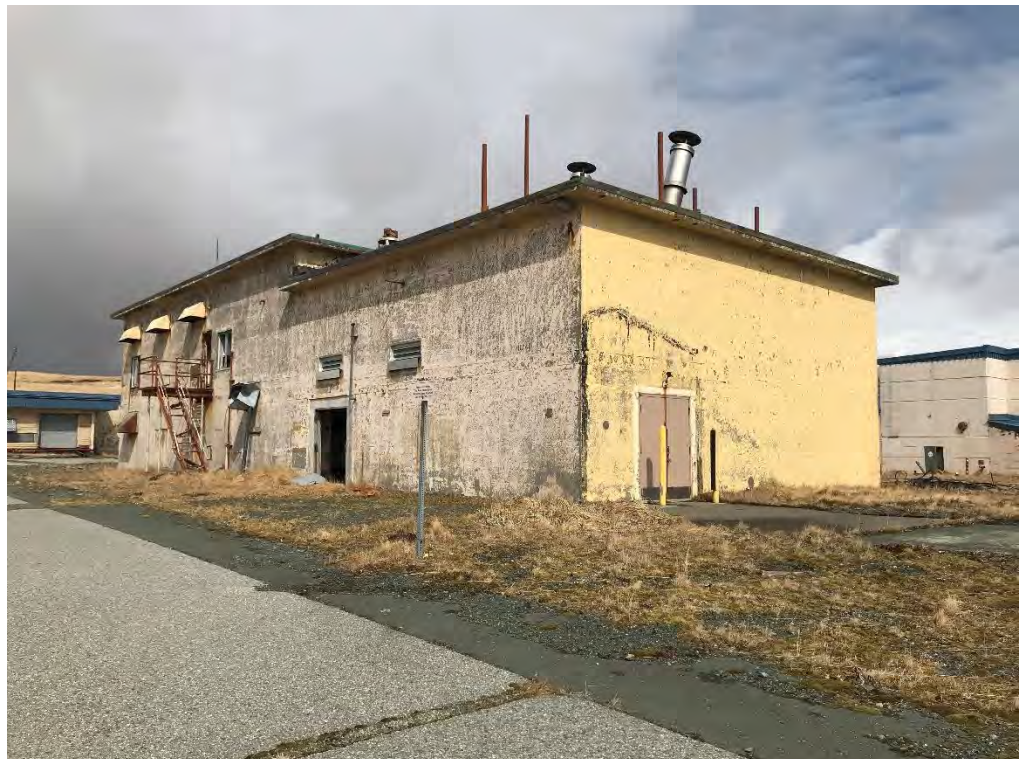
**Description:** South side  
of building 1034.  
Condition of building  
deteriorating.

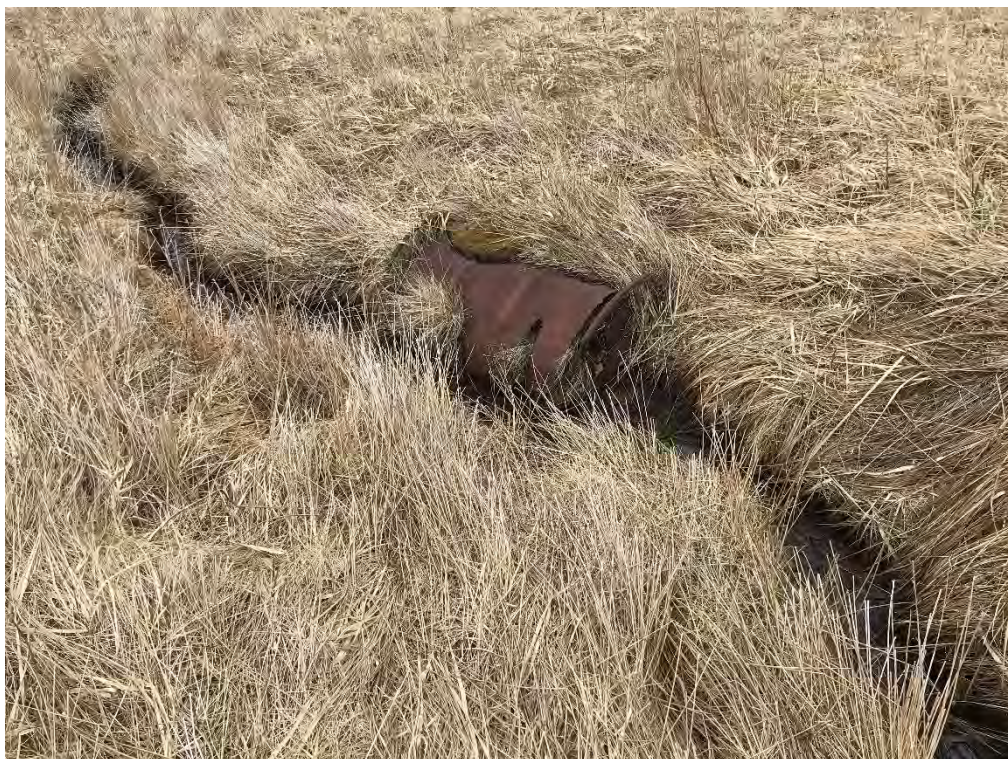
**Description:** Metallic  
debris (rusted 55-gallon  
drum) within surface water  
near base of hill in  
upgradient portion of site.
