# Fifth Five-Year Review Operable Units A and B-1 Former Adak Naval Complex

## **Naval Air Station Adak**

**Fifth Five-Year Review  
Operable Units A and B-1  
Former Adak Naval Complex  
NAVAL AIR STATION ADAK, ADAK ISLAND, ALASKA**

**December 2021**

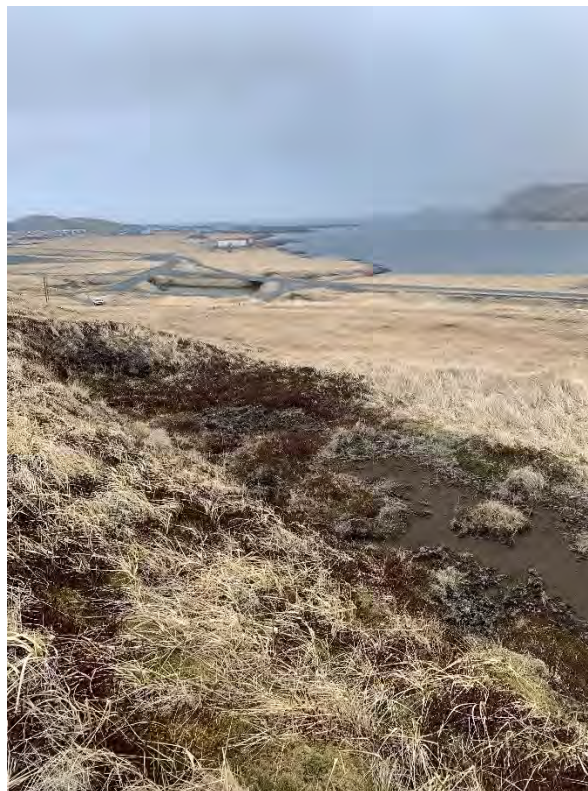
**Description:** Eroded  
depression within hillside  
of upgradient area.  
Distressed vegetation  
observed.

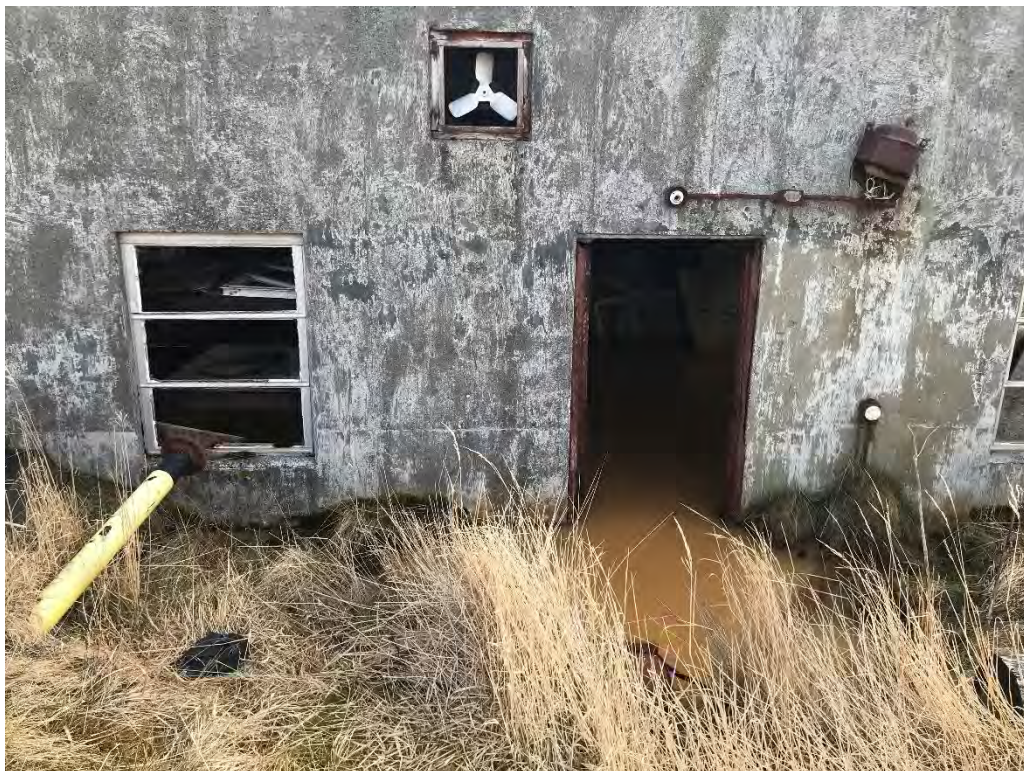
**Description:** North side of  
southern pumphouse.  
Building in poor condition  
due to excessive flooding.

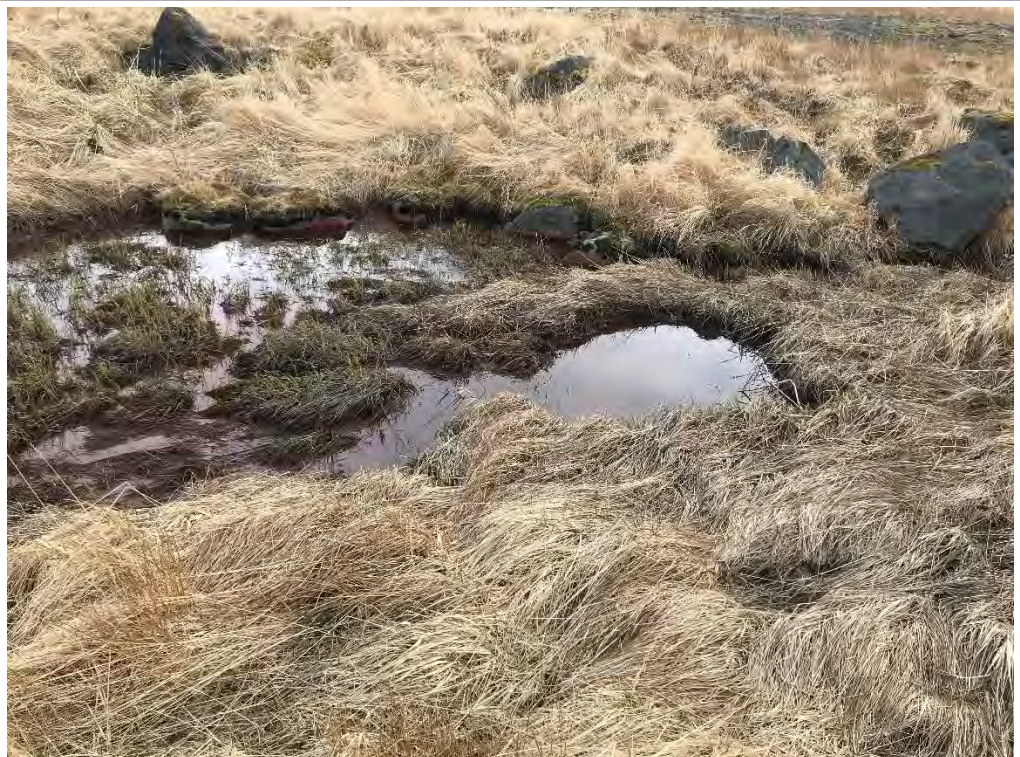
**Description:** Recently  
constructed culvert on the  
south side of access road.  
Culvert outlet overflowing  
and in poor condition.

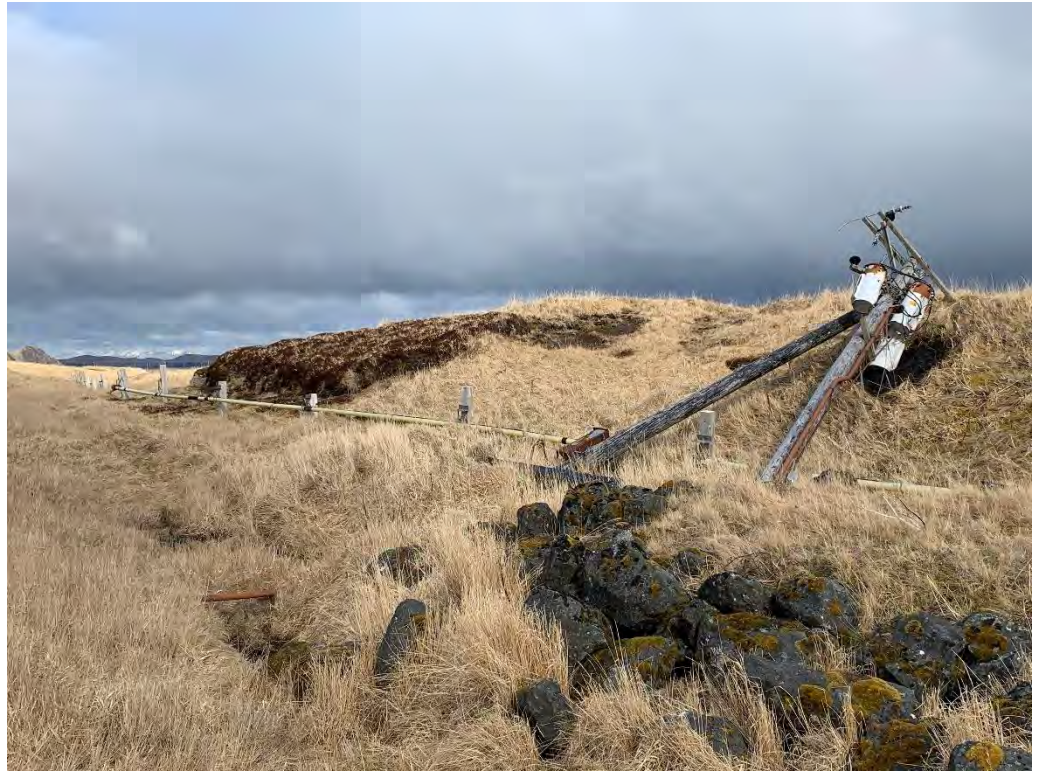
**Description:** Downed  
telephone pole near  
pipeline on northern  
portion of site. No  
damaged observed to  
pipeline.

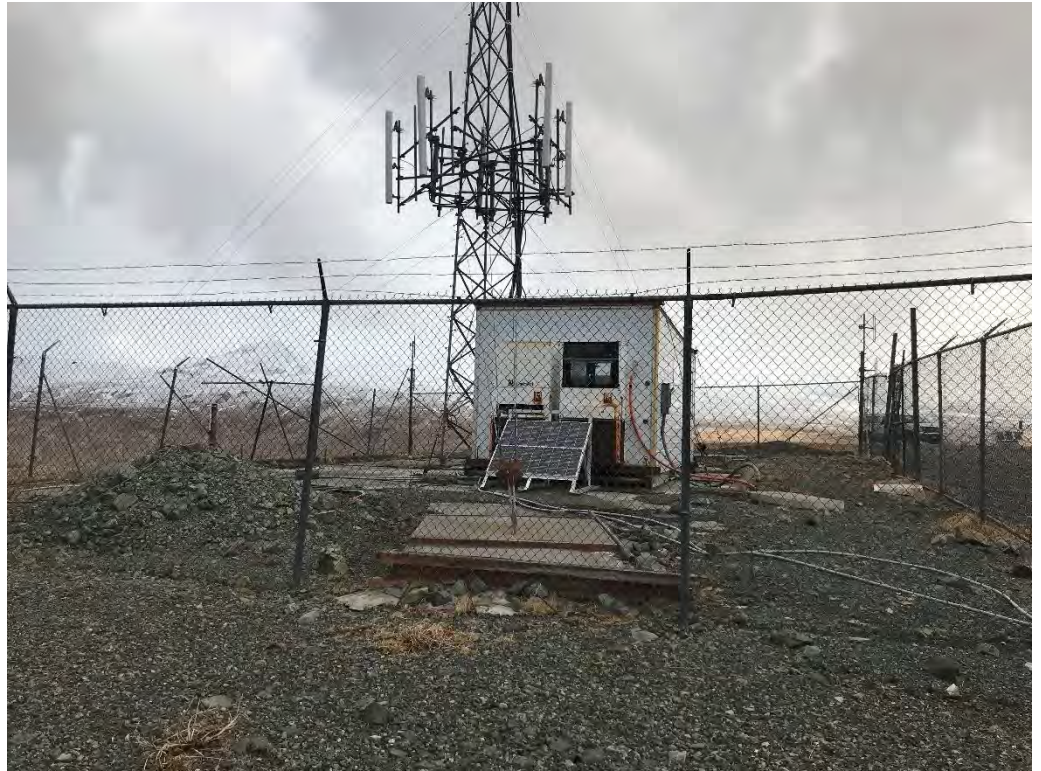
**Description:** Damaged  
fencing surrounding radio  
transmitter equipment.

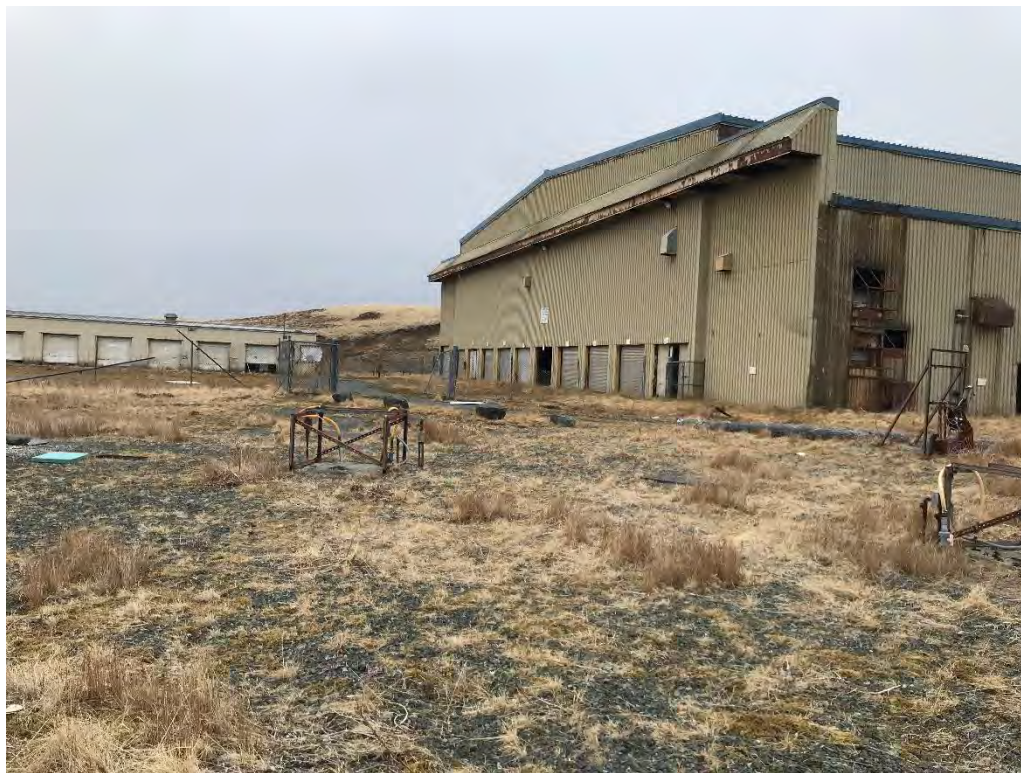
**Description:** Northwest  
corner of Yakutat Hanger.  
Metallic debris scattered  
throughout site.  
Decommissioned piping  
observed on site.

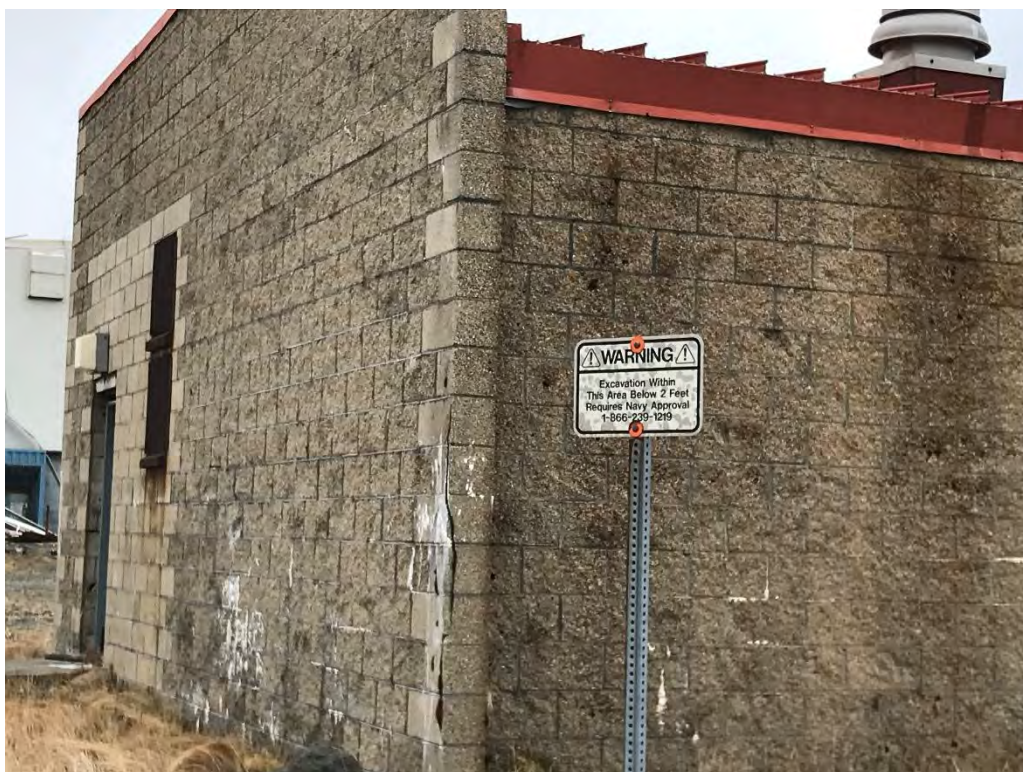
**Description:** Institutional  
controls sign facing a  
building adjacent to the  
SE corner of SWMU 14,  
Old Pesticides Area. The  
sign is not facing the  
SWMU 14 site.

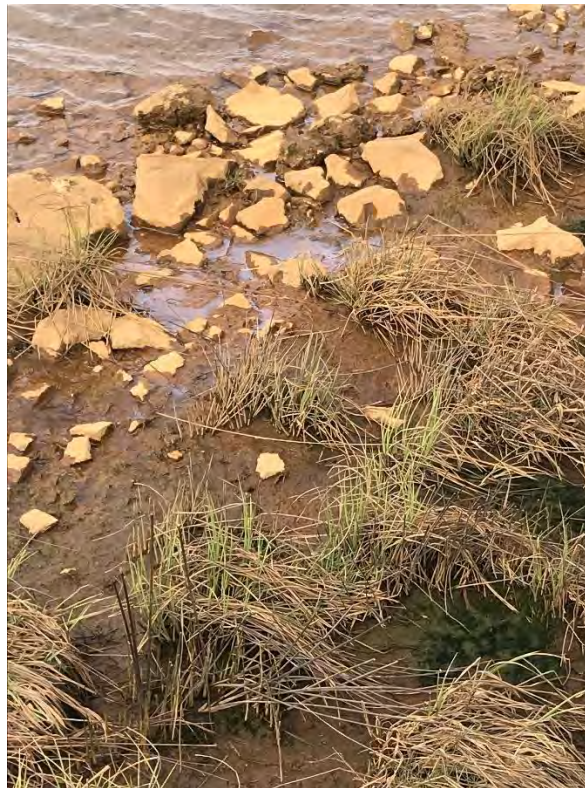
**Description:** Petroleum  
seep along east canal  
adjacent to booms at  
SWMU 62, Housing Fuel  
Leak Area.

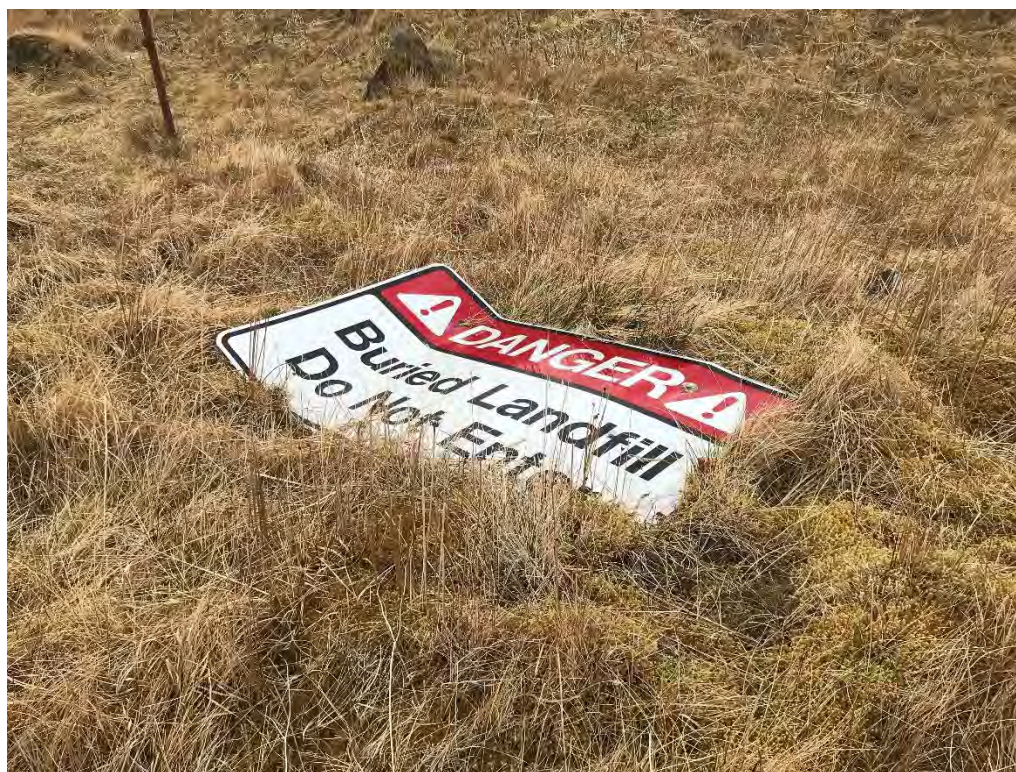
**Description:** Damaged  
buried landfill sign located  
at the base of the landfill  
on the south end.

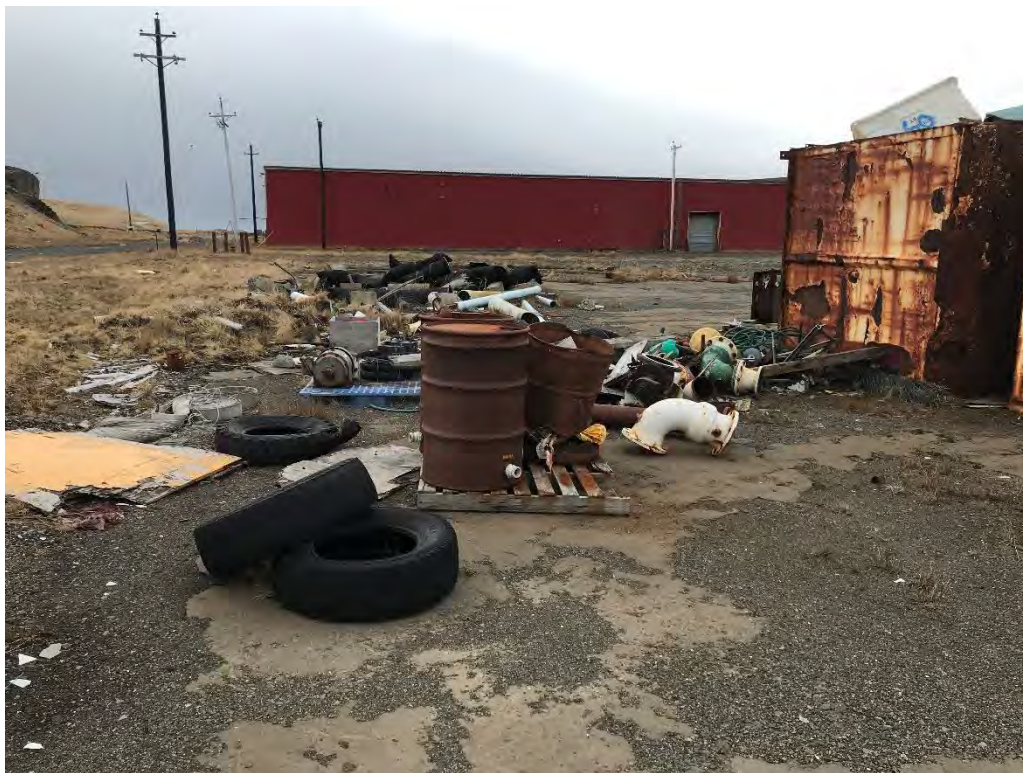
**Description:** Debris and  
drums scattered on  
ground along north end of  
SWMU 24, Hazardous  
Waste Storage Facility.
