United States  
Coast Guard

## MEMORANDUM

Subj: MAJOR INCIDENT INVESTIGATION (MII) INTO THE CIRCUMSTANCES  
SURROUNDING THE HARD LANDING OF CG-6599 ON 11 FEBRUARY 2021  
AT NAVAL AIR STATION OCEANA

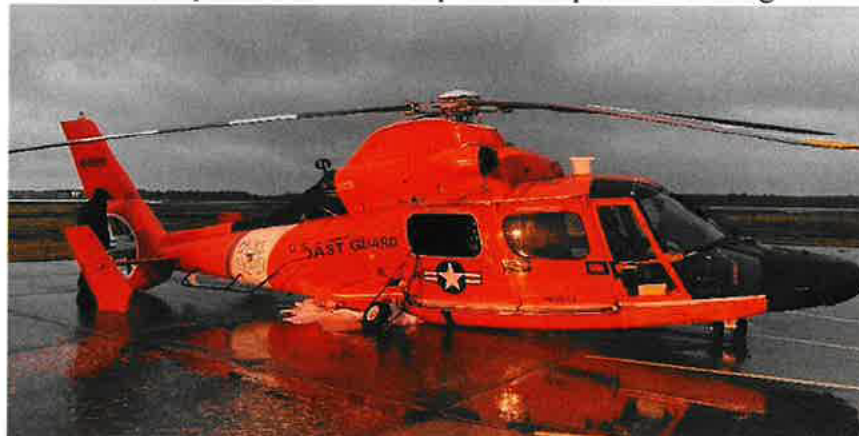
b. Accident Summary: On 11 February 2021, CG-6599 was completing a Magnetic Sensing Unit (MSU)/compass calibration at NAS Oceana. To better align the aircraft on the compass rose, the MLSP and MBA were taking turns proceeding outside the rotor arc and off the nose of the aircraft to confirm the aircraft's positioning. While the MLSP was reentering the aircraft after a planned switch of personnel, the aircraft suddenly became airborne and climbed to approximately 20 feet in the air. The aircraft yawed as the MLSP fell onto the left seat and the MRSP attempted to maintain control of the aircraft. The MBA, who was outside the aircraft when it became airborne, ran under the aircraft and safely off of the compass rose. The MMEP was in the rear of the aircraft working with the maintenance laptop and equipment; the MMEP was not fastened into a seat. After approximately five seconds of being airborne, the MRSP descended the aircraft to the pavement. The first point of impact was the Right Main Landing

Gear. The aircraft continued to rotate to the right after impact. Once all motion stopped, the Emergency Shutdown Procedures were performed and the remaining crew evacuated the aircraft. Naval crash crew personnel arrived on scene within a few minutes. (Exhibits 1, 2, 3, 4, 5, 6)
