Naval Facilities Engineering Systems Command Washington Washington, D.C.

Comprehensive Fourth Five-Year Review Report

Former Naval Surface Warfare Center White Oak Silver Spring, Maryland

June 2022

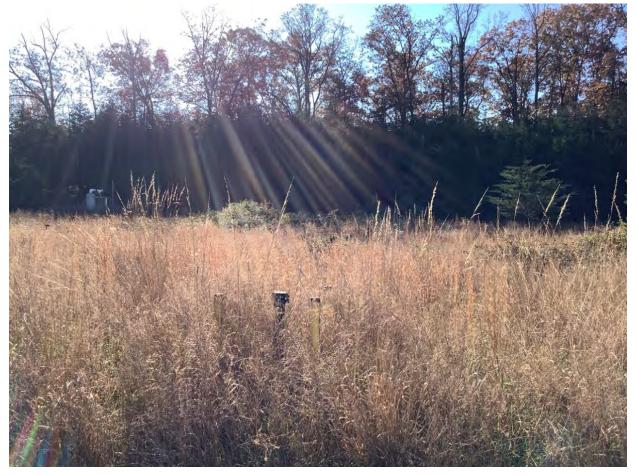
Looking southeast to the Source Area at Site 4.

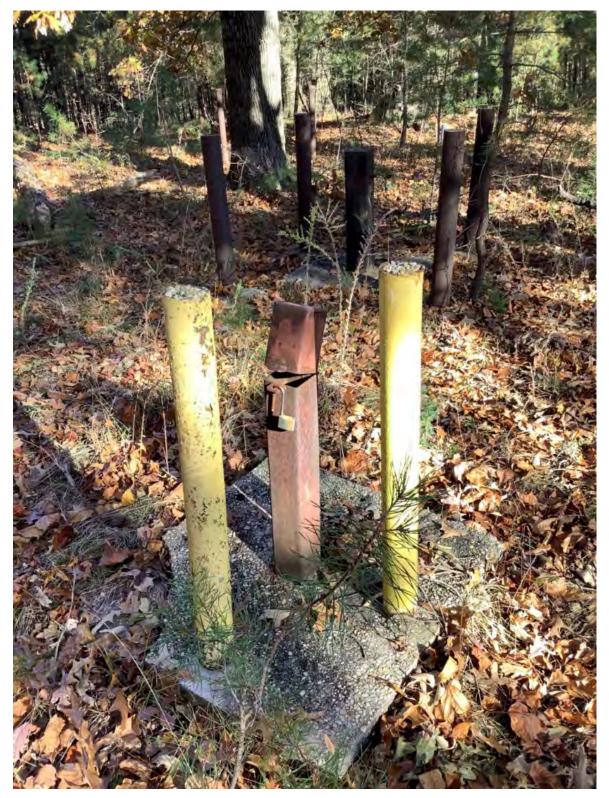
Open well lid at 04GW50 looking north. Well lid will not close. J-plug present.

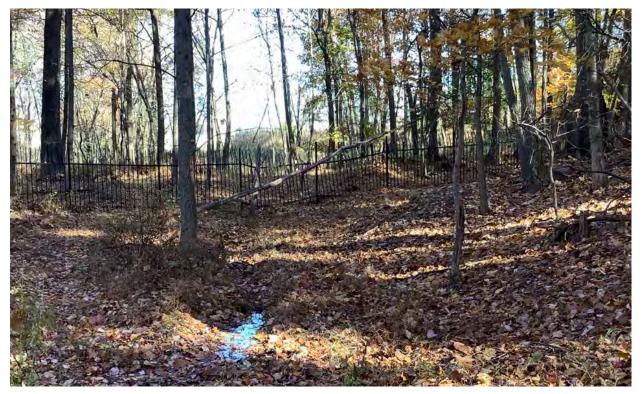
Damaged perimeter fence at Site 13 looking northeast.

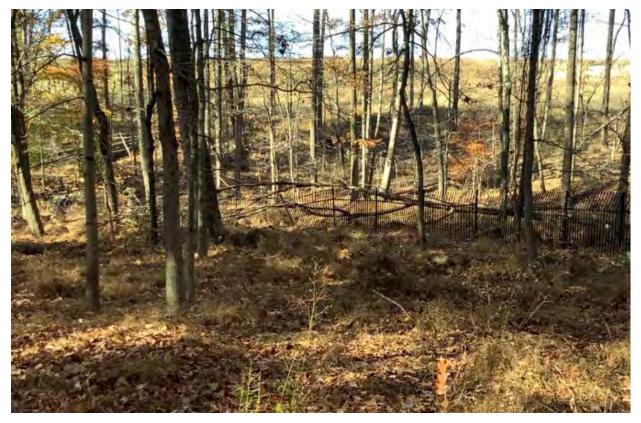
Fallen trees on perimeter fence at Site 13 looking northwest.

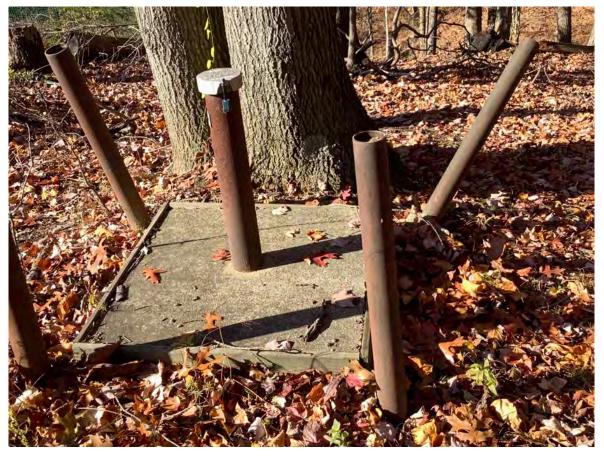
Broken bollard at 13GW202 looking west.

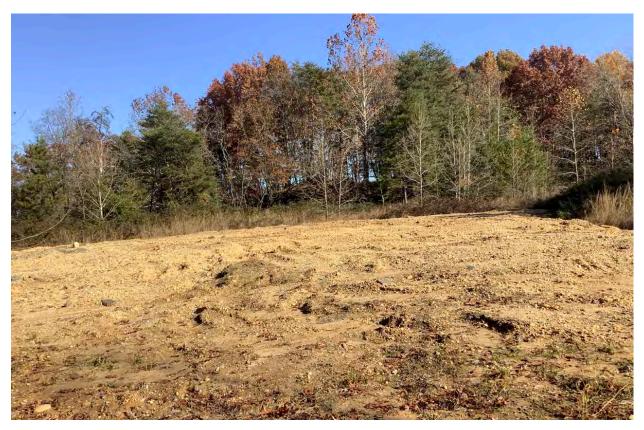
Recently disturbed soil in field to the south of Site 13 looking northeast.

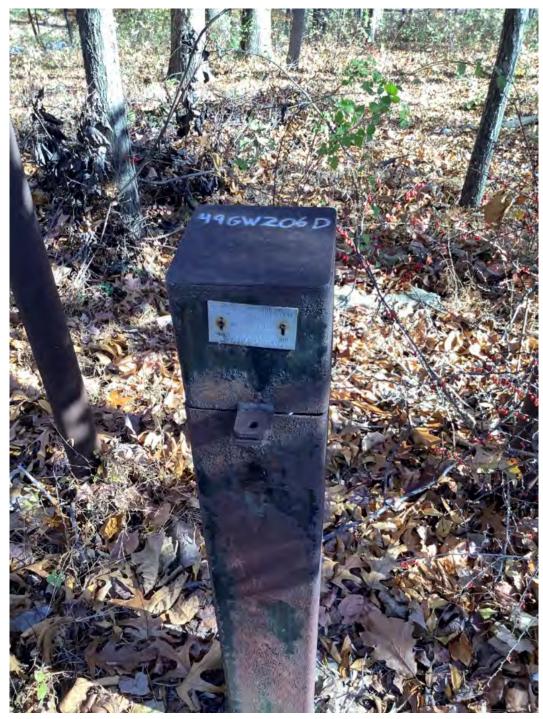
Missing well lock on 49GW206D.

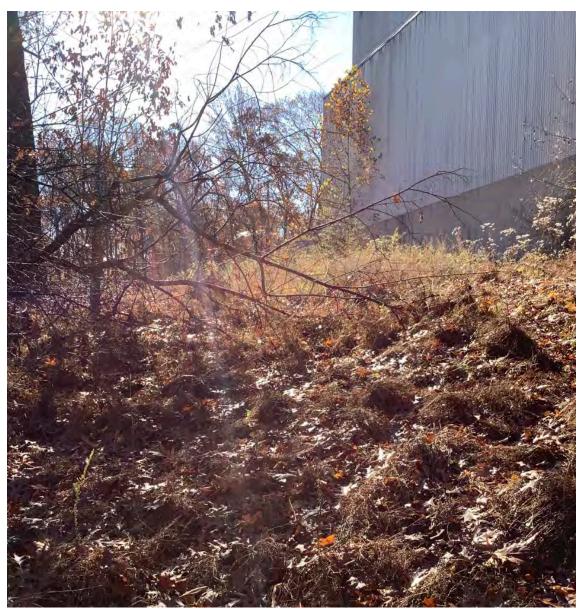
Western side of Site 49 looking south toward 49GW207S & D and 49GW208S & D.

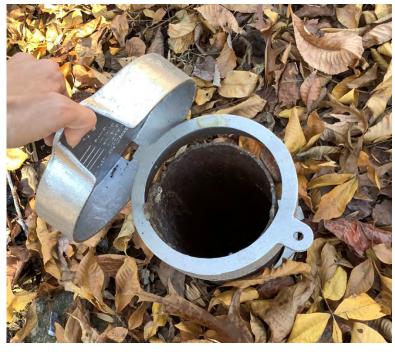
Missing well lock and J-plug on well along former perimeter road at Site 49.

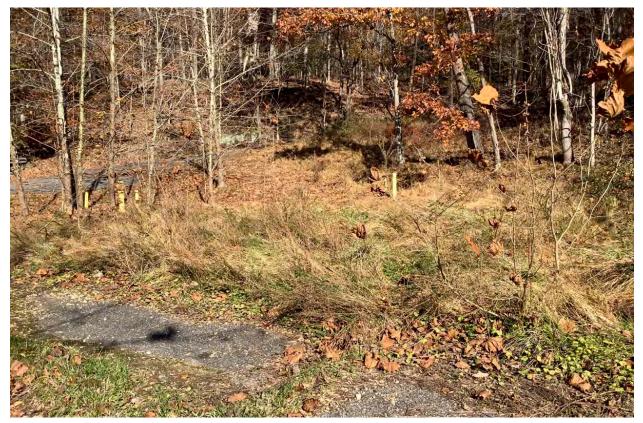
Looking north at SWMU 87.

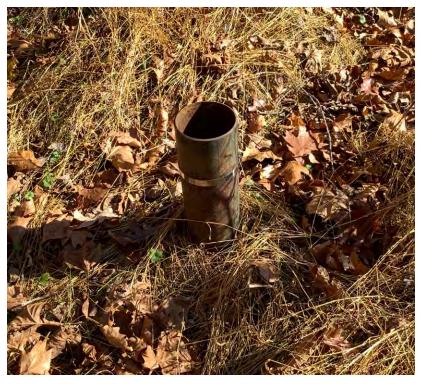
Missing J-plug on injection well at SWMU 87.

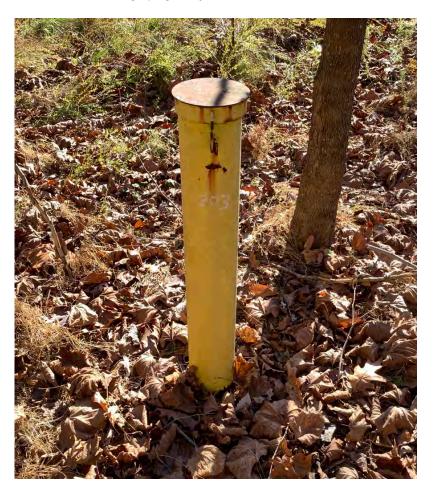
No well locks on wells at SWMU 87.
