**Final Five-Year Review  
For  
Bay Head Road Annex  
IR Program Site 1**

**Former Naval Surface Warfare Center  
Carderock Division  
Annapolis Detachment  
Annapolis, Maryland**

JM Waller Associates  
December 2004

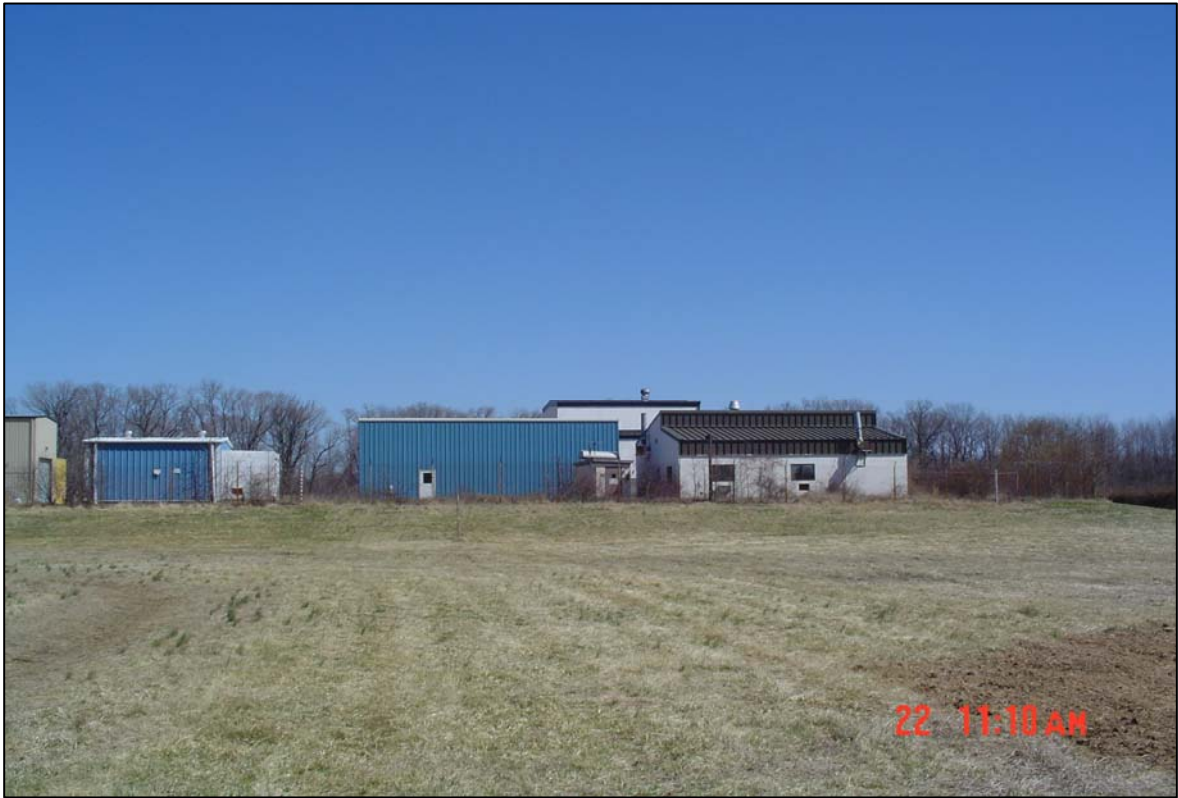
Photo 1: View of Nike missile facilities from former ball field.

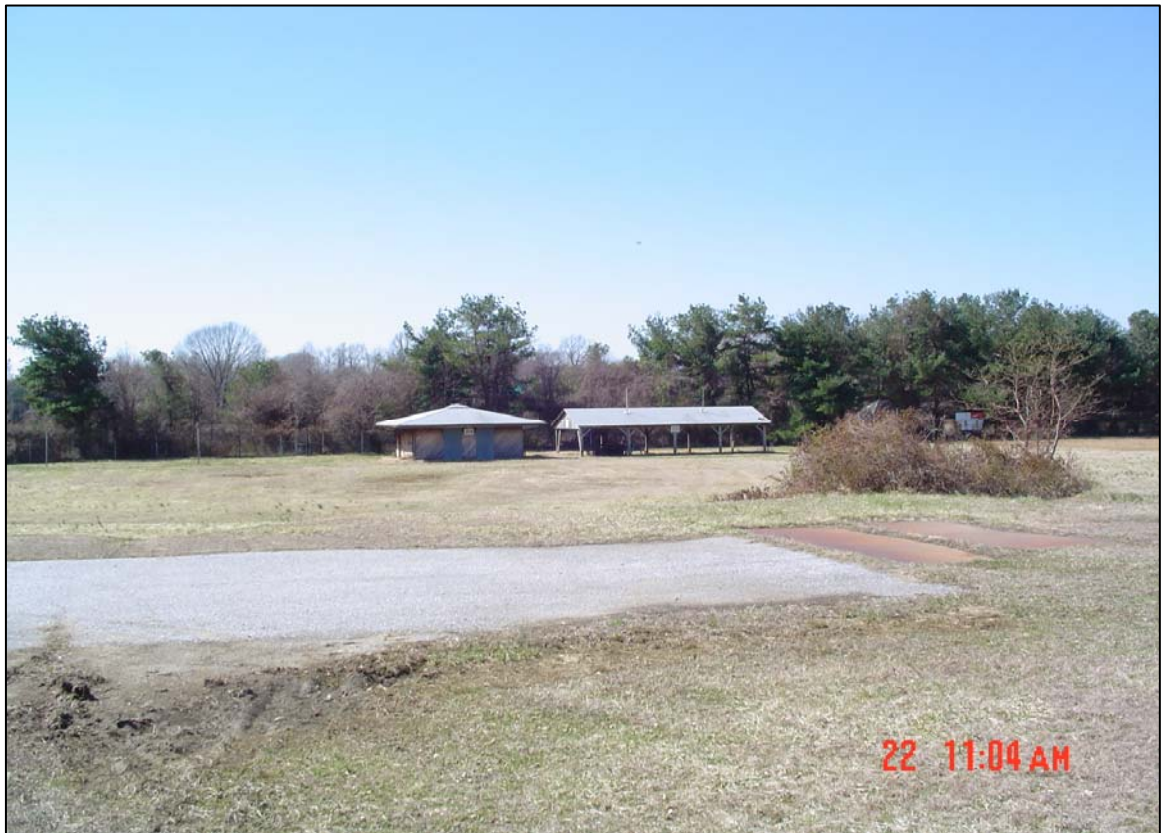
Photo 2: View of former ball fields and picnic area and facility.

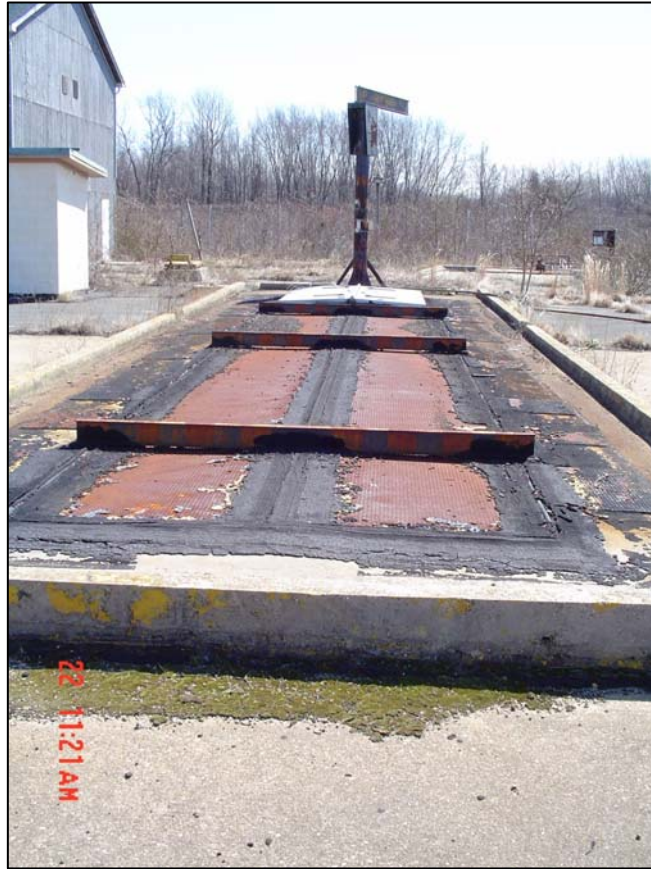
1) There is an opening in the southern fence line that appears to have been used for human entrance and exit onto the property. 2) One of the missile magazine hatches over one of the Nike missile underground storage areas was open and was not secured behind a fence on the property. This is a physical hazard to anyone who is already on the property; this would include those who use the children's theater on the property. 3) A portion of the fence surrounding the former launch area is missing thereby allowing easy access to those who use the children's theater on the property. The interviews have revealed that the community in general is frustrated with the lack of progress for reuse of this property: both for the deteriorating status of the property (i.e. the baseball fields) and the community's needs for more field and recreational property.

Remarks ONE OF THE ENTRY / MAN-HOLE COVERS INTO A NIKE MISSILE UNDER-GROUND AREA WAS OPEN. THERE IS NO FENCING PROTECTING THIS AREA FROM THE CHILDRENS THREATEN. THIS IS A PHYSICAL HAZARD. CLOSE THE ENTRY ON FENCE THE AREA TO LIMIT ACCESS.

Photo 3: Cover of former underground Nike missile magazine elevator.

These safety/access issues have been reported by the Navy to Anne Arundel County with a recommendation that the issues be corrected.

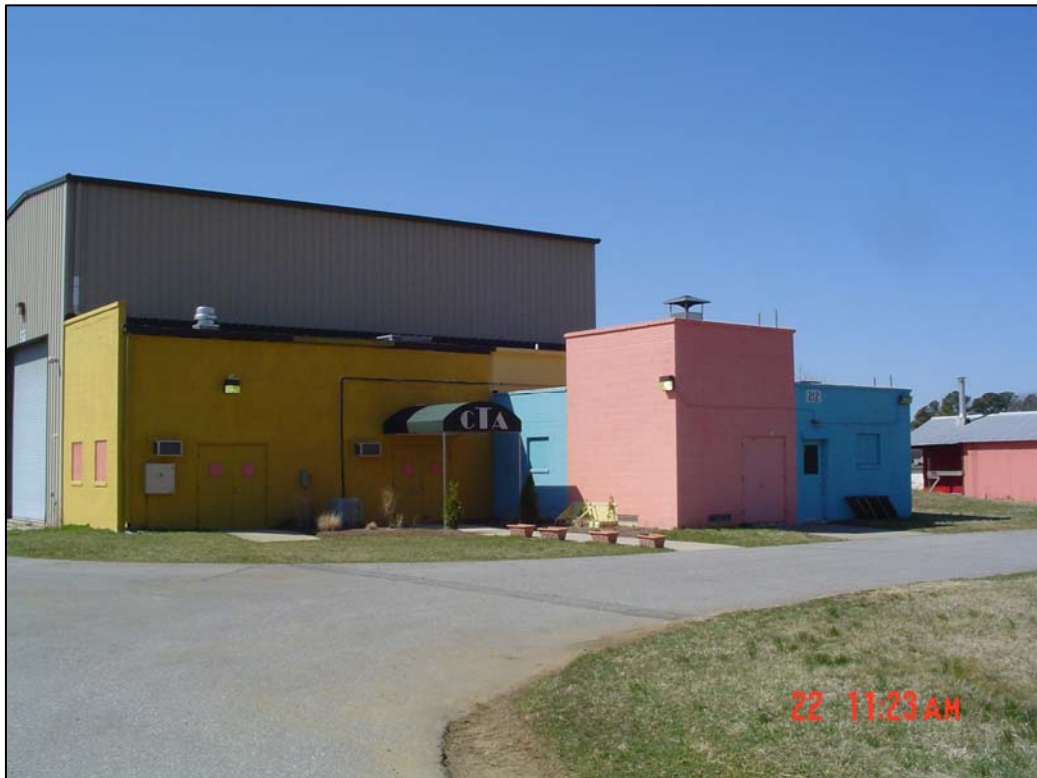
Photo 4: Children's Theater on the Bay Head Road Annex property.

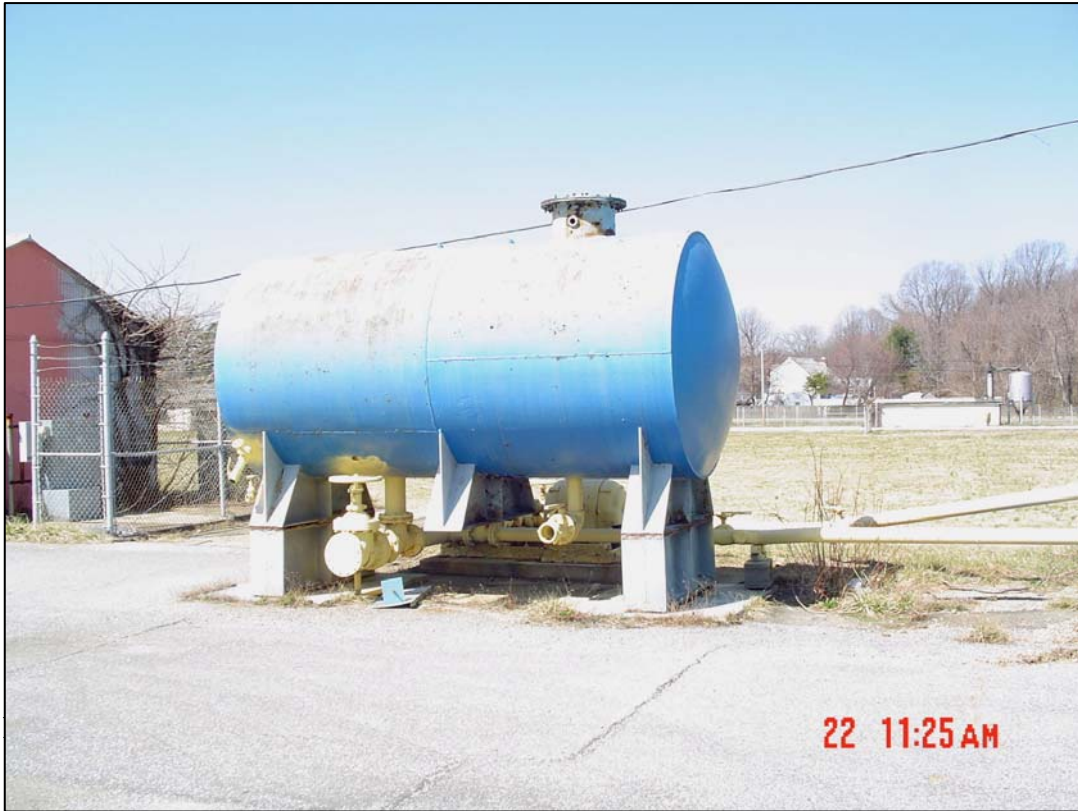
Photo 5: Aboveground Water Storage tank on property, which is empty and disconnected.
