MEMORANDUM

FINAL ACTION OF MAJOR INCIDENT INVESTIGATION REPORT INTO THE CIRCUMSTANCES SURROUNDING THE CGC WINSLOW GRIESSER COLLISION ON 08 AUGUST 2022 NEAR PUERTO RICO

Subj: POST-INVESTIGATION MEMORANDUM – MAJOR INCIDENT
INVESTIGATION (MII) INTO THE CIRCUMSTANCES SURROUNDING CGC
WINSLOW GRESSIER COLLISION ON 8 AUGUST 2022 NEAR PUERTO RICO

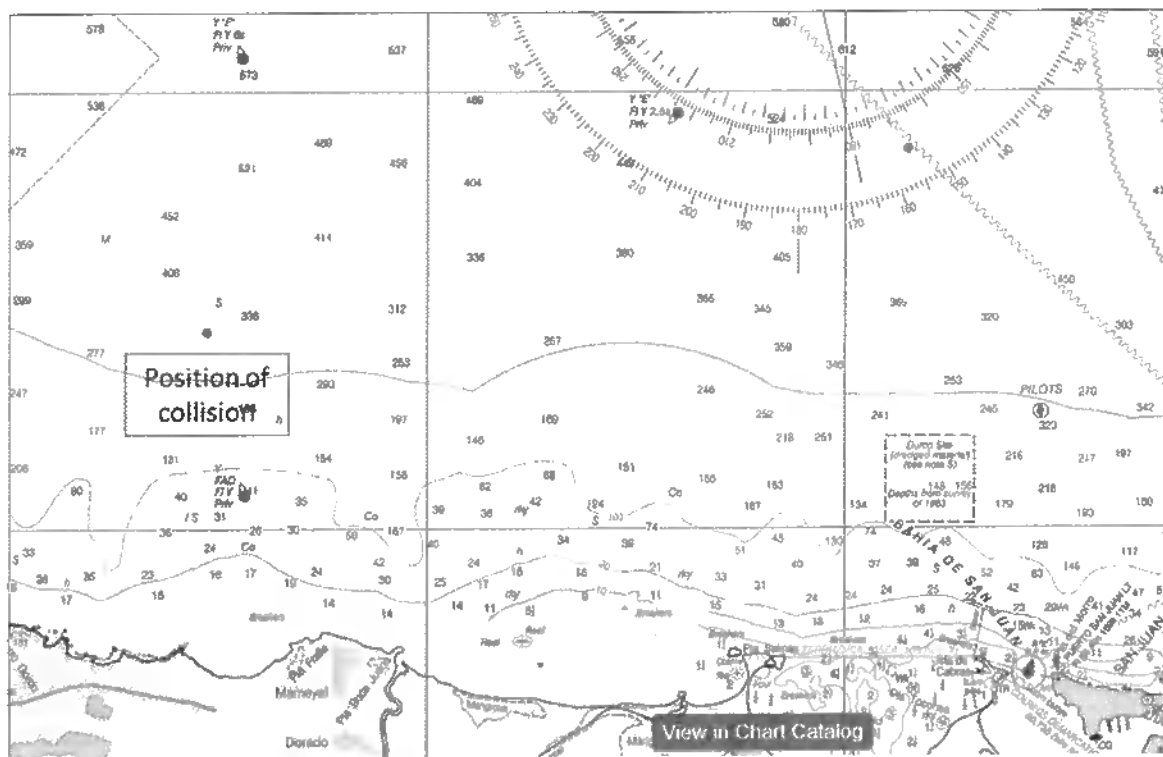
At 1411, the WG collided with the C/C, approximately four nautical miles north of Dorado, Puerto Rico. The WG recovered two people from the water—the C/C Operator had minor

Figure 1: MII estimated position of collision.

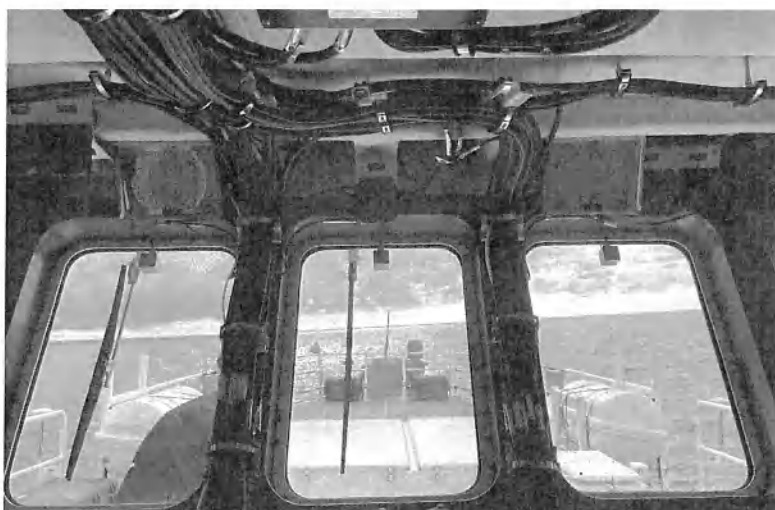
- e. Vessel Systems:
- a. The FRC Bridge windows are separated by frames approximately 4.5 inches wide. The engineering staff at Coast Guard Headquarters FRC program office produced an analysis of the potential blind spots created by the window frames for a person conning the ship from the helm position. The resultant diagram shows a 10-degree blind spot from 345°R to 355°R to the bow of the ship. (Exhibit 24)

Figure 2: View from FRC center conning position

to the bow. In this mishap, the Relative Motion position of the Center Console remained at 350°R to the bow of the FRC, creating a condition where the OOD, when remaining at the center conning station, would not see the C/C even in benign conditions. (Facts: 5.c.xvii, 5.e.a; Figures 2, 3)

1. Without the testimony of the OOD, CO, or QMOW, I cannot factually conclude whether or not the WG maintained a proper lookout.
- iii. It is my opinion that the position of the OOD at the center helm position and the design of the WG's bridge windows caused a blind spot that hindered view of the C/C. (Fact: 5.e.a)
