U.S. Department of Defense

NOVEMBER 8, 2024

(U) Evaluation of the Operation, Maintenance, Safety, and Oversight of the Navy's Red Hill Bulk Fuel Storage Facility

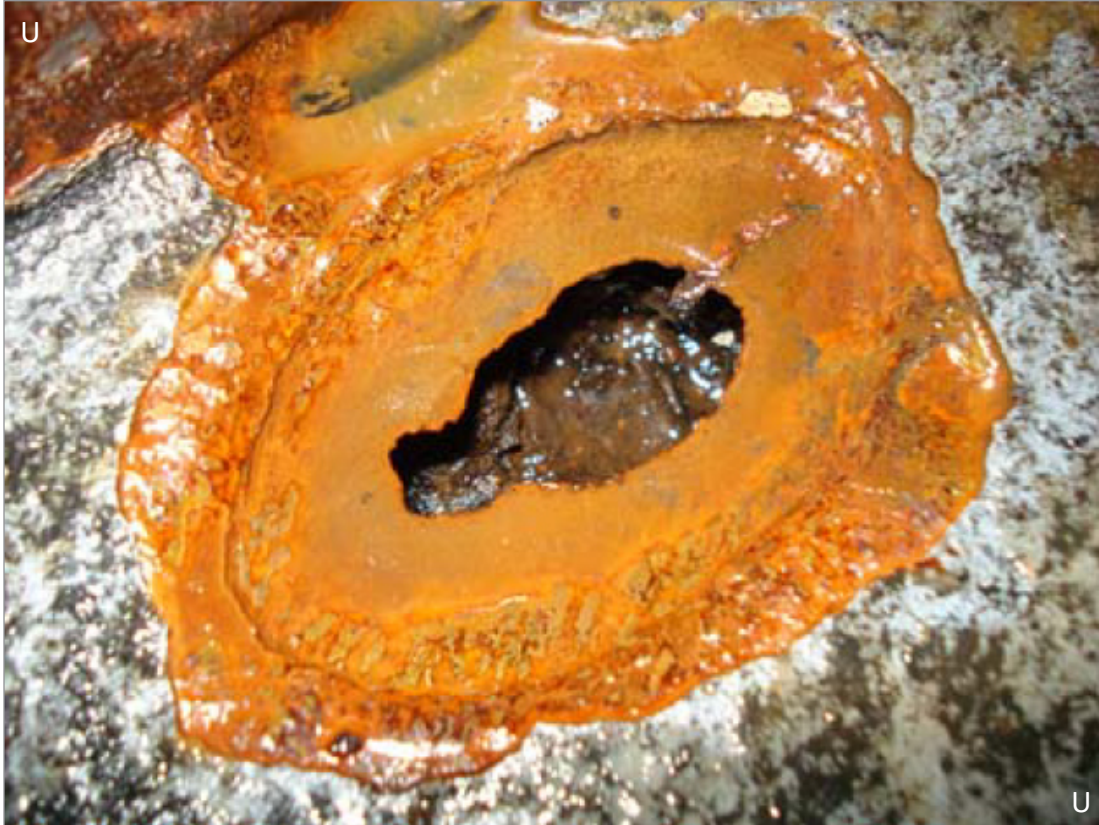
(U) Figure 9. Hole in Upper Tank Farm AST #48 at Naval Station Pearl Harbor
(U) Source: NAVSUP.

(U) Navy officials estimated approximately 359,000 gallons of fuel leaked into the ground through a hole in a tank.

Navy officials estimated that 359,000 gallons of F-76 fuel leaked into the ground beneath the tank, and Navy officials began remediation efforts in May 2007. According to the Navy, Navy officials conducted significant work to remediate the leak, including using 87 groundwater monitoring wells,

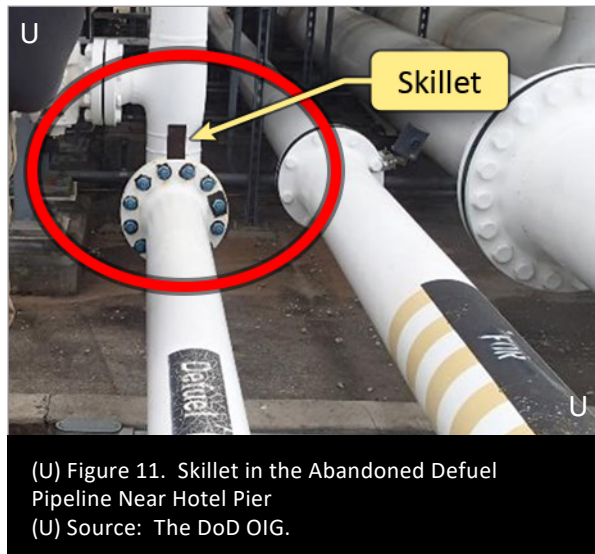
(U) Figure 11. Skillet in the Abandoned Defuel Pipeline Near Hotel Pier
 (U) Source: The DoD OIG.

(U) According to a DoD report, on January 20, 2021, the abandoned defuel pipeline failed a leak detection test.⁶⁷ Subsequently, according to Navy officials, the NAVSUP FLC PH Fuels Deputy Director directed the addition of “skillets” to the abandoned defuel pipeline to seal another portion of the pipeline and prevent the possibility of failing another leak detection test.⁶⁸ However, according to the DoD report, on January 23, 2021, the abandoned defuel pipeline failed a second leak detection test, despite the addition of skillets. On February 2, 2021, an oil release investigation and cleanup company contracted

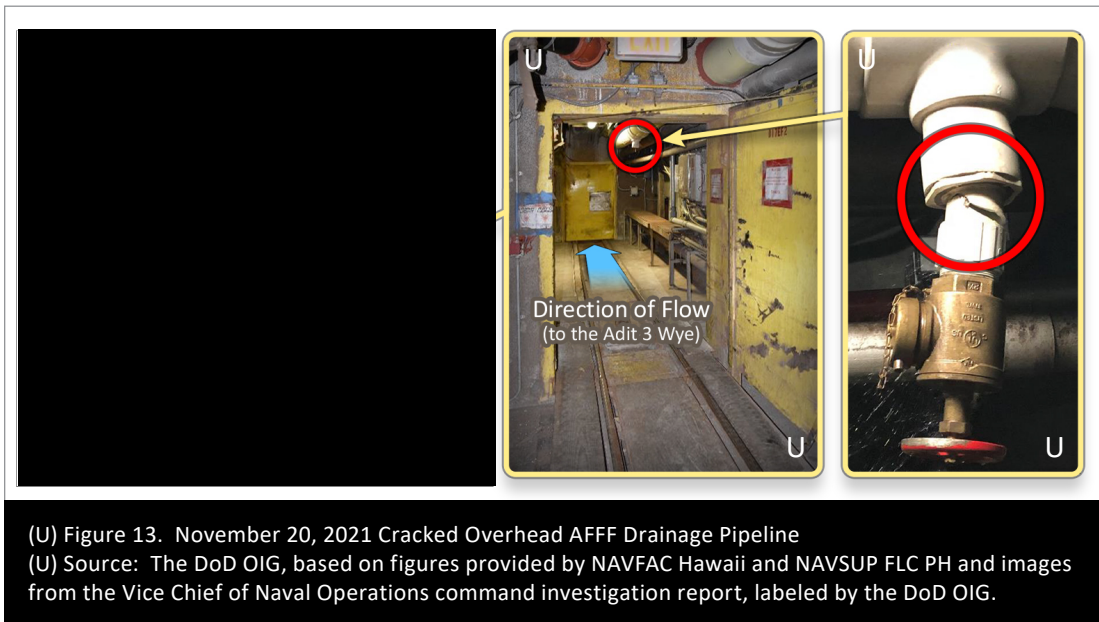
(U) On November 20, 2021, at 4:50 p.m., a battery-powered locomotive and cart in the Red Hill BFSF LAT, driven by a NAVSUP FLC PH Red Hill rover, struck a valve on a low-point drain in the overhead AFFF drainage pipeline.⁷⁸ The overhead AFFF drainage pipeline cracked, and a strong flow of fuel began to be released.⁷⁹ Figure 13 shows the location of the incident, the overhead AFFF drainage pipeline, and the crack in the PVC from where the fuel flowed.

(U) Note: At the time of the incident, the second fire door in the image in the center was open. Although the NAVSUP FLC PH employee driving the battery-powered locomotive and cart closed the door, fuel continued to flow under the door. Through this fire door is the Adit 3 Wye, as shown in Figure 14.
