INSPECTOR GENERAL

(U) Evaluation of DoD Actions Related to the Red Hill Bulk Fuel Storage Facility's Contamination of the Joint Base Pearl Harbor-Hickam Community Water System

(U) November 8, 2024

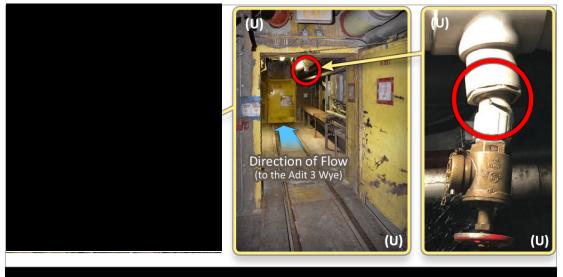
(U) Figure 8. November 20, 2021 Cracked Overhead AFFF Drainage Pipeline
 (U) Source: The DoD OIG, based on figures provided by NAVFAC Hawaii and NAVSUP FLC PH and images from the Vice Chief of Naval Operations command investigation report, labeled by the DoD OIG.

(CUI) On November 20, 2021, at 4:50 p.m., the battery-powered locomotive and cart in the Red Hill BFSF LAT, driven by a NAVSUP FLC PH employee, struck a valve on a low-point drain in the overhead AFFF drainage pipeline.⁴⁸ The overhead AFFF drainage pipeline cracked, and a strong flow of fuel began to be released.⁴⁹ The fuel poured onto the LAT, **1990**, and began collecting in

water development tunnel located below the LAT, and contaminated the Red Hill well.⁵¹ Figure 8 shows the overhead AFFF drainage pipeline and the crack in the pipeline from where the fuel flowed.

(U) Note: At the time of the incident, the second fire door in the image in the center was open. Although the NAVSUP FLC PH employee driving the battery-powered locomotive and cart closed the door, fuel continued to flow under the door. Through this fire door is the Adit 3 Wye, as shown in Figure 3.

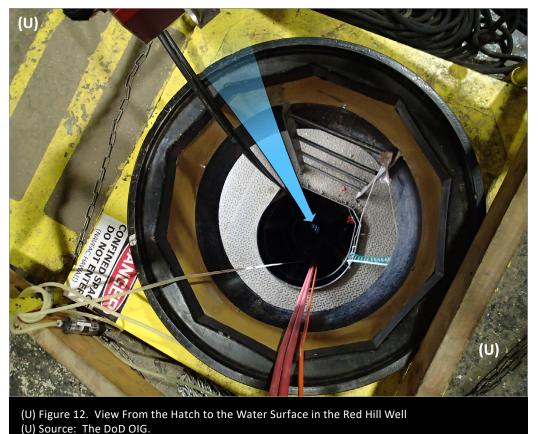
(CUI) Navy officials visited the Red Hill well on November 28, 2021. At the Red Hill well, they opened the hatch that covers the well and looked down to the surface of the groundwater in the water development tunnel. Navy officials did not observe a visible fuel sheen on the water surface. However, the Red Hill well is **a surface for a server of the server of the server of the Red Hill well during our site visits to JBPHH and found that the distance from the hatch to the water surface would have made a visual assessment of the water quality unreliable, as shown in Figure 12.**

(U) Note: The blue arrow points to the water surface.

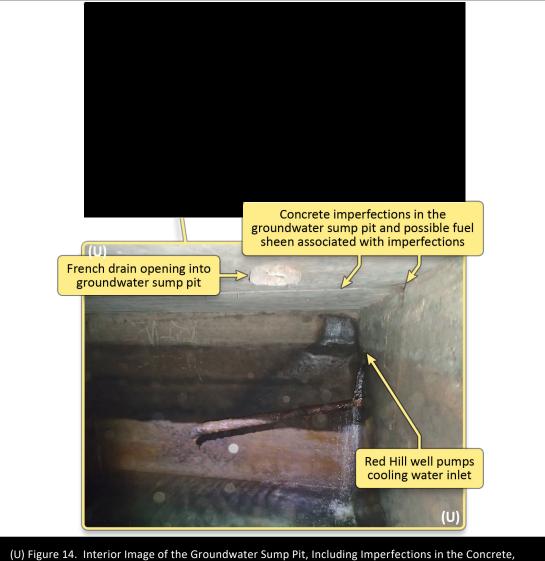
(U) However, Navy officials did not review the engineering drawings until after November 28, 2021, when resident complaints began. During our site visit, we inspected the groundwater sump pit and used handheld cameras to photograph the interior. We found that imperfections in the concrete, the French drain inlet, and the cooling water inlet were readily visible, as shown in Figure 14.
