# Materials Investigation of the Experimental OceanGate Submersible Titan

U.S. Coast Guard Marine Board of Investigation  
September 25, 2024

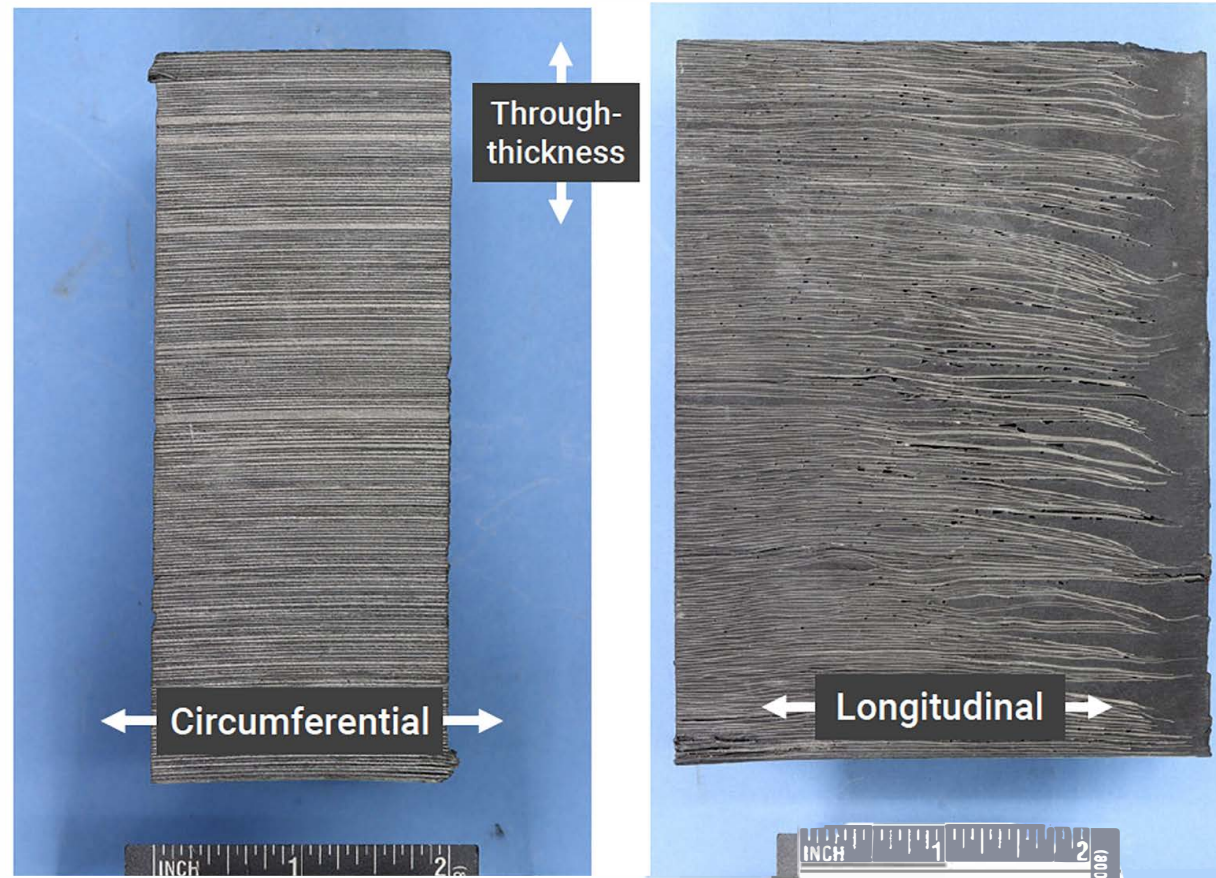
**Titan V1 trimmed end piece**

# V1 Hull Mid-thickness Delamination

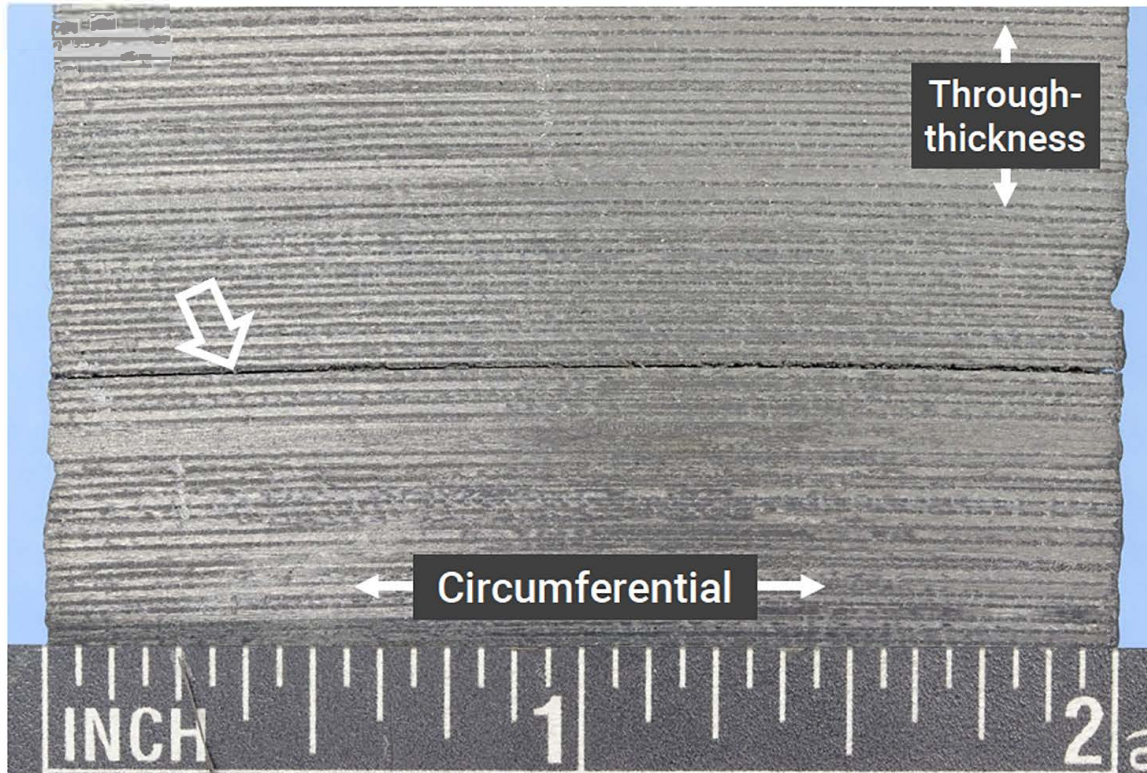
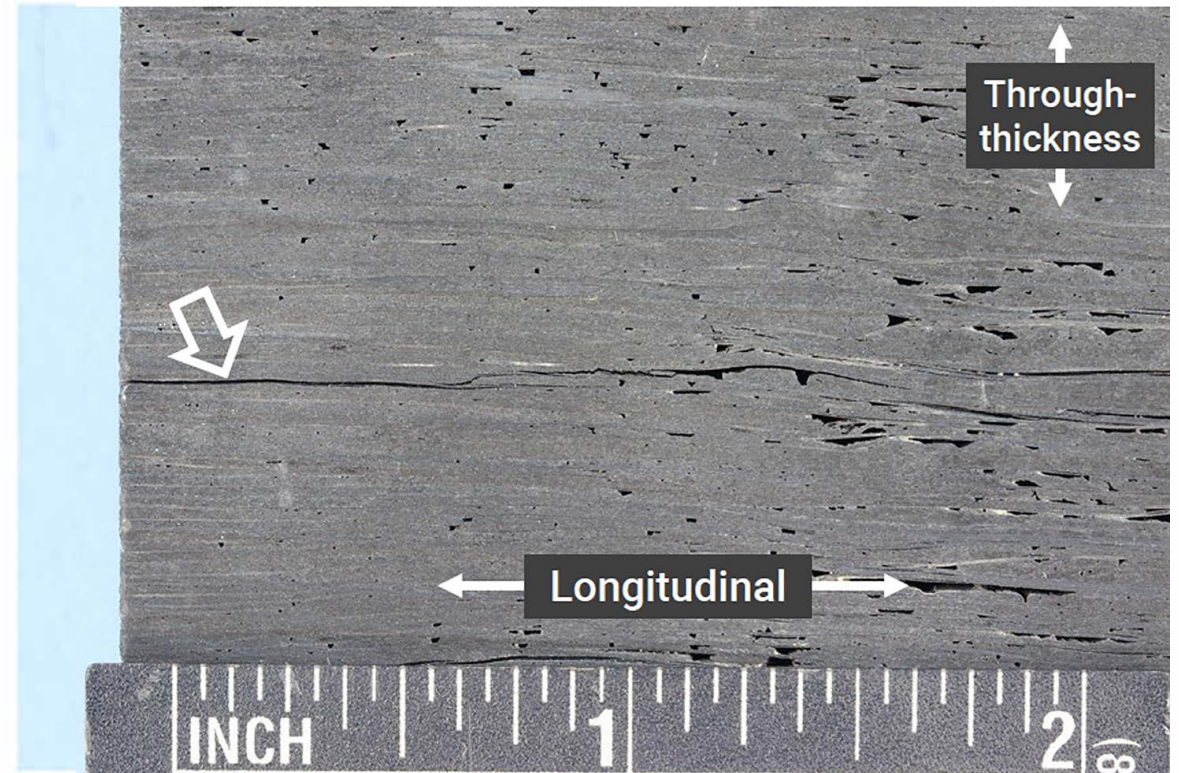
CG 107 **Titan V1 trimmed end piece**

# Mid-thickness Delamination

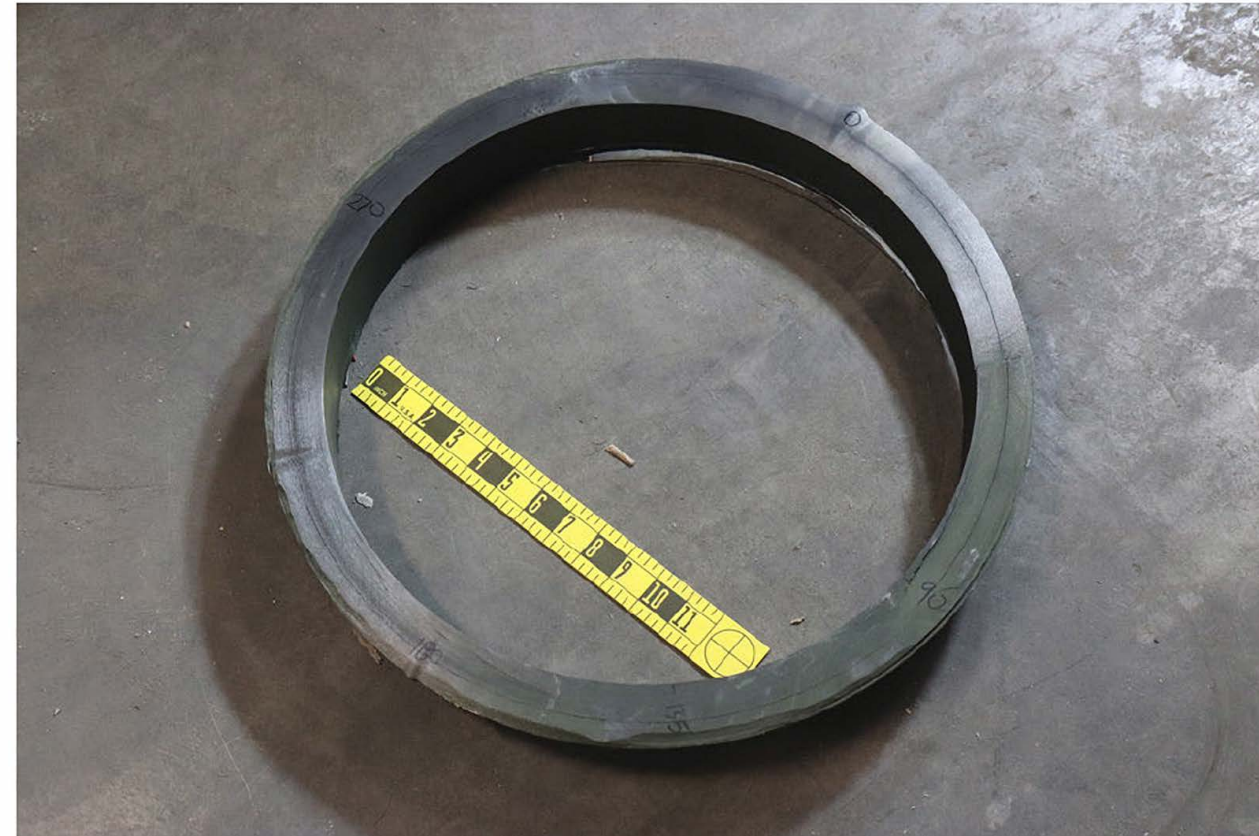
**First test article - trimmed end**

Wrinkles.

Mid-thickness delaminations.

Imploded or on verge of imploding at or below 2,800 m.

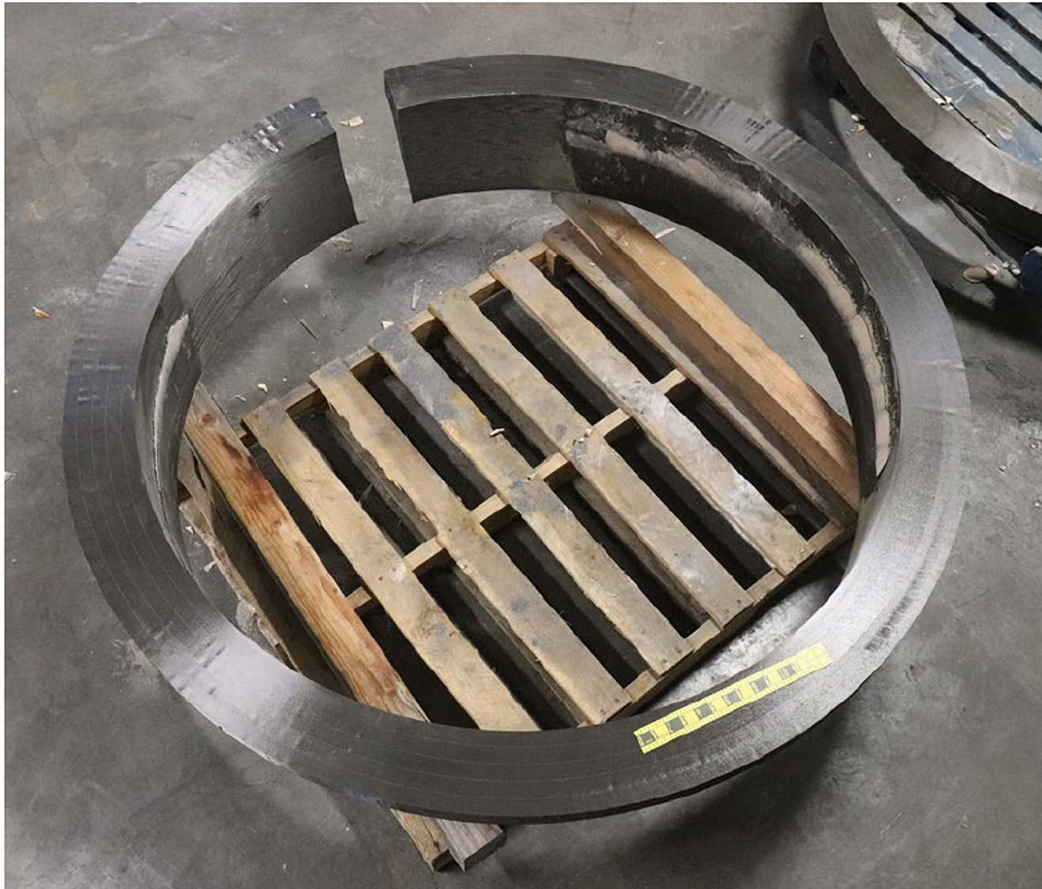
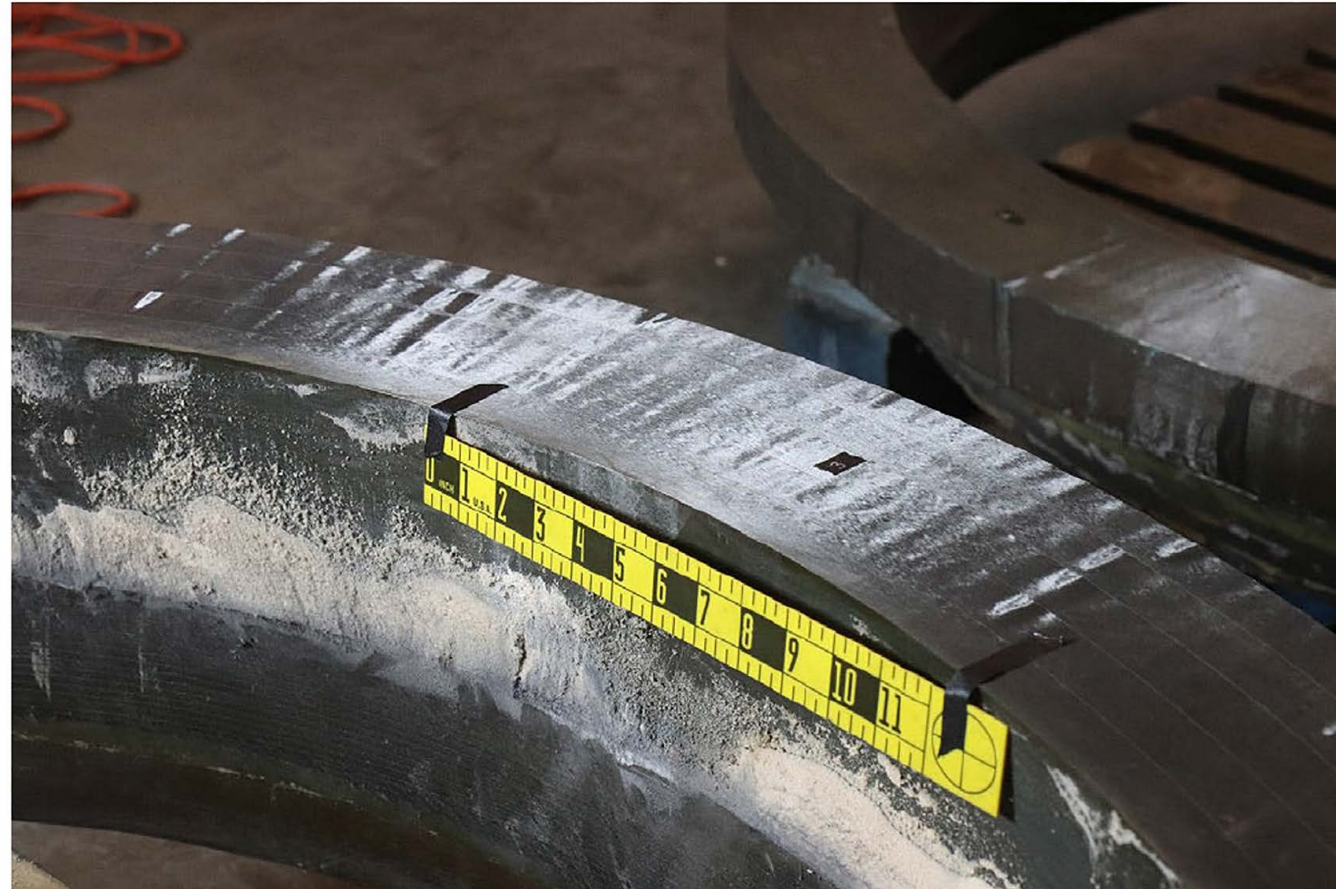
# Titan V2 Hull Trimmed End– Waviness and Wrinkles

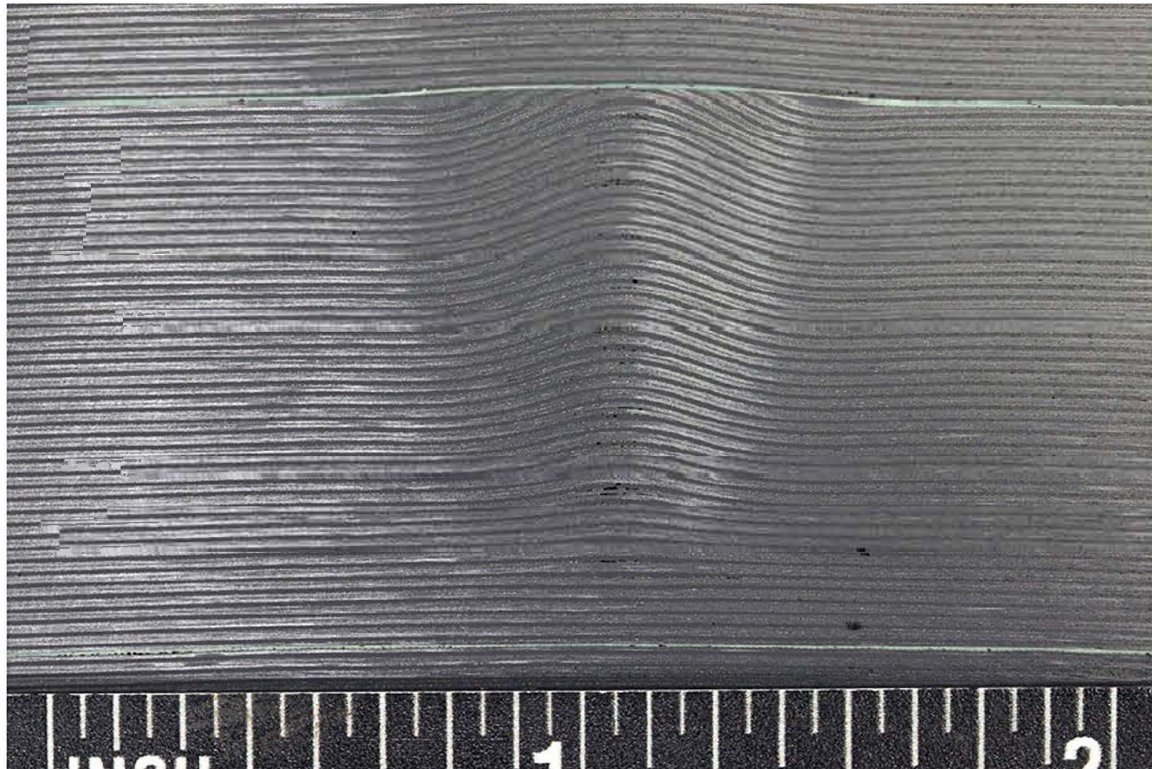
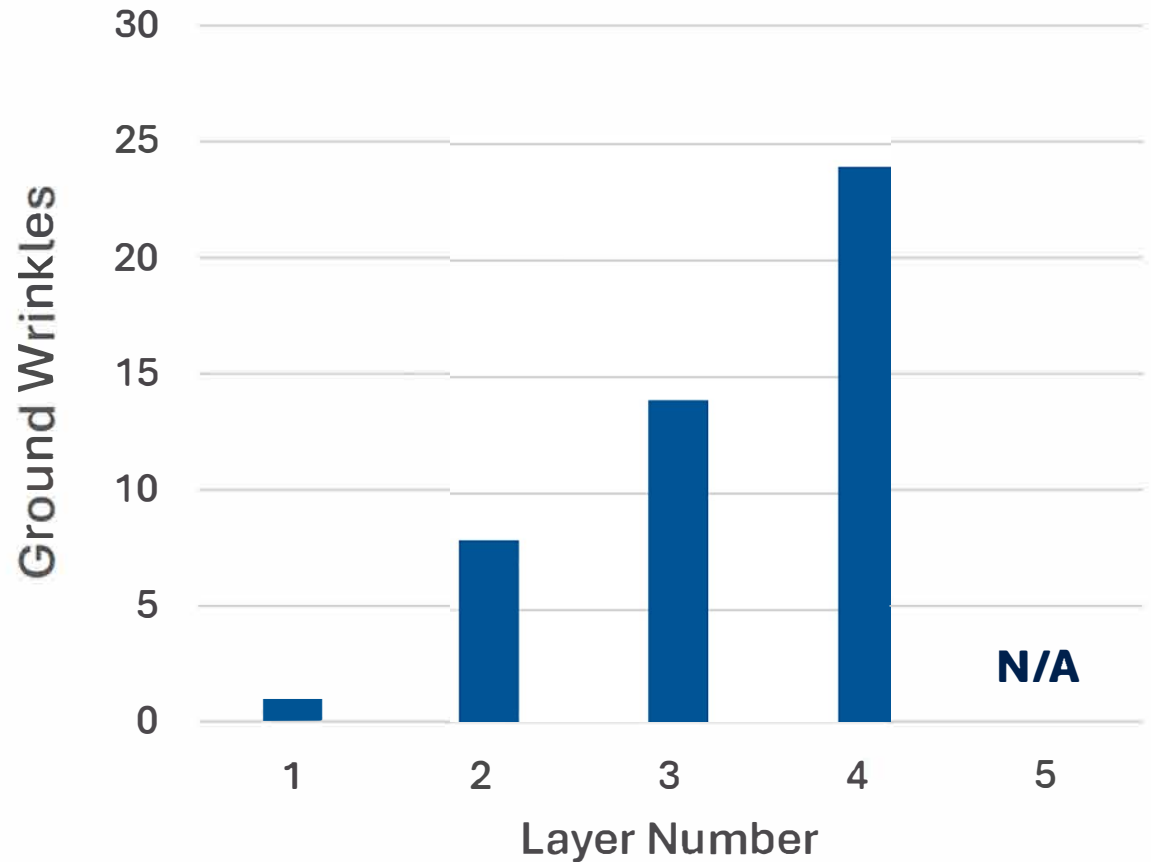
# Titan V2 Hull Trimmed End – Wrinkles

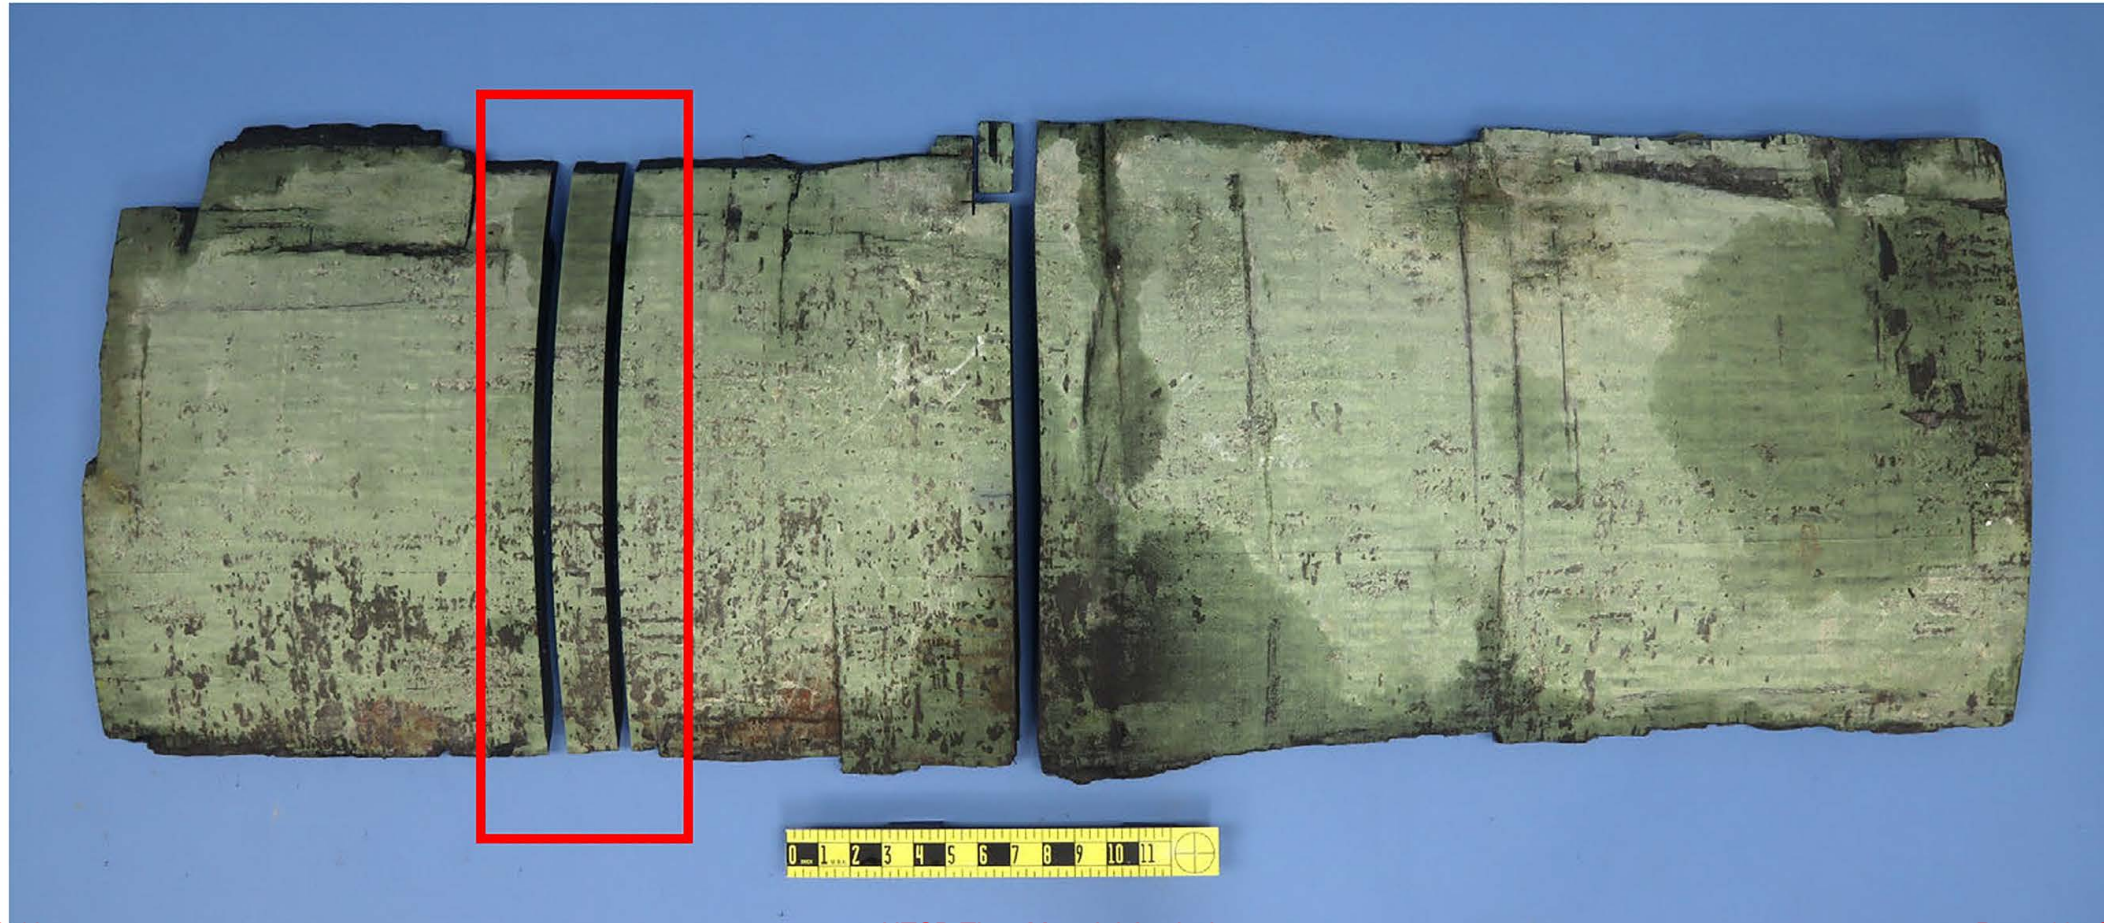
# Titan V2 Hull – Porosity

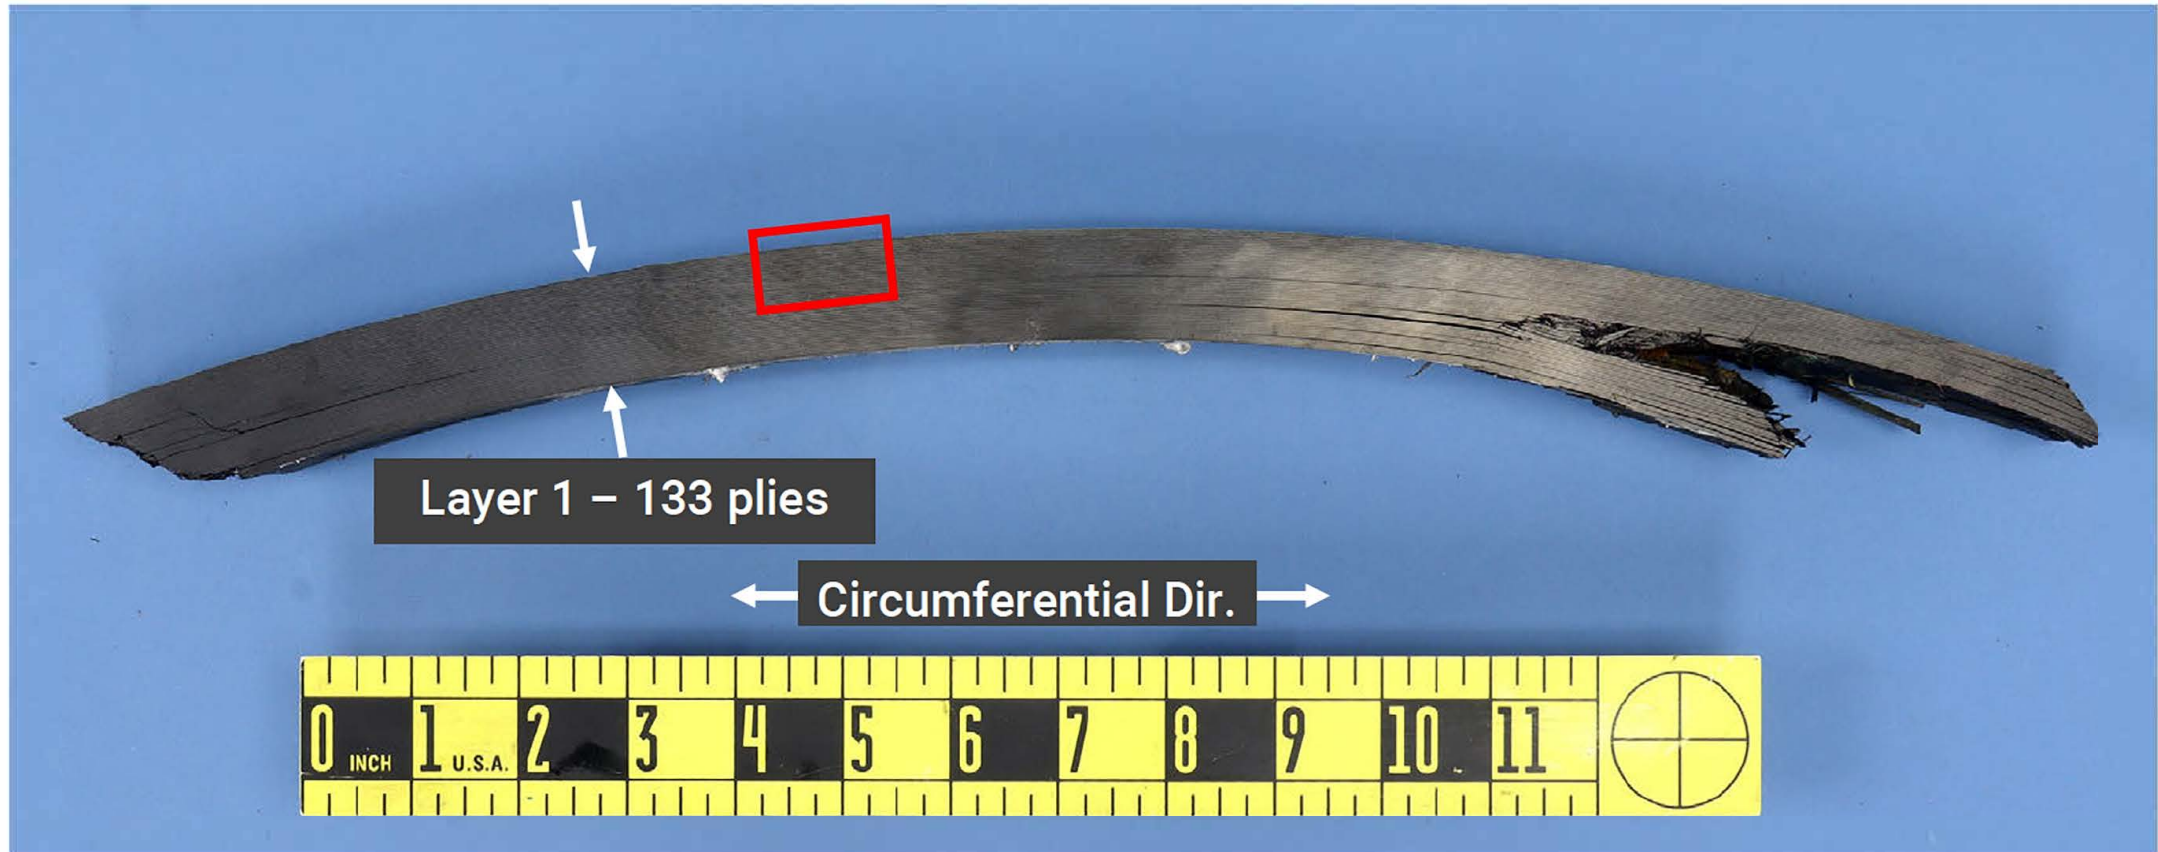
# Titan V2 Hull – Porosity

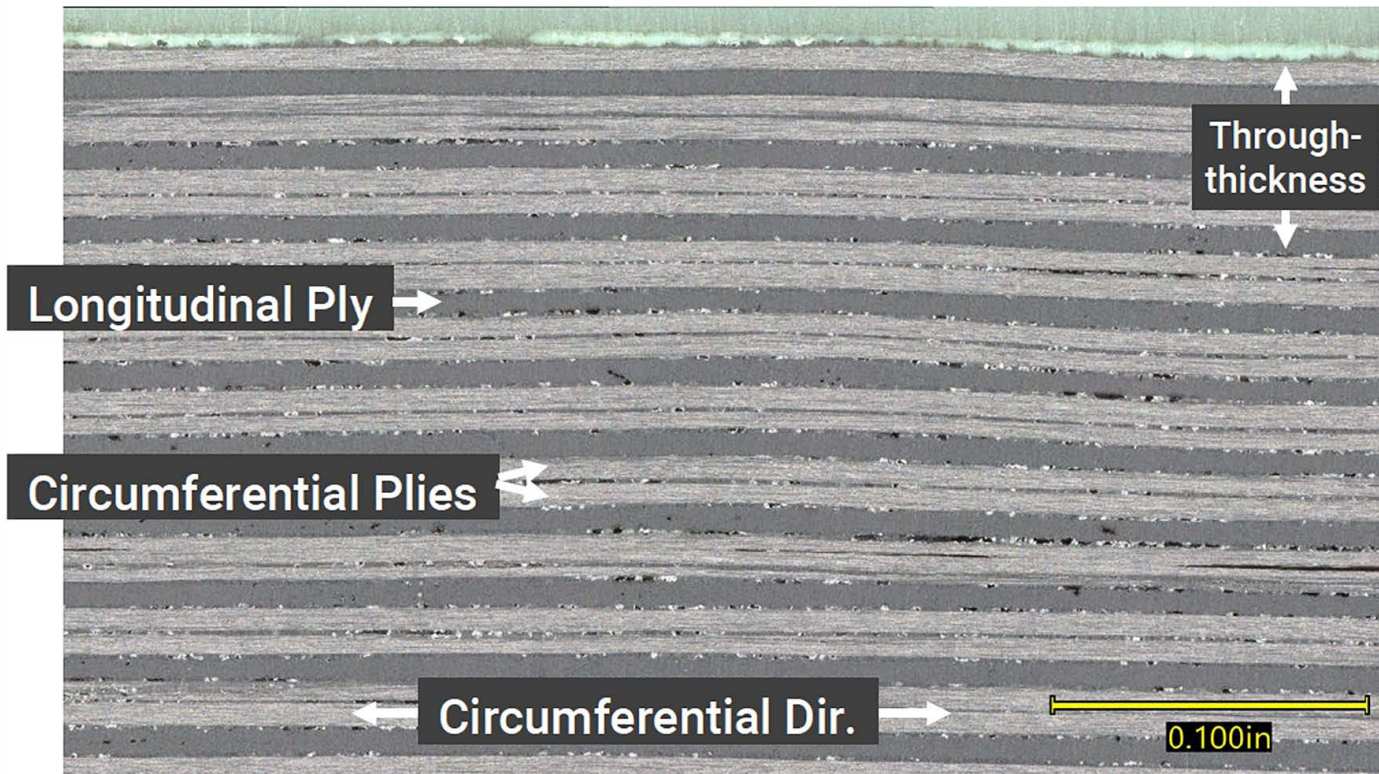
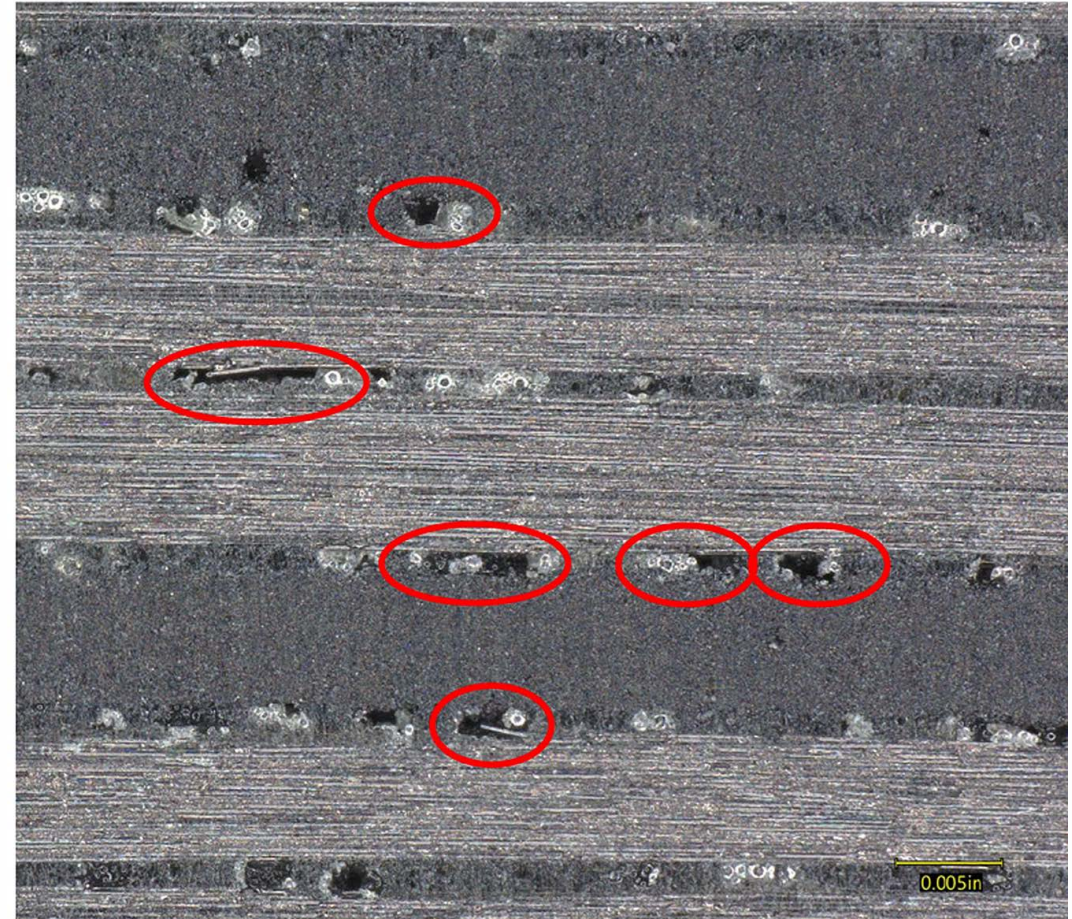
Cross-section through layer 1

# Titan V2 Hull – Porosity

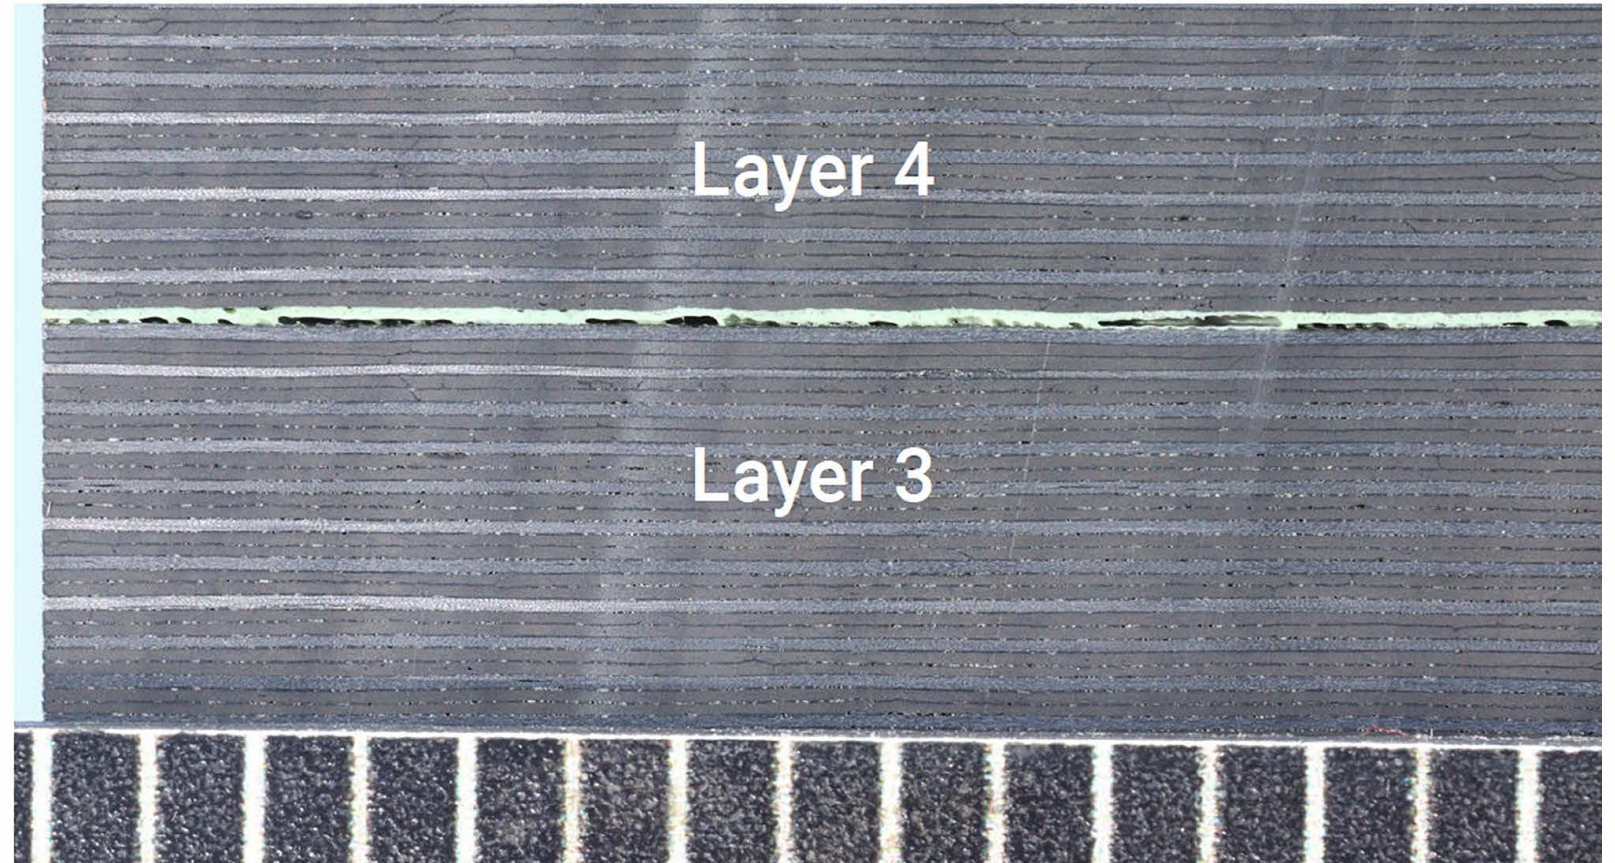
**Longitudinal cross-section**

Elongated void structures in adhesive.

Between layers 1 and 2.

Between layers 3 and 4.

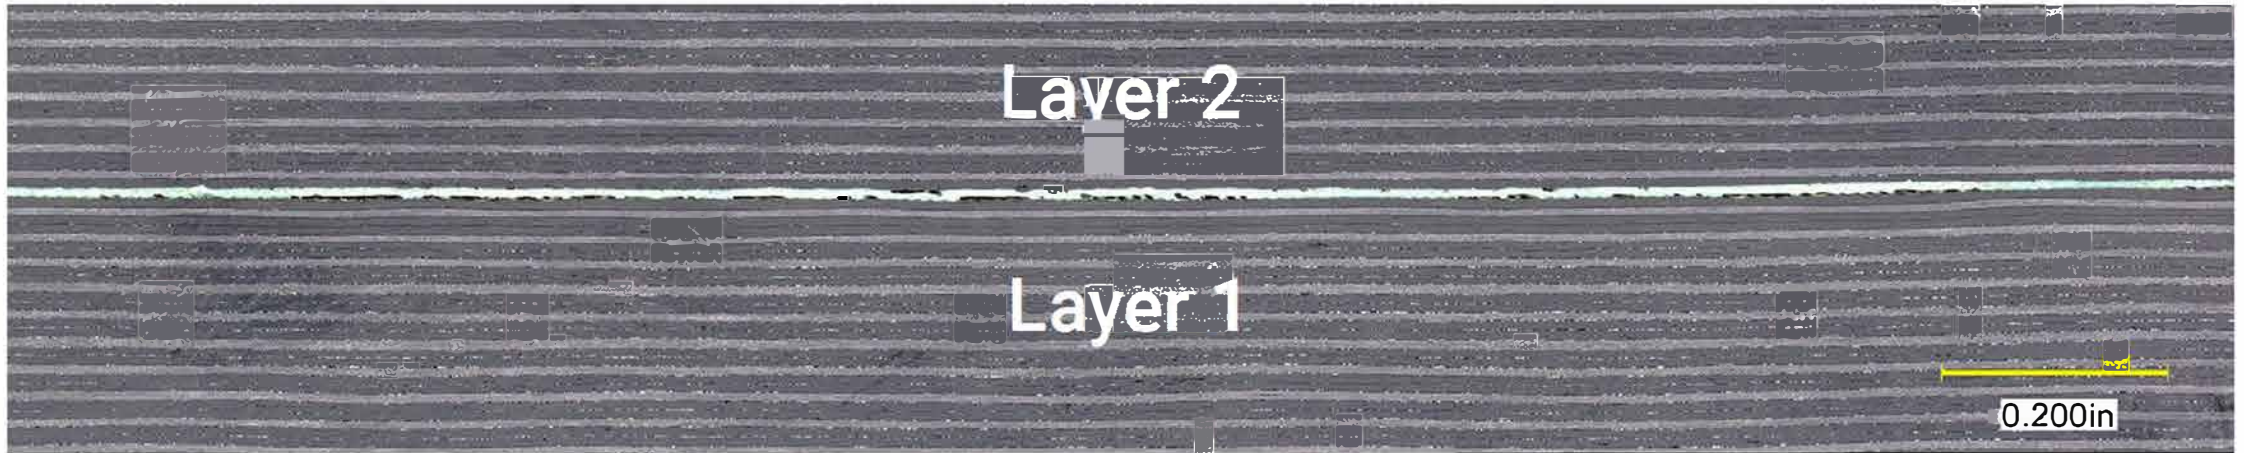
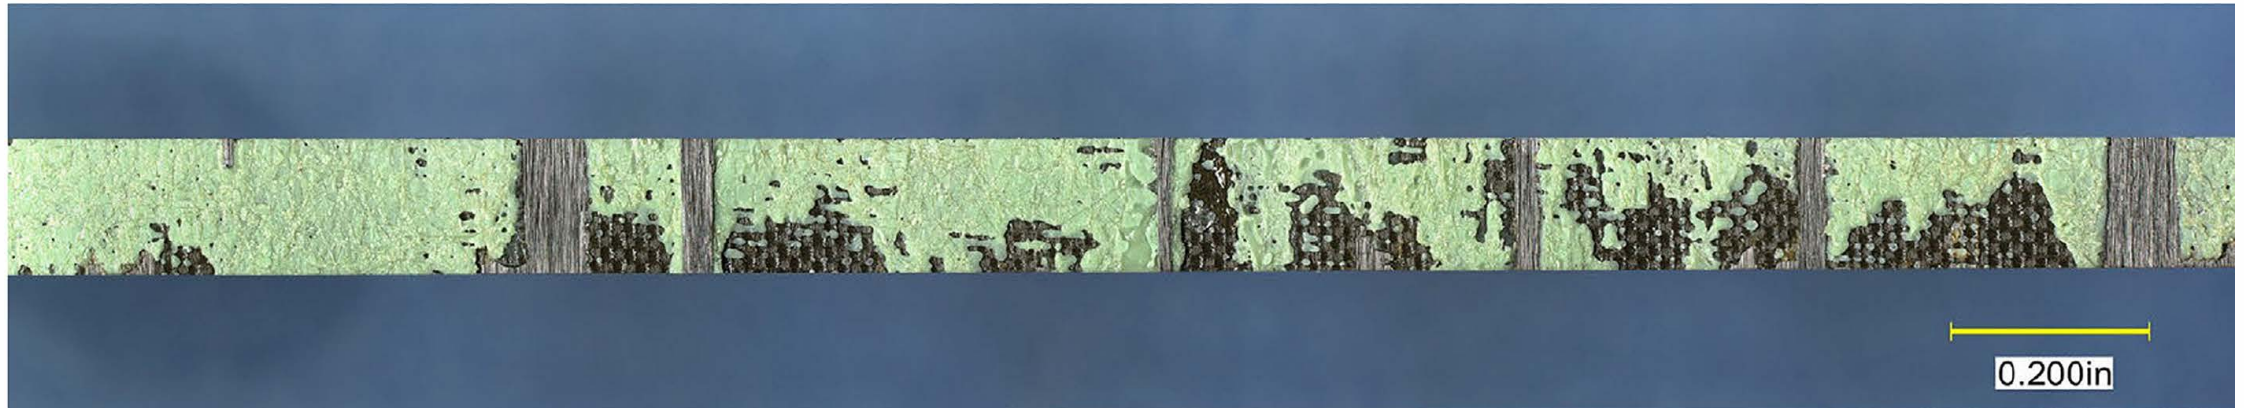
# Titan V2 Hull – Voids in Adhesive

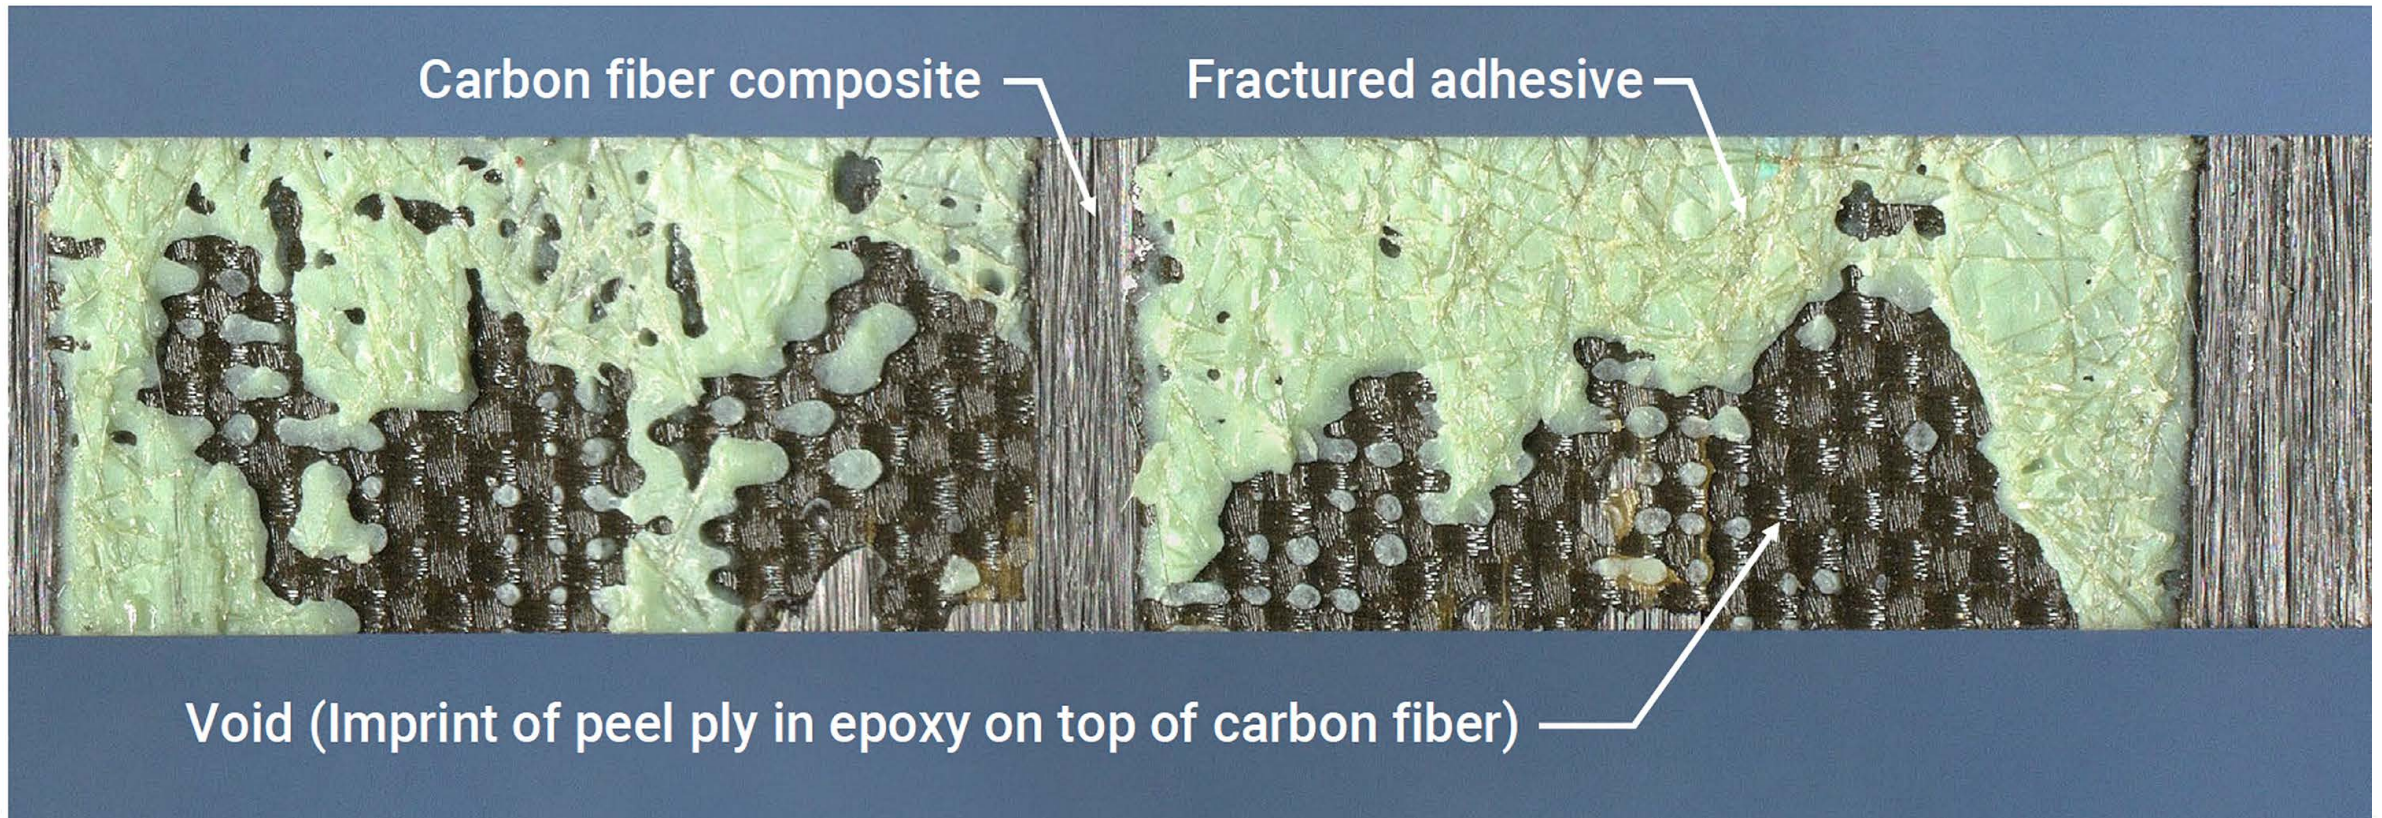
# Titan V2 Hull – Voids in Adhesive

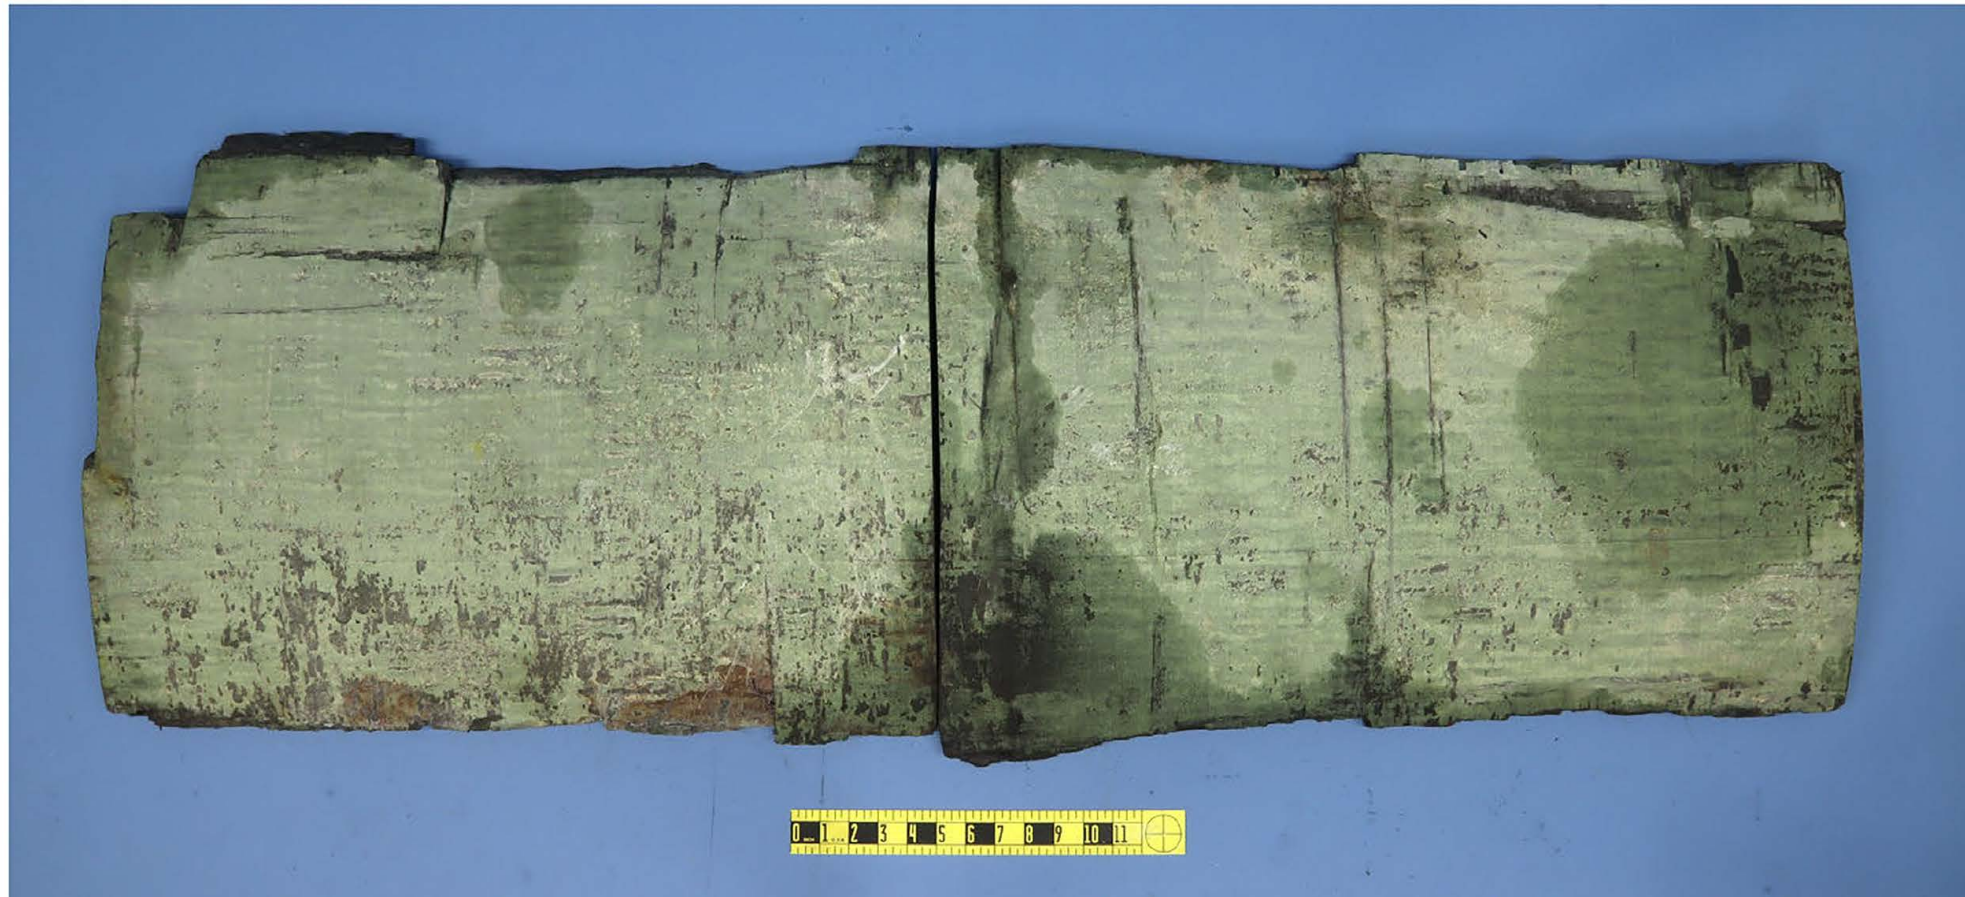
# Rubbing Damage – Retrieved Layer 1 Piece

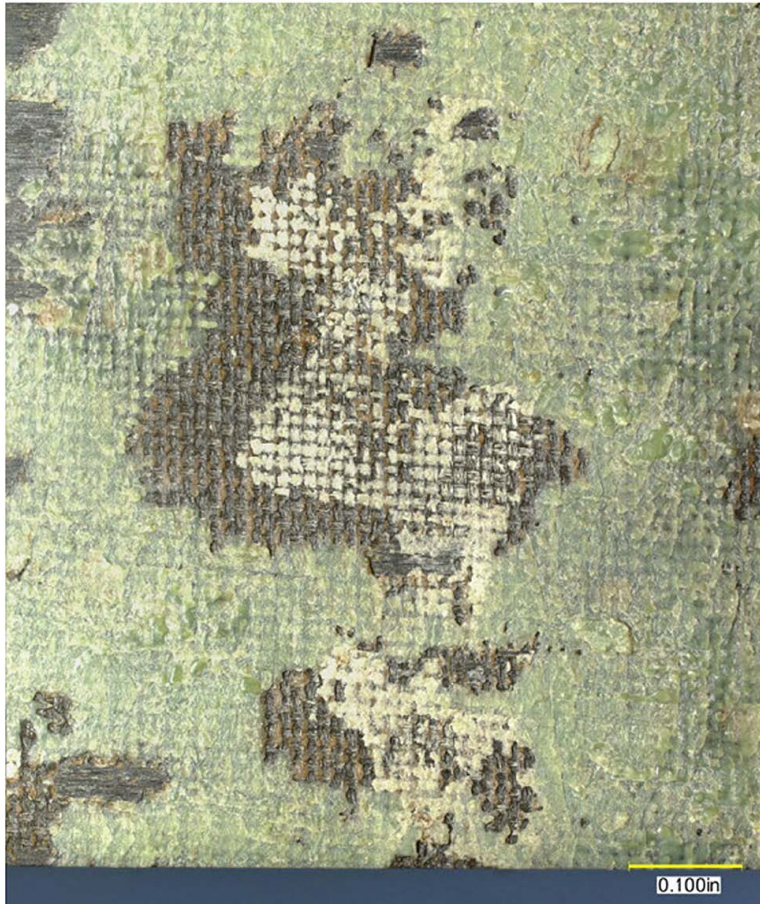
**As recovered**

# Rubbing Damage – Debris Collected in Voids
