# Materials Investigation of the Experimental OceanGate Submersible Titan

U.S. Coast Guard Marine Board of Investigation  
September 25, 2024

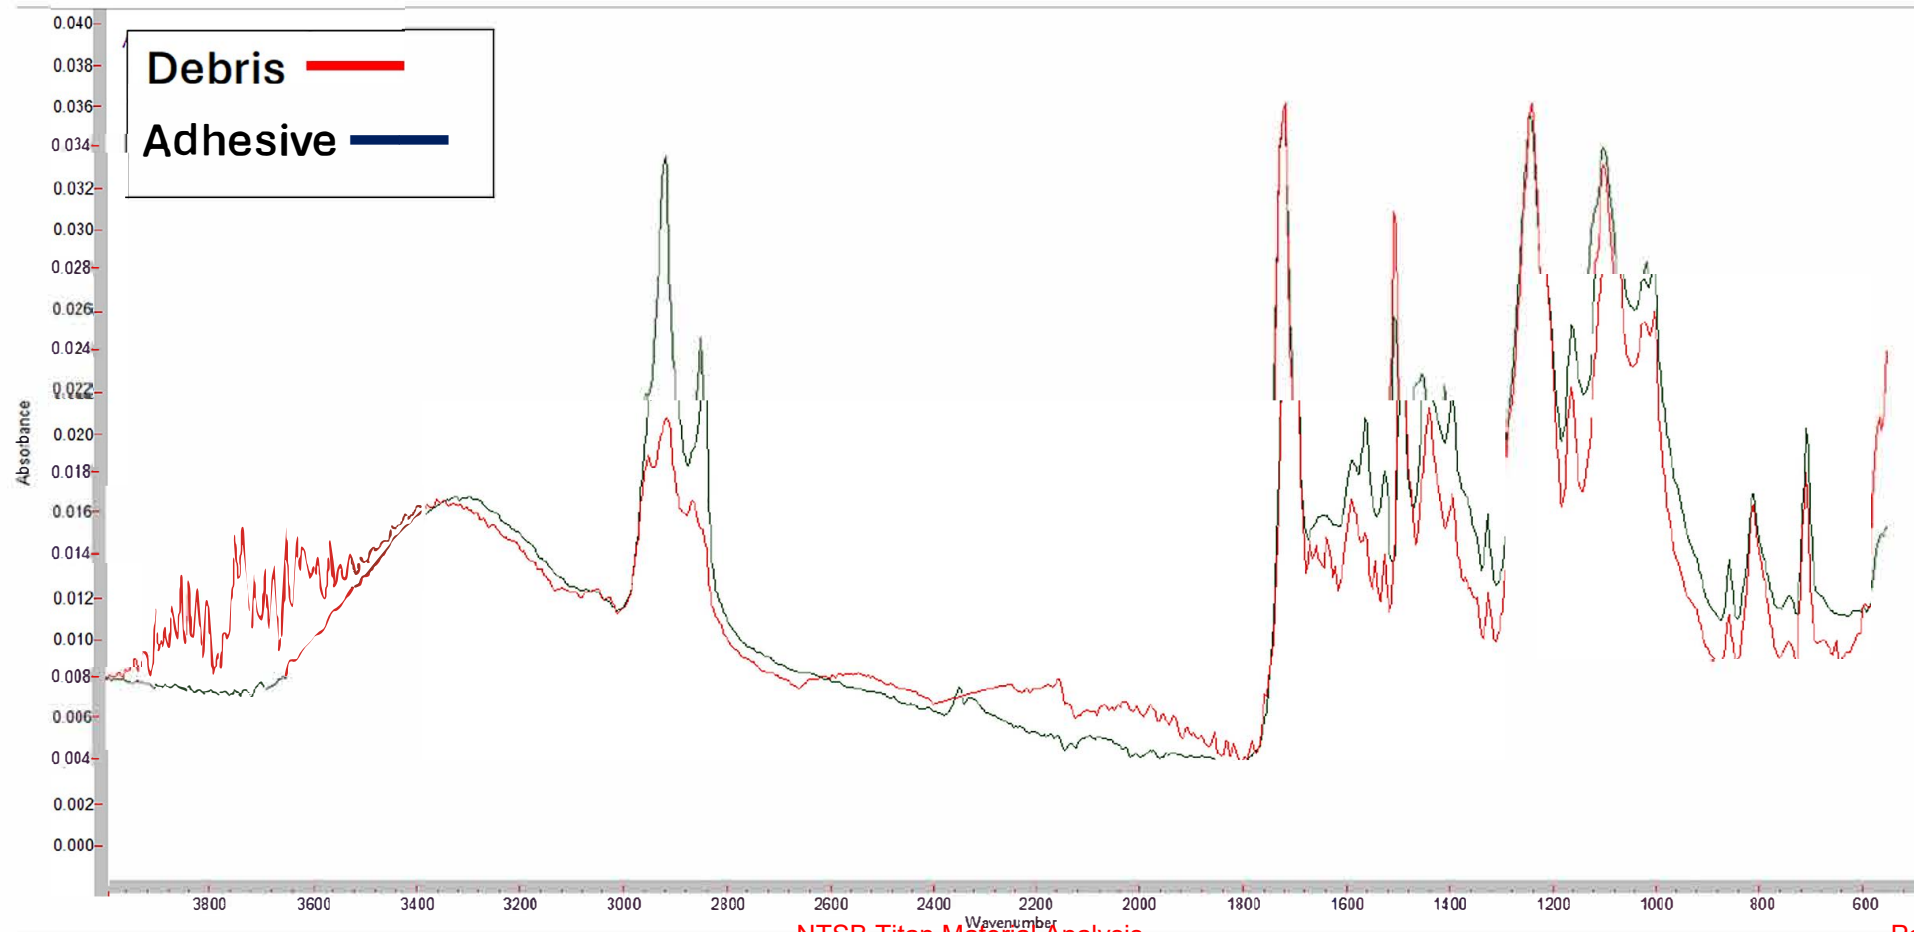
# Rubbing Damage – Debris Consistent with Adhesive

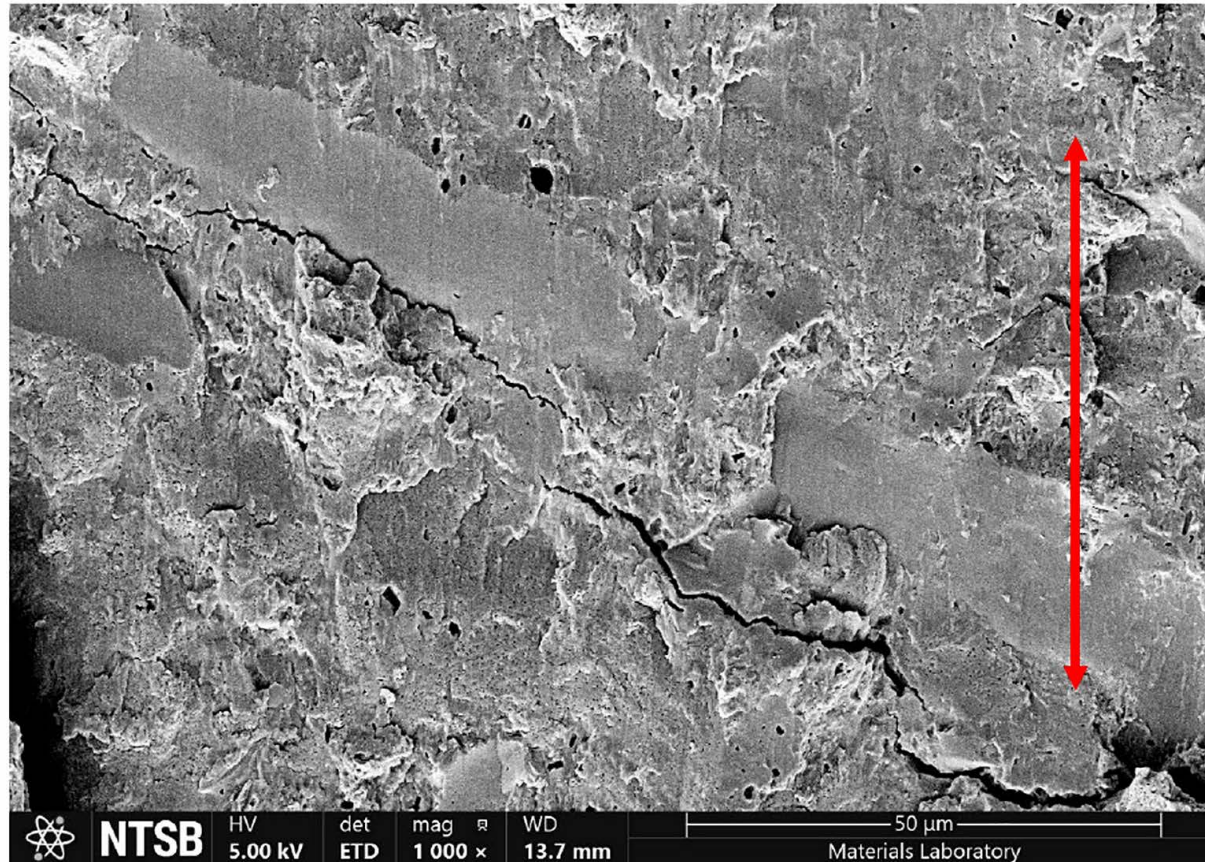
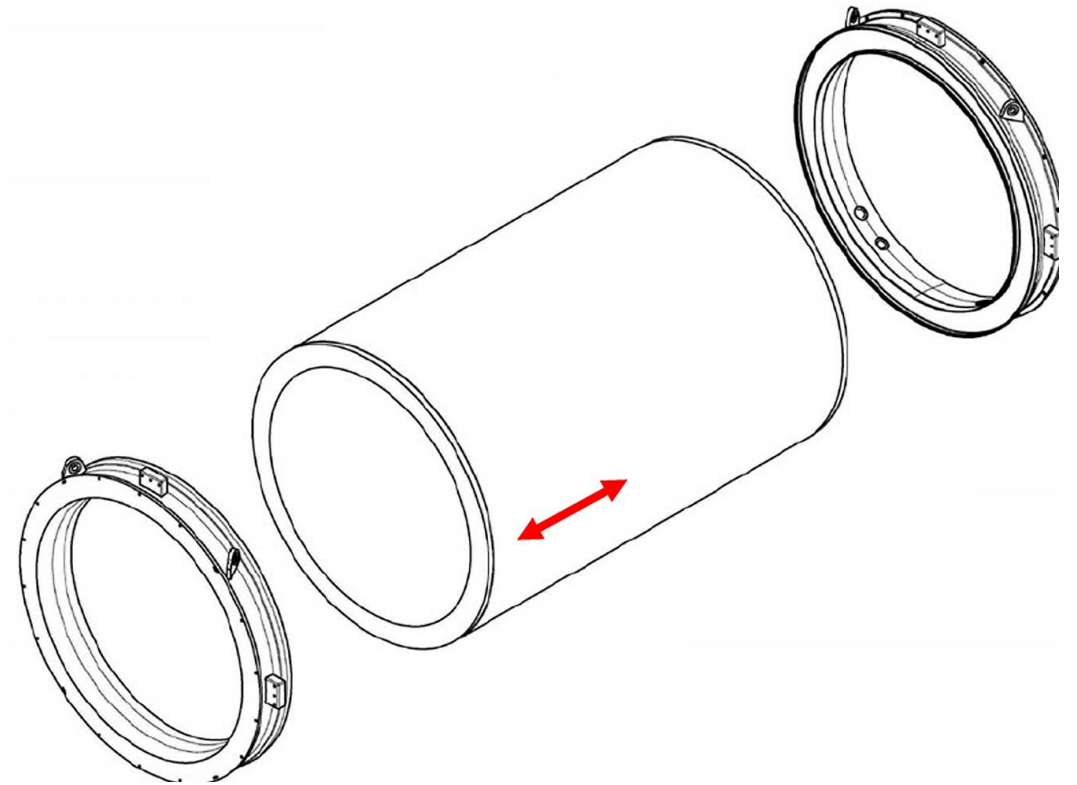
# Rubbing Damage – Longitudinal Rub Marks

CG 107 Rubbing in longitudinal direction

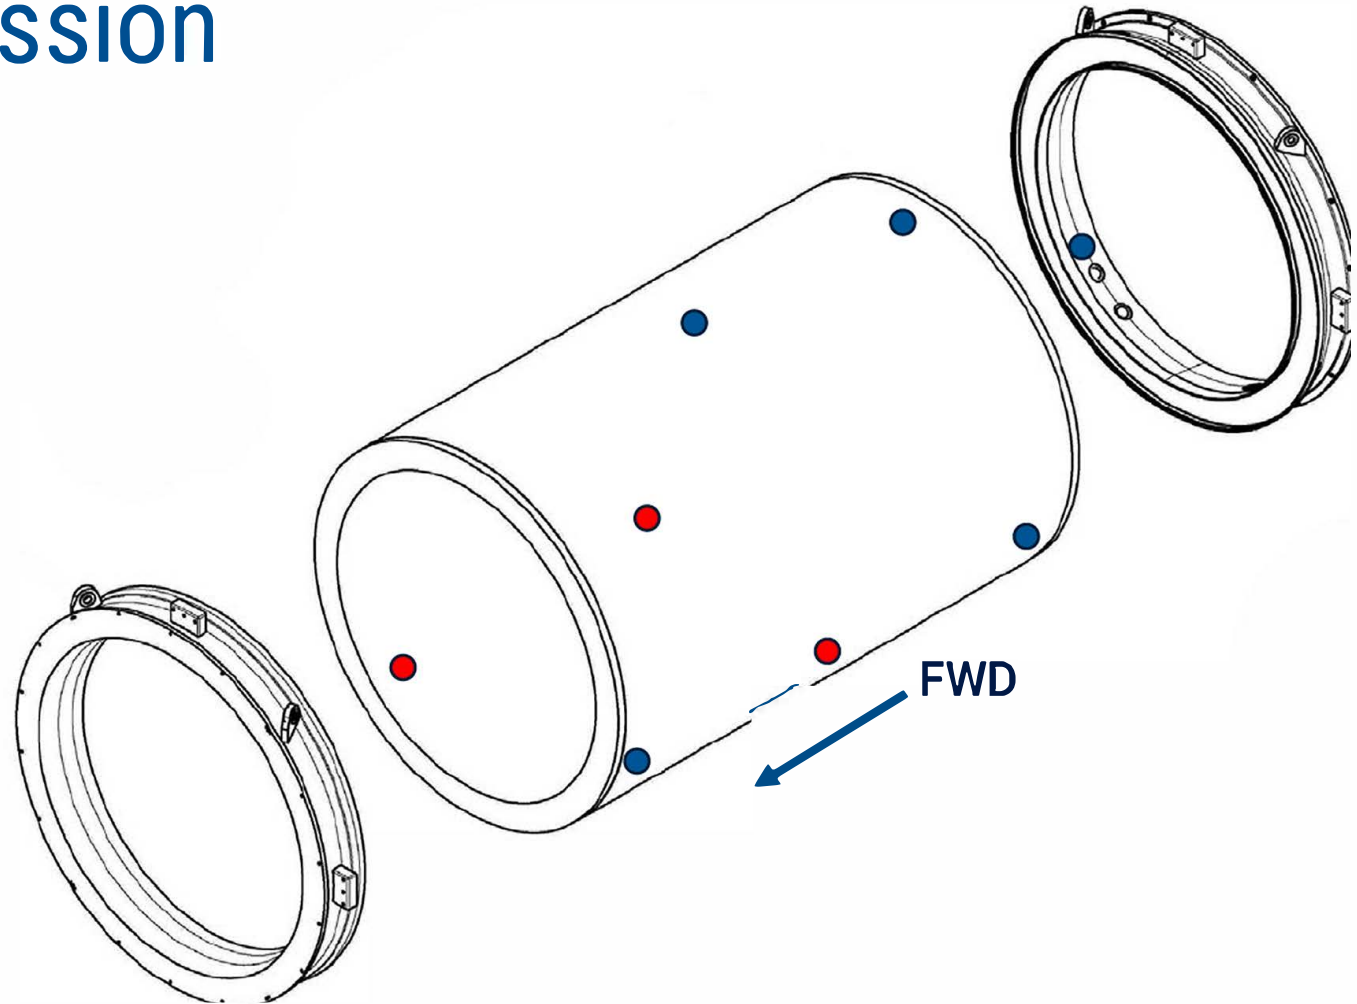
3 of 8 sensors did not appear to detect acoustic events.

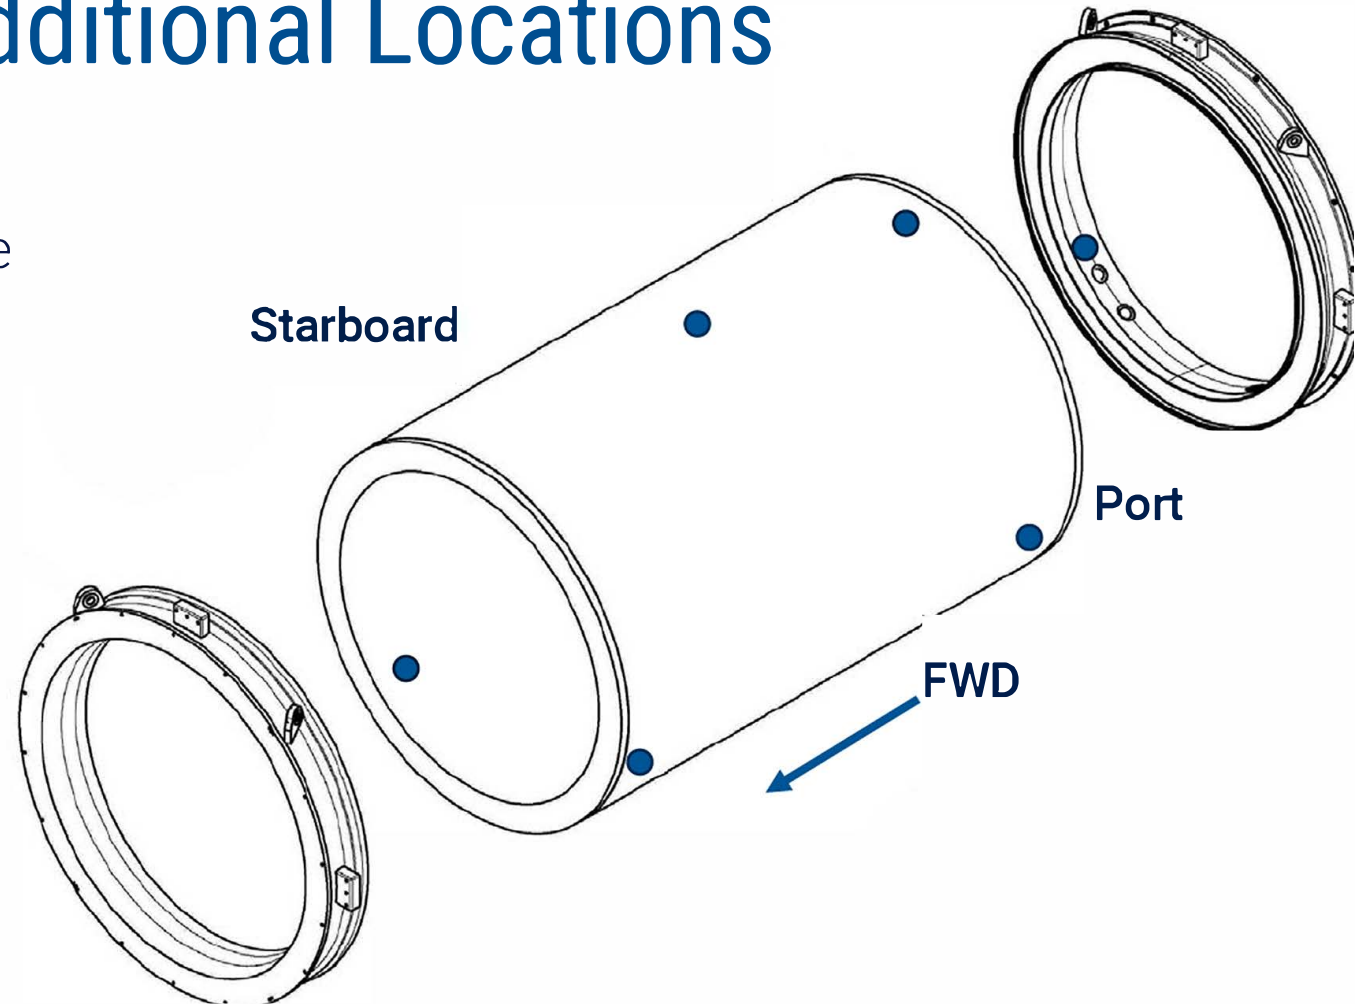
Changes in strain response after Dive 80 also seen for groups 5 and 8.

Changes persisted for Dives 81 – 83.

No changes for groups 3 or 7.

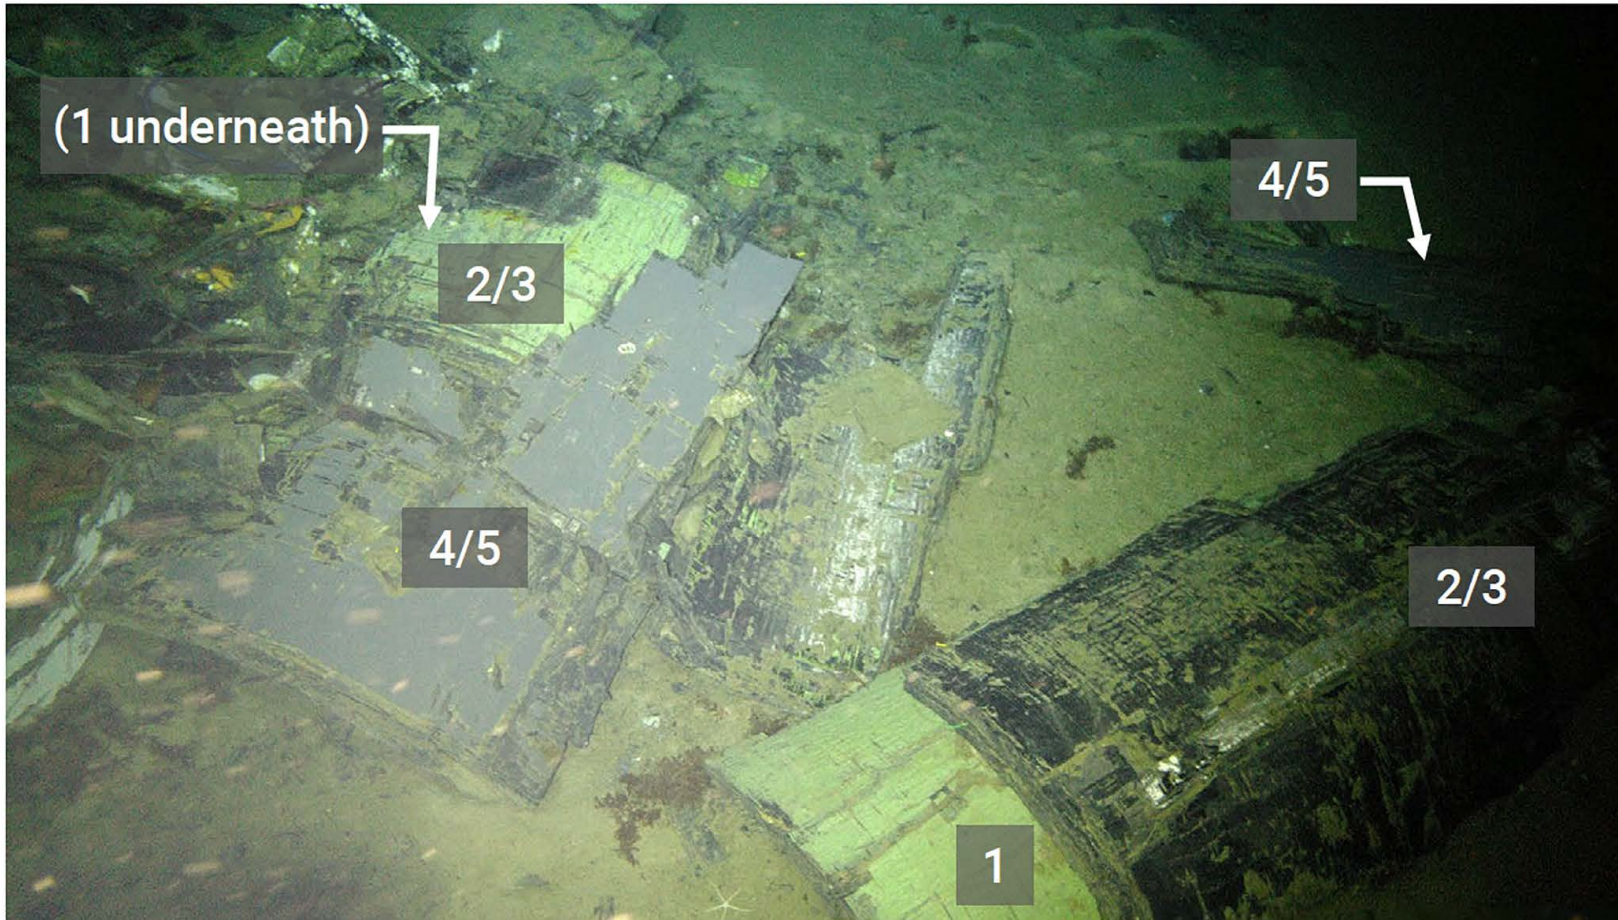
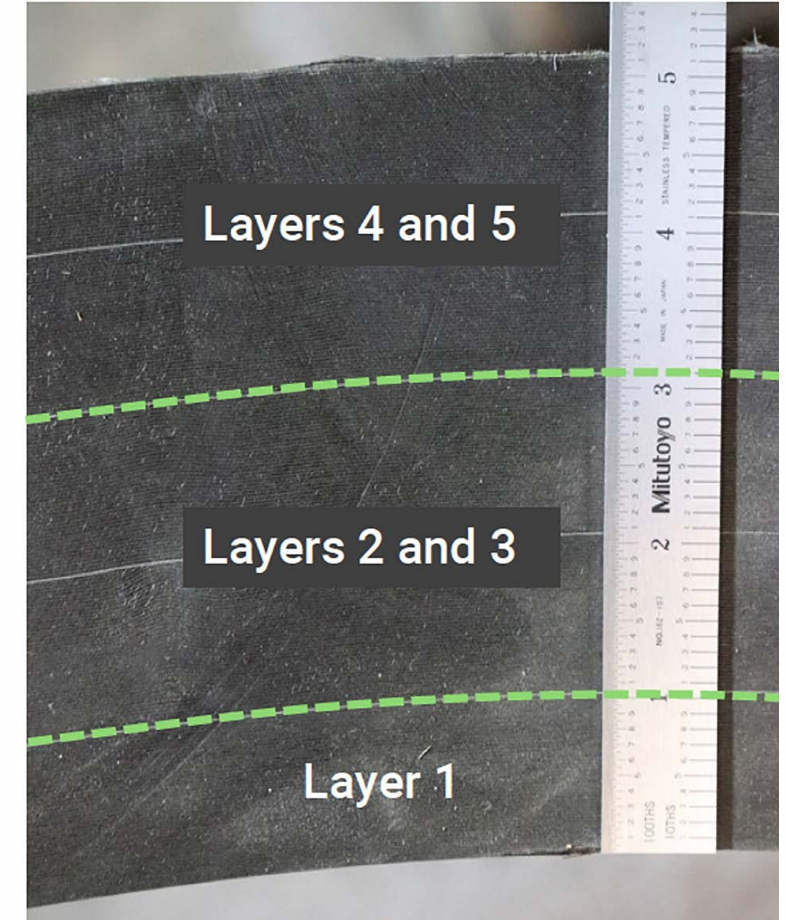
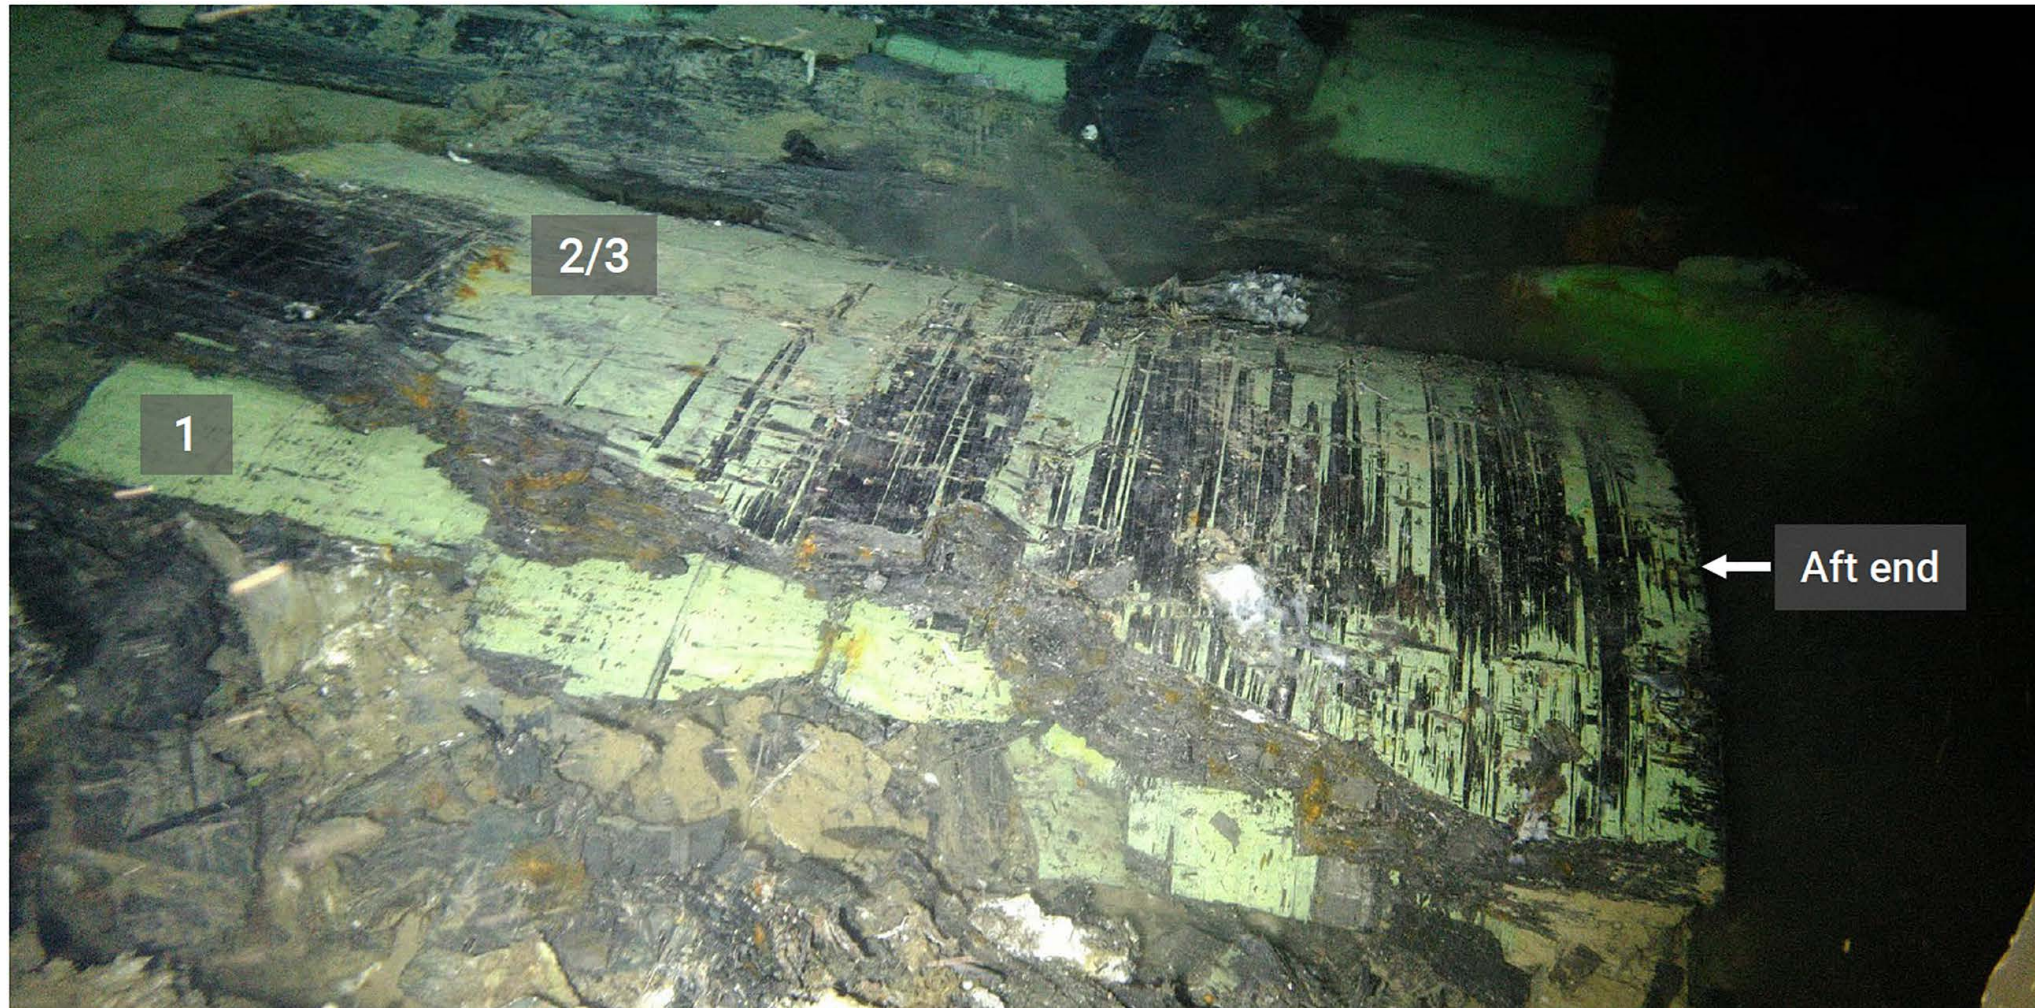
# Hull Fragments Exhibit Delaminations

Hull wreckage shows significant delamination into three shells.

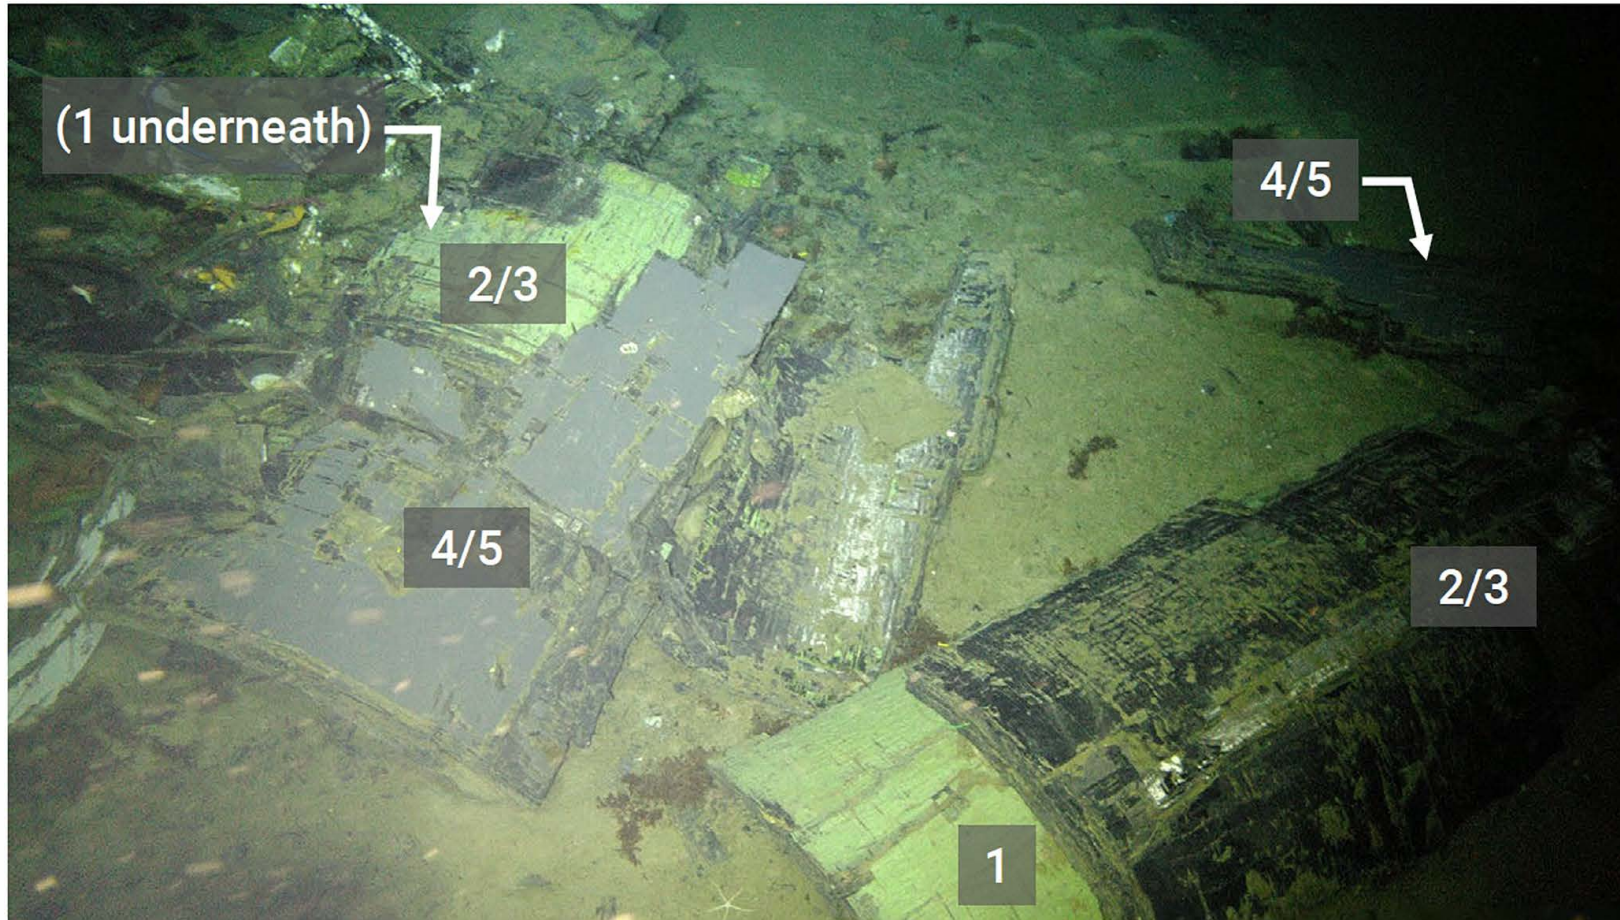
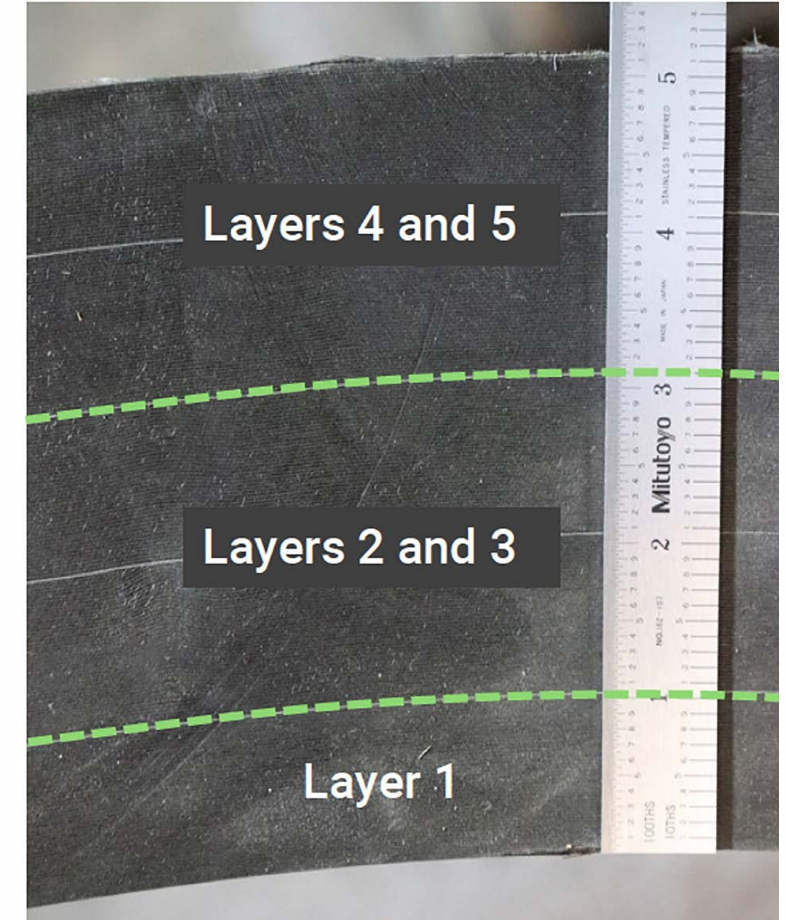
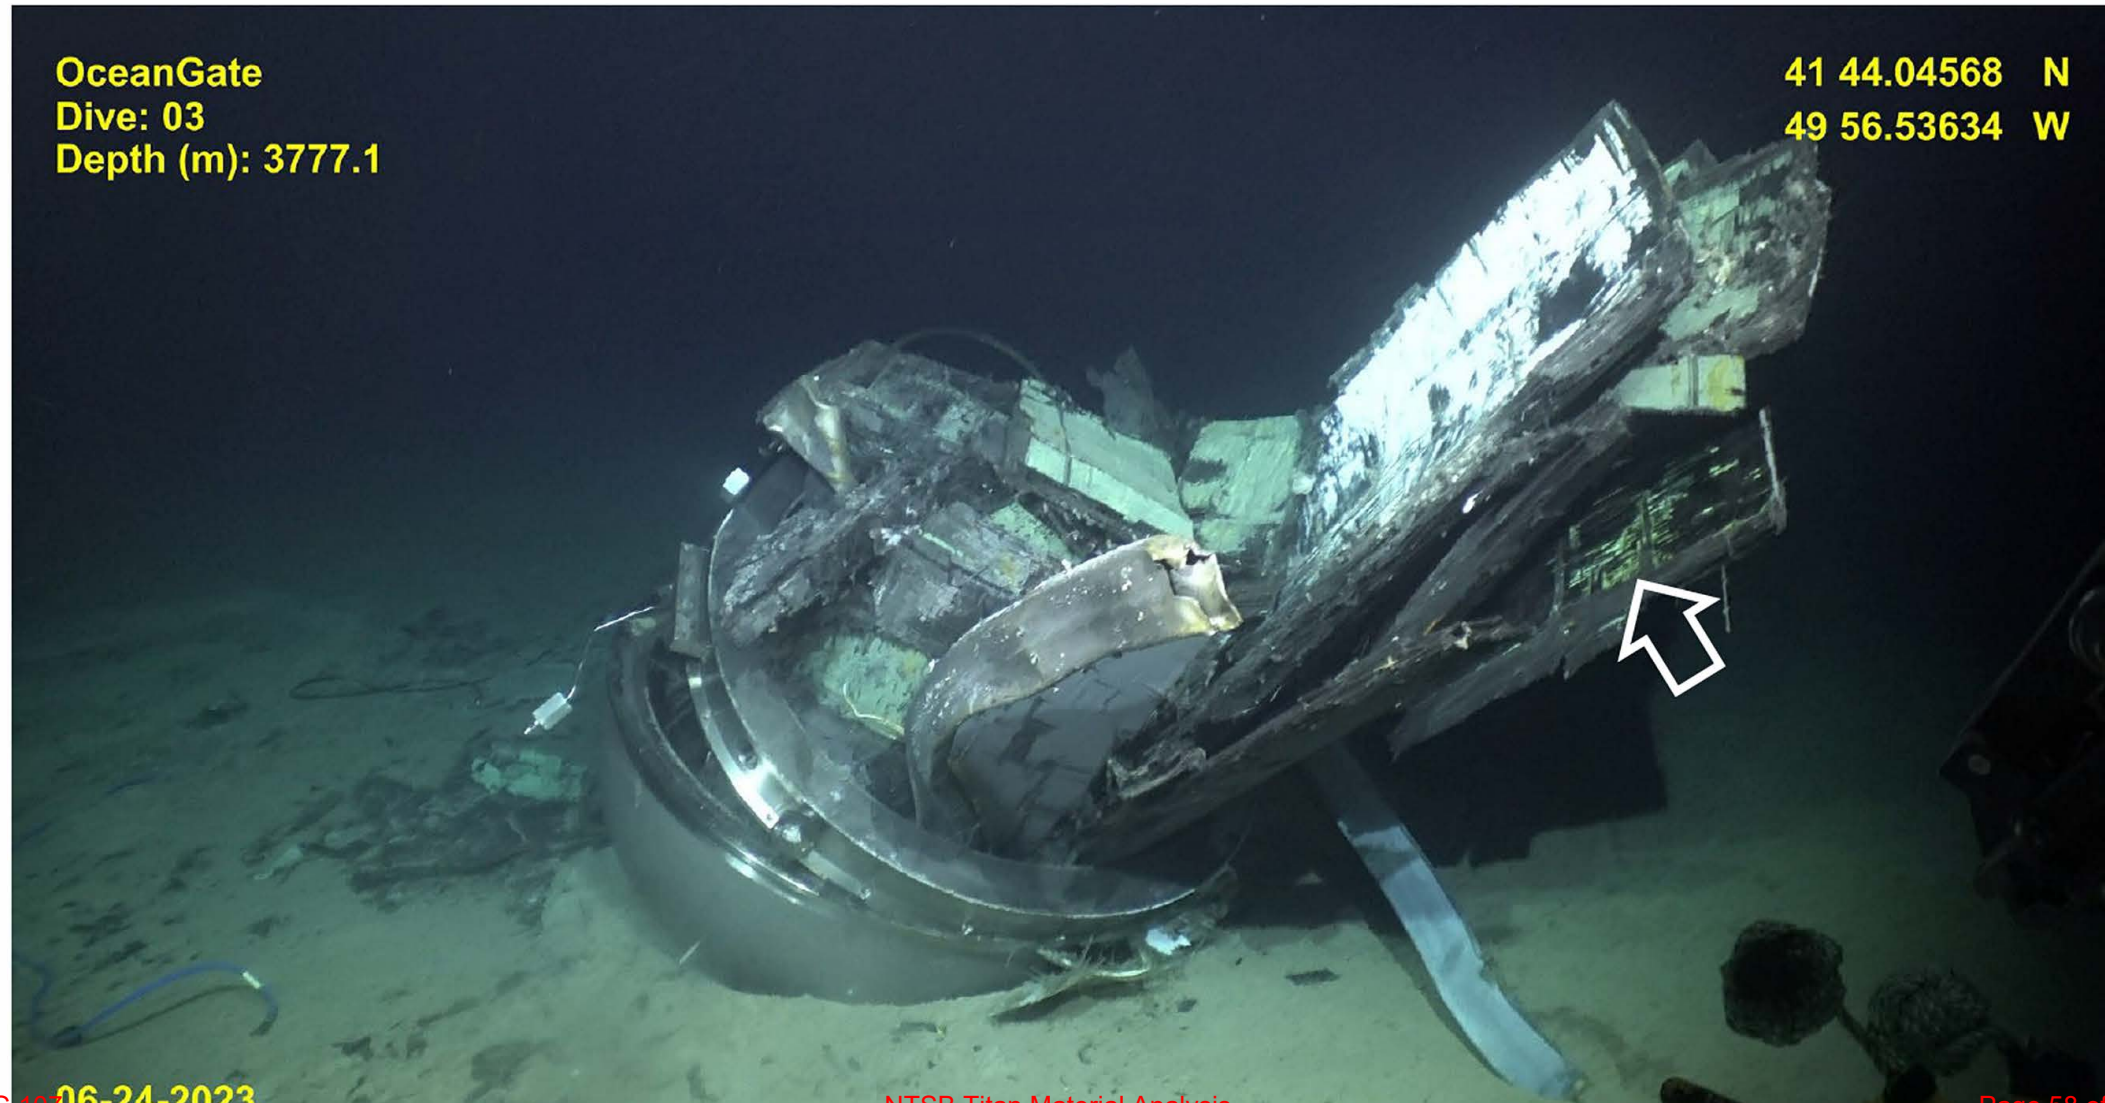
# Hull Fragments Exhibit Delaminations
