INSPECTOR GENERAL

The Army Needs To Improve Property Accountability and Contractor Oversight at Redistribution Property Assistance Team Yards in Afghanistan

March 4, 2014

SUBJECT: The Army Needs To Improve Property Accountability and Contractor Oversight at the
Redistribution Property Assistance Team Yards in Afghanistan
(Report No. DODIG-2014-043)

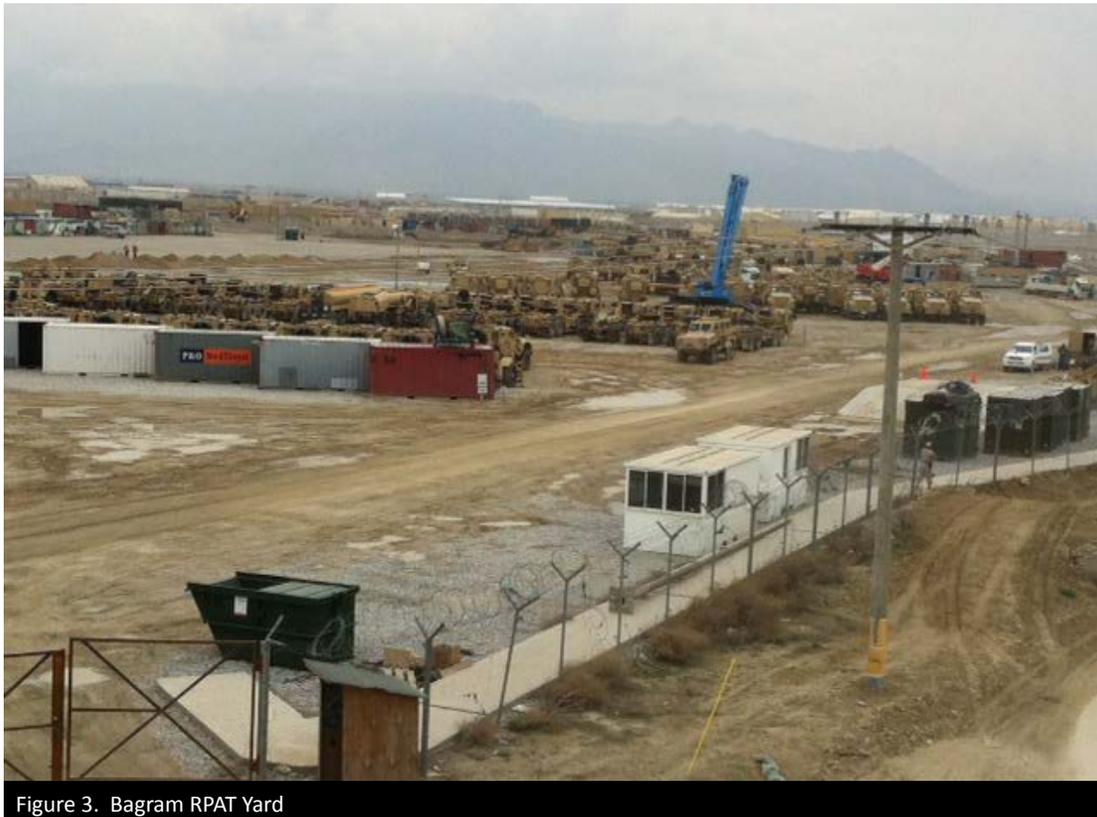
Figure 3. Bagram RPAT Yard

The accountability systems used at the RPATs do not offer a reliable reflection of the equipment that the Army has on hand. Until corrective actions are implemented and property accountability is restored at the RPATs, the Army will not know the exact amount of equipment that has been lost at the RPATs. Additionally, until the property records are reliable, the RPAT environment will remain conducive to property loss, including CIIs. Figure 3 presents an aerial view of the Bagram RPAT yard.
