DODIG-2015-013

U.S. Department of Defense

Military Housing Inspections – Republic of Korea

October 28, 2014

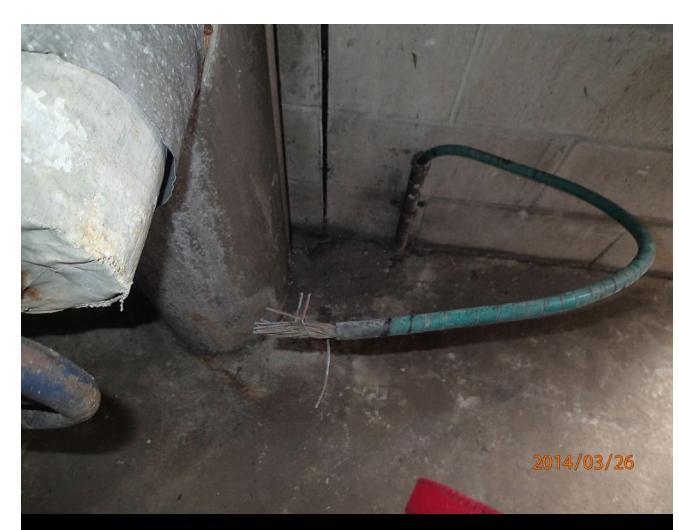
disconnected from the main water pipe. This created an electrocution hazard to anyone in contact with the equipment (see Figure 3). Also, buildings at Camp Jackson, Camp Bonifas, and Camp Stanley had fossil fuel burning equipment and lacked carbon monoxide alarms. Soot build-up on surfaces and around vent flue joints and dampers of the boilers in the mechanical rooms were signs of inadequate combustion ventilation, indicating higher risk of carbon monoxide poisoning.

Figure 3. Grounding electrode disconnected leaving the building ungrounded. (Deficiency No. JAC-EL-140326-006) Source: DoD OIG

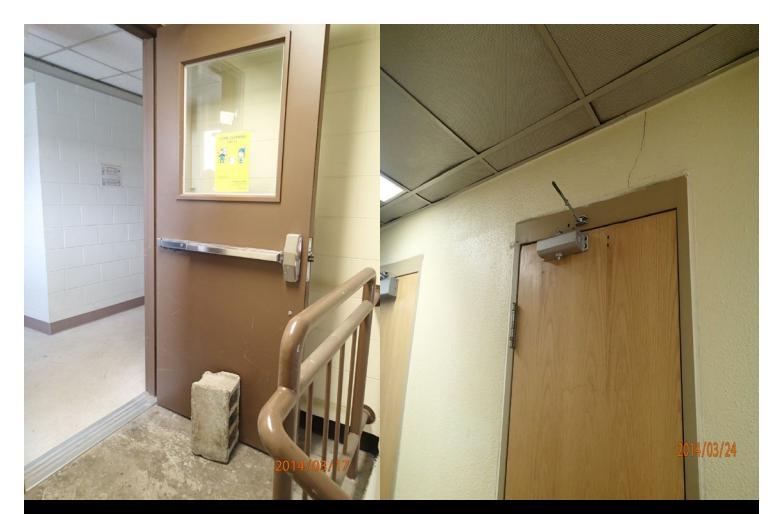
Figure 4. Ineffective use of fire doors allows fire to draft through the entire building. Left: Fire rated doors often propped open (Deficiency No. CAS-FP-140317-024) Right: Broken automatic closing mechanisms (Deficiency No. CRC-FP-140324-013) Source: DoD OIG

Fire protection deficiencies included fire doors that were propped open, did not automatically and fully close, and were not fire rated (see Figure 4). We found dryer vents that were disconnected, pinched or shredded, and constructed of improper material (see Figure 5). Also, we found multiple sprinkler systems that were out of service and without temporary life safety measures.

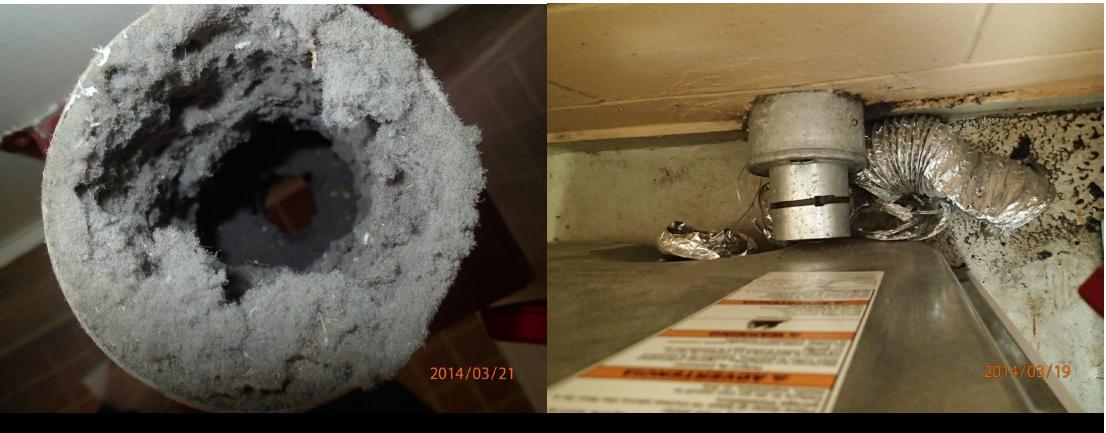
Figure 5. Left: Clogged dryer duct (Deficiency No. BON-FP-140317-007). Right: Disconnected and damaged dryer duct (Deficiency No. HOV-FP-140317-006) Source: DoD OIG

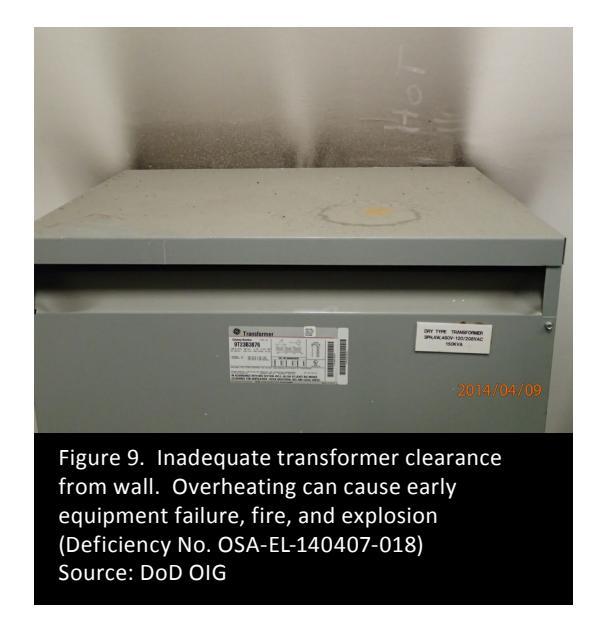
Electrical deficiencies included inadequate vent space for cooling transformers (see Figure 9), and improperly maintained or functioning temperature control equipment in mechanical and electrical rooms. As at other bases, we found broken conduits, receptacles with reversed polarity, and missing covers in junction boxes. We also identified missing GFCI protection in laundry rooms, vending machines, and water coolers. These deficiencies create electrocution hazards for installation personnel.

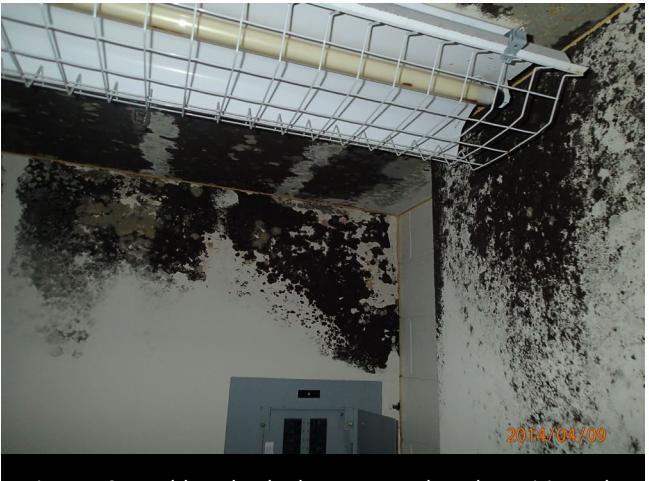
Figure 10. Mold unchecked, unreported, and unmitigated (Deficiency No. OSA-EN-140407-007) Source: DoD OIG

evidenced by mold found in several buildings (see Figure 10). In addition, Osan Air Base did not address the radon issue at buildings that exceeded acceptable radon levels and did not develop and implement a radon mitigation program for military housing, despite EPA studies stating that radon is a carcinogen that causes thousands of deaths each year.

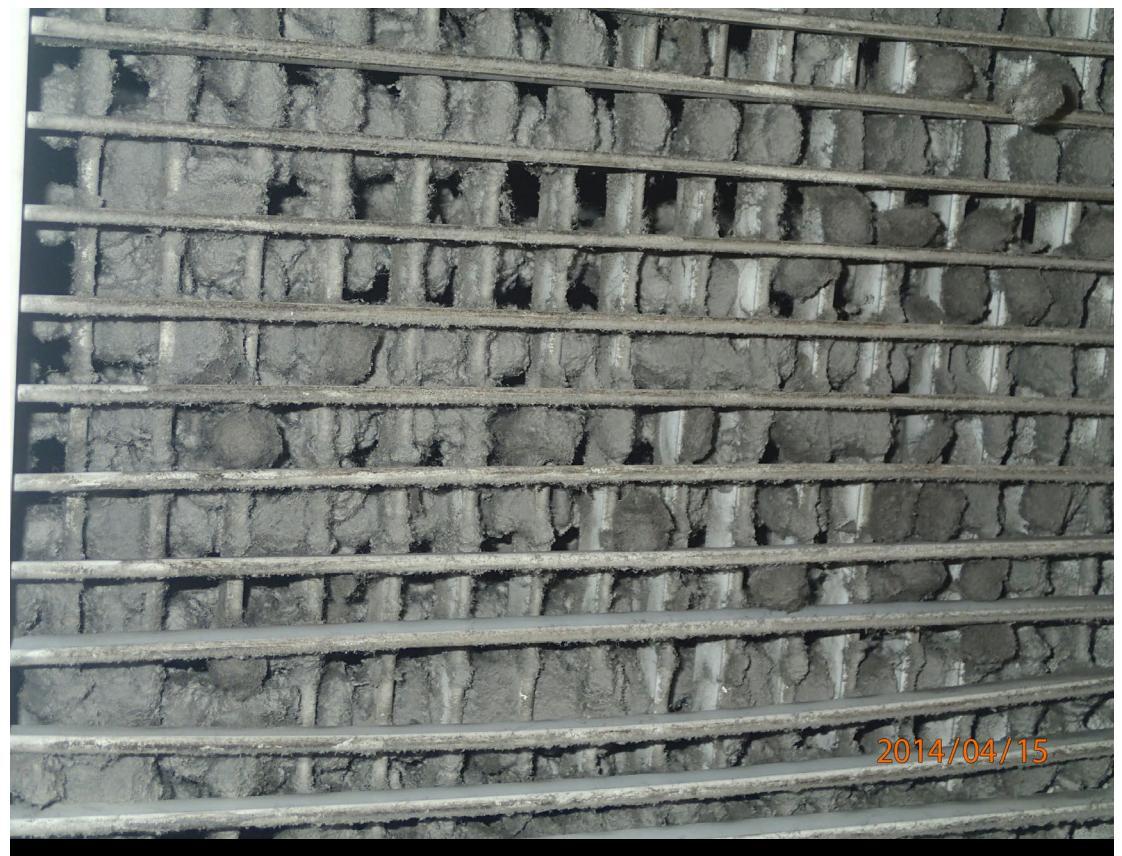
Electrical deficiencies included a lack of monitoring and maintenance of fuel tank leak detector systems. We found building service drops improperly attached and abrading against a mechanical room door. We also found water heaters not grounded in single family units. As at other bases, we found exposed energized wiring due to missing electrical service panel breaker blanks or broken electrical covers, missing exterior light fixture covers, homemade dead fronts for electrical panels that were not certified per code, and missing knockout seals and covers in junction boxes. Also, we identified conductor wires that were fused at a higher rating than their amp rating. These deficiencies create electrocution hazards for installation personnel. Environmental deficiencies included water damage to ceiling tiles and drywall due to poorly maintained HVAC systems and plumbing pipes. We also found that in some instances, the air handling units were not operating. We noted a lack of communication between unaccompanied housing and the civil engineering component on established roles and responsibilities. For example, there were no agreed-upon procedures for preventive maintenance of the fan coil unit filters and air registers (see Figure 11).

Figure 11. Clogged air return registers (Deficiency No. KUS-EN-140414-001) Source: DoD OIG
