F/V DESTINATION • TRIM AND STABILITY REPORT • R. W. ETSELL, P.E.

F/V DESTINATION USCG Subpeona #1, Page 244 Exhibit 007 Page 60 of 69

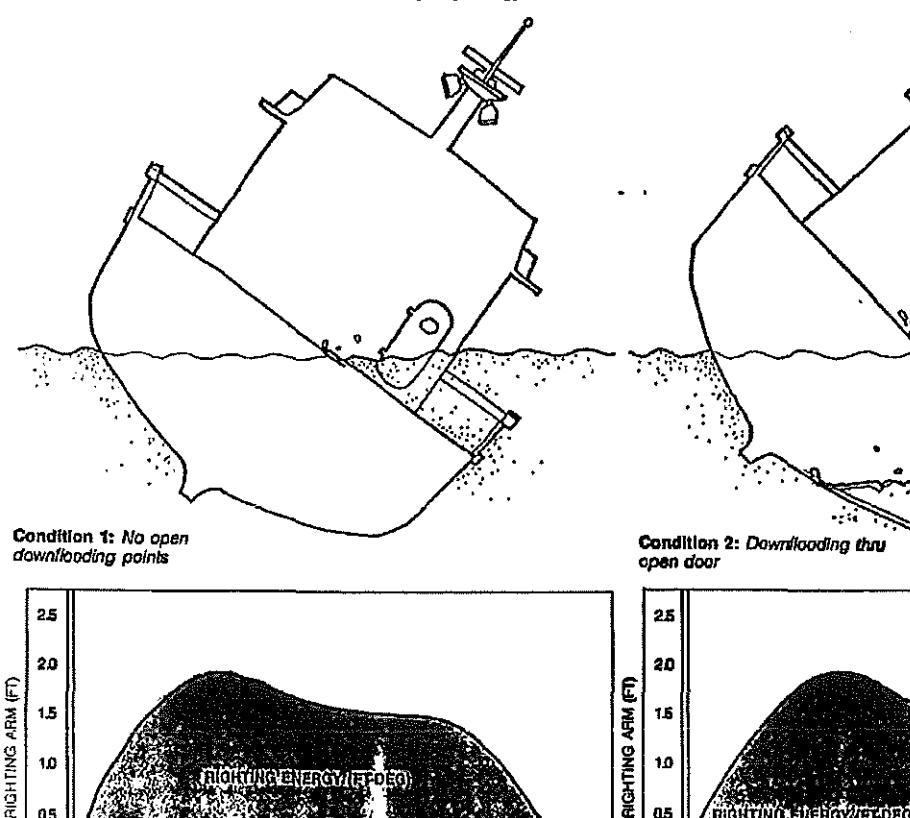
Figure 10. Effect of Downlicoding **Height on Righting Energy**

Figure 10 shows the sample vessel with two different downflooding points considered. In condition 1, all doors, hatches and vents are properly secured, thereby allowing the vessel to develop its full righting energy. Condition 2, on the other hand, shows a door left open allowing flooding to occur as soon as the door is immersed. Although the hull has significant

righting energy available, it cannot be fully used if the vessel takes on water.

The importance of closing off openings, particularly in heavy weather cannot be overemphasized. If operators make it a practice to maintain this integrity, it really does become a habit. which significantly improves the chances of survival in heavy weather conditions. Operators should be aware of the status of all watertight

closures at all times. They should be closed, except when actually being used. to maintain both the watertight integrity and the stability of the vessel. Potential downflooding points include doors into engineroom and crew spaces, hatches into fish wells or lazarettes, portholes and any other openings through which water can gain entry.
