**UNITED STATES AIR FORCE**  
**AIRCRAFT ACCIDENT INVESTIGATION**  
**BOARD REPORT**

**HH-60G, T/N 92-6466**

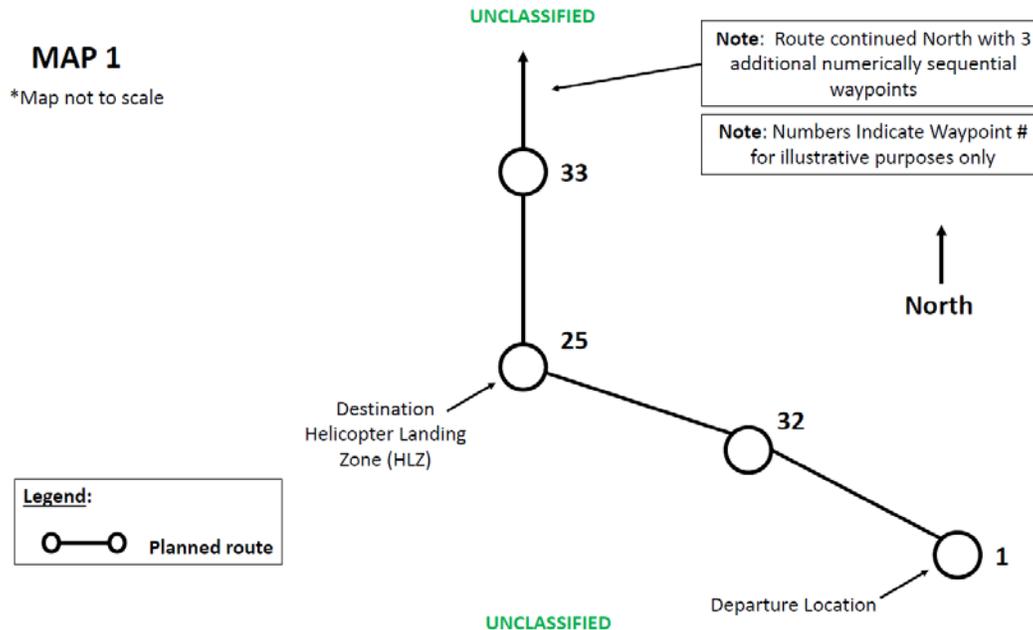
**Figure 1: Map 1, MF Planned Route (Tab Z-4)**

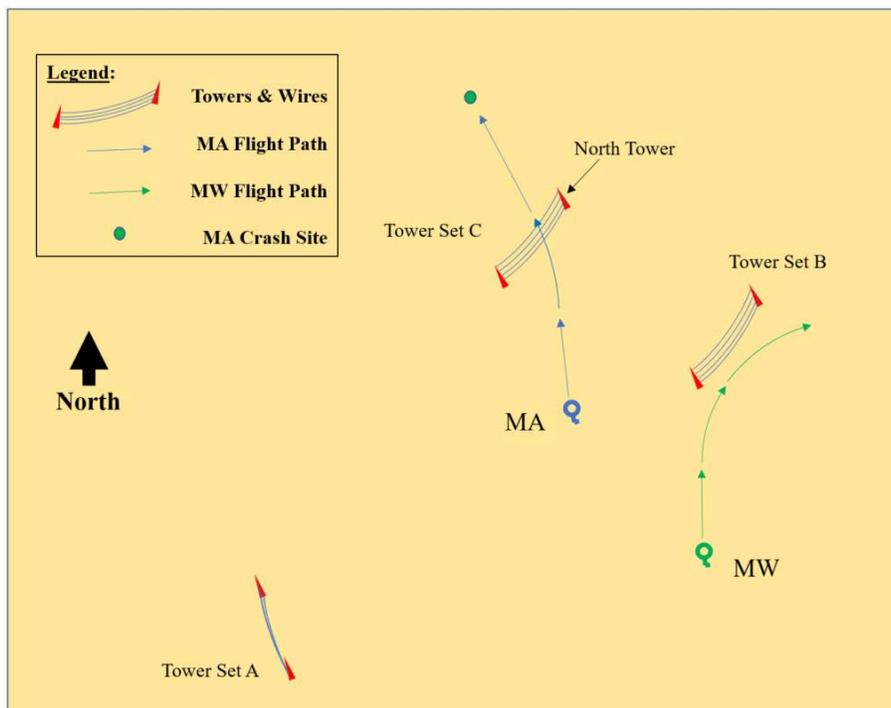
**Figure 7: MF Flight Path Illustration (Tab Z-6)**

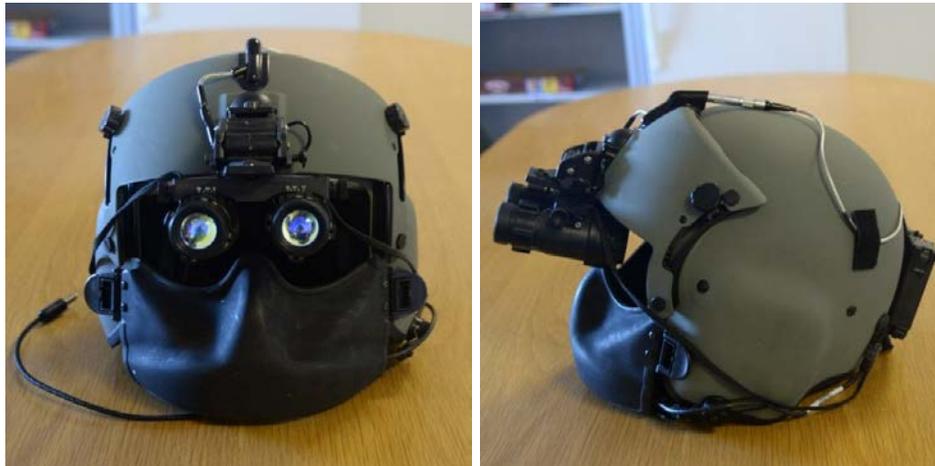
Figure 8: ANVIS-4949 NVGs Mounted to HGU-56/P Helmet (Front and Side Views) (Tab Z-10 to Z-11)
