Naval Facilities Engineering Command Southwest BRAC PMO West San Diego, CA

Second Five-Year Review

Former Naval Station Treasure Island, CA

August 5, 2020

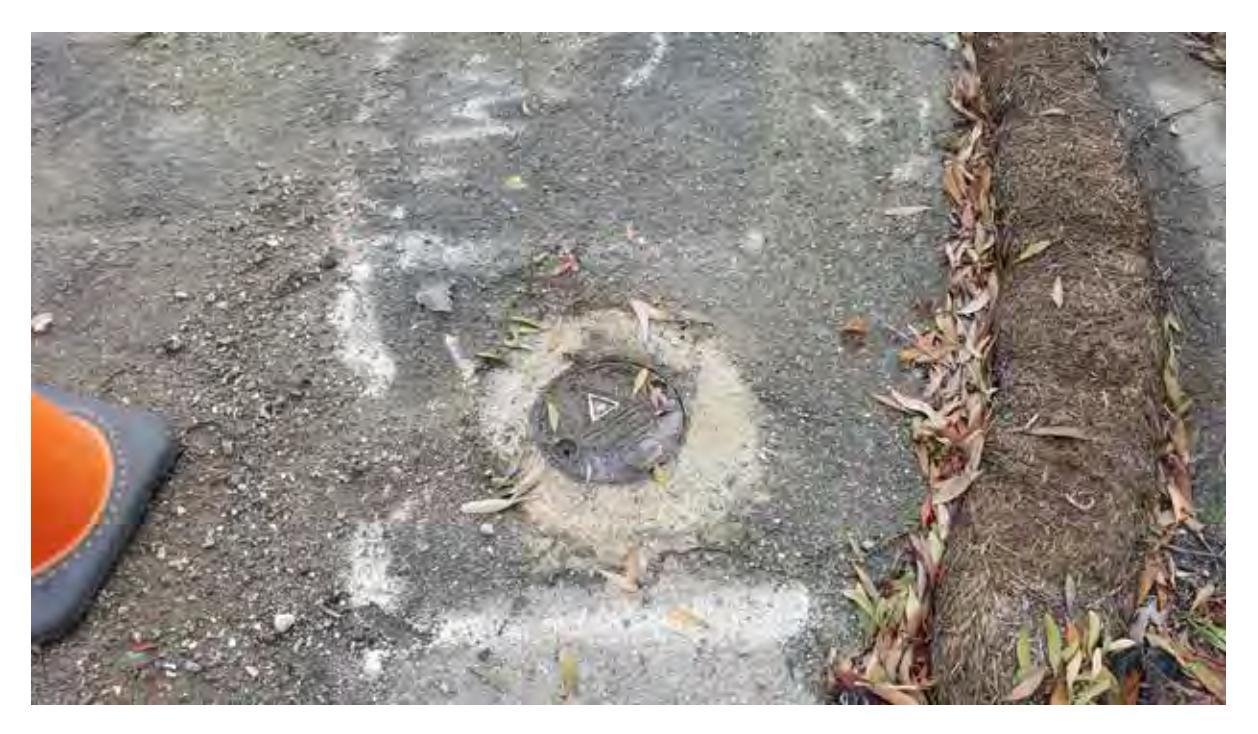
Photograph 5: View of well 06-MW30 at Site 6. Note missing bolt (1/10/2019).

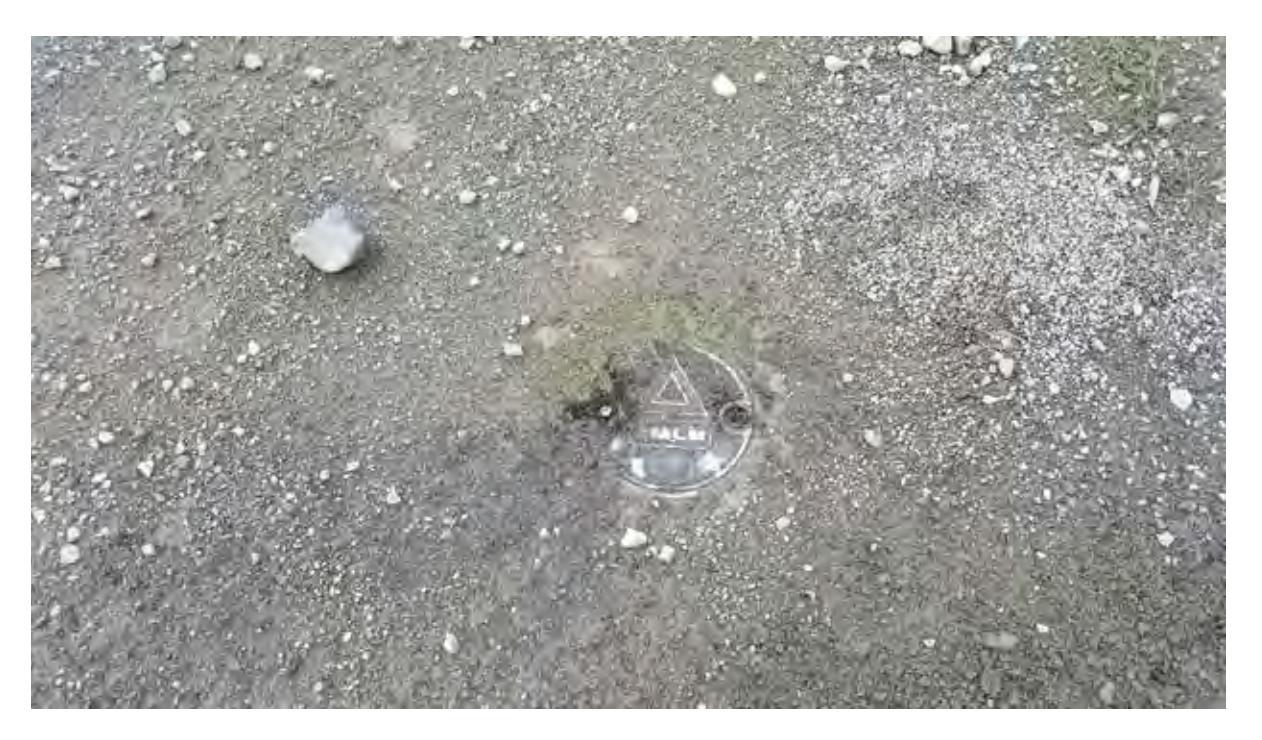
Photograph 15: View of uncapped former well or similar structure adjacent to well 06-MW36 at Site 6 (1/10/2019).

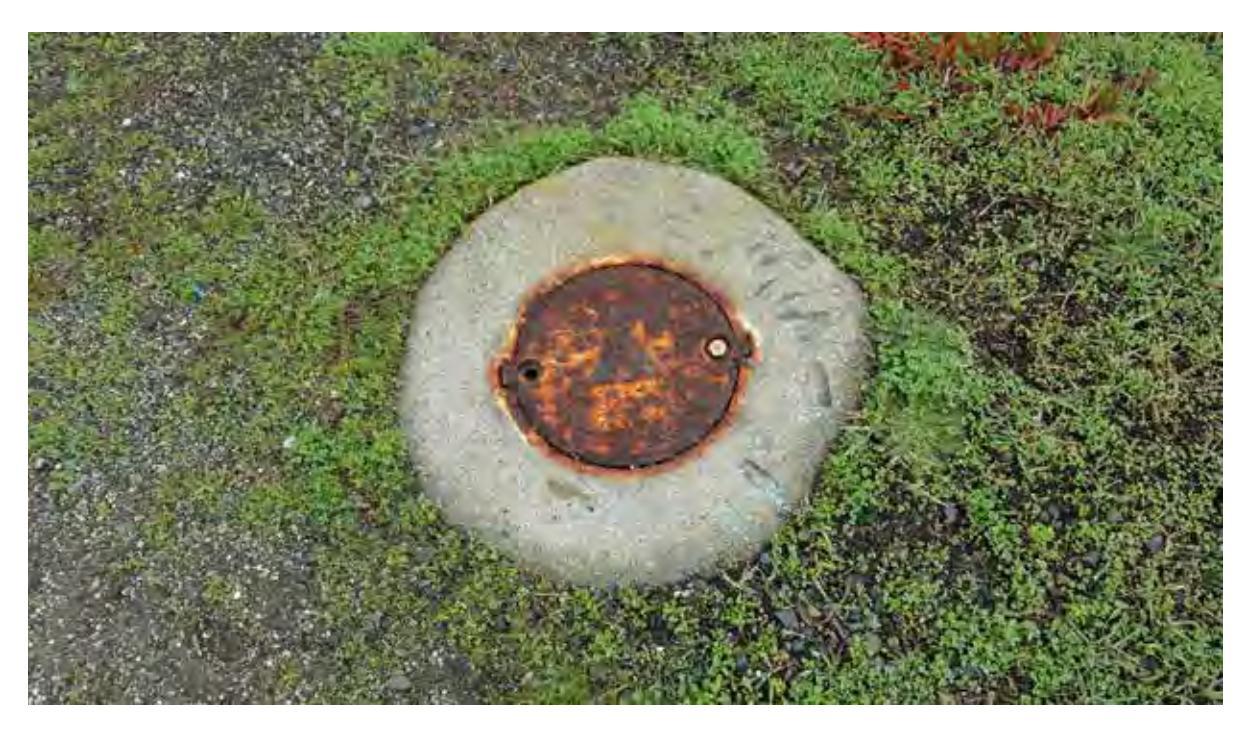
Photograph 5: View of well 12-MW33 at Site 12 Gateview Petroleum Area. Note missing bolt (1/10/2019).

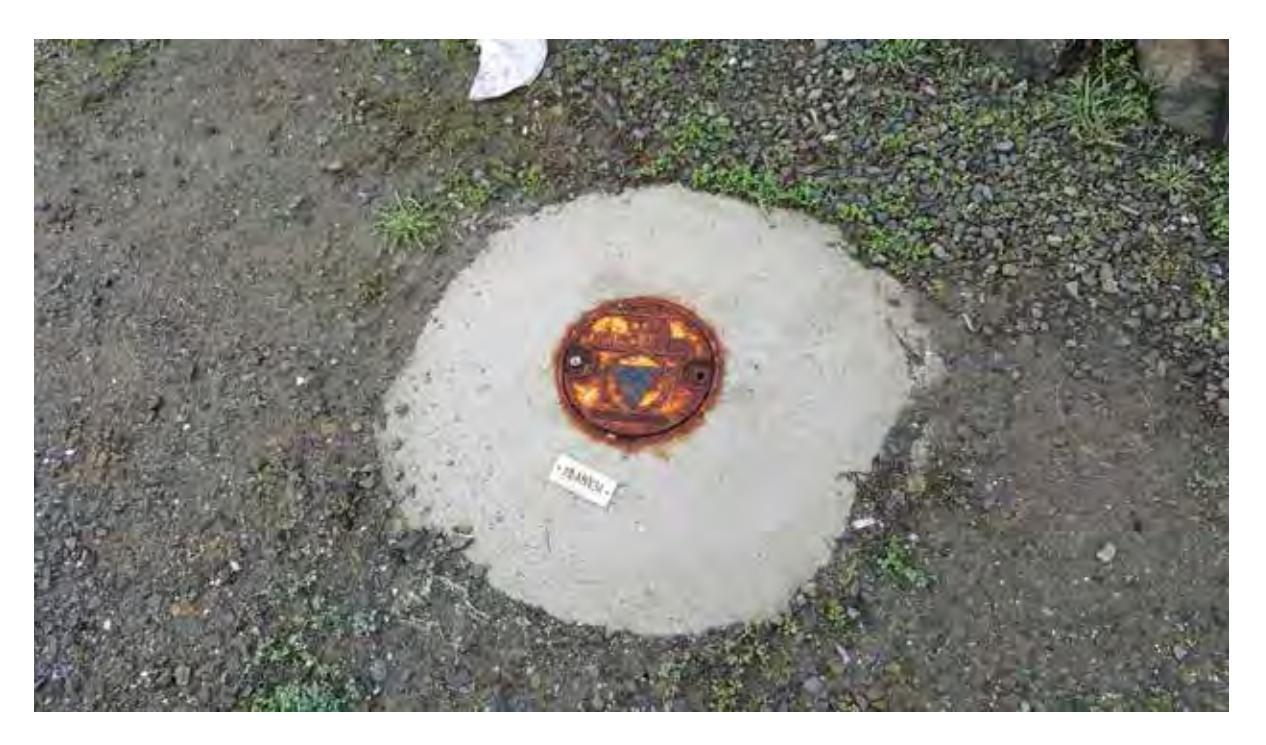
Photograph 6: View of well 12-MW34 at Site 12 Gateview Petroleum Area. Note missing bolt (1/10/2019).

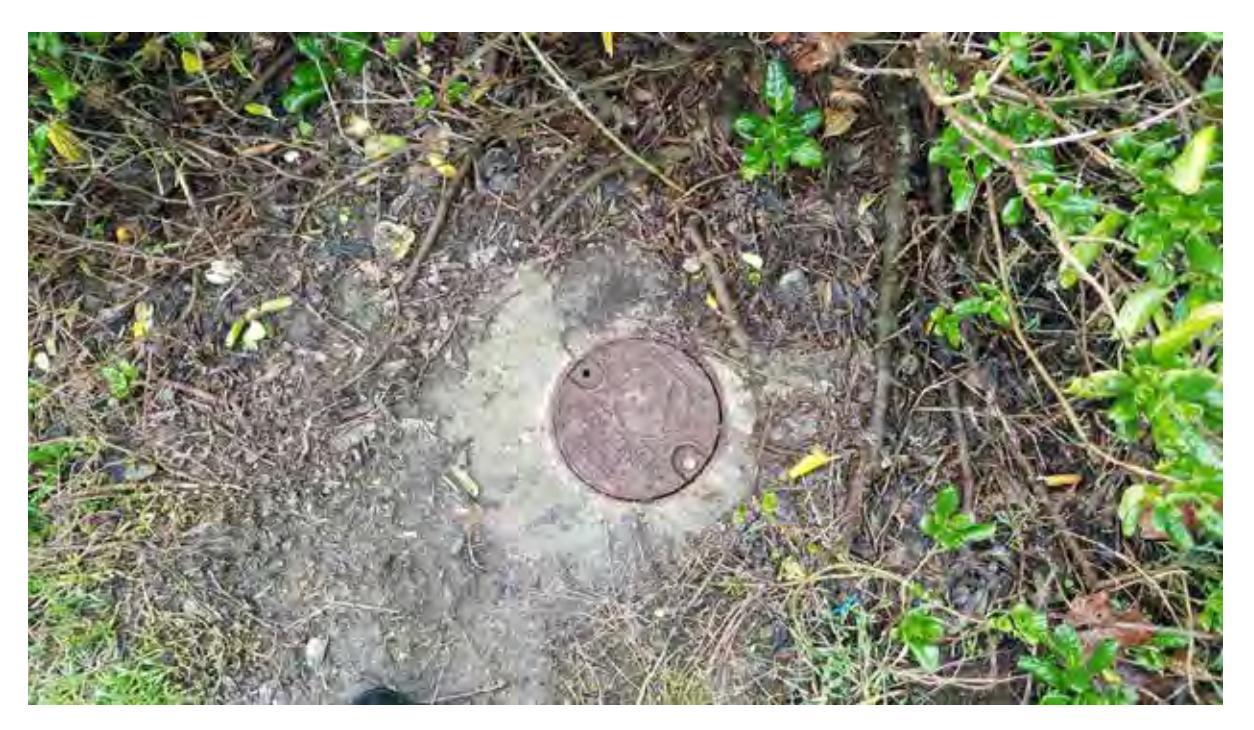
Photograph 7: View of well 12-MW35 at Site 12 Gateview Petroleum Area. Note missing bolt. Remaining bolt is damaged, preventing secure attachment of cover (1/10/2019).

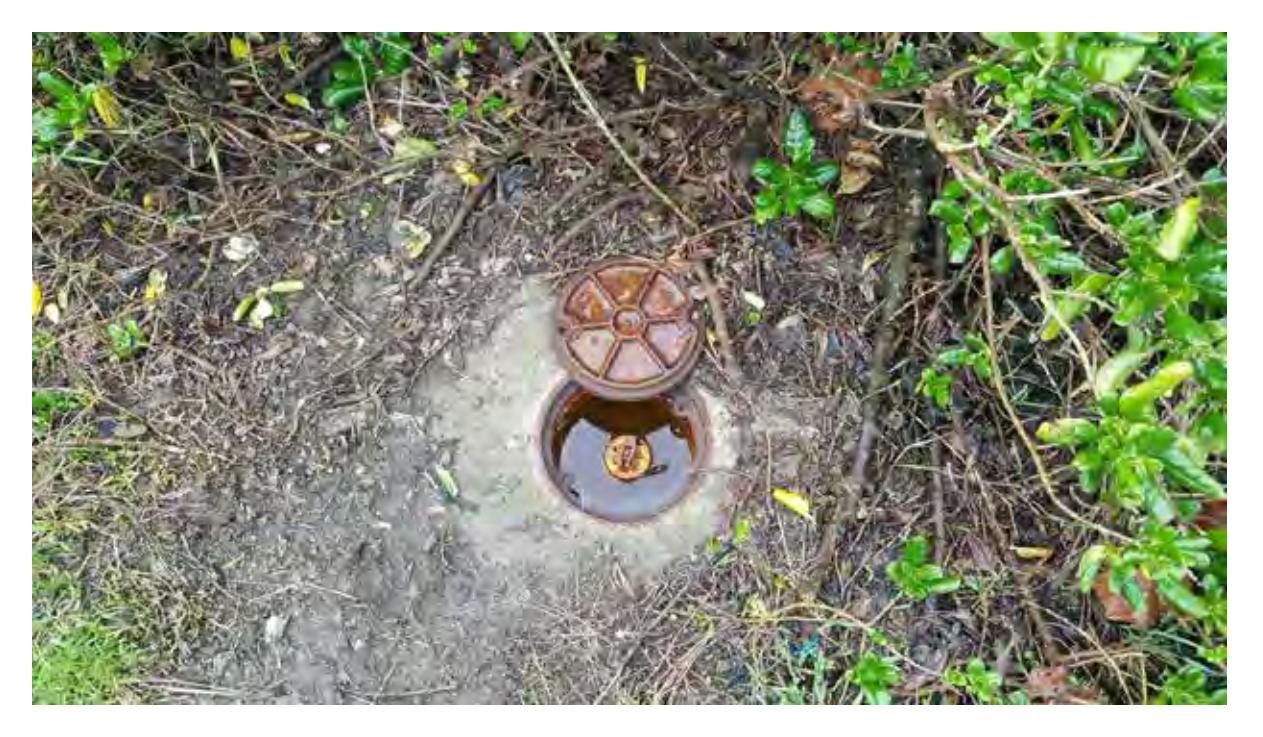
Photograph 8: View of flooded well box of well 12-MW35 at Site 12 Gateview Petroleum Area (1/10/2019).

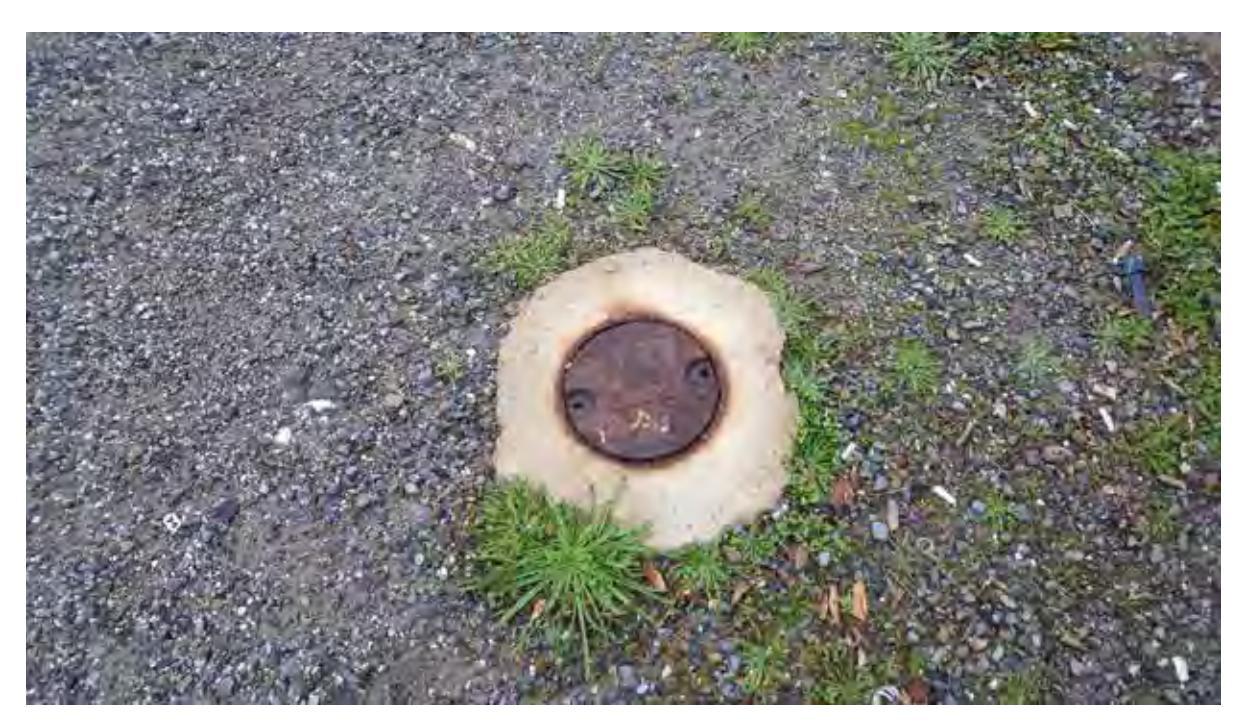
Photograph 9: View of well 12-MW36 at Site 12 Gateview Petroleum Area. Note missing bolts (1/10/2019).

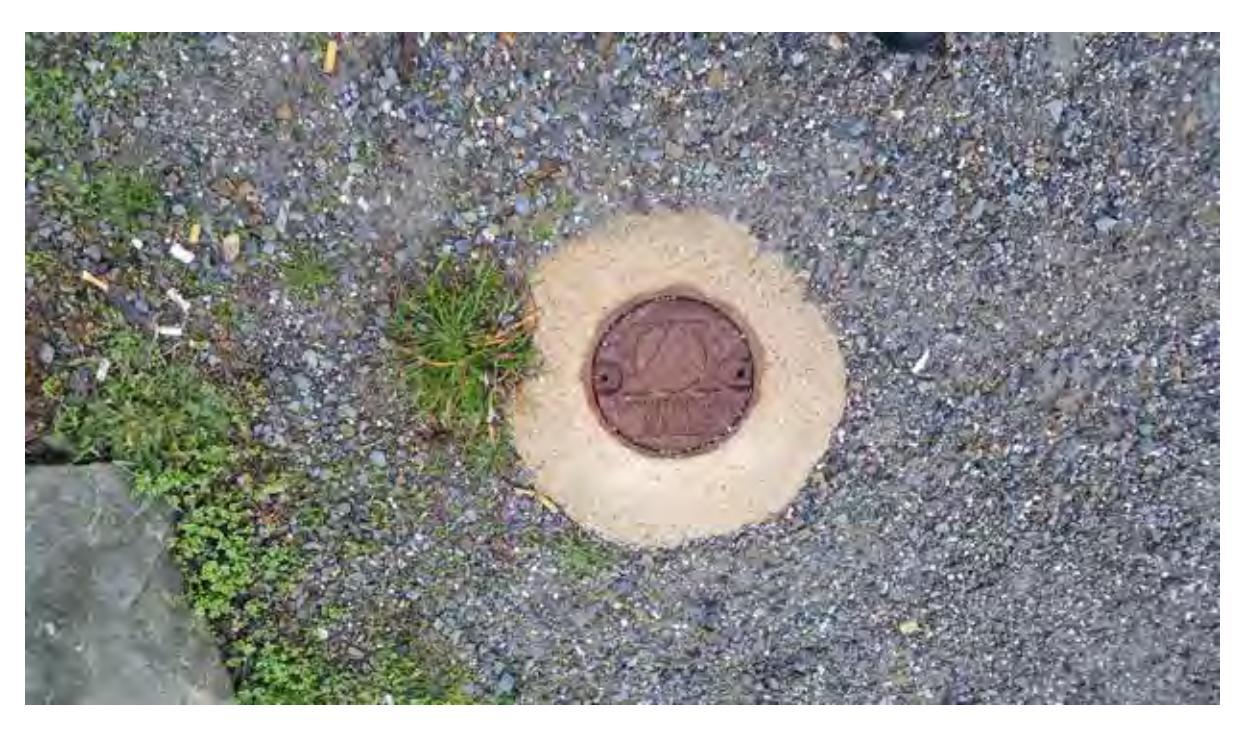
Photograph 11: View of well 12-MW37 at Site 12 Gateview Petroleum Area. Note missing bolts (1/10/2019).

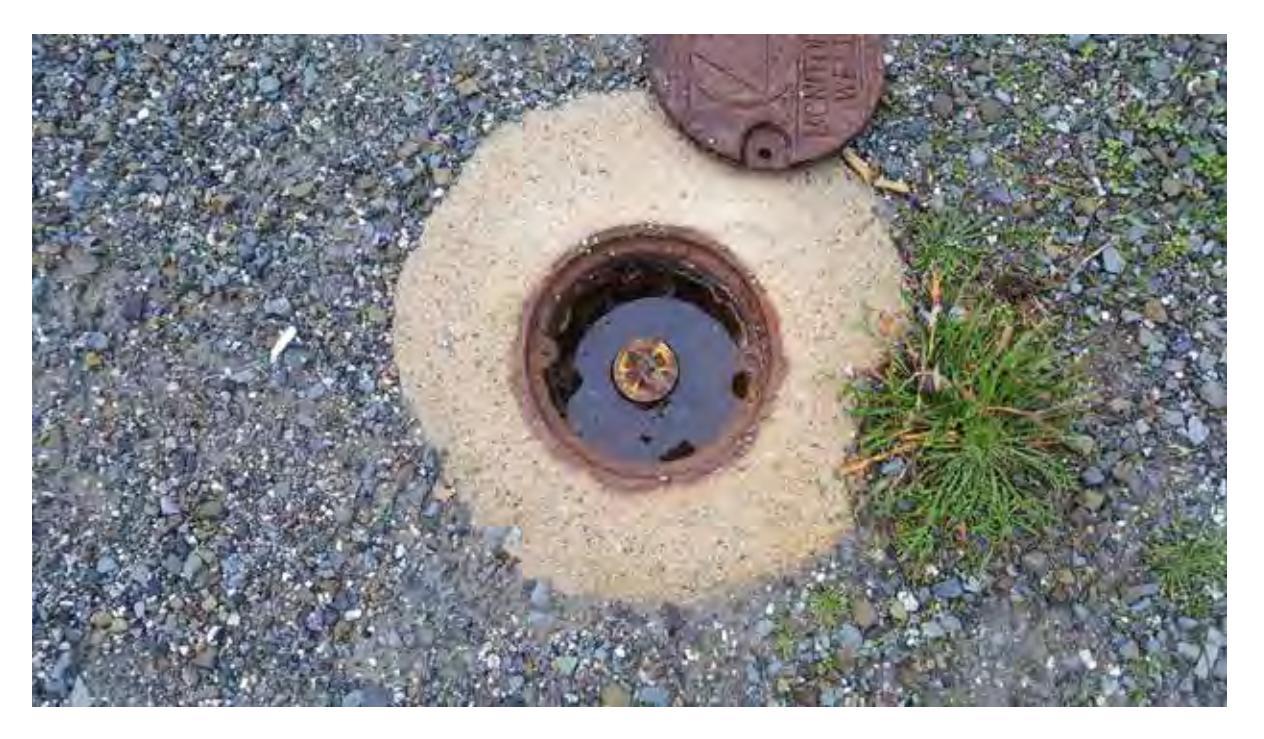
Photograph 12: View of flooded well box of well 12-MW37 at Site 12 Gateview Petroleum Area (1/10/2019).

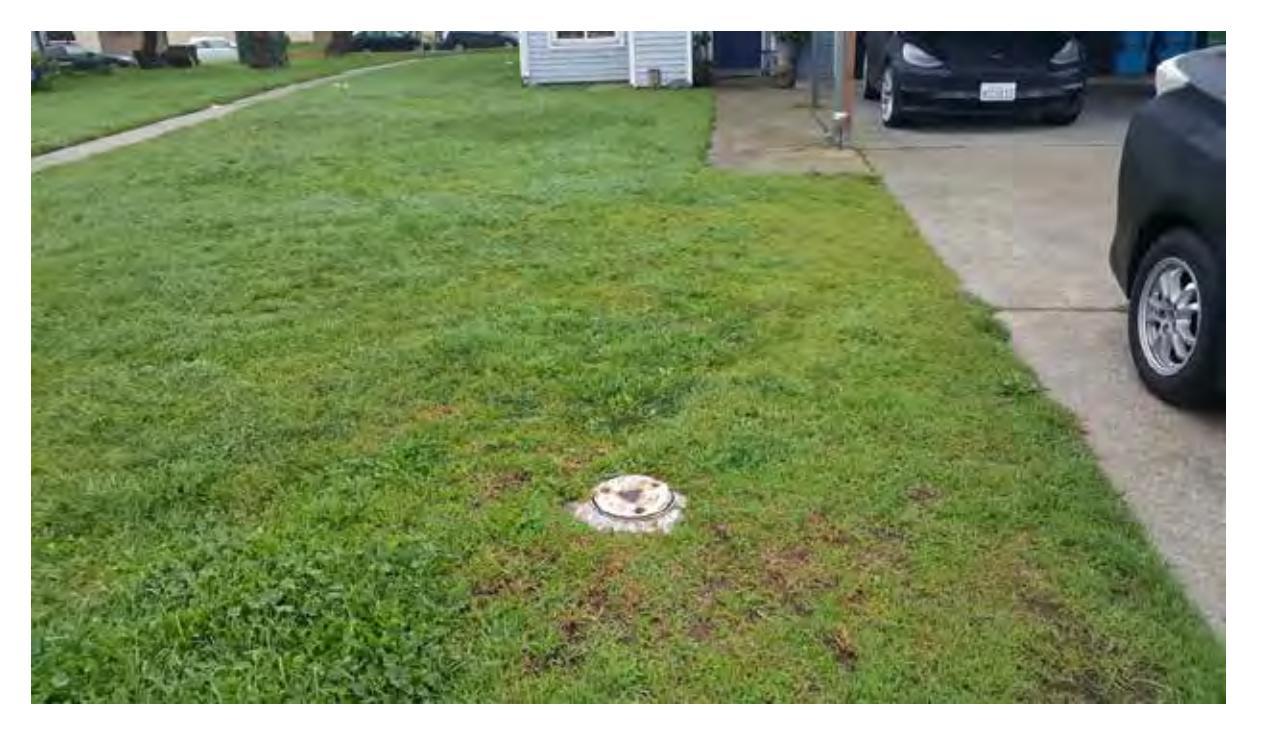
Photograph 18: View of well 12-MW07 at Site 12 Gateview Petroleum Area. Note missing bolts (1/10/2019).

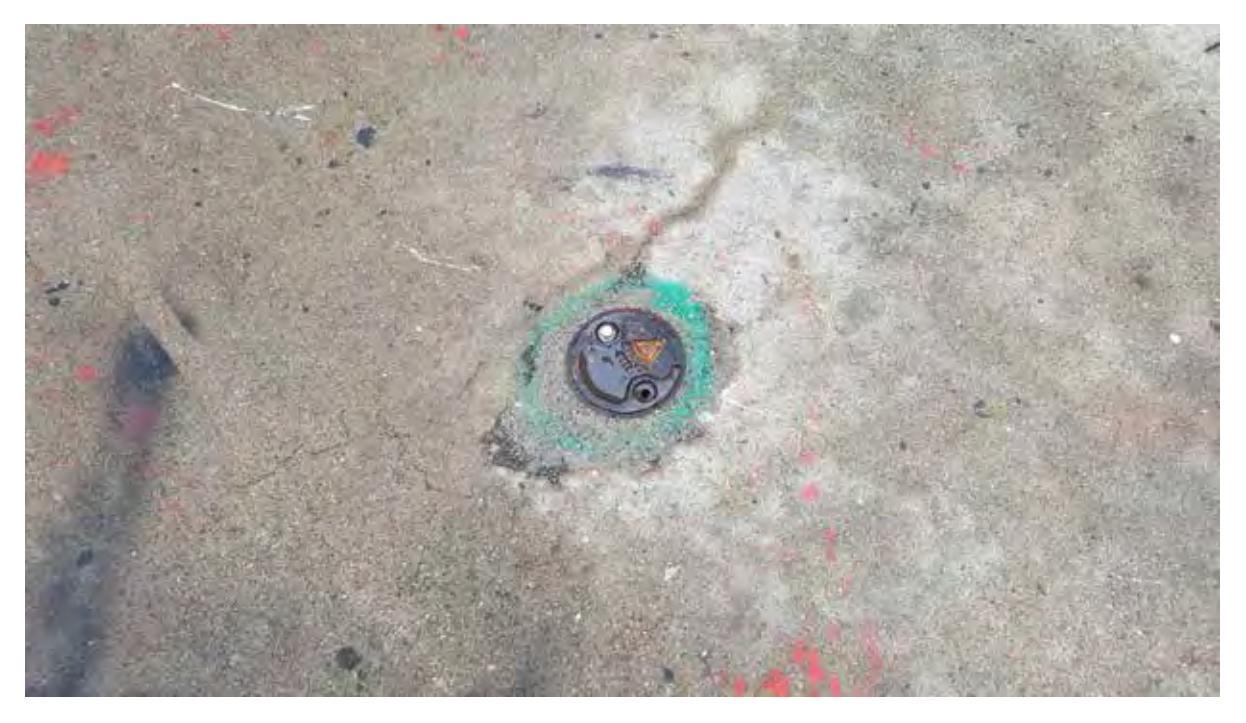
Photograph 14: View of well 21-SG01 at Site 21. Note missing bolt (1/8/2019).

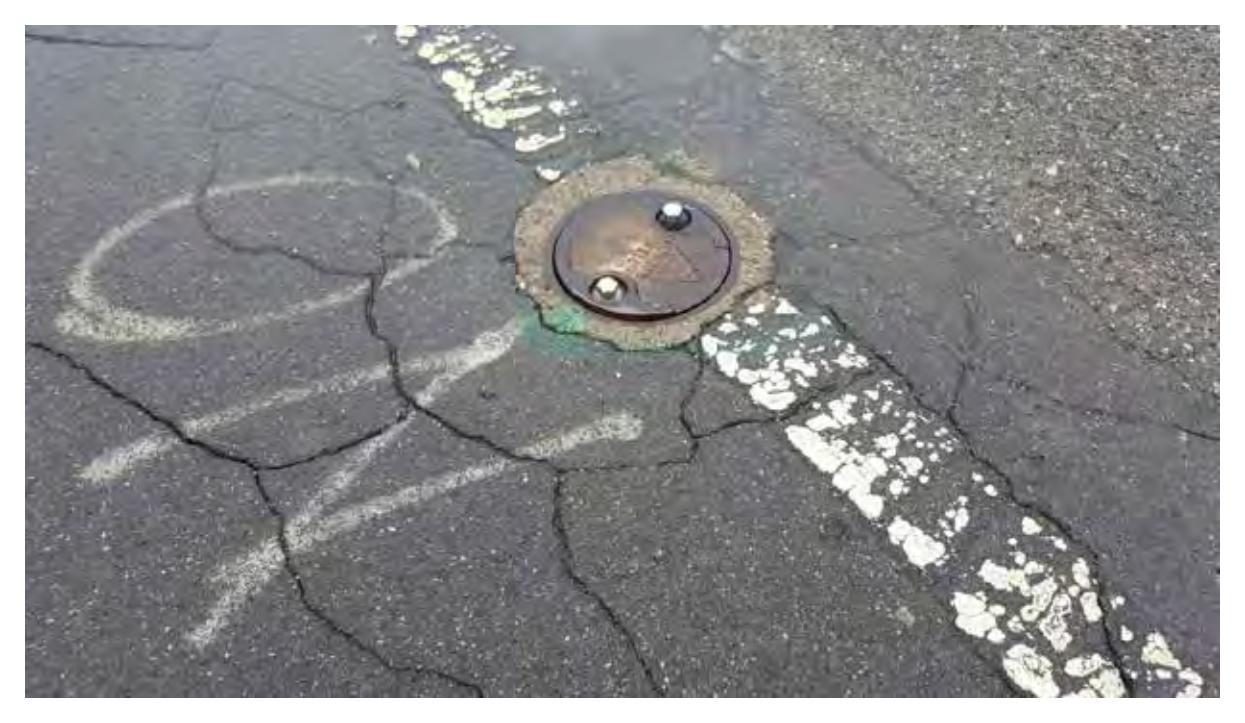
Photograph 15: View of well 21-IP10 at Site 21. Note raised bolts (1/8/2019).

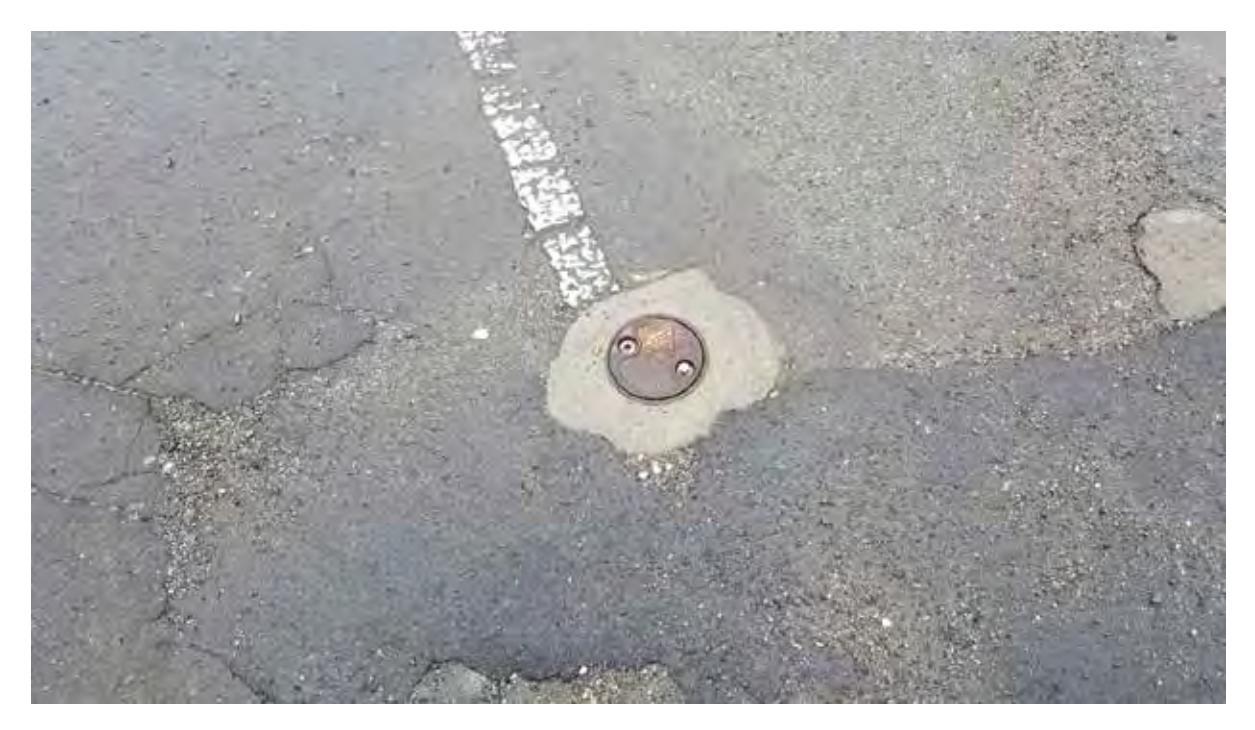
Photograph 16: View of well 21-IP11 at Site 21. Note missing bolt (1/8/2019).

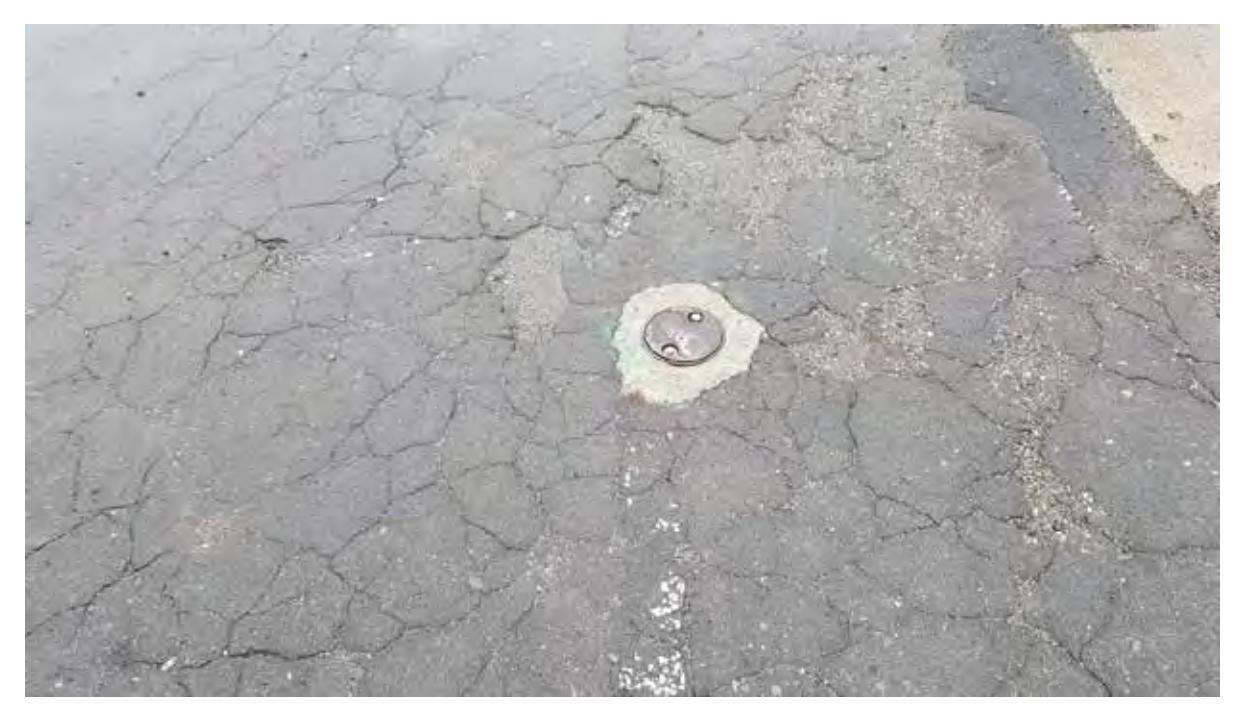
Photograph 17: View of well 21-IP12 at Site 21. Note missing bolt (1/8/2019).

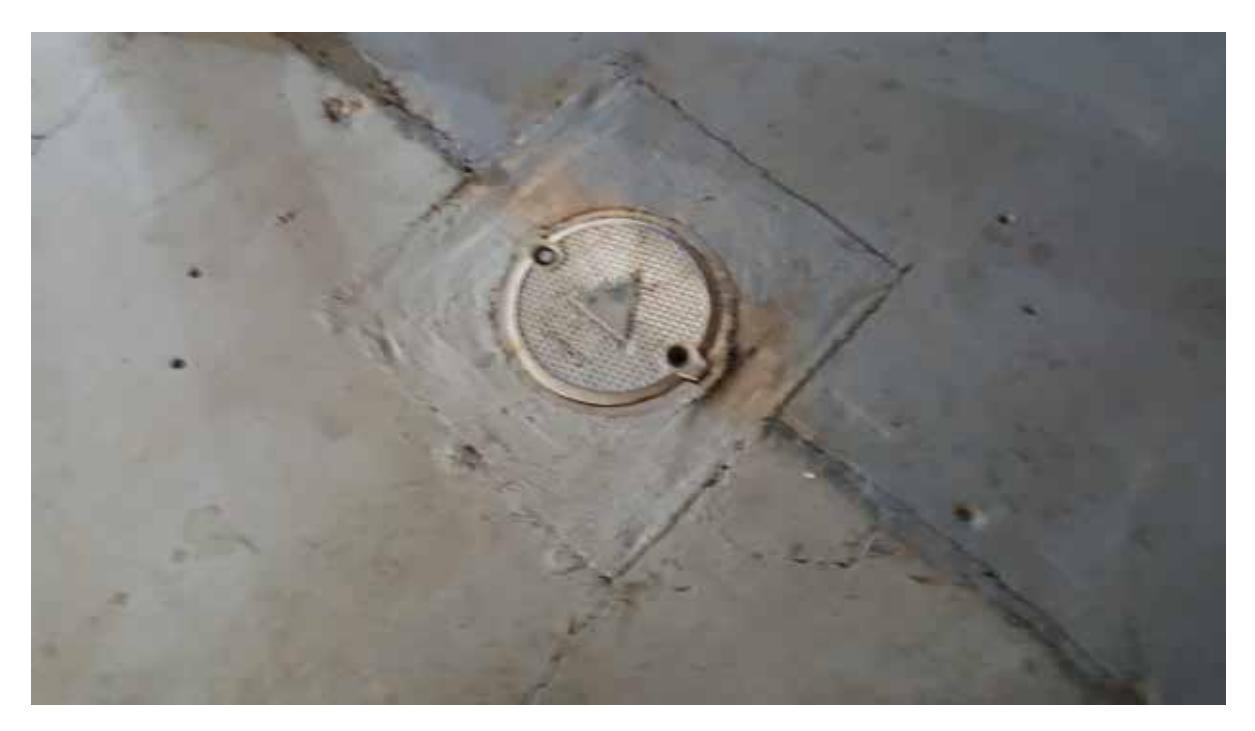
Photograph 11: View of 24-IW9 within Building 96 at Site 24. Note missing bolt (1/10/2019).

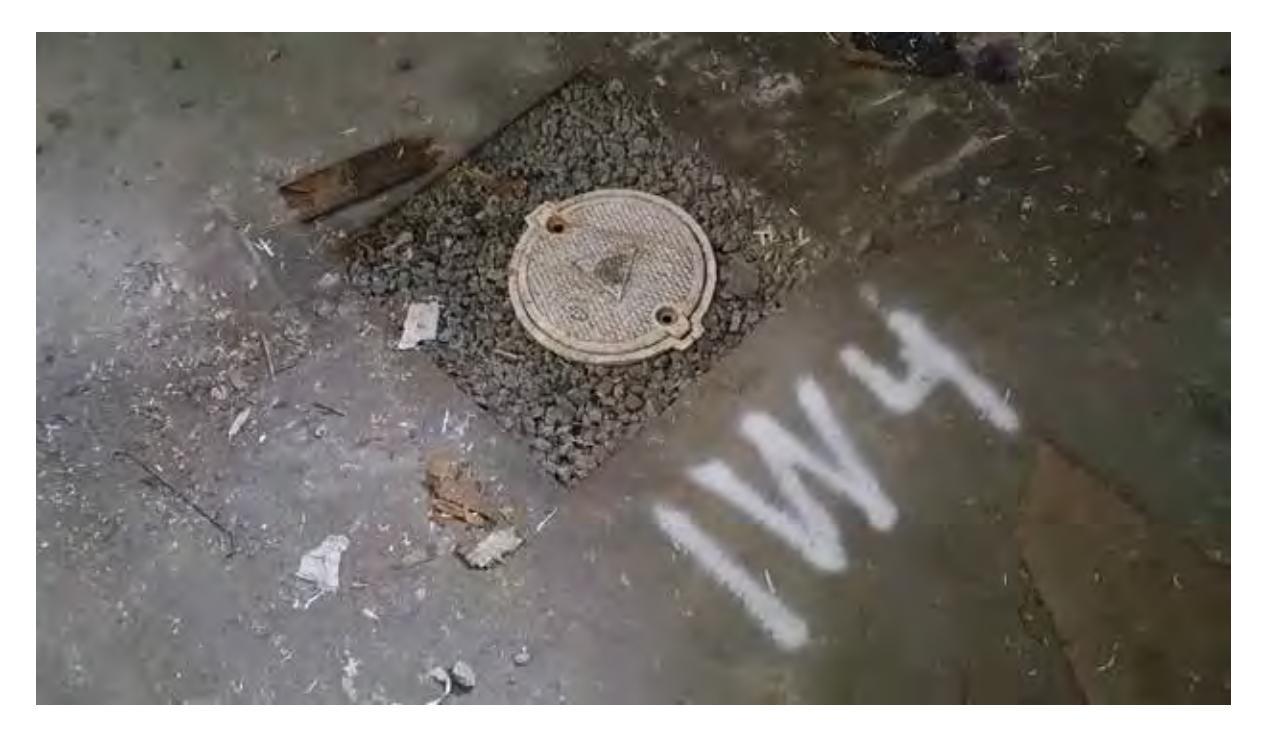
Photograph 16: View of 24-IW4 within Building 99 at Site 24. Note missing bolts (1/10/2019).

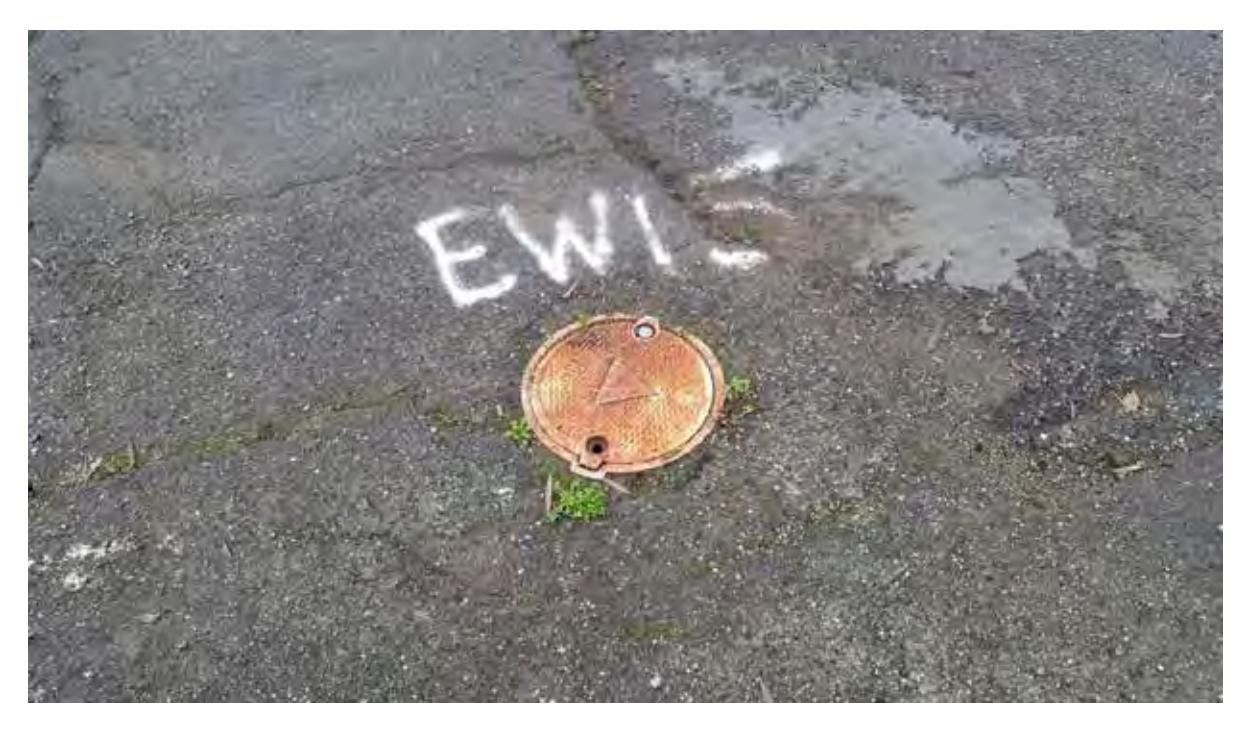
Photograph 19: View of 24-EW15 at Site 24. Note missing bolt (1/8/2019).

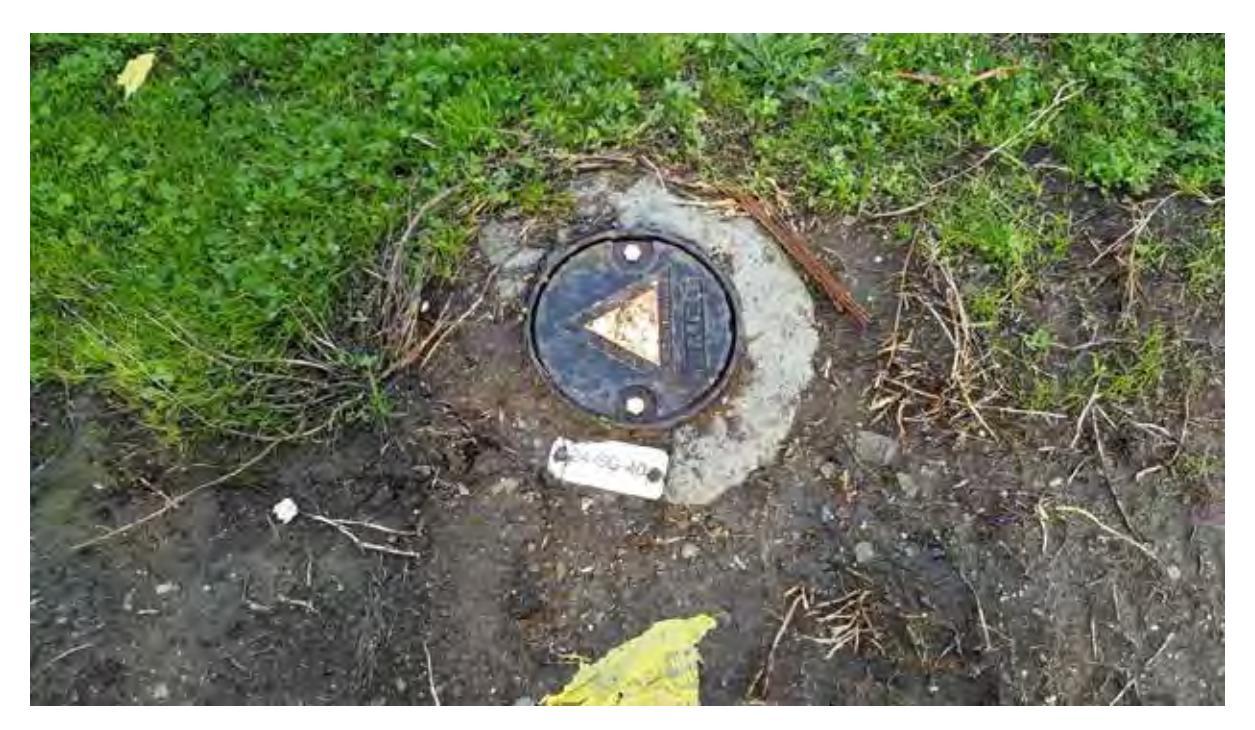
Photograph 25: View of 24-SG-40 at Site 24. Well not flush with ground, and likely damaged by heavy vehicle (1/8/2019).

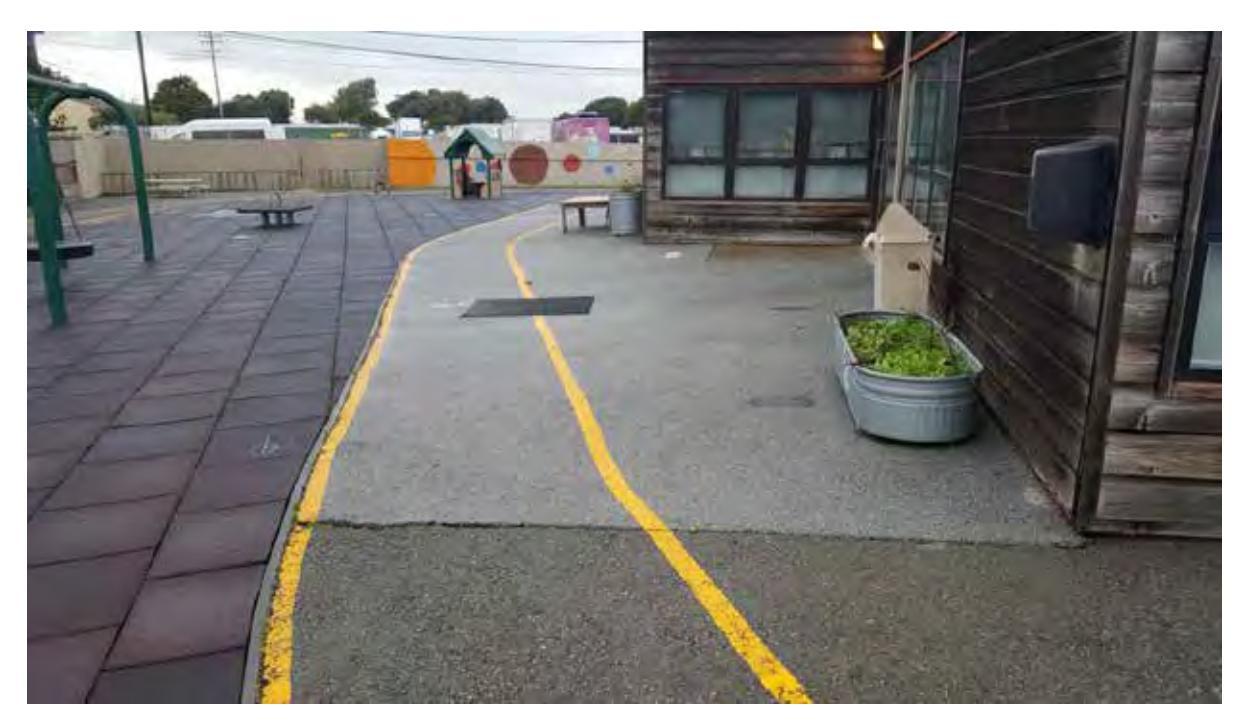
Photograph 17: View of southern edge of Site 30 concrete slab covering subterranean soil contaminants, looking north. Note weathering and minor degradation of asphalt seam (1/8/2019).

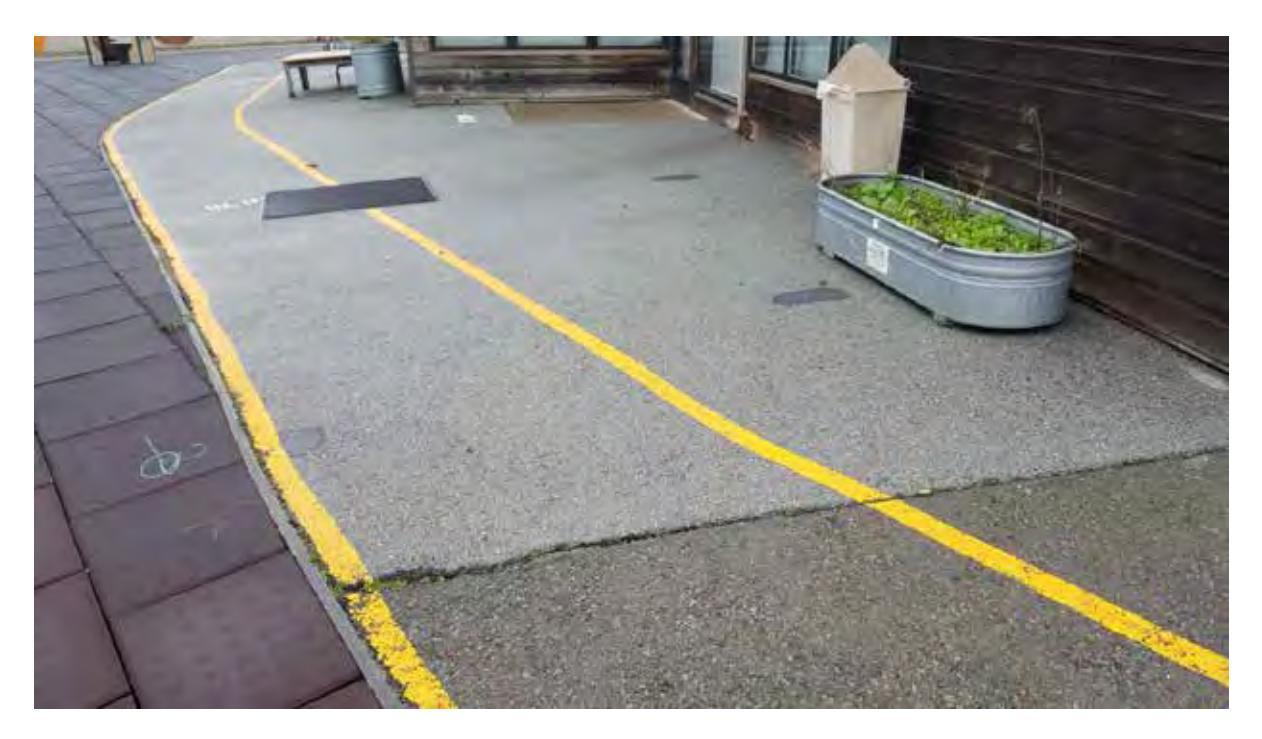
Photograph 18: View of southern edge of Site 30 concrete slab covering subterranean soil contaminants. Note weathering and minor degradation of asphalt seam (1/8/2019).

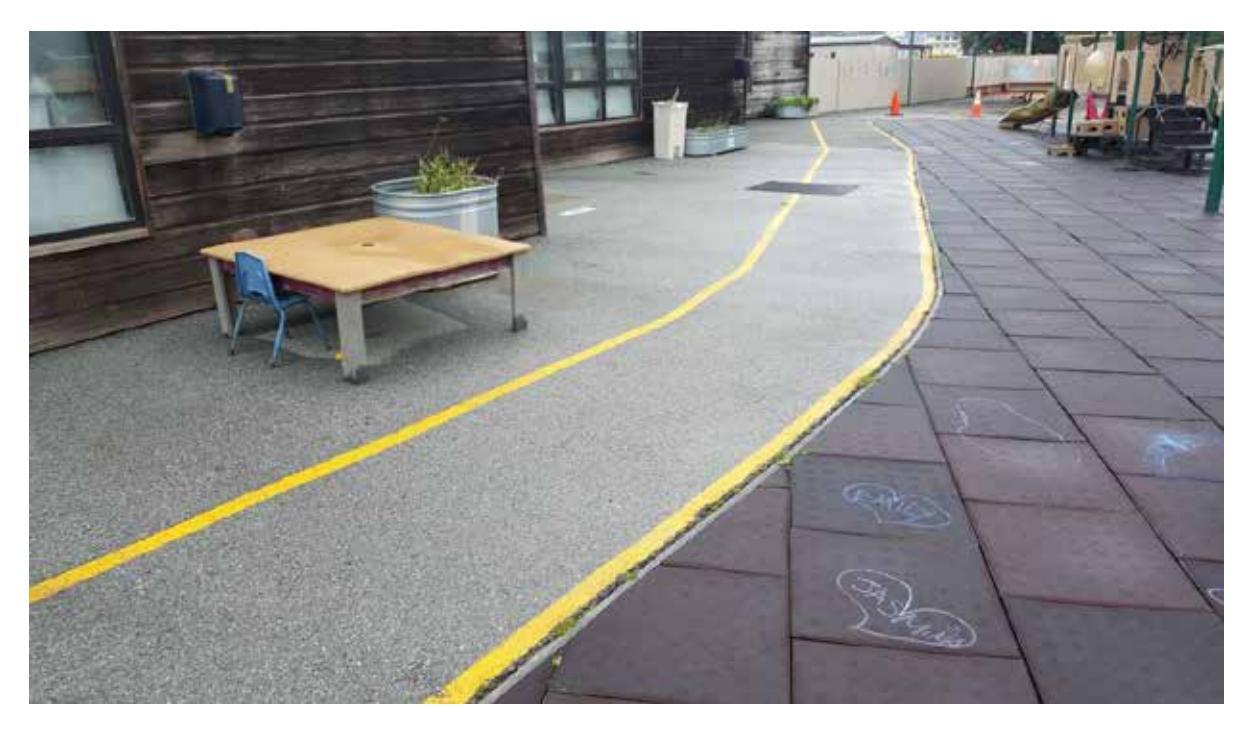
Photograph 20: View of concrete slab covering subterranean soil contamination from centerpoint of Site 30, looking south. Note weather degradation and vegetation growth along asphalt seam (1/8/2019).

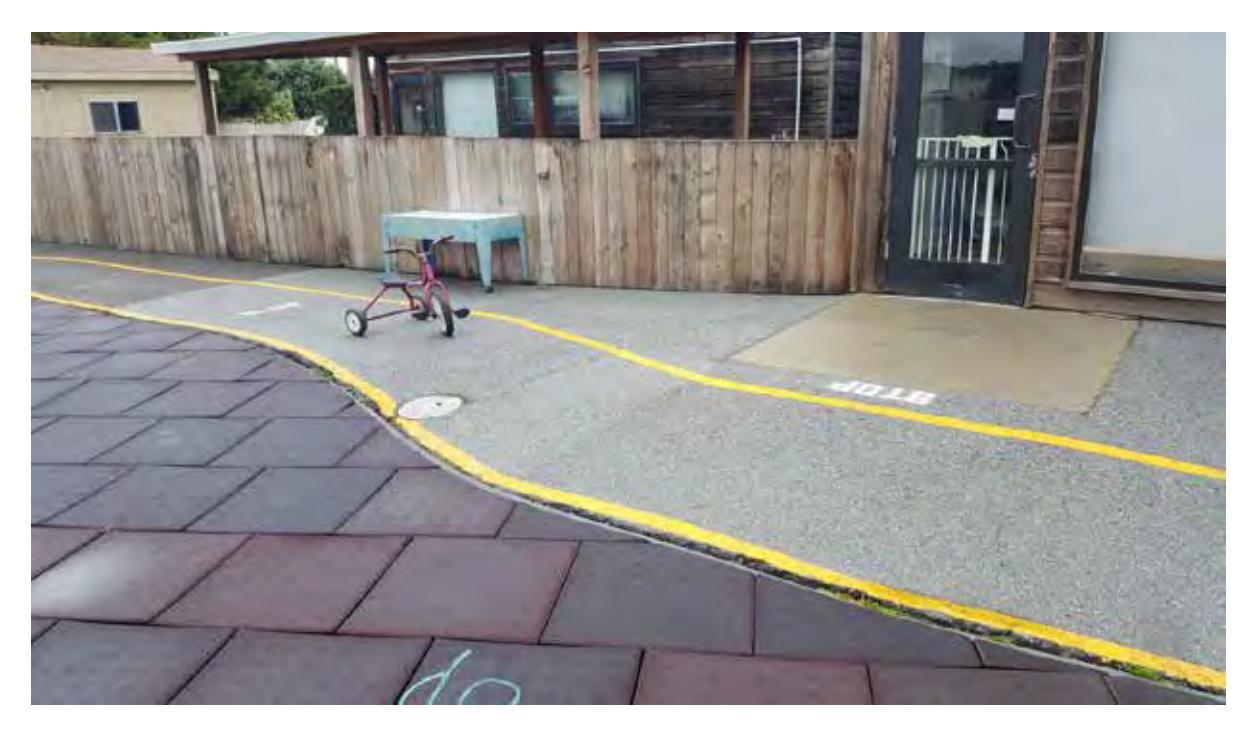
Photograph 21: View of concrete slab covering subterranean soil contamination from centerpoint of Site 30, looking north. Note weather degradation and vegetation growth along asphalt seam (1/8/2019).

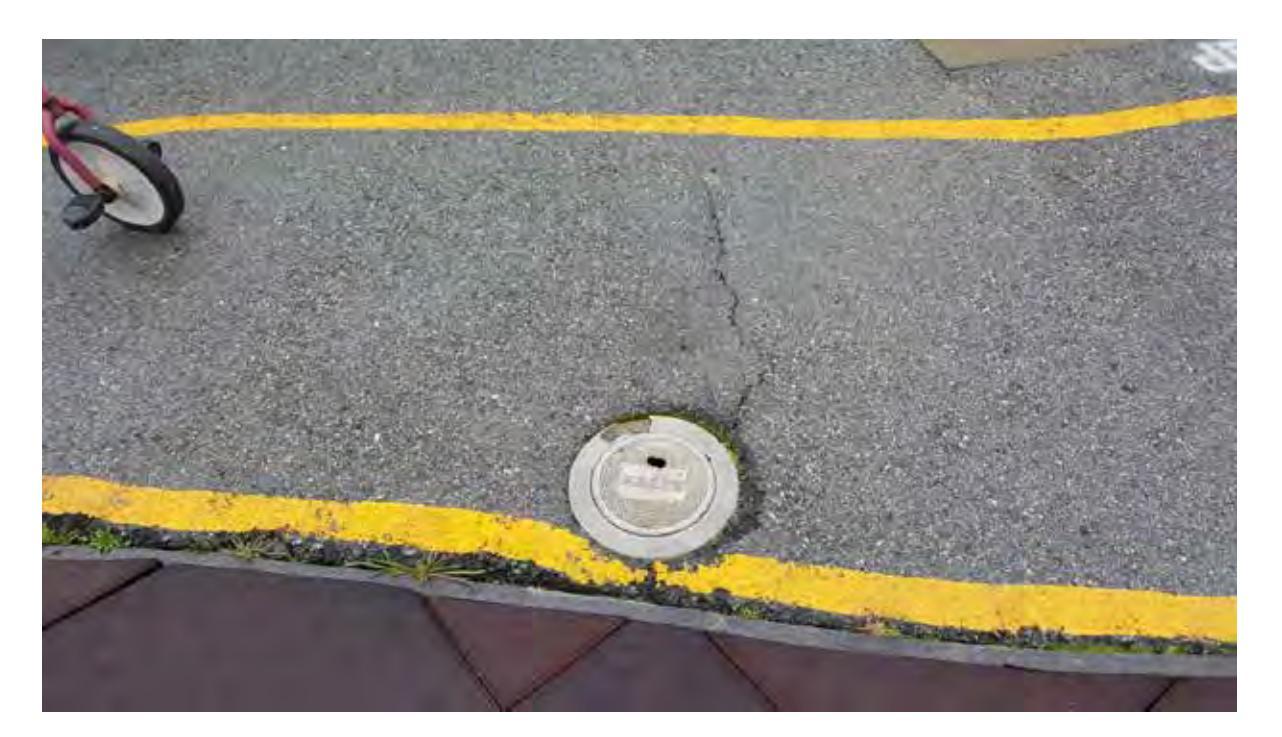
Photograph 22: View of small crack within concrete slab at Site 30. Note weather degradation and vegetation growth along asphalt seam (1/8/2019).

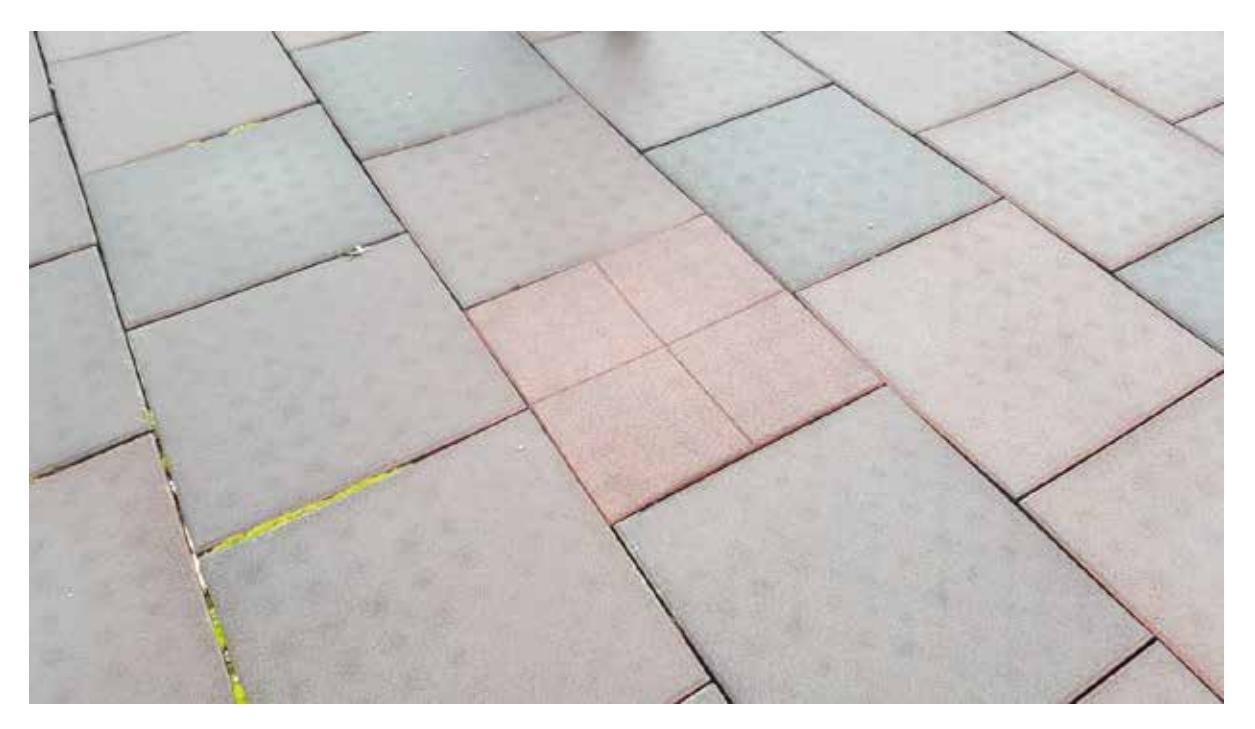
Photograph 25: View of vegetation growth between rubber tiles forming surface of play area at Site 30. Note replacement tile at center (1/8/2019).
