INSPECTOR GENERAL

(U) Evaluation of Army Pre-Positioned Equipment Issued in Response to Ukraine and the NATO Defense Forces

(U) February 27, 2023

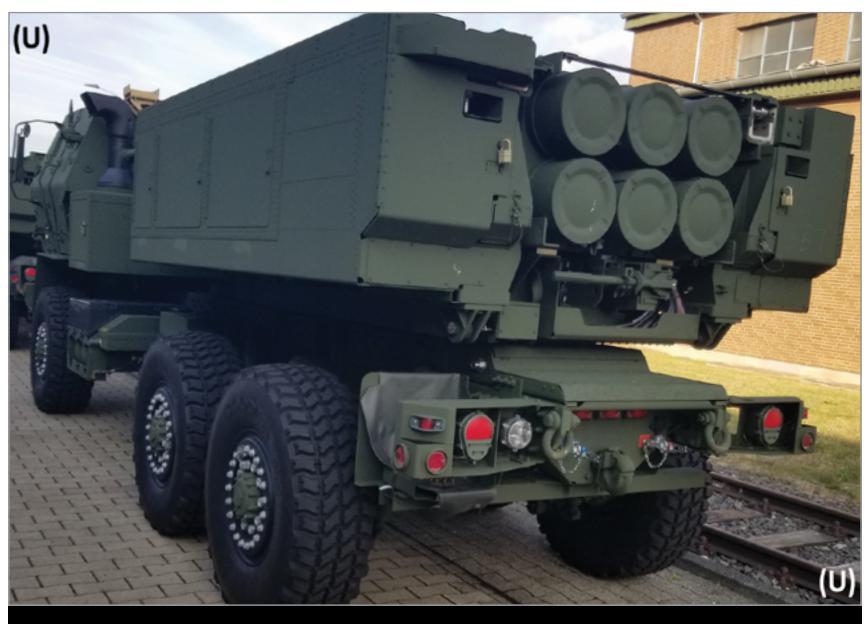
(U) Figure 2. A High Mobility Artillery Rocket System at Dulmen Work Site. (U) Source: The DoD OIG.

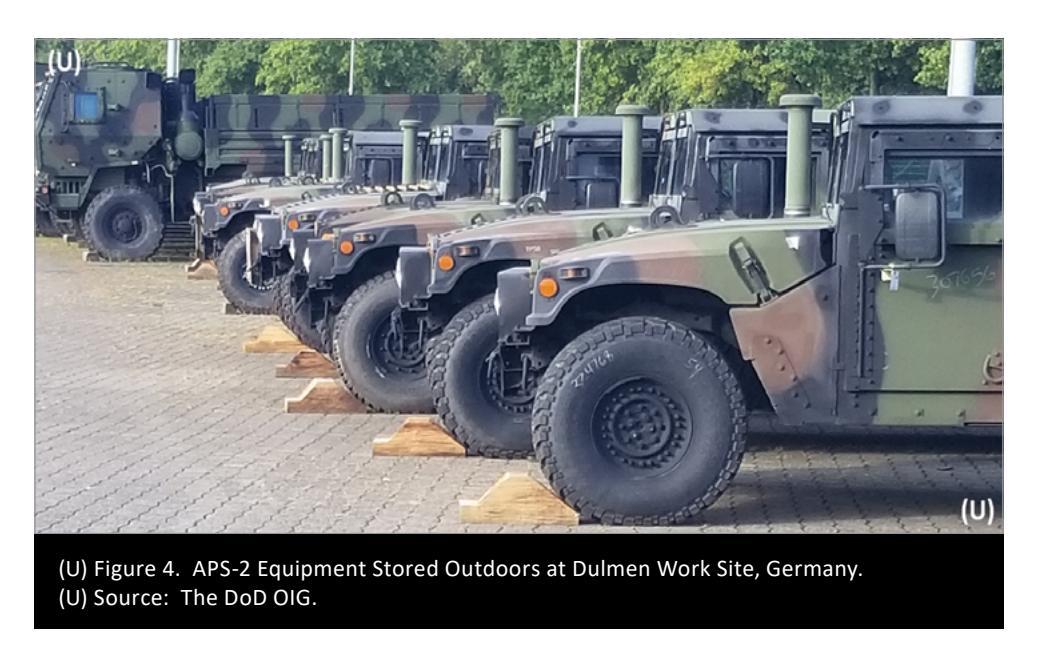
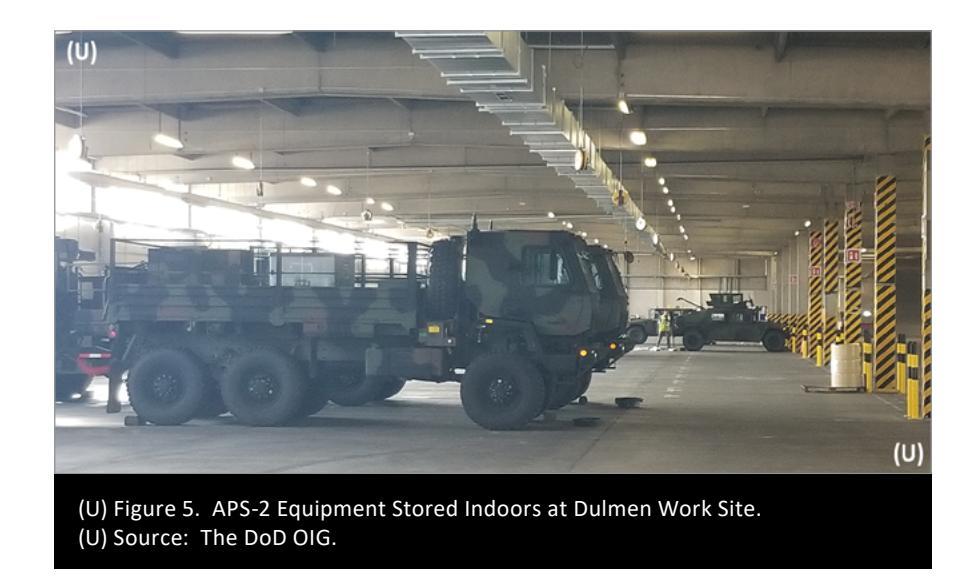
(U) The 405 AFSB could not exercise APS equipment during storage, as required in TM 38-470 and in equipment technical manuals, because their facilities do not have exercise tracks. According to TM 38-470, equipment exercise must be integrated into the cyclic maintenance program for APS equipment to the fullest extent possible. TM 38-470 states that the primary purpose of equipment exercise is to determine the degree of functionality of equipment, prevent its accelerated deterioration, and maintain the equipment's operational capability. It states that combat vehicles in storage require exercise every 36 months in a controlled humidity environment, and every 18 months if stored outdoors. Tactical vehicles in storage require exercise every 48 months in a controlled humidity environment, and every 24 months, if stored outdoors.

(U) The lack of 405 AFSB exercise tracks contributed to the 405 AFSB issuing equipment to the 1 ABCT that was non-FMC. An AFSBn–Mannheim official stated that there was no exercise track at either Dulmen Work Site or Coleman Work Site to carry out this vehicle exercise requirement. We physically observed that neither site has an exercise track.

(U) A maintenance and a support operations officer from the Mannheim battalion stated that, because of the lack of a dedicated exercise track, APS-2 contractor personnel are unable to exercise vehicles, per the exercise requirements in the vehicle technical manuals. An AFSBn maintenance official stated that many equipment faults that render vehicles non-FMC often go undetected because the vehicles do not receive required exercise. A senior AFSBn contracting officer's representative stated that many APS-2 vehicle faults are caused by the COSIS cycle, and mission capability will not improve without regular exercise of APS-2 equipment.

(U) We recommend that the Commander of the 405 Army Field Support Brigade, in coordination with the Commander of the Army Materiel Command, identify and implement ways to exercise APS-2 equipment, in accordance with care of supplies in storage and Technical Manual 38-470 requirements.

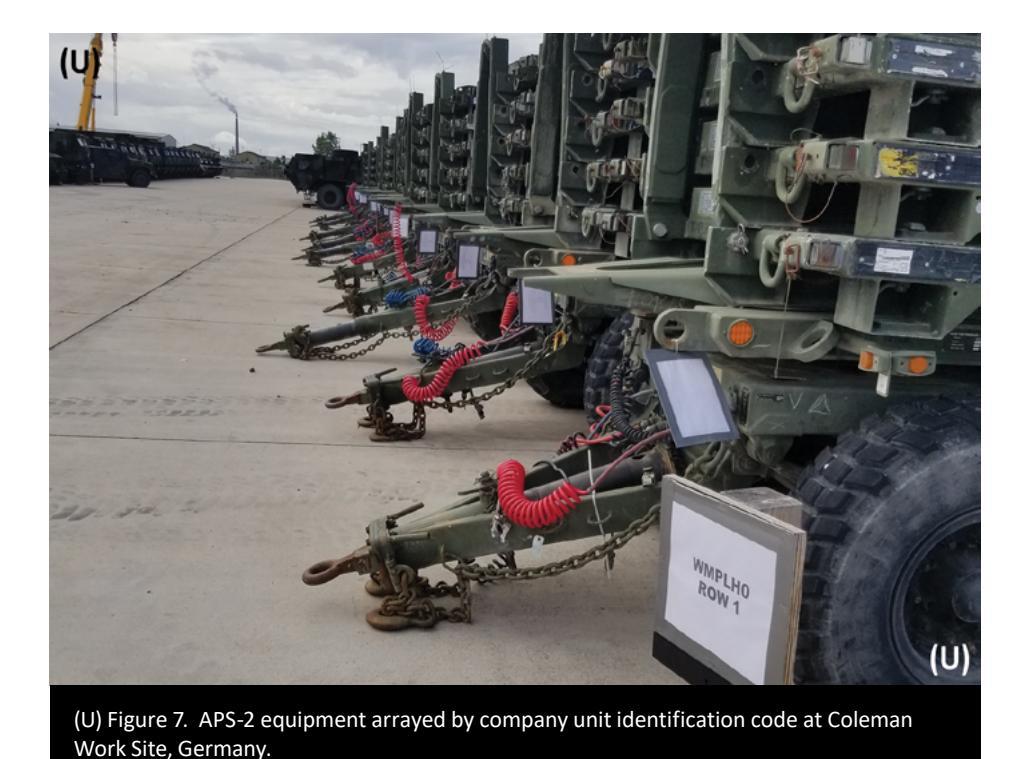
(CUI) A 1 ABCT maintenance official stated that a lack of APS-2 vehicles configured for combat at the handover area was a challenge for the 1 ABCT, as many issued vehicles did not have the necessary secondary items to ensure that they worked properly. The 1 ABCT maintenance official said that, for example, over 60 percent of the M88 recovery vehicles issued to the 1 ABCT did not have all of their required secondary equipment in the vehicle, and that the 1 ABCT had to remove parts from multiple M88 recovery vehicles to create working M88s.

(U) APS doctrine instructs APS sites to configure unit sets of equipment for combat before issuance, to reduce equipment issuance times. ATP 3-35.1 states that APS unit sets may be configured for combat to reduce the preparation and issuance time required to round out deploying Army units. This reduces installation, configuration times, maintenance, inventories, and other logistical activities for units drawing APS equipment. Additionally, ATP 3-35.1 states that equipment in combat configuration and maintained at FMC standards reduces equipment issuance times.

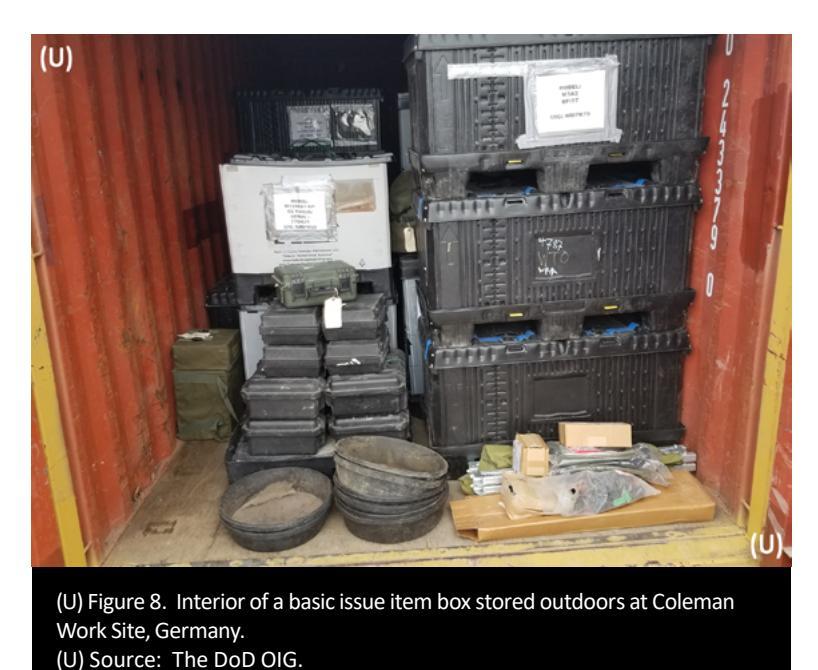
(U) The type of equipment configuration at the APS storage sites has ramifications for how quickly the APS-2 equipment can be transported to a handover area. An AFSBn-Germany official stated that AFSBn personnel at the APS-2 sites store equipment in configure for combat format due to guidance from the AMC, and therefore personnel at APS-2 sites store basic issue items and components of end items alongside their associated vehicles (Figure 8).¹⁹

(U) AR 190-51 states that communications and electronic equipment, tool sets, night vision devices, and other high-value optical equipment require double barrier protection when not in use, including during transit. AR 190-51 further states that units must secure these items within two locked and secured containers or structures.²⁰ To meet these requirements, an AFSBn–Mannheim official stated that APS-2 sites should store APS-2 equipment in a configuration for transportation status, as opposed to a configured for combat status. This official stated that 405 AFSB personnel install communications systems in the vehicles at the storage sites as part of configure for combat, but then personnel must uninstall communications systems and pack them separately for transporting when it is time to transport them to the handover area.
