SFO Shoreline Structures Repair Program

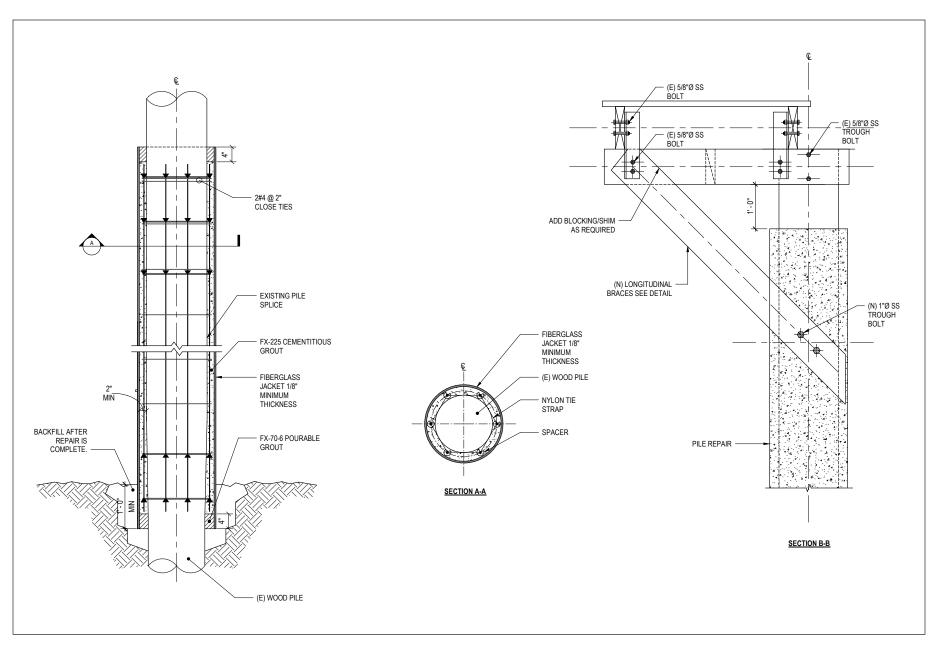
## FIGURE 3 PIER/PILE STRENGTHENING DETAIL

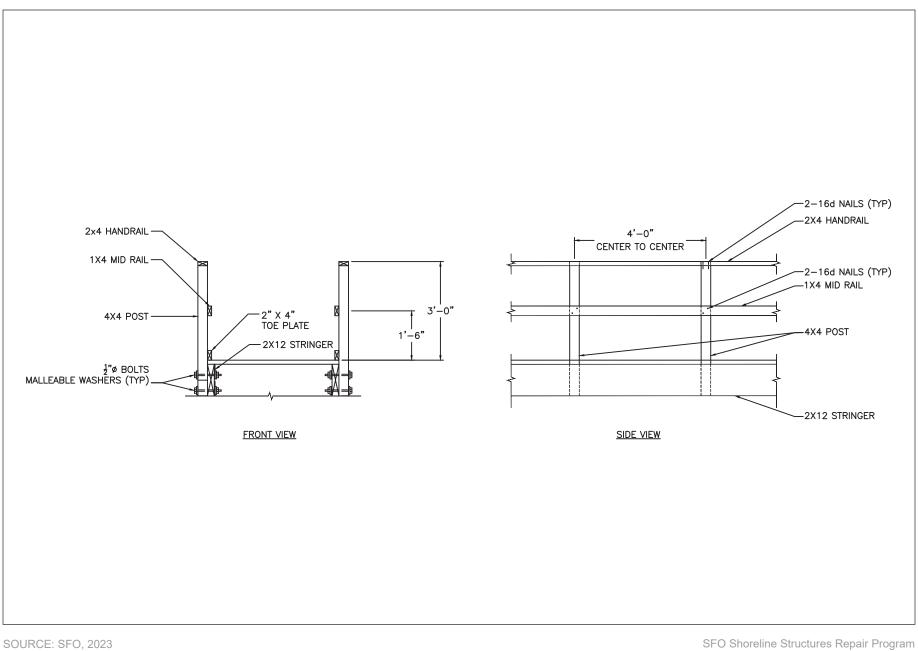
FIGURE 4 TYPICAL TIMBER TRESTLE COMPONENT REPAIR – GUARDRAIL AND STRINGER

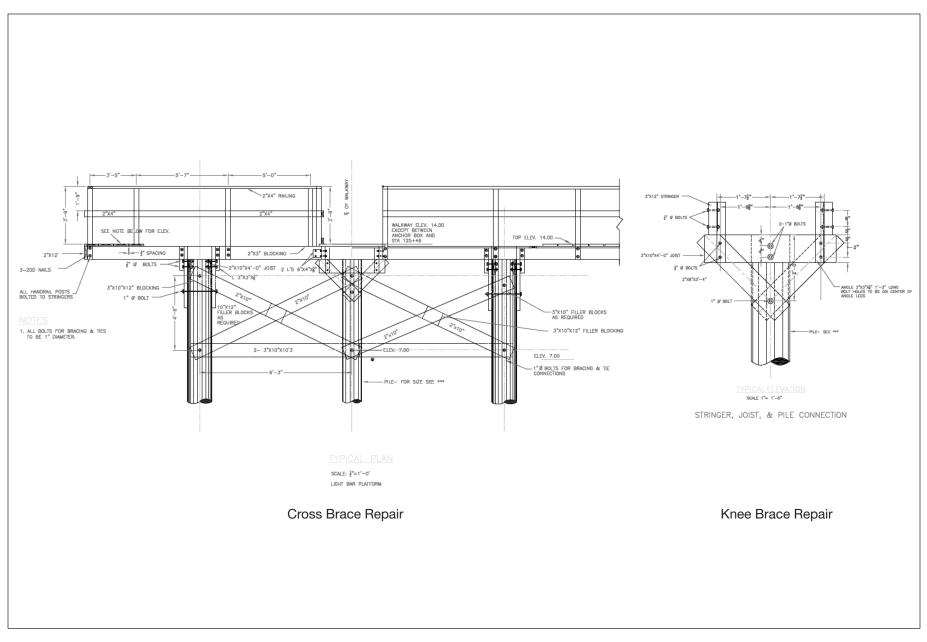
## FIGURE 5 TYPICAL TIMBER TRESTLE COMPONENT REPAIR – CROSS AND KNEE BRACE

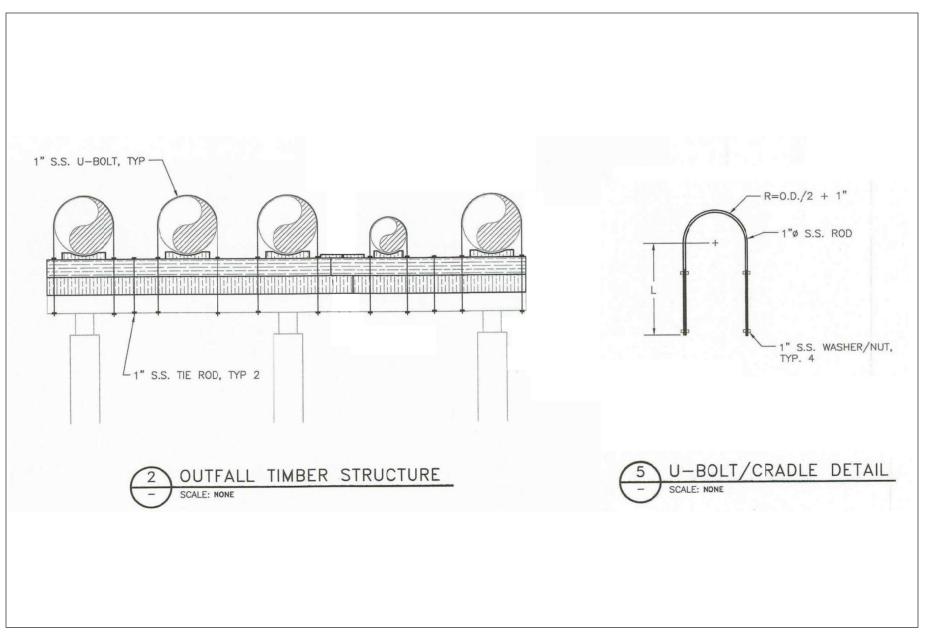
## FIGURE 6 OUTFALL CONNECTION STRAP REPLACEMENT
