То:	OceanGate
From:	, Director of Marine Operations
Date:	1/19/18
Re:	Cyclops 2 (Titan)

### **OCEANGATE CYCLOPS 2 QUALITY CONTROL INSPECTION REPORT**

PROJECT NAME:	CYCLOPS 2 (TITAN)	DOCUMENT VERSION NO:	1
PREPARED BY:		DOCUMENT DATE:	18 <sup>th</sup> JANUARY 2018

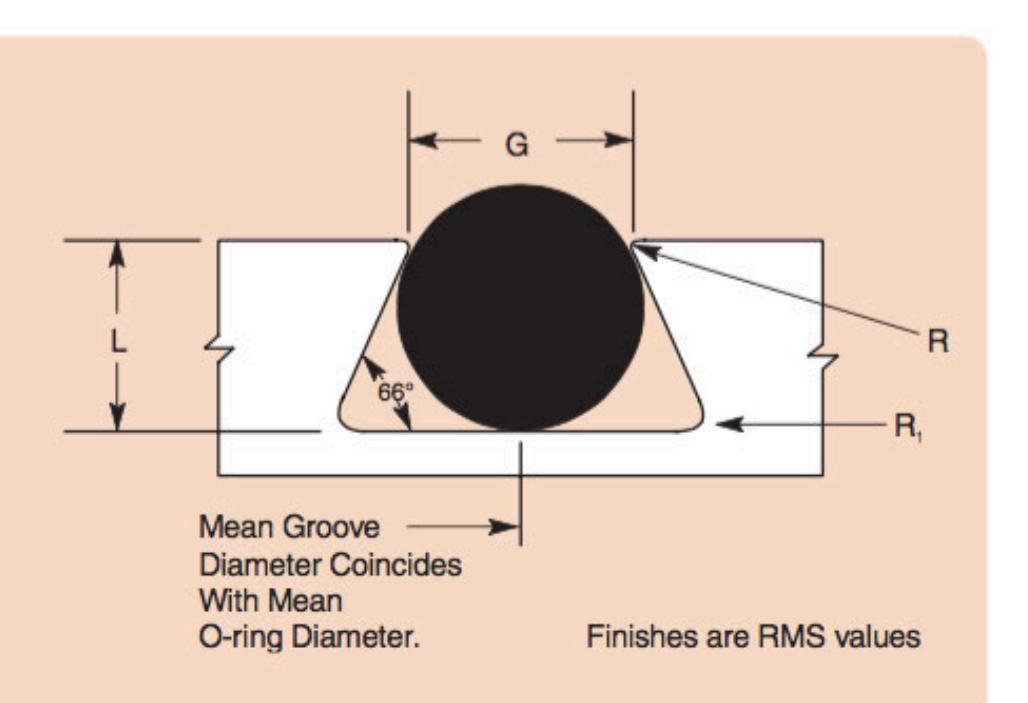
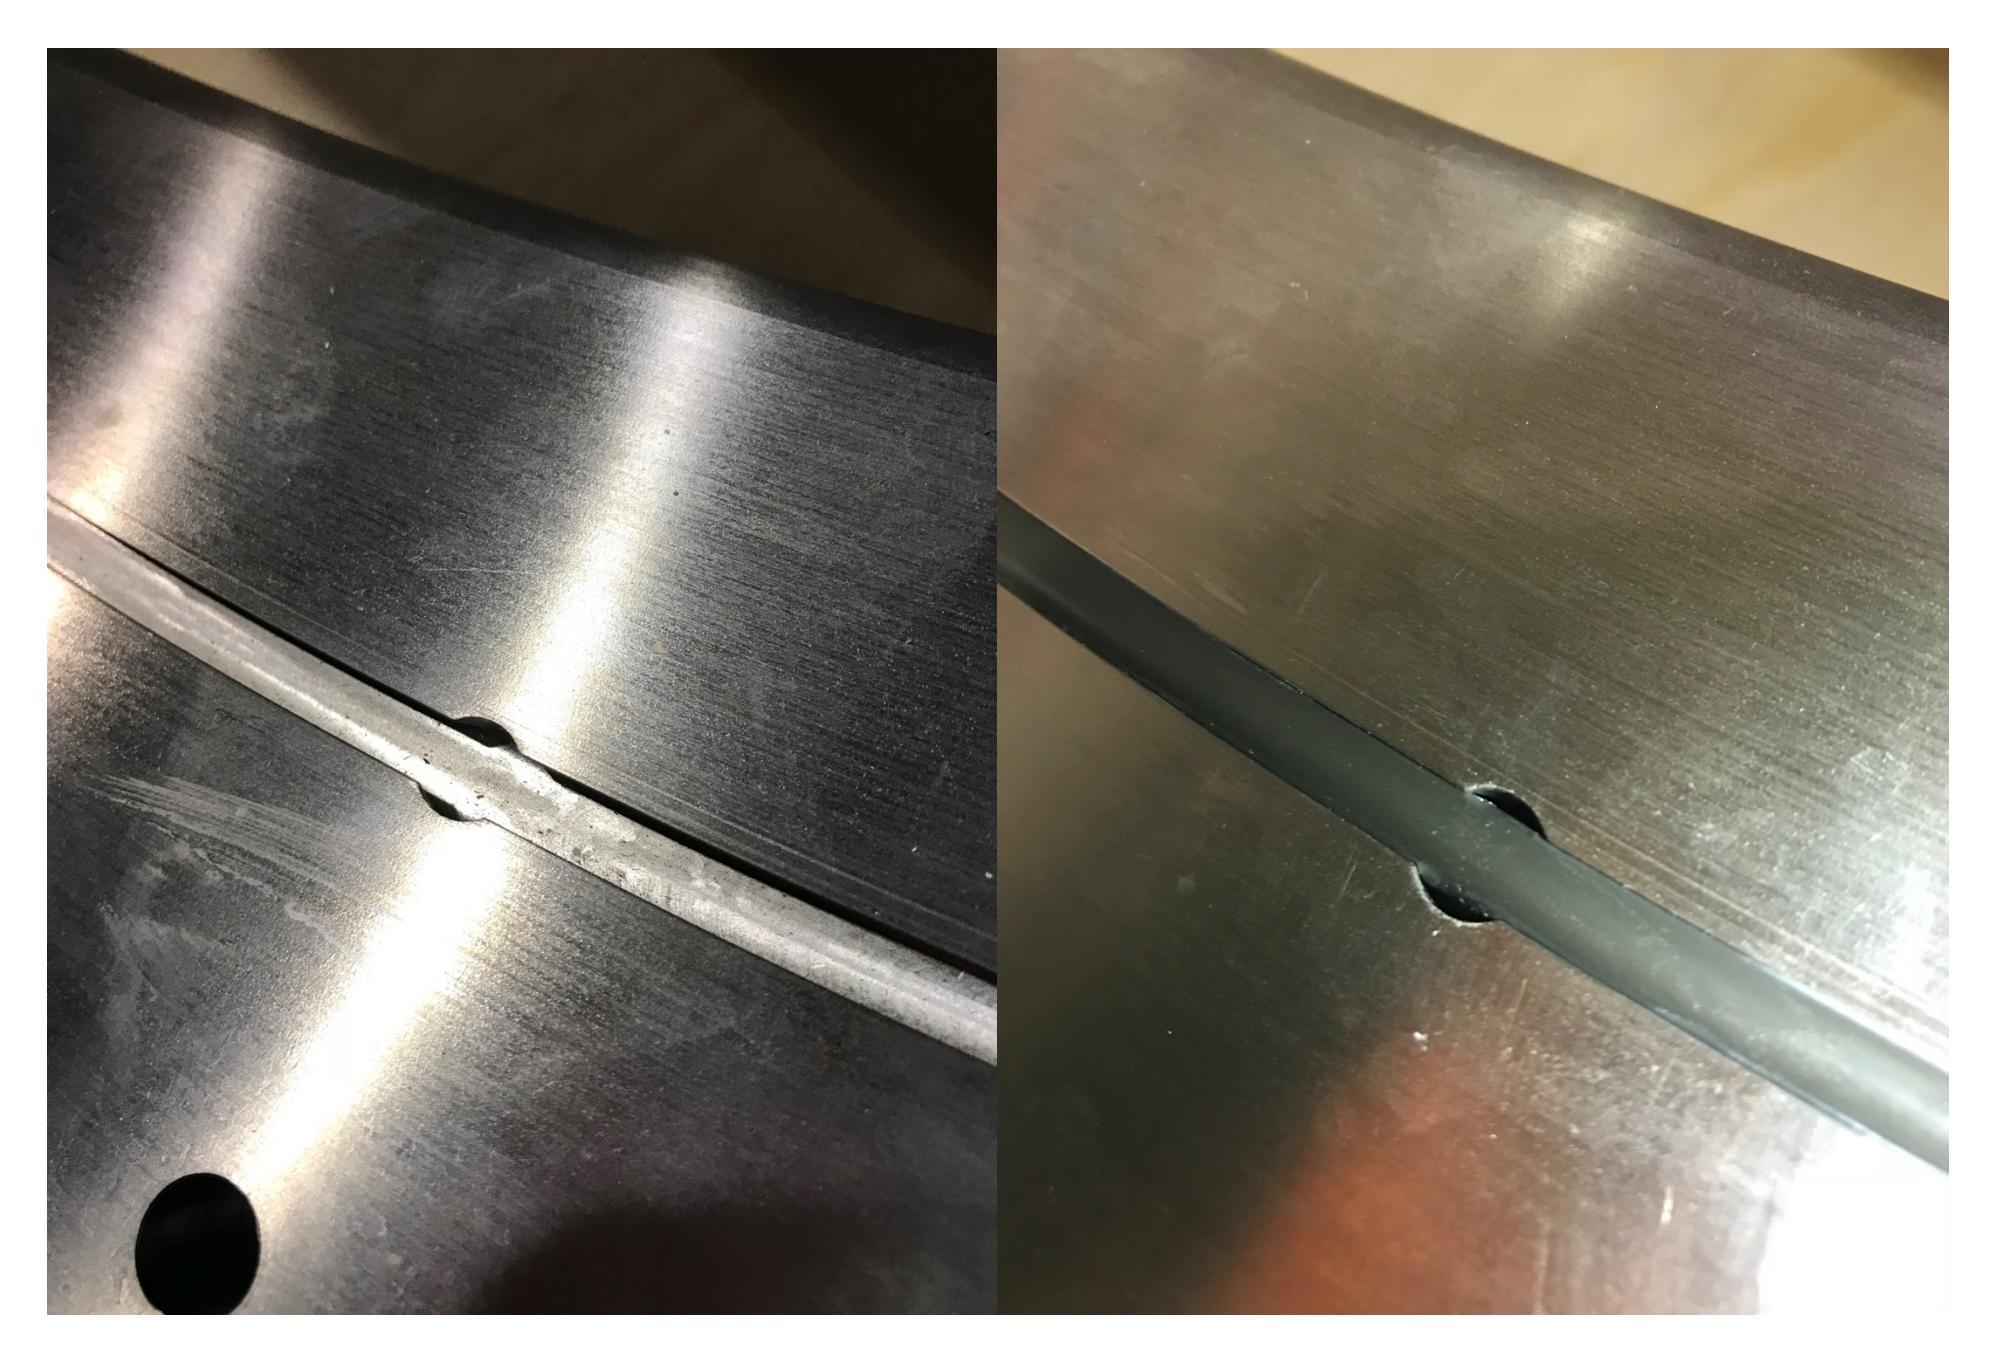
The PDF image below shows the type of O-ring groove currently machined on both Forward and Aft Cyclops 2 (Titan) Dome sealing faces. This selection deviates from the standard design process for our application.

The addition of the unnecessary plunge hole on both our O-ring grooves also deviates from standard design process.

As can be seen on both the images on the next page the O-rings are not fully captivated due to the plunge hole, and this void on either side creates the potential for the least path of resistance of seawater. In my experience the potential for this issue will be exacerbated if we see any sort of buckling of the materials during the immense pressure changes as we go deeper.

It should be noted that although this method has been used successfully, it is not generally recommended. The inherent characteristics of the groove design limit the amount of void area. Normally acceptable tolerance extremes, wide service temperature ranges, and fluid media that cause high swell of the elastomer are conditions that cannot be tolerated in this type of groove design.

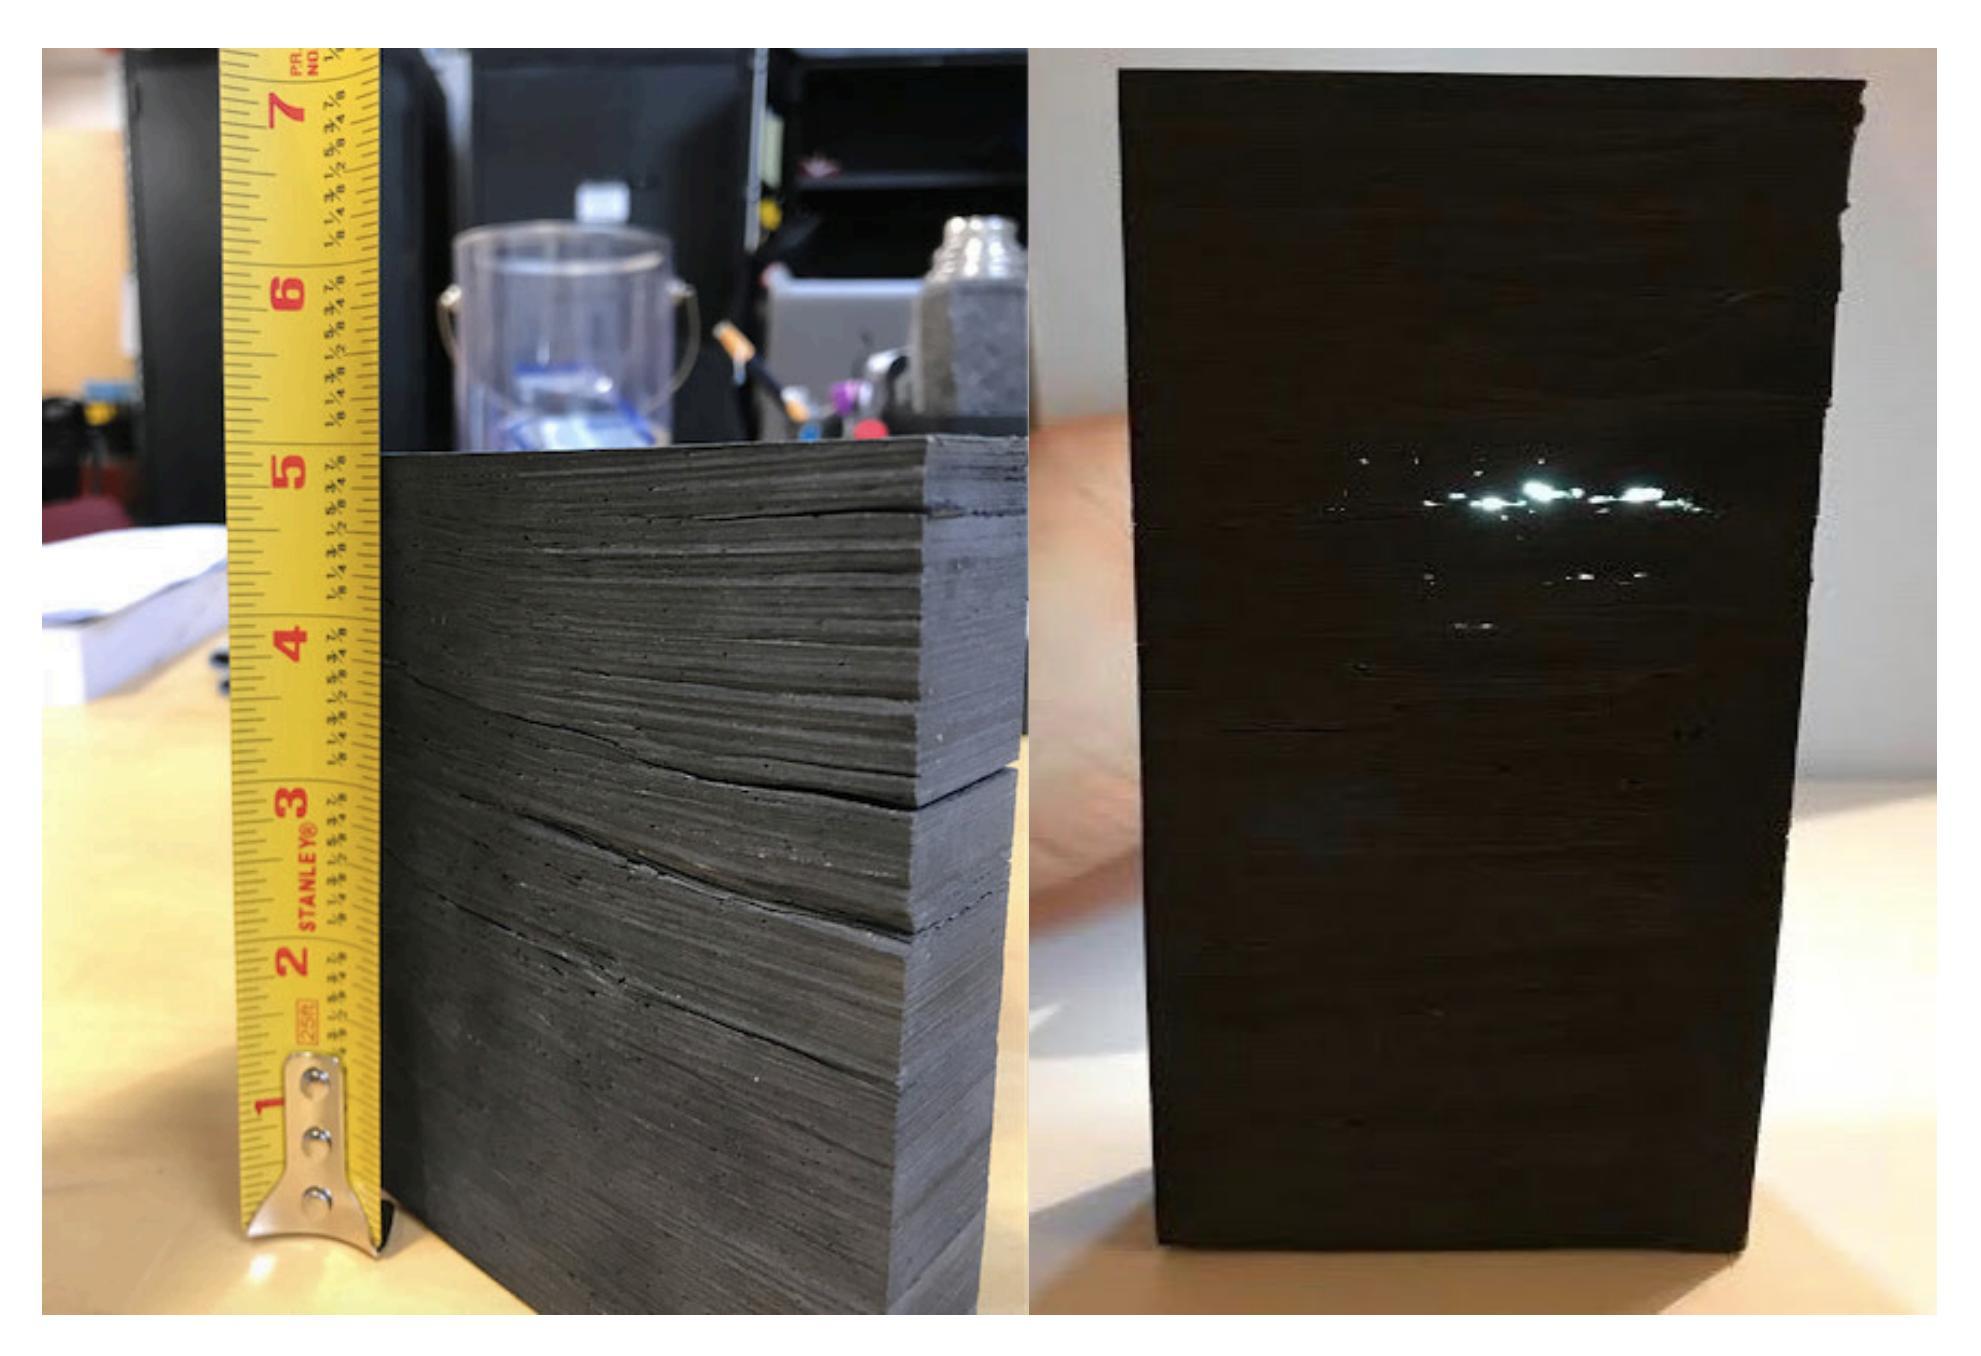
As we have all seen the Carbon hull end sections that were machined off after the completion of the winding show very visible signs of delamination and porosity within the Carbon.

I understand that most Carbon manufacturers expect some but not an excess of porosity (voids) from their end sections hence why they too machine off the ends after winding. With our application of the hull seeing such immense pressures not yet experienced on any known carbon hulled vehicle we run the risk of potential inter-laminar fatigue due to pressure cycling, this especially if we do have imperfections in the hull itself.

Image 1 shows a section of the hull end segment cut off with visible delamination's and porosity

Image 2 shows another piece of the hull end segment cut off with intense light shined onto it from behind, this method shows how prevalent the porosity actually is throughout.

We should fully endorse what the company initially set out to do and carry out a full Non Destructive Inspection of both the hull and also the Bond line between the Carbon hull and both Segment 1 and 2. The results will provide us all with the knowledge that either the hull is indeed intact or there may be deficiencies. This also applies to the Bond line to verify the adhesion process. The images on the following page show examples of the delamination's and porosity within our hull cut off sections.

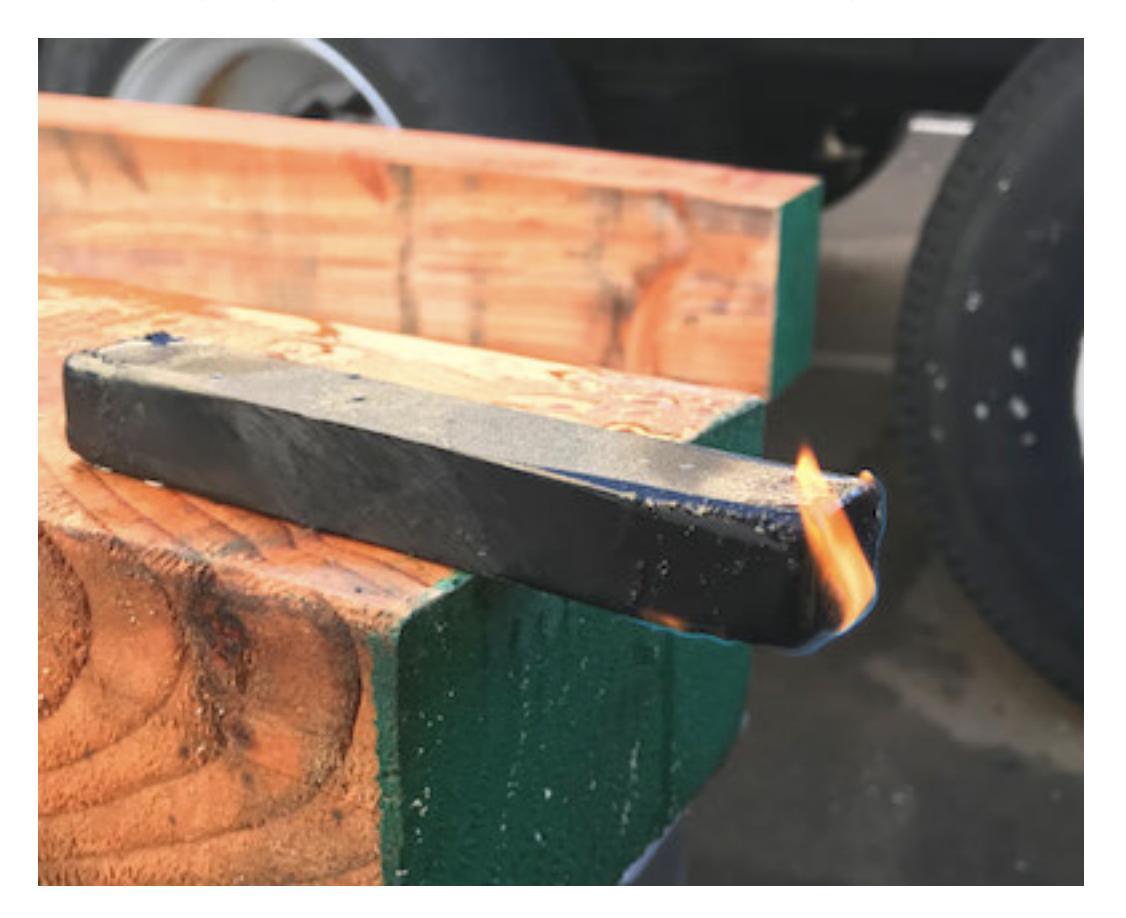
The flooring of the cabin within Cyclops 2 (Titan) is currently made from a material called HDPE.

A sample of the flooring material was set alight for approximately 3 seconds outside of the OceanGate facility and the material continued to burn after removing the ignition source, the burning material released toxic fumes and the resultant melted remains continued to burn as they dropped to the asphalt below. It should also be noted a sample of the vinyl tape wrapped internally within Cyclops 2 (Titan) emits highly toxic gasses upon ignition.

The following image shows the test material used. Video footage of the test can be provided to show the continued burn.
