<u>CHECK ONE, if applicable:</u>	Pre-Construction Notification (PCN) <input type="checkbox"/> (For Nationwide Permits ONLY)	SPGP <input checked="" type="checkbox"/>
---	---	--

The Hickory Manor Phase I was permitted through WP4-16-0704. Phase II of the development proposes to construct 83 detached condominiums and associated infrastructure on 19.64 acres of land. The resources to be impacted on the property include a PEM wetland that is 10,116 acres and 30,081 sq ft of farm ditches that were used for irrigation when the property was a tree farm. The USACE called these ditches linear wetlands because the ditches had not been maintained, vegetation had grown in some of them, and they held water. All wetlands within the project boundary will be impacted due to the layout of the homes and geometry of the site. It is not preferable to leave a ditch running through the center of a neighborhood due to safety concerns. The proposed stormwater BMPs will contain and treat stormwater better than the existing ditches on the property. All wetlands will be mitigated except Impacts 7a, 7b, 8, 9 that lack vegetation. The applicant will purchase 0.499 wetland credits from a mitigation bank within

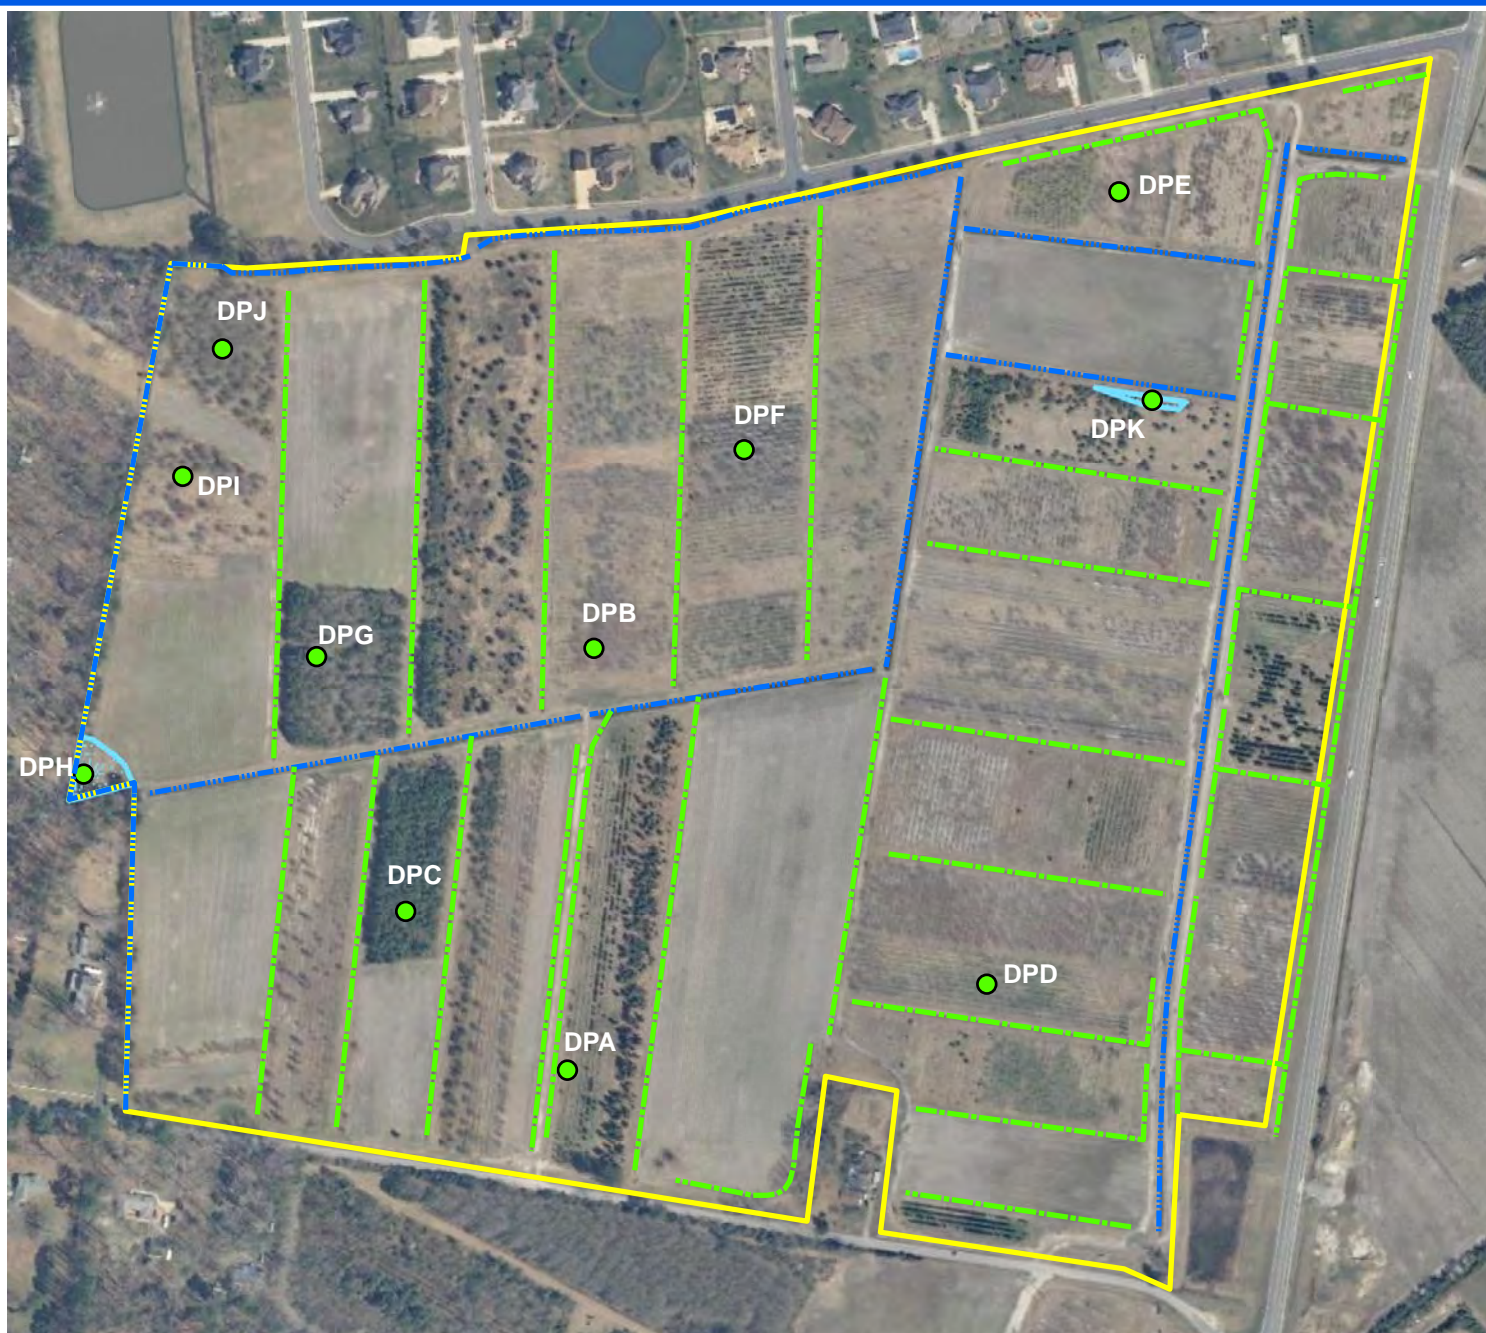
Figure 2: Site Conditions
 Greenbrier Farms
 Wetland Delineation
 Chesapeake, Virginia

Scale: 1 in = 400 ft
 Bay #: 14-204-01
 Date: 5/28/15
 Prepared by: AJLC
 VA PWD # 3402000113
