Survey Report for Sediment Sampling and Analysis at Port Orford and Umpqua River Federal Navigation Channels, OR

Contract No. W912DW-12-D-1016-DT01

ANAMAR Environmental Consulting, Inc.
1001 SW 5th Avenue, Suite 1100
Portland, OR 97204

October 2016

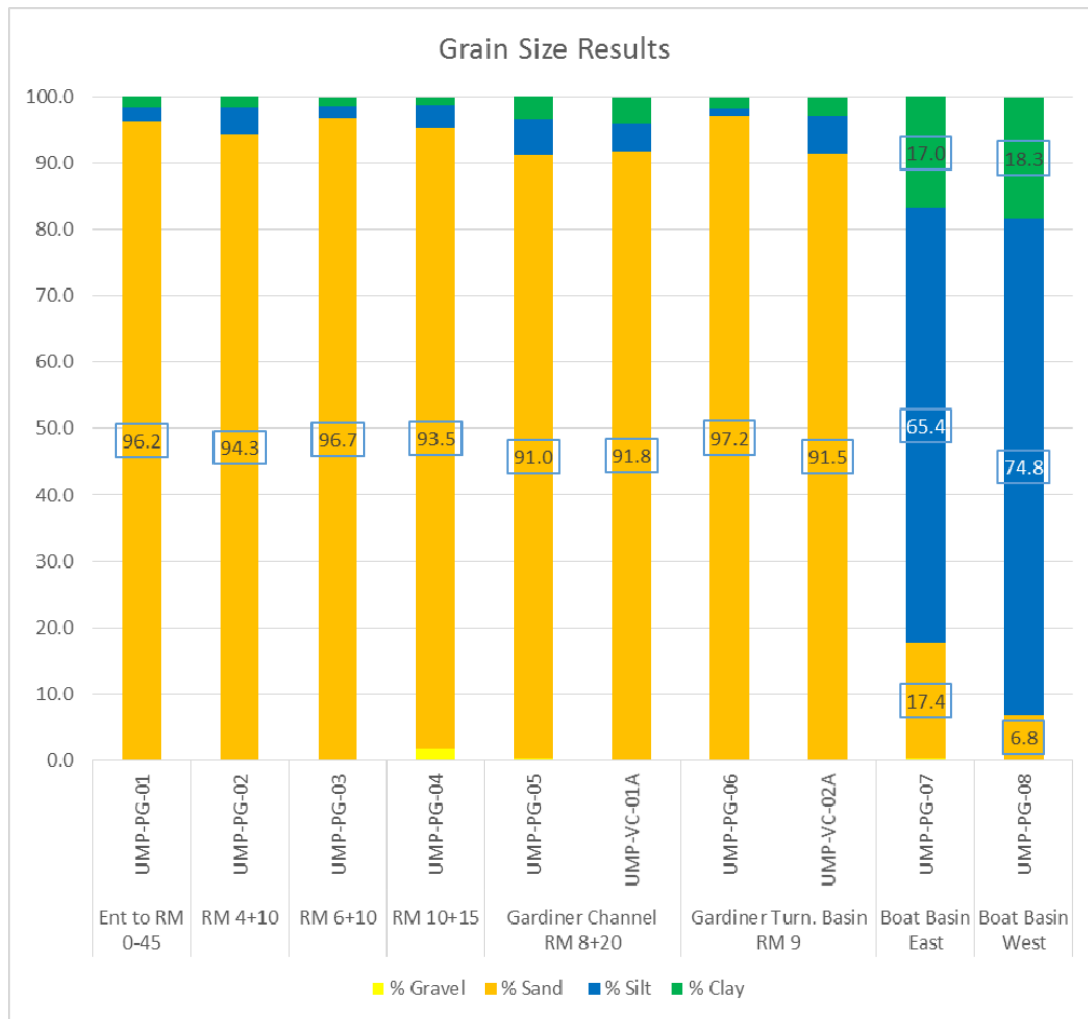
Figure 3-2. Percent Grain Size Distribution – Umpqua River and Boat Basins

Eight samples were collected for physical grain size analysis. Complete results for physical analysis are presented in the laboratory reports provided in **Appendix C**. Percent grain size distribution is presented in **Figure 3-2**. All of the samples within the Umpqua River federal navigation channel consisted of predominately sand ranging from 91.0% to 97.2%. The two samples collected from the boat basins in Winchester consisted primarily of fines (silt/clay) ranging from 82.4% to 93.1%.

Table 3-2 summarizes additional physical data. All samples within the Umpqua River federal navigation channel were classified as poorly graded sand with silt (SP-SM) or poorly graded sand (SP) and non-plastic. The samples collected from boat basins east and west were classified as sandy elastic silt (MH).
