# F/V SCANDIES ROSE

## Search and Survey Report

February 25, 2020

F/V SCANDIES ROSE – February 11, 2020

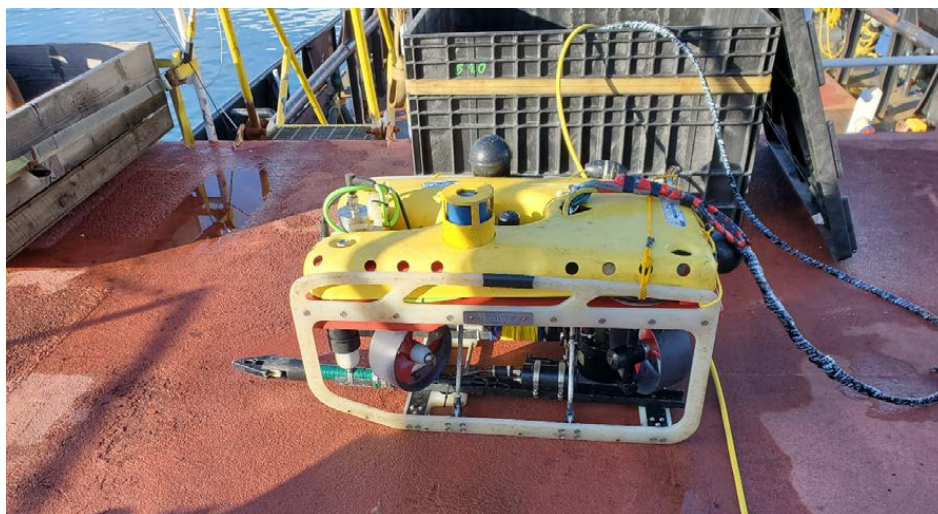
Figure 2: SAAB SeaEye Falcon ROV

Global utilized the SAAB Seaeye Falcon Remotely Operated Vehicle for the survey. The SAAB Seaeye Falcon is an inspection-class vehicle rated for depths up to 330 meters. Lightweight yet powerful, the Falcon is an exceptionally efficient, versatile machine. The Falcon is small enough to be deployed and retrieved by hand and transported in a pick-up. Global's Falcon is fitted with single-beam scanning sonar and supports a number of other sonar options, additional sensors and tooling add-ons. The Falcon's high-resolution fixed-focus camera is fitted to a platform that can be tilted up to 90-degrees

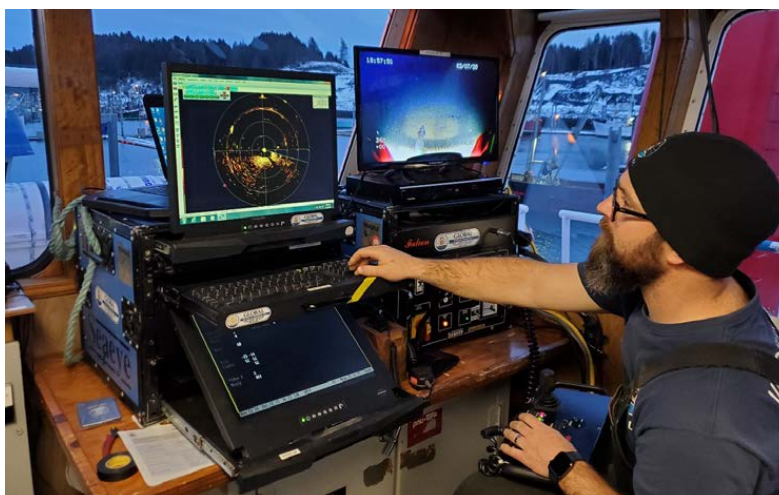
Figure 3: ROV Pilot testing the ROV Sonar and camera systems

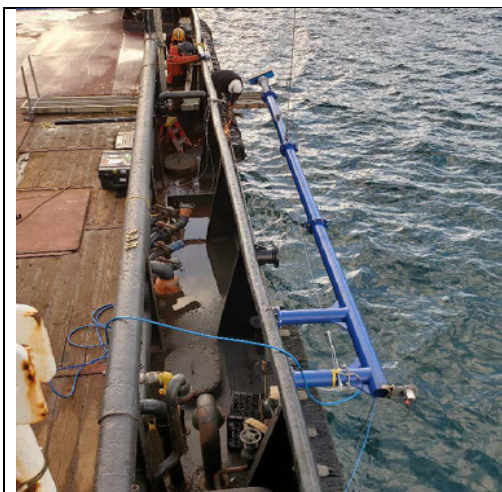
Figure 4: Crew deploying hydrographic pole after installation of the multibeam sonar head. The pole is stored in this position during transit.

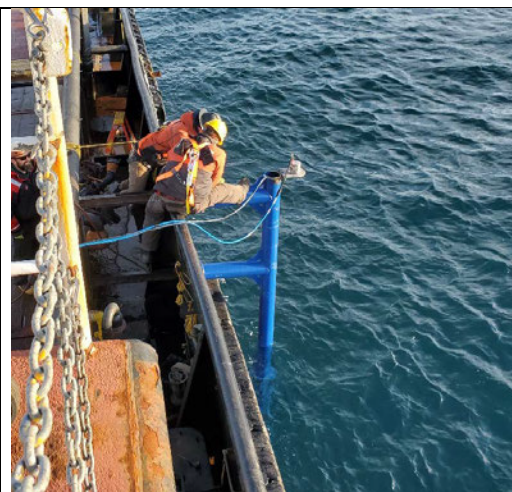
Figure 5: Hydrographic pole deployed and being secured into the vertical position

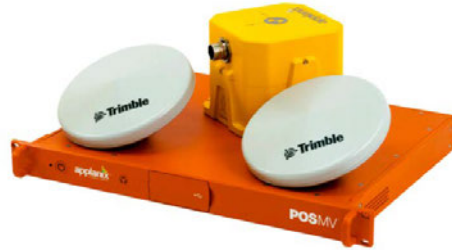
A POS MV OceanMaster V5 was used to provide accurate attitude, heading, heave position and velocity data for the survey vessel ENDURANCE. The POS MV OceanMaster blends GNSS data with angular rate and acceleration data from an IMU and heading from the GNSS Azimuth Measurement Subsystem (GAMS) to produce a robust and accurate full six degrees-of-freedom position and orientation solution.

**Specification Details:** Position Accuracy, Horizontal: +/- (10mm + 1 ppm x baseline length) Position Accuracy, Vertical: +/- (20mm + 1 ppm x baseline length) Roll and Pitch Accuracy: 0.03° Post processed to 0.015° Heading Accuracy: 0.03° Heave Accuracy: 5cm

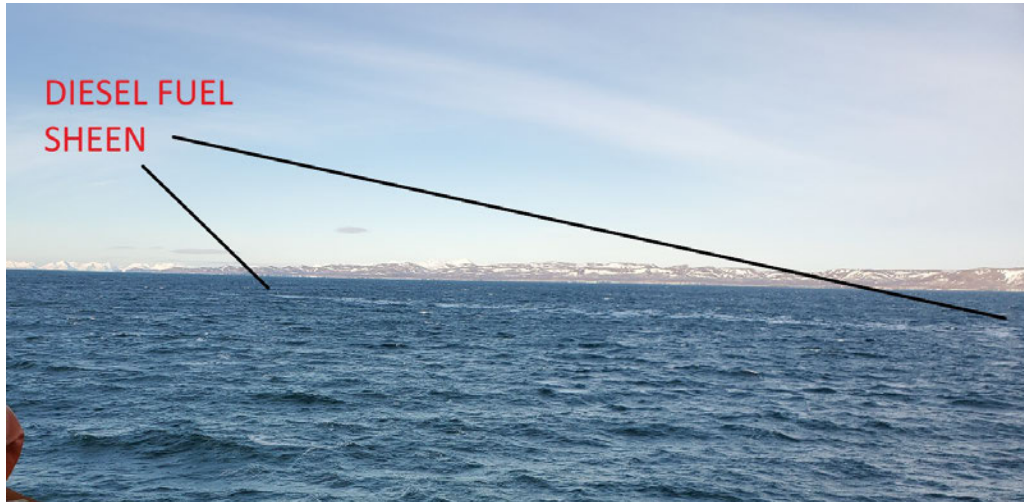
Upon arrival in the vicinity of the SCANDIES ROSE the crew observed the sheen of diesel fuel rising to the surface and extending with the current approximately  $\frac{1}{4}$  mile. This discharge was observed throughout the time spent on the location. At one point during the ROV survey fuel bubbles were observed at the front of the house but no point of origin could be determined due to debris and entanglement hazards.

Figure 6: Diesel fuel on the surface

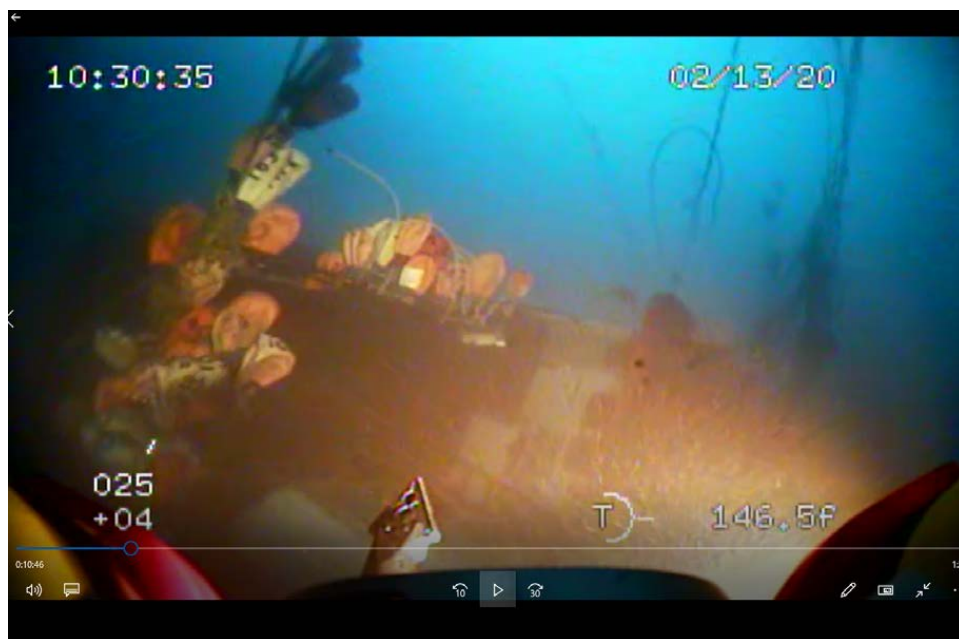
Figure 8: Crab pots, a tethered life ring and random lines extend upward from SCANDIES ROSE to within 40' of the surface

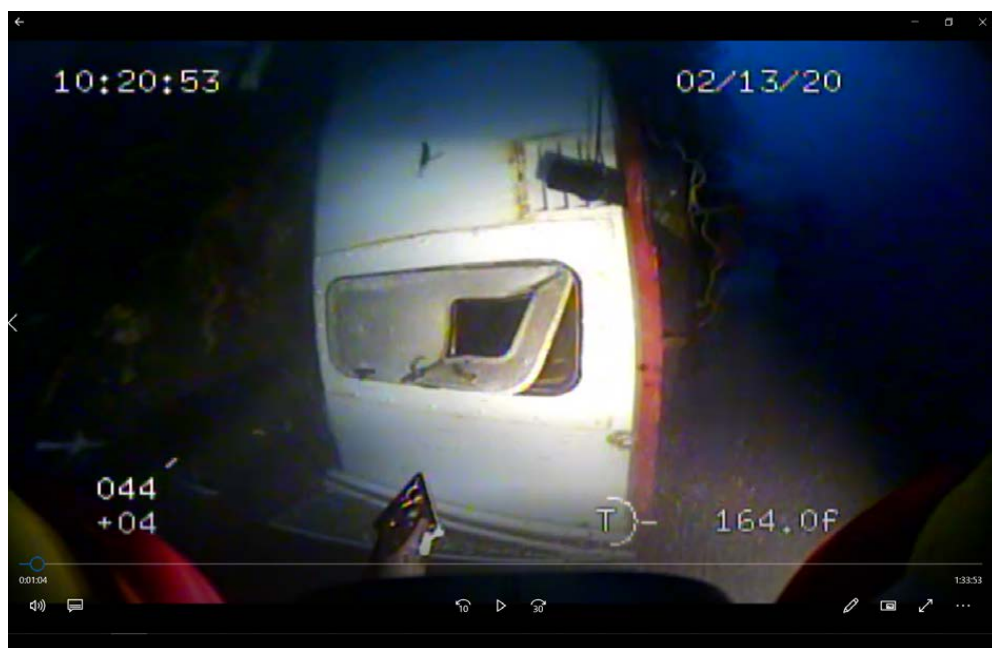
Figure 9: A man door located at the starboard stern of the accommodation suffered damage.

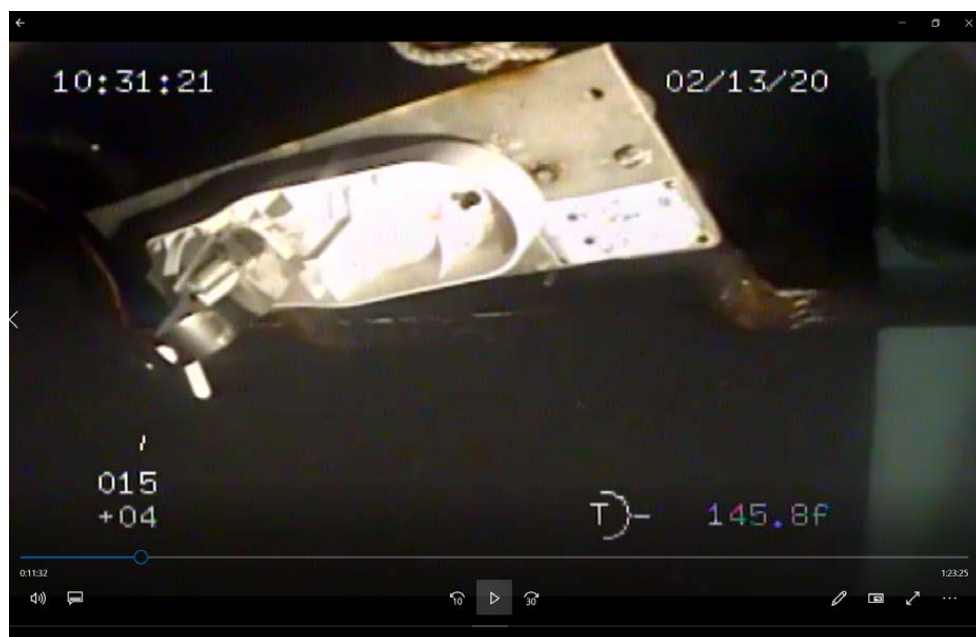
Figure 10: The EPIRB bracket was located on the port rail aft of the wheel house door.

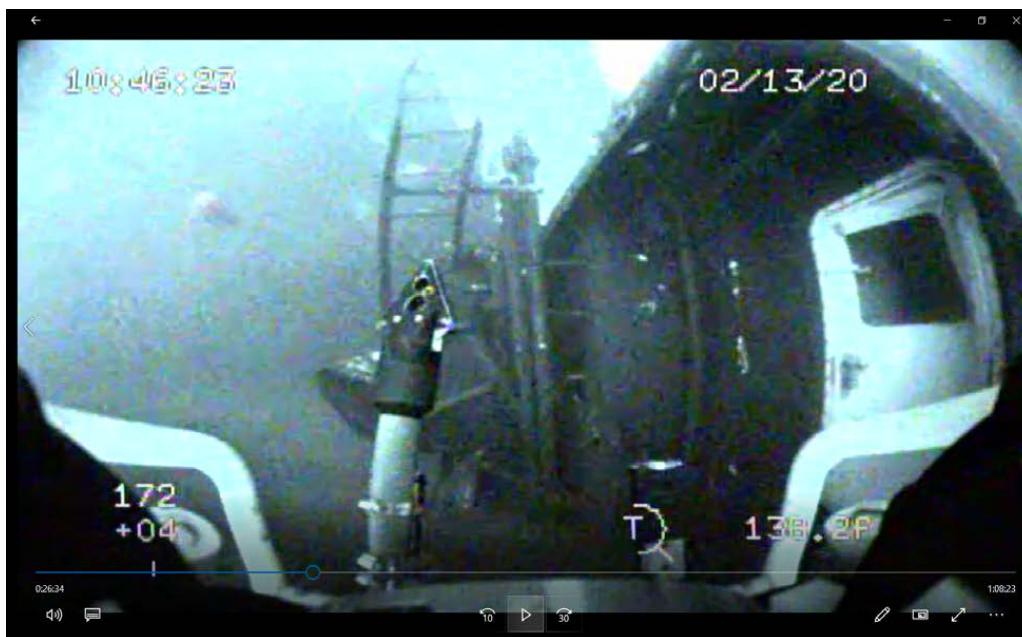
Figure 11: Port side forward main deck door is damaged

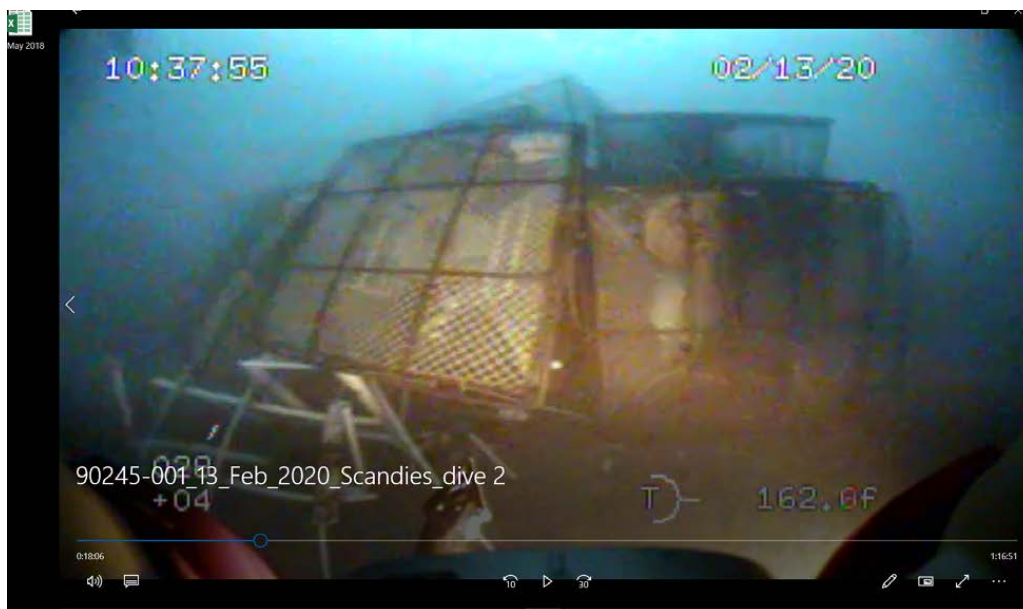
Figure 12: Dislodged crab pots are piled on the sea floor

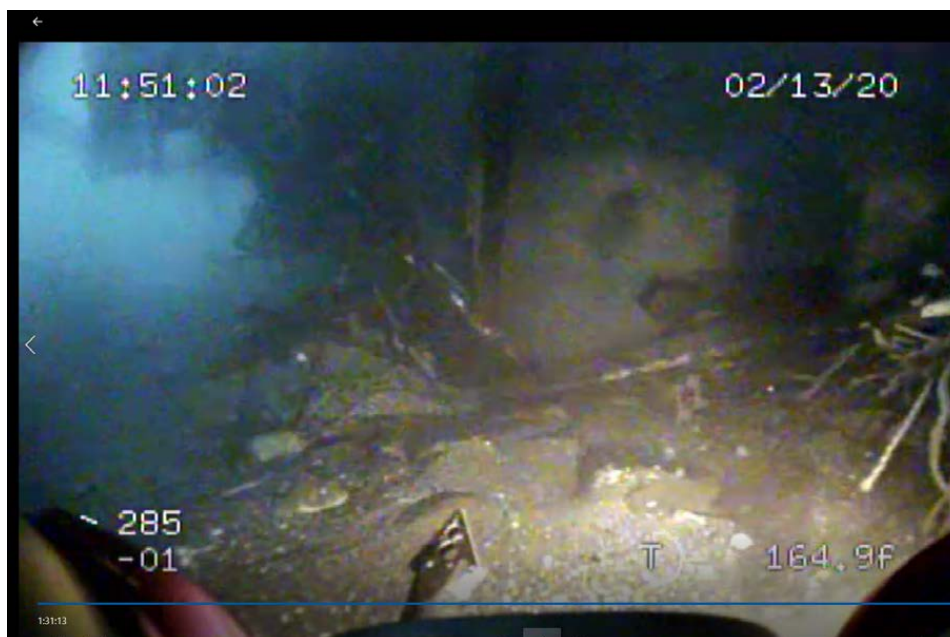
Figure 14: Starboard side shell impacting the seafloor and crushed debris precluded inspection of the starboard area of concern.

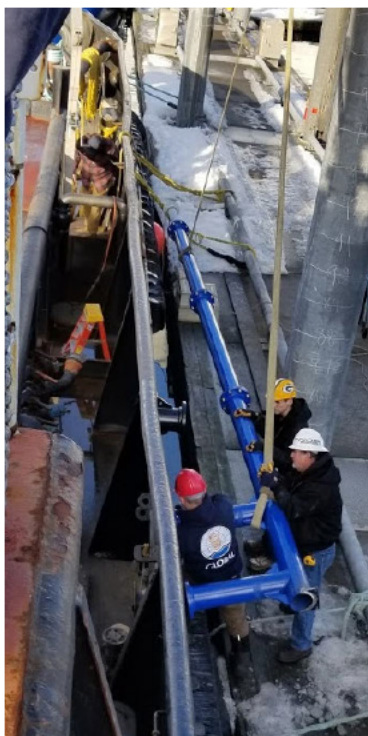
Figure 3 Endurance Sensor Mount

To mount the R2Sonic 2024 sonar, HiPAP 352 and ADCP on *Endurance*, the crew had a custom sonar arm fabricated (Figure 3 *Endurance* Sensor Mount)

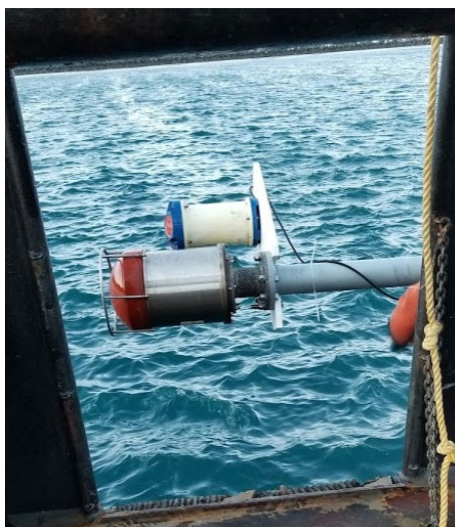
Figure 5 HiPAP (inboard) & ADCP (outboard) mounted on Endurance

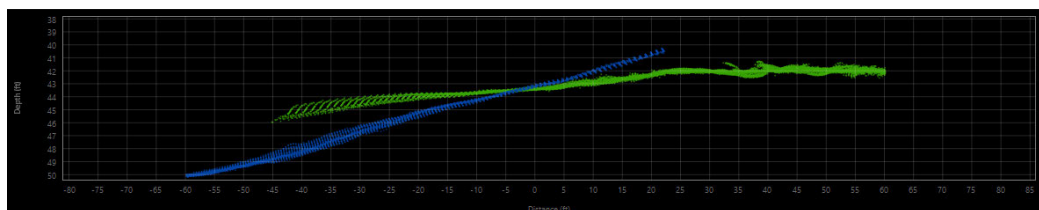
Figure 6 Pre-Patch Test Roll Calibration

A patch test calibration quantifies and adjusts for misalignment angles between the multibeam sonar and the IMU. During the survey, specific planned lines were run to account for Roll, Pitch, and Yaw misalignment values.

Based on this patch test, each of the three misalignment angles can be isolated and corrected in post processing. An example of a pre and post patch test calibration can be seen below in Figure 6 and Figure 7.

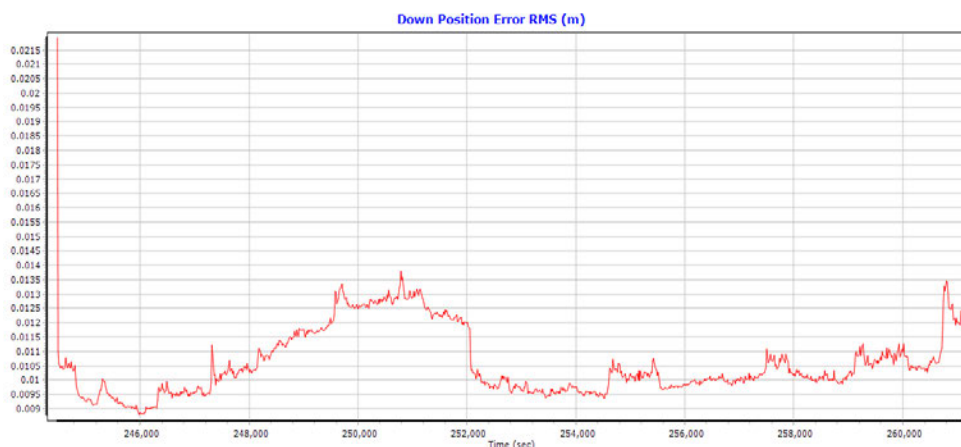
Figure 8 Example Down Position Error for MBES Surveys

Position data was post-processed in Applanix POSPac MMS Inertial Processing Software using both the vessel data file and receiver file (RINEX). This allowed for the creation of a more accurate and robust Smoothed Best Estimate of Trajectory (SBET) solution which was applied to the Multibeam data for positioning corrections and horizontal and vertical control throughout the duration of the surveys. Prior to applying corrections, the SBET was analyzed for errors as seen below in Figure 8. After the data was analyzed for errors, the full motion and position solution of the SBET was applied to the MBES data to maximize overall accuracy.

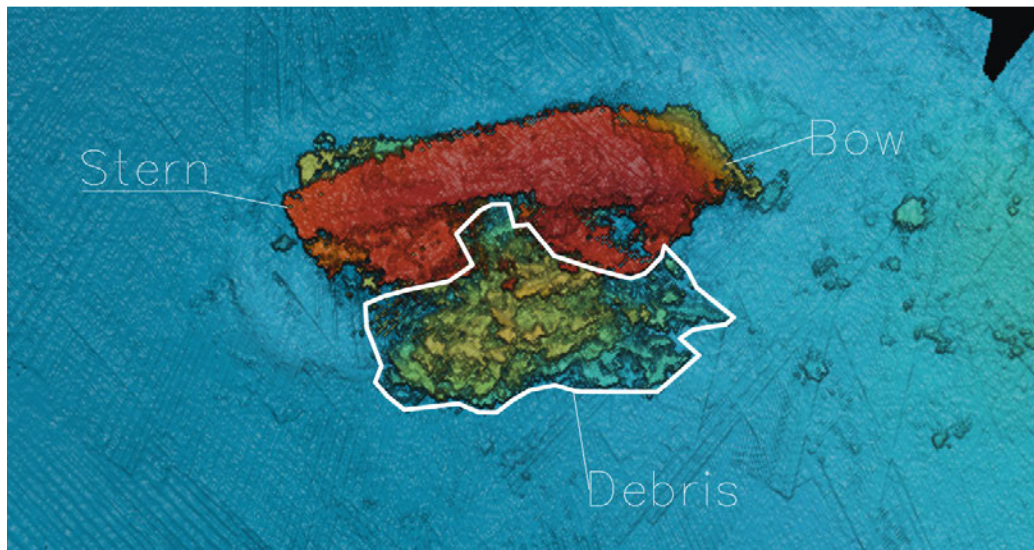
**Figure 9 2D gridded surface of Scandies Rose**

The multibeam bathymetric surface for the Scandies Rose ranges from -141ft to -167ft NAVD88 (Figure 9). What can be gathered from the multibeam data is the Scandies Rose is lying on its starboard side in an east-west direction with the bow pointing east. Off the deck side of the vessel is a debris field roughly 94ft x 42ft with height off the seafloor of ~20ft. East of the vessel shows various sized objects that could potentially be other debris that fell off the vessel during the sinking (Figure 10).
