Restoration Advisory Board Meeting 8 June 2011

Parkwood Inn, Brunswick, Maine
7:00 PM
(Printed on 100% post-consumer recycled paper)

Family Services Center - Building 27 Vapor Intrusion Study Update (cont'd)

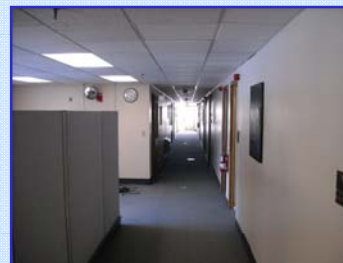
Central Corridor of Building 27

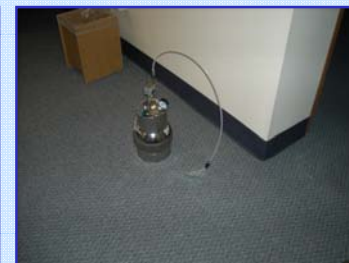
Subsurface Soil Gas Sampling –
Central Corridor of the Building
(SG-04)

- Collected four indoor air, six subslab soil gas, and two outdoor air samples in January 2011.
- Subslab soil gas probe locations were selected to obtain representative data from locations throughout the entire building.
- Subslab soil gas samples were collected over an 8-hour period using 6-liter SUMMA canisters.

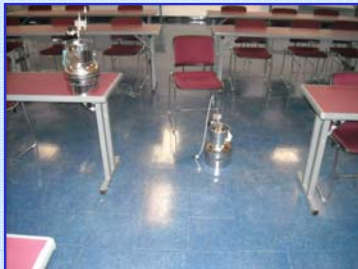
Subsurface Soil Gas Sampling –
Open Conference/Meeting Room
(SG-03)

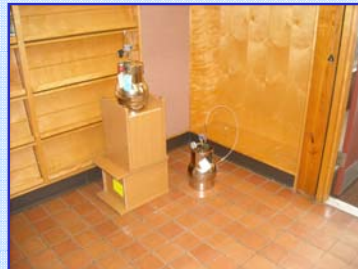
Subsurface Soil Gas Sampling –
Mid-Section of the Building in the
Reception Area (SG-05)

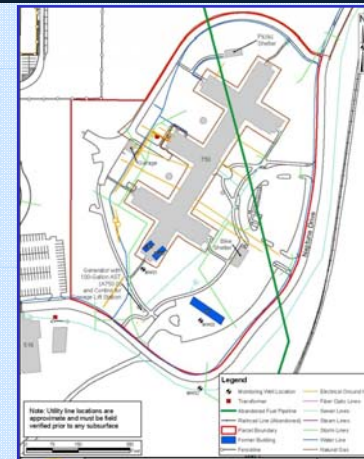
Building 35 Investigation Scope

- Three borings
- Three wells at top of clay
- Soil screening
- Groundwater sampling

- Soil: No photoionization detector (PID) headspace or other evidence of contamination; therefore, no soil samples collected.
- Groundwater: No detections of VOCs, volatile petroleum hydrocarbons (VPH), or extractable petroleum hydrocarbons (EPH) constituents.

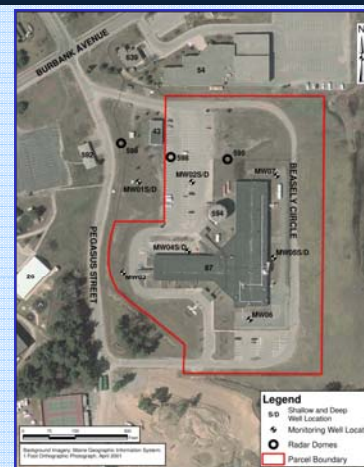
Building 87 Investigation Scope:

- Seven boring locations
- Seven shallow wells
- Four deep wells
- Soil screening
- Groundwater sampling

- Maximum detection of any analyte was trichloroethene (TCE) (2.6 µg/L) at B87-MW01D (21 to 31 feet). No detections in 8 of 11 wells. All results less than EPA vapor intrusion criteria for workers.
- Few minor exceedances of minimum screening criteria. TCE and tetrachloroethene (PCE) concentrations exceeded EPA Regional Screening Levels (RSLs) in two samples but were significantly less than Maximum Contaminant Levels (MCLs). The PCE concentration in one well exceeded the MEG.

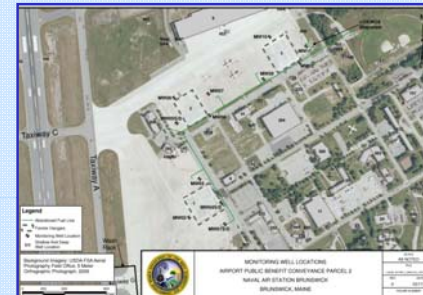
Hangars 1, 2, and 3 Investigation Scope:

- 12 boring locations
- Soil screening/sampling
- 15 temporary wells
- Groundwater samples

- Concentrations of seven metals exceeded minimum screening criteria, but only manganese and sodium exceeded Maine Maximum Exposure Guidelines (MEGs).
- Few VOCs were detected in three wells in excess of minimum screening criteria, but only one MCL/MEG exceedance (TCE at 12 µg/L at MW02).
- VPHs exceeded MEG at one well (C5-C8 aliphatics at 2,500 µg/L, C9-C10- aromatics at 210 µg/L at MW03).

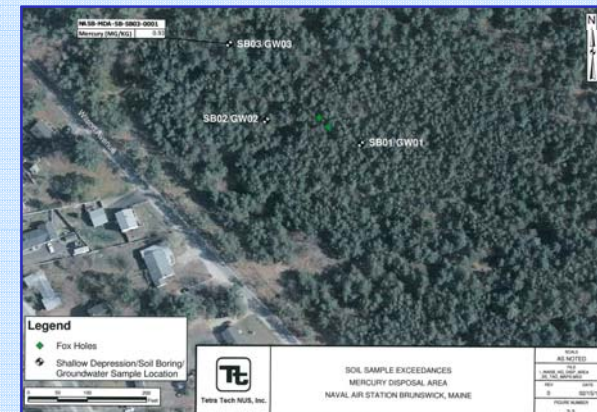
Mercury Disposal Area Soil Results

- Soil samples collected for mercury analysis at four locations based on mercury field screening.
- Mercury detected in one soil sample at 0.74 mg/kg), less than EPA and MEDEP residential soil screening values.
- Groundwater samples collected from three temporary wells; mercury was not detected.

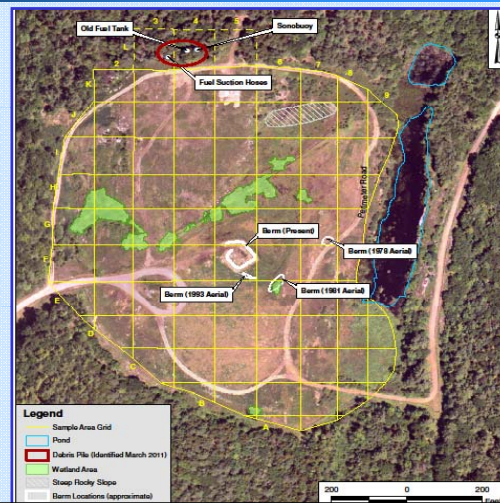
Site 12 EOD Area – Wetlands, Rocky Slope, and Debris Area North of Site to be Cleared During TCRA

- Complete the 2010 TCRA
 - Wetlands area – detector-aided survey and clearance of munitions and explosives of concern (MEC)/material potentially presenting an explosive hazard (MPPEH), if any, from ground surface
 - Steep rocky area – visual survey
- Investigate newly identified debris area north of site boundary (old fuel tank, sonobuoys, fuel suction hoses)
 - Detector-aided survey and clearance of MEC/MPPEH, if any, from ground surface
